# PERFORMANCE VERSUS SAFETY OF SOME PRIMARY AND RECHARGEABLE LITHIUM BATTERIES

The performance and safety of selected portable, military batteries is discussed, with emphasis on extreme physical and electrical abuse tests, such as nail penetration and overcharging. The battery couples discussed are the lithium-sulphur dioxide and lithium-manganese dioxide non-rechargeable systems plus the nickel-metal hydride and lithium-ion rechargeable systems.

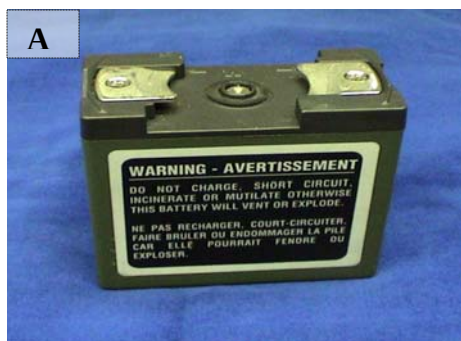
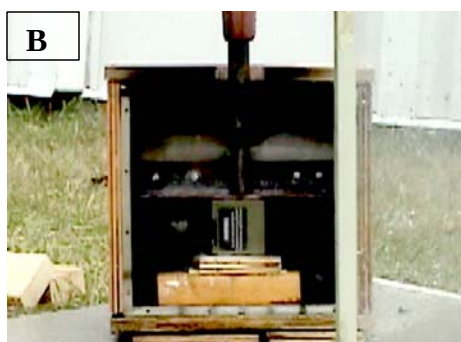
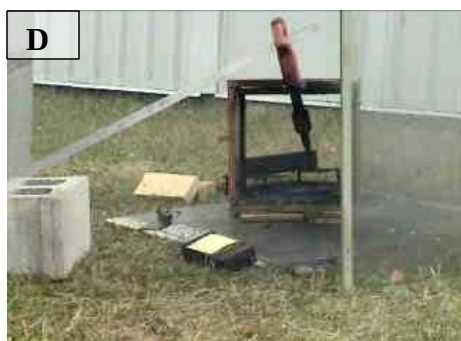
Figure 3. A. Photograph of a BA-521 battery; B. a lithium-thionyl chloride version of the battery in the nail test apparatus. C. the battery exploding (see text). D. the damaged apparatus.

A prototype BA-521, which contained lithium-thionyl chloride cells was offered to the CF for evaluation. This couple has very good low temperature performance but there are safety issues with the spirally wound cells. A nail test was performed on this prototype battery and it immediately caught fire and emitted thick white choking fumes of hydrogen chloride (hydrochloric acid). The fire was put out but, 5 minutes later the battery exploded violently, severely damaging the nail test apparatus (see Fig. 3). What had happened here was that the nail had penetrated 2 or 3 cells of one of the 4-cell strings of the battery, while the other string was left undamaged. However, the heat generated by the short-circuit had eventually been conducted to the good cells and, when the melting point of lithium metal had been reached, these cells reacted violently. This is an important aspect to remember when encountering a vented or damaged battery in the field – some of the cells may still be live and plastic insulation on the cells and connecting wires may have been burned away such that a short-circuit could be activated by disturbing the battery.

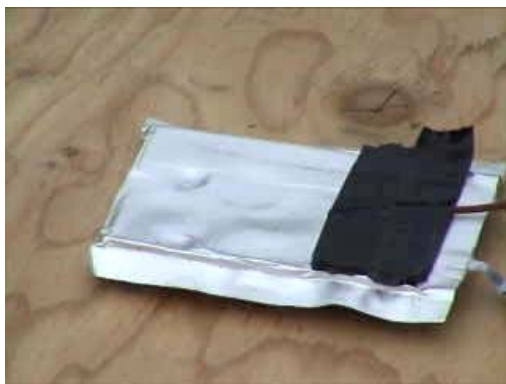
Figure 6. Photograph showing damage inflicted onto a lithium-ion gel-polymer cell by several hammer blows.

The UN impact test, which was really designed for metal can cells, requires having a 5/8" diameter rod resting across the cell and then dropping a 20 lb weight onto it from a height of 2'. The UN tests are aimed at the safety of new cells during transportation from the factory, which is often by air. For these tests, the cells need only be 50% charged, because new cells are delivered with a low state-of-charge. For our testing, we used 100% charged cells, because we are considering the safety of the cells in service. With this test, impact caused a rapid increase in pressure in the cell and it ruptured within 3 seconds, emitting copious white fumes. The cell then caught fire. When the test was repeated using a 50% charged cell, it was found to be passive. A perhaps more realistic impact test that we used was to hit the cell with a small hammer. This was done several times on the same fully charged cell and it maintained its voltage of 4.2V and did not increase in temperature. The indentations on a cell can be seen in Fig. 6. Another fully charged cell was chopped with an axe as it lay flat. The cut was in between the two cell tabs and across half of the cell. The cell maintained its voltage and no smoke or fire was produced. The test was terminated after 20 minutes.
