# **Numerical Simulation of Galvanic Corrosion Caused by Shaft Grounding Systems in Steel Ship Hulls**

**Defence R&D Canada – Atlantic**

Technical Memorandum  
DRDC Atlantic TM 2004-284  
January 2005

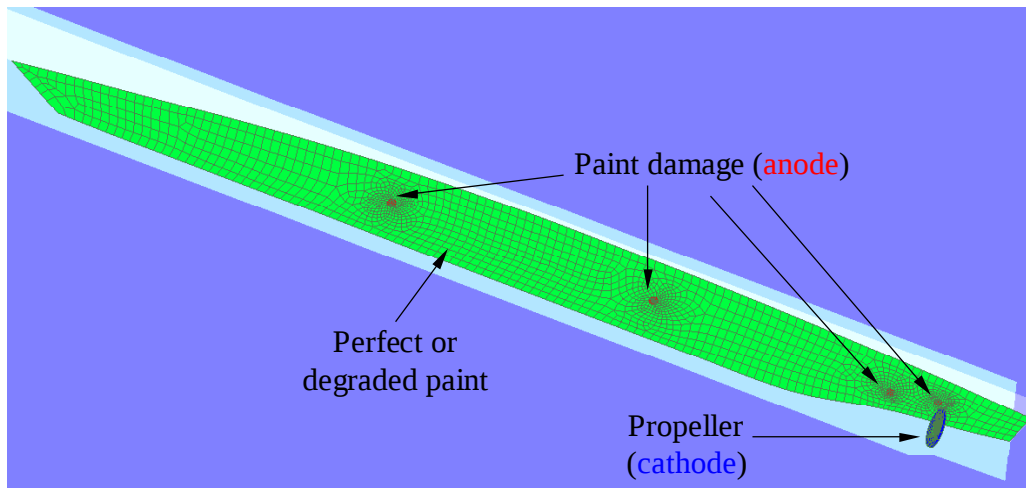
*Figure 1. Ship model for galvanic corrosion modelling.*

The model under consideration is based on a Canadian naval ship. The model, generated using the CPBEM code, is presented in Figure 1. In this study, it was assumed that all paint damage areas on the ship hull are symmetric to the central plane. Therefore, only half the ship hull needs to be panelized and modelled. The model includes a propeller (cathode) and various paint damage areas (anode). The large light area represents the well-painted area (insulation) or degraded paint (anode), depending on the boundary conditions assigned in the area. The propeller, which is made of nickel-aluminum bronze (NAB), was modelled as a disk with the cathodic area on the disk equal to the surface area of the NAB propeller. The NAB disk is electrically connected to the ship hull although the shaft was not included in the model. A total of 1160 to 2050 elements were used in the model, depending on the number of paint holidays modelled, with smaller elements assigned to the area adjacent to the anodes. This mesh design will facilitate the smooth variation of the potential profiles expected in this area.

In most simulations conducted in this study, the model with a single paint damage site was used to investigate the effect of paint damage area and damage location on galvanic corrosion rate, while the model with four paint damage areas was used to study the distribution of galvanic corrosion current along the ship hull in both open-sea and alongside scenarios. The seawater conductivity of  $0.032 \Omega^{-1}cm^{-1}$  was used in the modelling study.

In another modelling trial, four paint damage sites of the same damage size ( $0.3 \text{ m}^2$ ) were assigned on the steel hull (see also Figure 1) in order to demonstrate the distribution of the galvanic corrosion current on the hull. Two fluid domains were taken into account: an infinite domain accounting for a ship in an open sea and a finite domain for a ship in a shallow water zone (e.g. alongside). In the finite domain, a quarter box was added to serve as the outside boundary of the domain. The dimension of the quarter box was 200 m long, 20 m wide and 10 m deep. The depth of 10 m is a typical water depth near the jetties in the Halifax harbor.

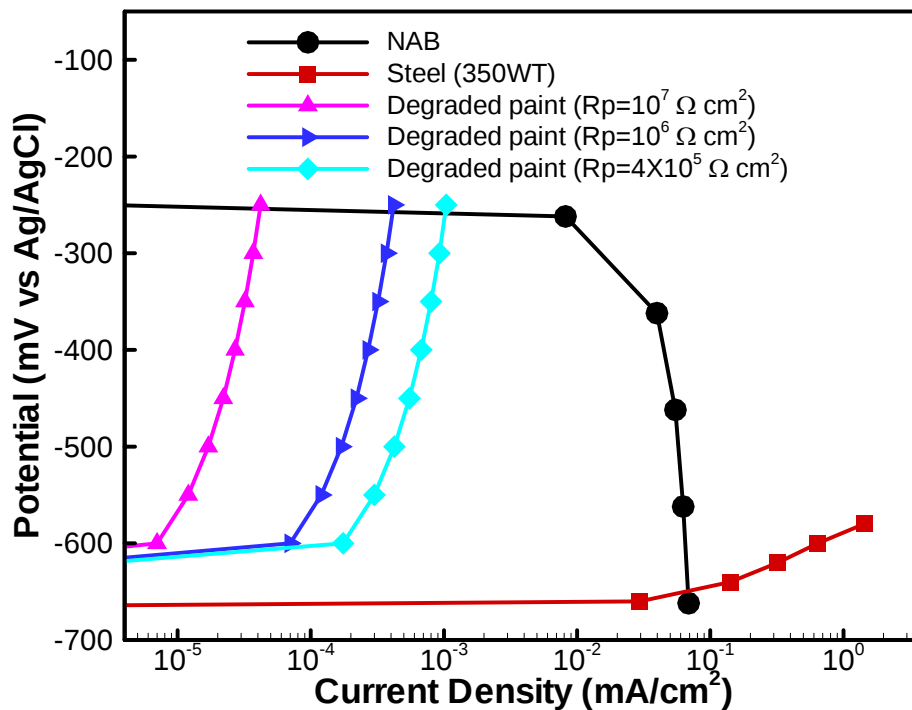
Figure 2. Polarization curve data for NAB, 350WT steel and degraded paint coating.

The polarization curve data for NAB, 350WT steel and degraded paints are presented in Figure 2. Those polarization curves were used as the boundary conditions for the galvanic corrosion modelling. The polarization curve for 350WT steel was used as boundary condition for the paint damage areas where bare steel was exposed. It should be noted that the polarization curves for both NAB and 350WT steel varied considerably with the surface conditions of the alloy or metal, seawater conditions (e.g. composition,  $O_2$  level, temperature), and ship operating conditions (e.g. alongside or at sea). One set of polarization curve data would not be able to predict galvanic corrosion rate for all conditions. The focus of this paper was to conduct parametric studies to investigate the effect of paint damage area and location, and paint degradation on the distribution of galvanic corrosion current, instead of predicting exact galvanic corrosion rate.

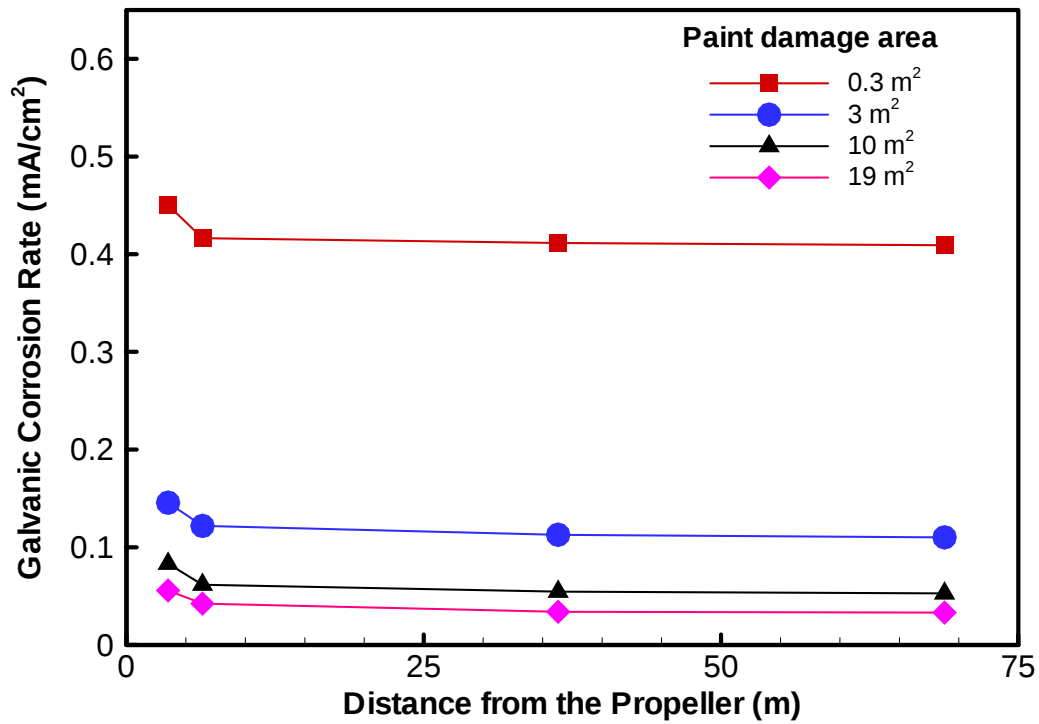
Figure 3. Galvanic corrosion rates as a function of distance from the propeller

The predicted galvanic corrosion rates of a single paint damage site at various distances from the propeller are presented in Figure 3. The ship was assumed to be in an open sea so the infinite domain was used. The distance was measured between the center of the paint damage site and the center of the NAB disk. The closest paint damage site on the ship hull to the propeller is the one right above the propeller, which is 3.5 m from the propeller. Figure 3 showed that, overall, the distance does not have significant effect on the galvanic corrosion rate of the steel hull. The galvanic corrosion rate, while slightly higher at the distance of 3.5 m, was approximately the same at the distances of 6.4 m and 68.8 m from the propeller. At 3.5 m from the propeller, the modelling results showed that the predicted galvanic corrosion rate is only 10% and 67% higher than that at 68.8 m from the propeller for the damage areas of  $0.3 \text{ m}^2$  and  $19 \text{ m}^2$ , respectively. Laque<sup>20</sup> experimentally demonstrated the distance effect on galvanic corrosion by simulating the possible galvanic action between a bronze propeller and a steel shaft in seawater. In this experiment, several folds of bronze mesh that had an exposed surface area that was equivalent to a bronze propeller were used to represent the propeller. A bare steel pipe and a steel shaft with insulating coating interrupted by a few bare spots at different distances from the propeller were used to represent the steel shaft. The length of the steel pipe was about 12 m. The results showed that the distance effect was great only within a short distance from the propeller. In both test cases the galvanic corrosion rate of the steel was approximately the same along the steel pipe after 1 m from the propeller. As mentioned before, the closest spot to the propeller on the steel hull is 3.5 m from the propeller. The modelling results in this study indicated that if there were one paint holiday on the under-water hull, the galvanic corrosion rate would be equally great no matter where the paint holiday was located on the wetted hull.

The results in both Figure 3 and Figure 4 also indicated that the solution resistance between the anode and the cathode is affected not only by the distance in between, but also by the sizes of both anode and cathode and the fluid domain. The solution resistance under various scenarios will be discussed in the subsequent section.

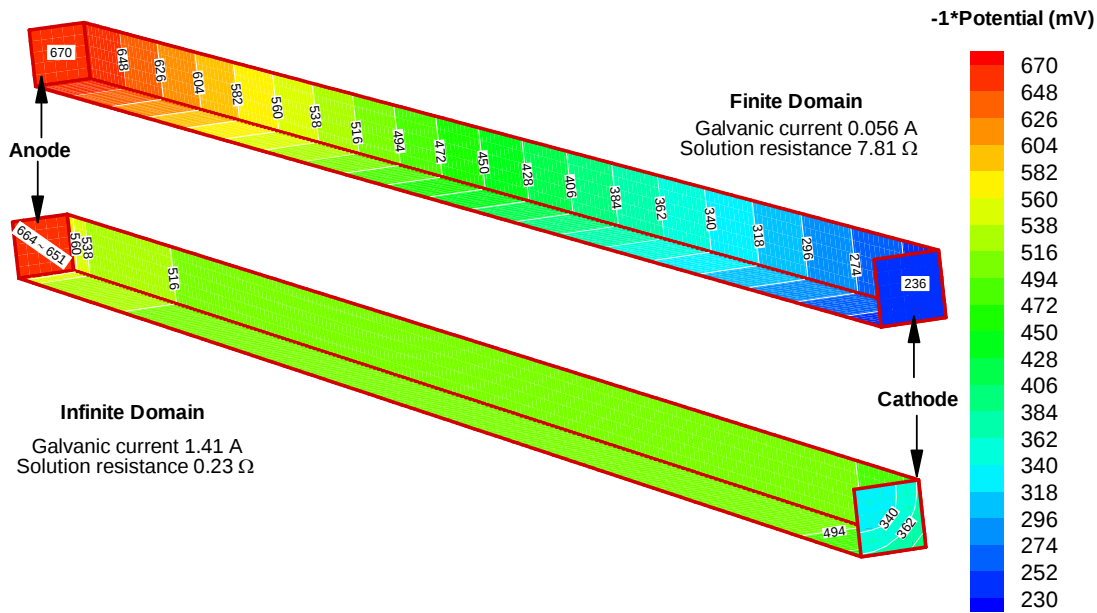
**Figure 5. Potential contours on the box surface in both finite and infinite domains.**

A box model was built to demonstrate the effect of fluid domain on solution resistance and galvanic corrosion current. The box was assumed to be 100 m long, 4 m wide and 4 m high. One end was assumed as anode and the other one as cathode. The remaining surfaces on the box were assumed as insulation. As the box was symmetric to the longitudinal centerline, the quarter box (i.e. 100 m long, 2 m wide, and 2 m high) was used in the computer modelling. The polarization curve data for the steel and NAB, which are presented in Figure 1, were used as boundary conditions for the anode and cathode, respectively. The same seawater conductivity data was also used for this modelling. Two fluid domains, finite domain and infinite domain, were used. In the finite domain, the box was filled with seawater and the box served as the outside boundary of the domain. In this case, all electrode surfaces faced inward. In the infinite domain, the box was assumed to be surrounded with large volume of seawater, and all electrode surfaces were assumed to face outward.

The potential contours on the box surface in both finite and infinite domains are shown in Figure 5. This figure demonstrated that the two fluid domains produced significantly different potential distributions along the box surface. In the finite domain the potential contours were evenly distributed along the longitudinal direction. In other word, the potential profile along the box had a linear relationship with the distance from the anode. This linear relationship between the potential and the distance from the anode resulted from the constant cross sectional area through which

the galvanic current passes. In the infinite domain, the potential contours were not evenly distributed with much greater potential drop near both anode and cathode surfaces. The potentials on both electrodes were not uniform either in the infinite domain. In fact, the predicted potentials were between  $-664$  mV to  $-651$  mV on the anode and between  $-324$  mV to  $-394$  mV on the cathode. The solution resistance data in Figure 5 also showed that the solution resistance between the anode and the cathode in the infinite domain was over 30 times lower than that encountered in the finite domain. Because of the great difference in solution resistance, the predicted galvanic corrosion current in the infinite domain is much higher than that in the finite domain (Figure 5). The figure also showed that when the box is surrounded by a larger volume of seawater, which is similar to a ship in an open sea, the potential changed only 22 mV over 80% of the box length, compared to the total potential drop of over 260 mV between the two electrodes. This finding indicated that the galvanic corrosion current encountered very low solution resistance when passing through 80% of the box length. The very low solution resistance in this region is attributed to the much larger cross sectional area in the galvanic current path offered in the infinite domain. These modelling results further indicated that in a larger volume of electrolyte the effect of distance became less significant on galvanic corrosion as the galvanic couples were farther apart.

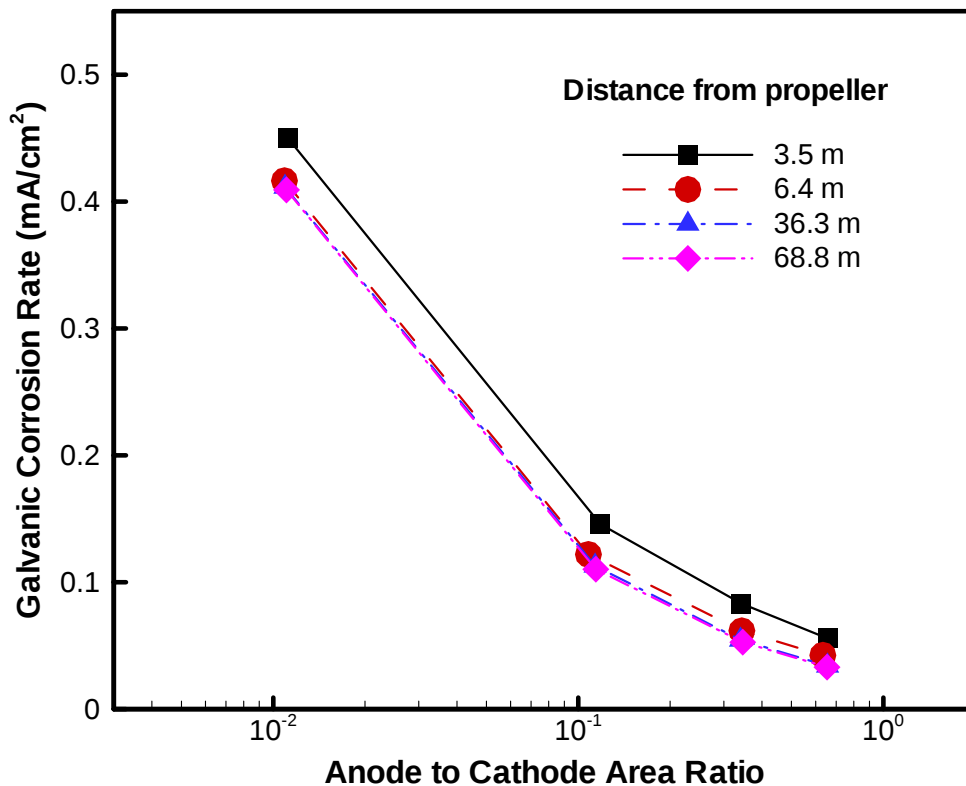
Figure 6. Effect of paint damage area on galvanic corrosion rate.

The paint damage area with a range from  $0.3 \text{ m}^2$  to  $19 \text{ m}^2$  was analyzed at different locations on the hull in this study. Figure 6 shows the effect of paint damage area, expressed as the ratio of anode to cathode area, on the galvanic corrosion rate. Although the galvanic corrosion current increases as the damage area expands, the galvanic corrosion rate decreases with the increased damage area. It is seen that the galvanic corrosion rate was 8 times higher at the anode-to-cathode area ratio of 0.01 than that at the area ratio of 0.65 no matter where the paint damage was located on the steel hull. Since the hull perforation caused by corrosion is the major concern, a smaller paint damage area would cause more corrosion damage to the steel hull than a larger paint damage area. These results also implied that a ship with a newly painted steel hull, which has fewer and smaller size of paint holidays, would be more likely subject to severe galvanic corrosion damage.

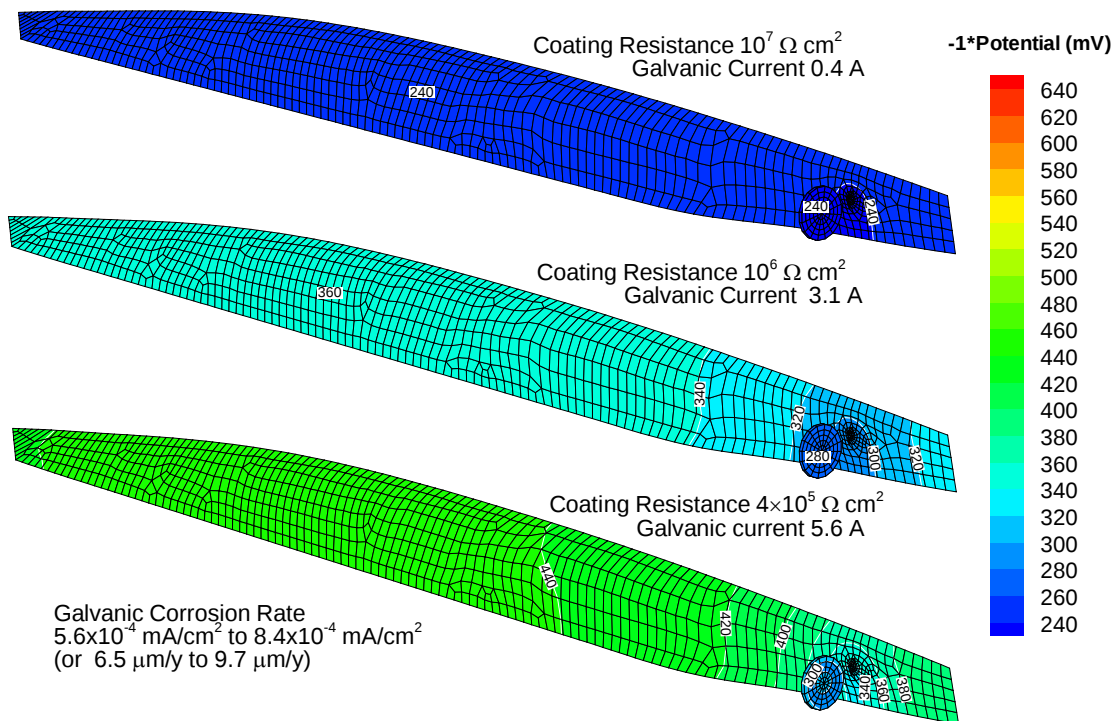
Figure 7. Potential contours on the ship hull computed at various stages of paint degradation.

The predicted potential contours and galvanic corrosion currents at various stages of paint degradation are presented in Figure 7. This figure shows that the coating resistance on the steel hull affected the overall hull potential levels and galvanic corrosion current. The predicted potentials were close to the open circuit potential of the NAB on the paint coating with high coating resistance. As the coating resistance decreased, the potential values on the hull shifted negatively toward the open circuit potential of the steel. The predicted galvanic corrosion current increased from 0.4 A to 5.6 A when the coating resistance decreased from  $10^7 \Omega \cdot \text{cm}^2$  to  $4 \times 10^5 \Omega \cdot \text{cm}^2$ . On the other hand, the simulation results showed that the galvanic corrosion current drawn to the NAB cathode was fairly equally contributed around the whole steel hull. For example, with a galvanic current of 5.6 A, the galvanic corrosion rate was predicted to be between  $0.00056 \text{ mA/cm}^2$  and  $0.00084 \text{ mA/cm}^2$  around the whole steel hull. The Figure 7 also shows that the potential level on the steel hull reflected the degree of the paint degradation. This result suggests that the electric potentials on the hull that were monitored when the ICCP system was off and the shaft grounding system was left on could be used to estimate the status of the overall paint degradation.

The above modelling results showed that both physical paint damage and the overall paint degradation on the steel hull contributed to galvanic corrosion current when the ICCP system was off and the active shaft grounding system was left on. The overall paint degradation could contribute substantial galvanic corrosion current as the paint coating aged because of very large paint coating area on the wetted hull. However, the sites with physical paint damage contributed much greater localized corrosion rate than that on degraded paint as a result of the smaller area and the much greater polarization current densities on the surface. These results imply that a high galvanic corrosion current does not always mean severe corrosion damage to the ship hull. This high galvanic current may be mainly contributed from the overall paint degradation around the ship hull. It is the total physical paint damage area that determines the extent of the localized corrosion damage to the steel hull.
