TITLE: Modeling for Military Operational Medicine Scientific and Technical Objectives

CONTRACTING ORGANIZATION: Jaycor  
San Diego, CA 92121

REPORT DATE: September 2005

TYPE OF REPORT: Annual

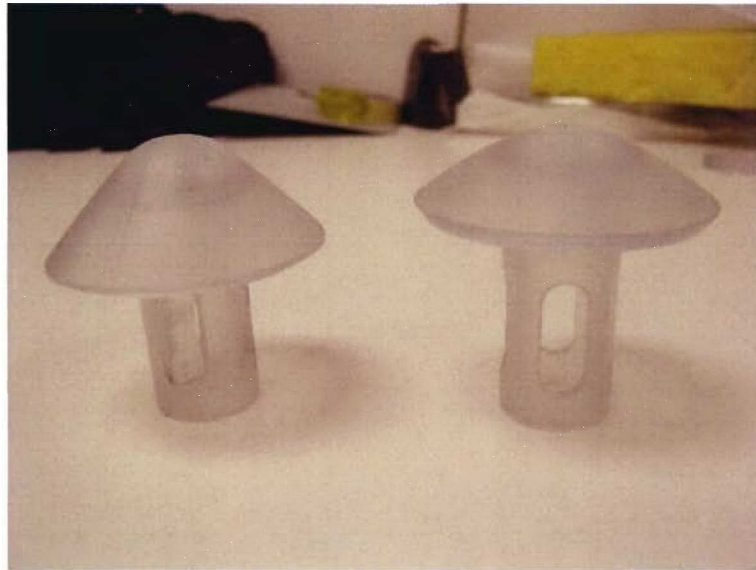
**Impactor clay tests** were conducted using a soft armor impactor and a hard armor impactor, as shown in Figure 2 below. These impactors have different diameter, shape and mass and simulate the behind soft and hard body armor impacts, respectively, at given speeds. Before each test, the clay was heated, using two heating pads and a reflective shell to contain the heat within the clay. The average temperature, taken along four equally spaced depths at nine equally spaced locations on the clay surface, was 93°F. During the tests, the impactors were driven by a piston that was launched by high pressure helium gas. The pressures in the tests varied from 100-800psi. These impactors free-flew after the launching rod was pushed to the end of its length, culminating in the collision with the clay block. The results from the clay tests performed using the impactors are given in Table 1.

Figure 2. SBA Impactor (left) and HBA Impactor (right)

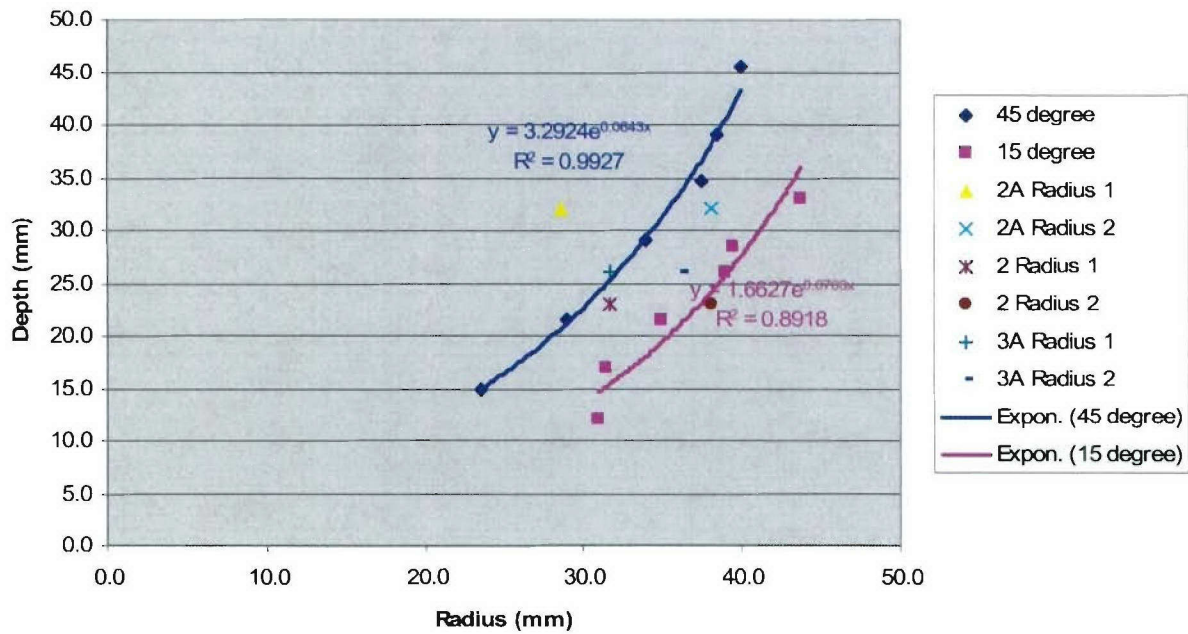
The results from the live fire tests performed on the clay are given in Table 3. These results were analyzed and then compared against the results from the laboratory clay test, as a means to validate the ability of the impactors to produce craters of similar dimensions to those observed in live fire testing. Figure 4 shows that the crater from the 45 degree smaller impactor matched very close to the live fire test results, indicating that it was a good simulator of behind body armor impacts at the velocity range used in the tests.

Comparison of Clay Depth and Radius from Lab and Live Fire Testing

Figure 4. Laboratory versus Live Fire Clay Data

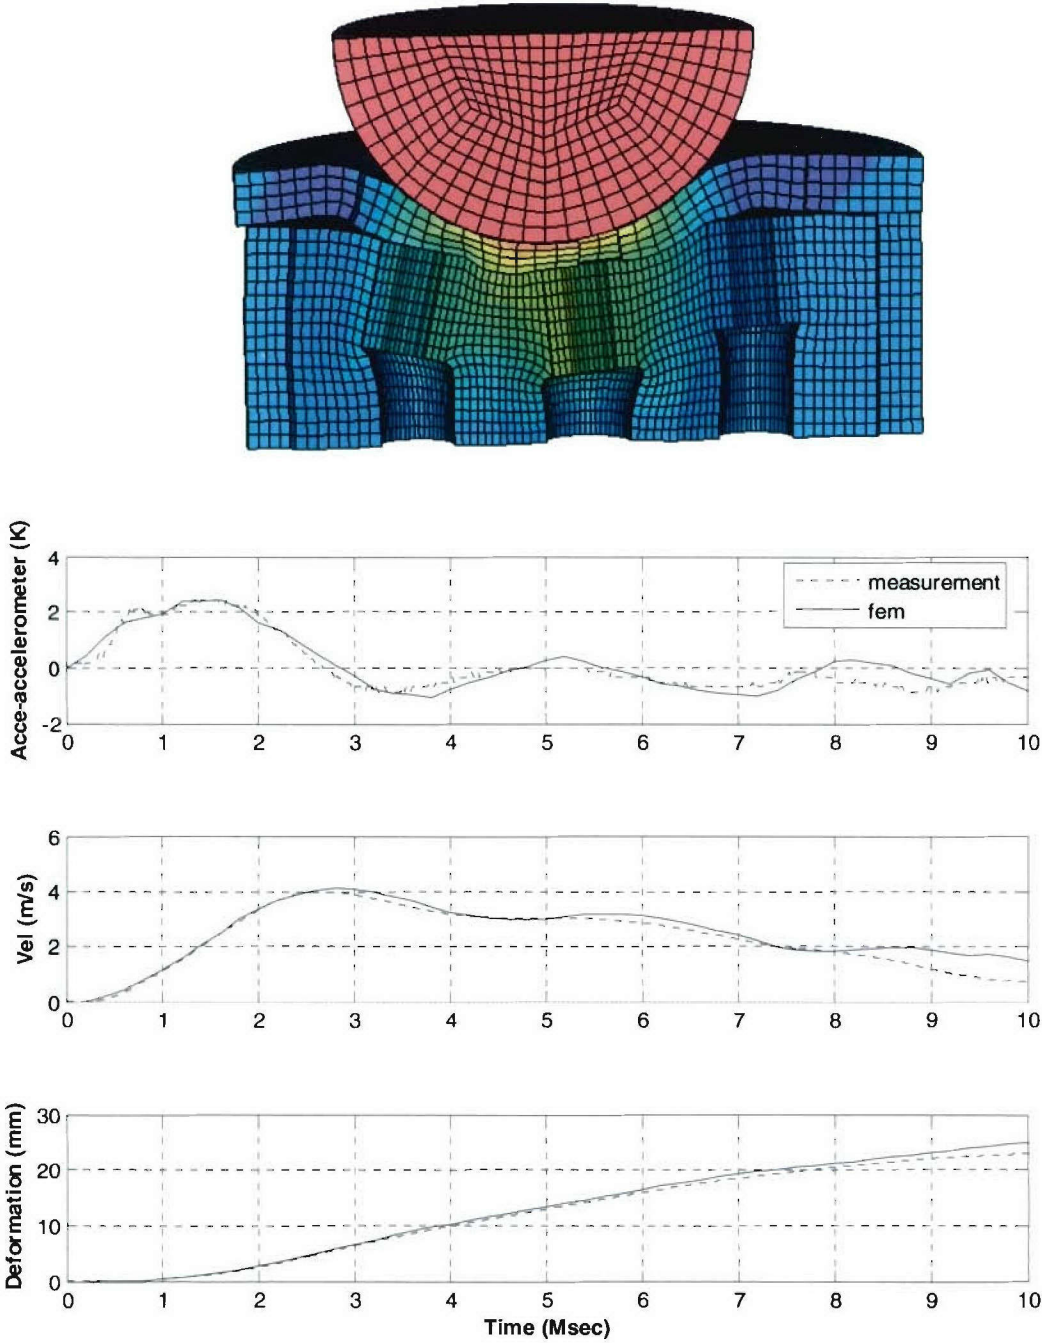
For interpreting ATM measurements and calibrating the response characteristics of ATM, finite element models were developed for the ATM and were validated against the drop

tests and impactor on ATM test data. FE simulations and the comparison of the calculated motion results were given in Figure 7 and Figure 10 respectively. These results indicated that the ATM FEM accurately predicts the ATM responses.

Figure 7. Validation of FE model of ATM against drop tests

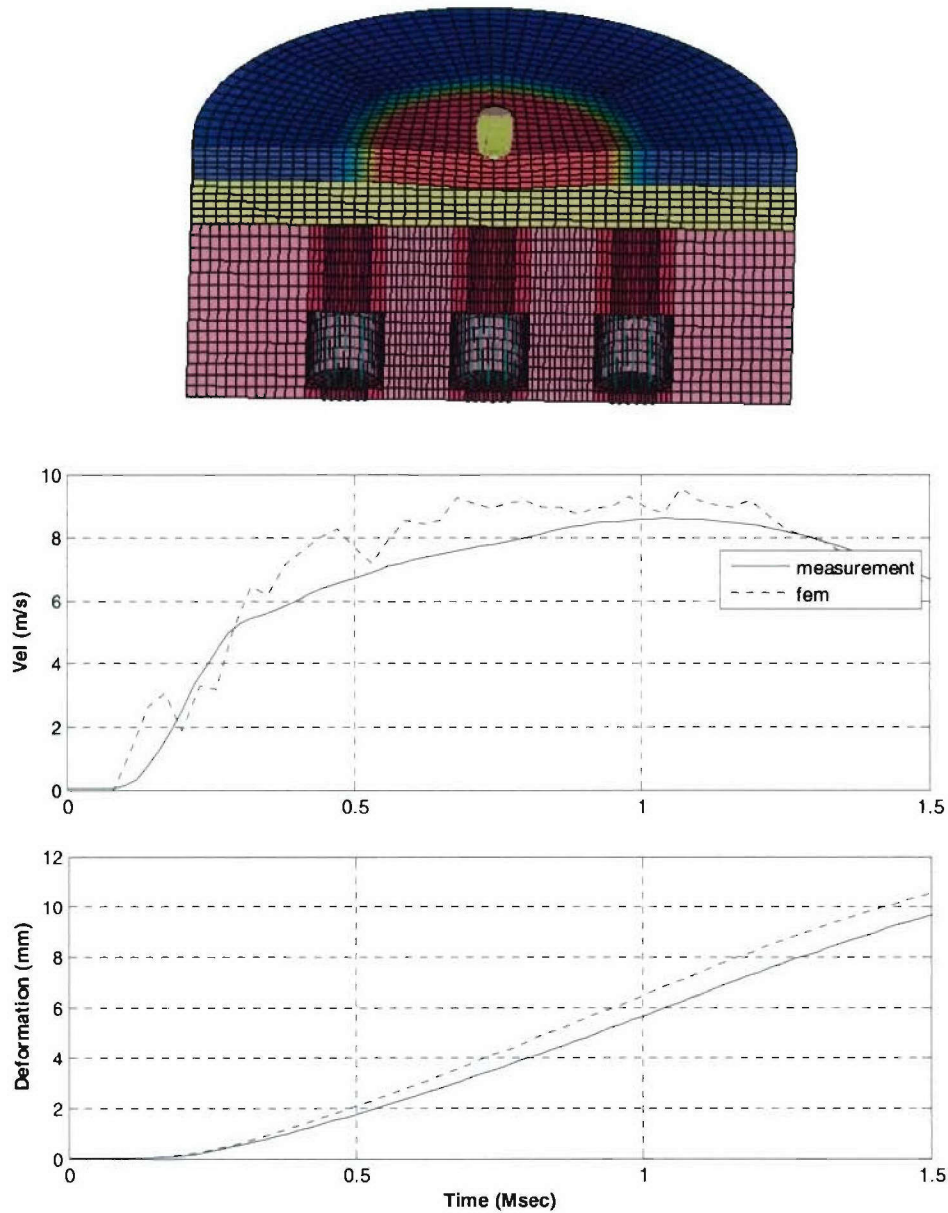
The validated FE model of ATM was then used to determine effective behind armor impact. To accomplish this, FE models of a bullet and a material layer that simulates the body armor were introduced. The armor simulating layer was modeled as a simple material which involves several material parameters, reflecting the overall armor response during the impact. Inverse solution of the problem by iteration determines the parameters that best match the ATM measurements. A comparison of simulation and live fire test results is given in Figure 9.

Figure 9. Validation of FE model of ATM against live fire test results

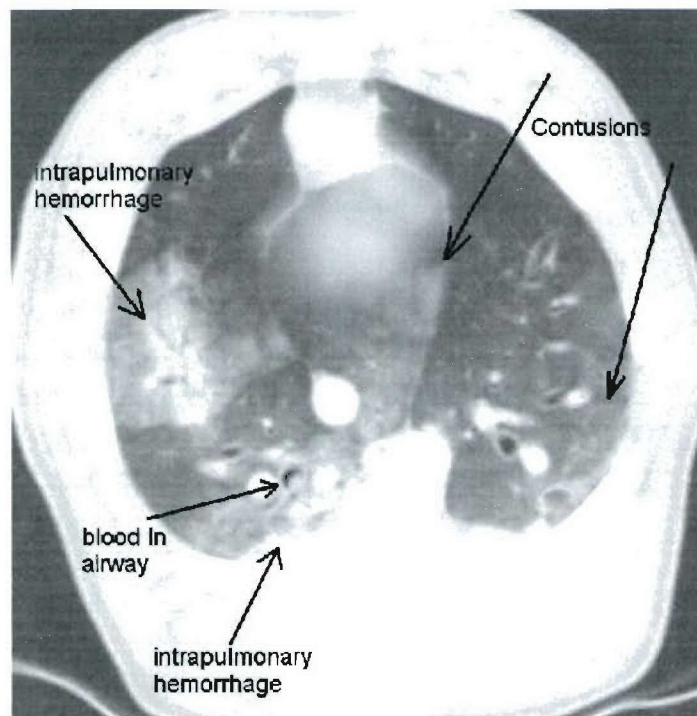
A post-impact CT image is given in the following Figure 11, indicating the success of using post-impact imaging in quantifying behind armor trauma.

**Figure 11. Sample post-impact CT image shows the injuries**

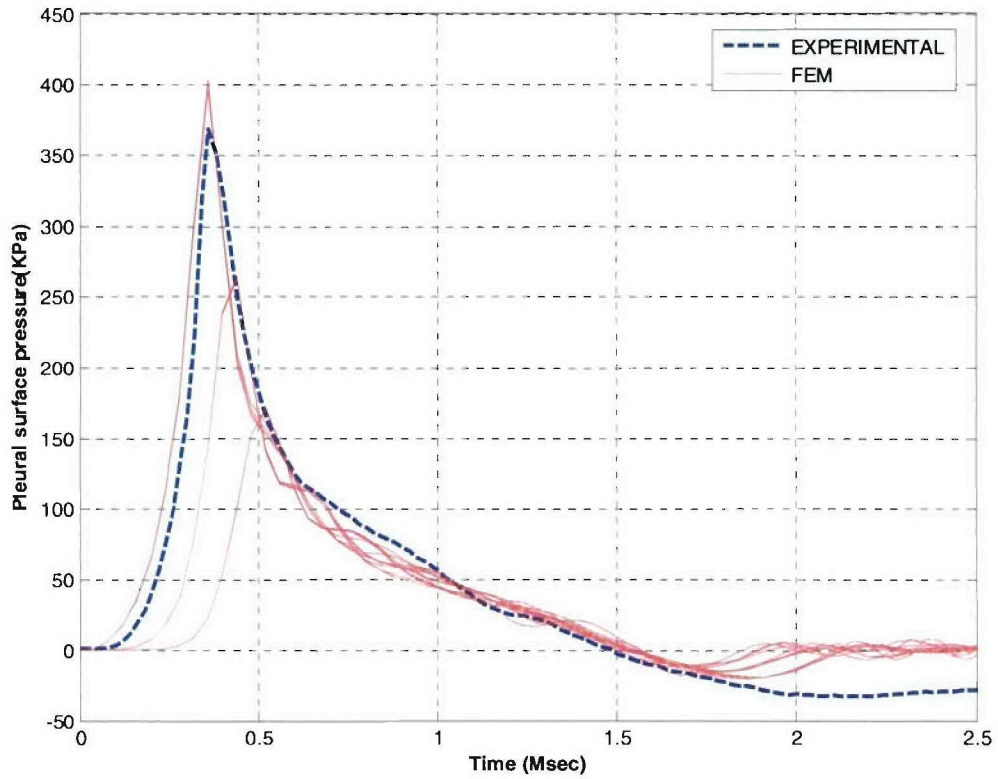
Figure 17. Comparison of lung pressure catheter measurement and FE prediction

A method for developing swine thoracic FEM, based on CT images of a specific animal subject, was developed in FY03. FY04 efforts focused on the improvement of the model and validation of the model against test measurements. The major improvements made in this year include: better ribcage–lung interface treatment; addition of lung pleural surface; better treatment of rib contract; and better muscle and skin material parameters, which are calibrated from the test measurements. The improved model is shown in Figure 15. The improved models were validated against the test measurements. Excellent agreements were achieved as shown in Figure 16 and Figure 17.

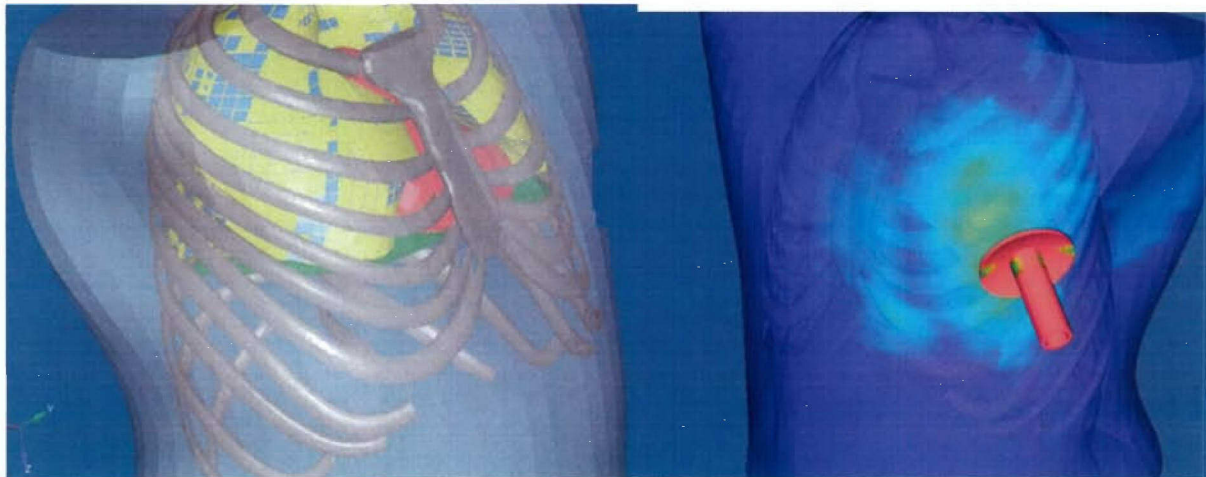
A Human FE model, based on the Visible Man data set, was also developed and used in blunt impact simulation, as shown in Figure 18.

Figure 18. Human FE model
