# The History of Structural Fatigue Testing at Fishermans Bend Australia

*L. Molent*

DSTO-TR-1773

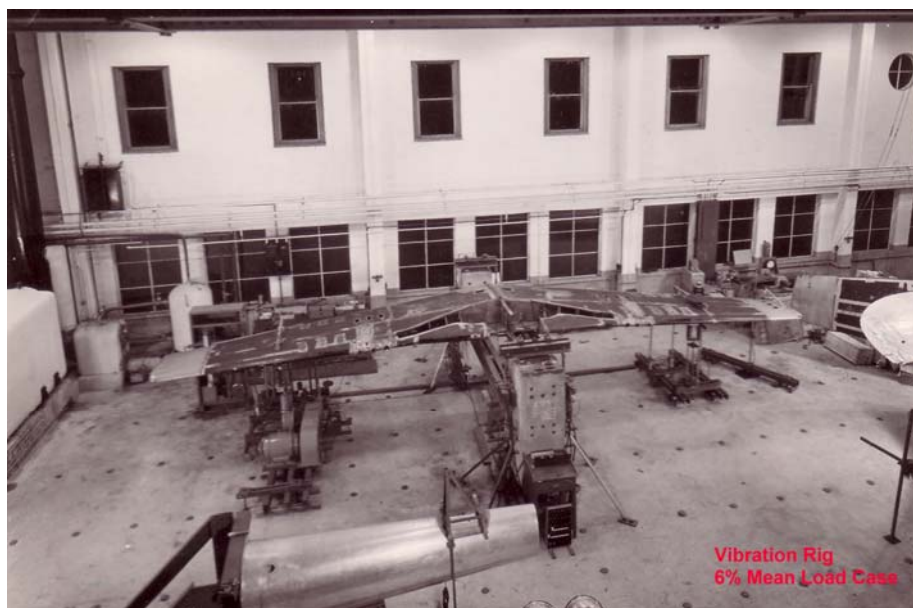
*Figure 5: Early version of the Mustang wing vibration loading rig*

Wings from 20 Mustang P51D wings declared surplus after World War 2 were obtained and tested [2], using improved versions of both the hydraulic loading rig and the vibration loading rig (Figure 5) to give further information on the behaviour of fabricated aluminium alloy structures. However, the bulk of the Mustang wing test program was conducted in the next decade.

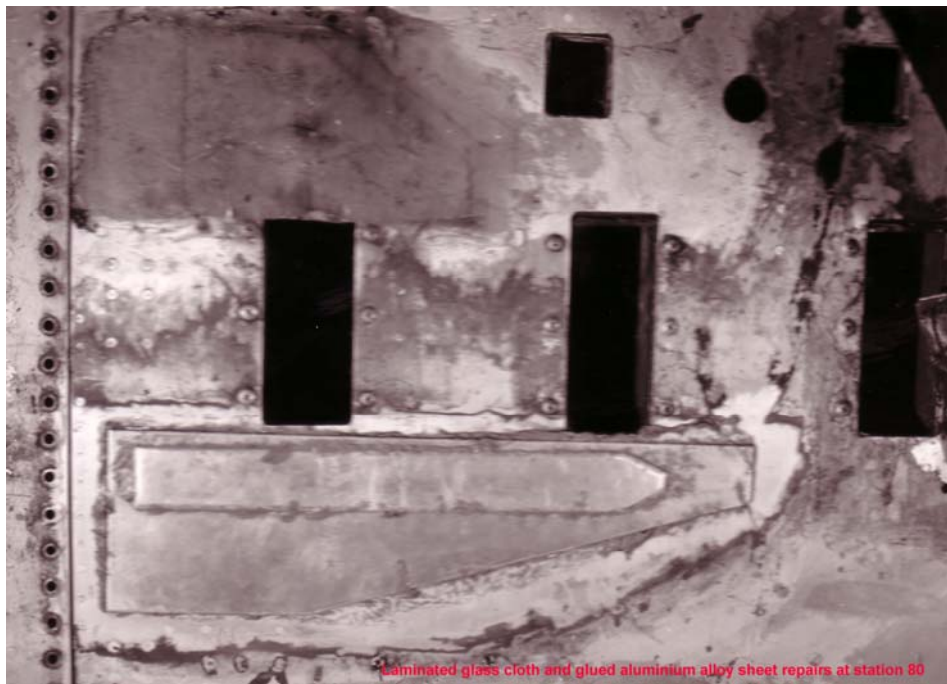
It is also of interest to note that the first application of bonded composite repair occurred on the Mustang wing tests (Figure 9) in order to repair/halt or delay crack growth [22].

*Figure 9: Early DSTO bonded repair on Mustang wing test (laminated glass cloth (above) and bonded metal sheet (below))*

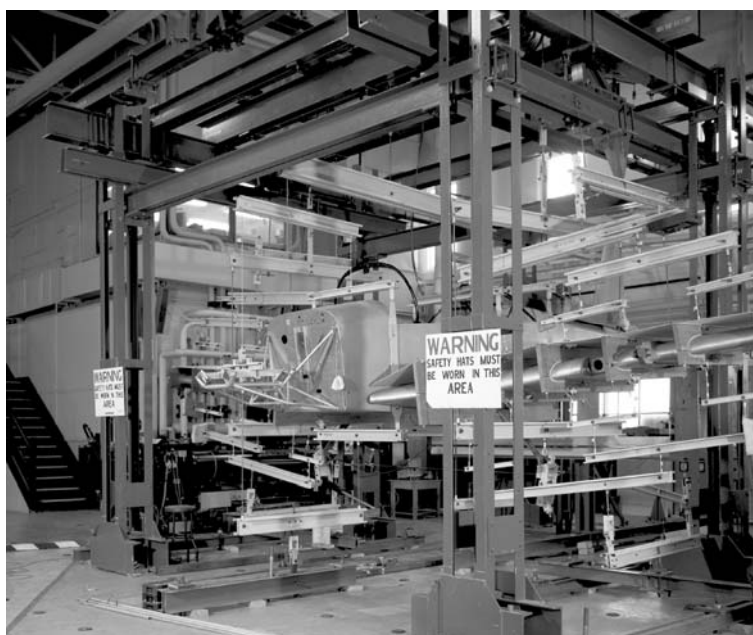
Figure 18: The CT4 test rig

A test rig incorporating control and loading equipment developed at ARL was designed and manufactured by the GAF and installed at ARL during 1982. Following a rig-commissioning period the test commenced in June 1983 and the first major structural failure occurred in August 1984. The fatigue test rig (Figure 18) comprised six steel columns supporting crossbeams in the form of a grid, from which the test airframe was suspended and on to which the loading jacks and associated mechanisms were mounted. Electro-hydraulic servo controlled loading jacks were used to apply the test loads at seven locations. Representative distribution of wing and horizontal tailplane loads was achieved through proportioned loading beams (whiffle trees). Direct application of loading was employed in the case of the undercarriage vertical, side, and drag loads, and also fin loads. The engine-mounting frame was used only to react fuselage loads and was not subjected to representative inertia and torque loading. Although this test rig arrangement is now common practice, several noteworthy advances were incorporated at the time including the ARL developed miniaturised manifold controlled servo-jack control system [47], and the use of a parallelogram linkage arrangement between the upper and lower whiffle trees so that the overhead actuators could apply both up and down loads.

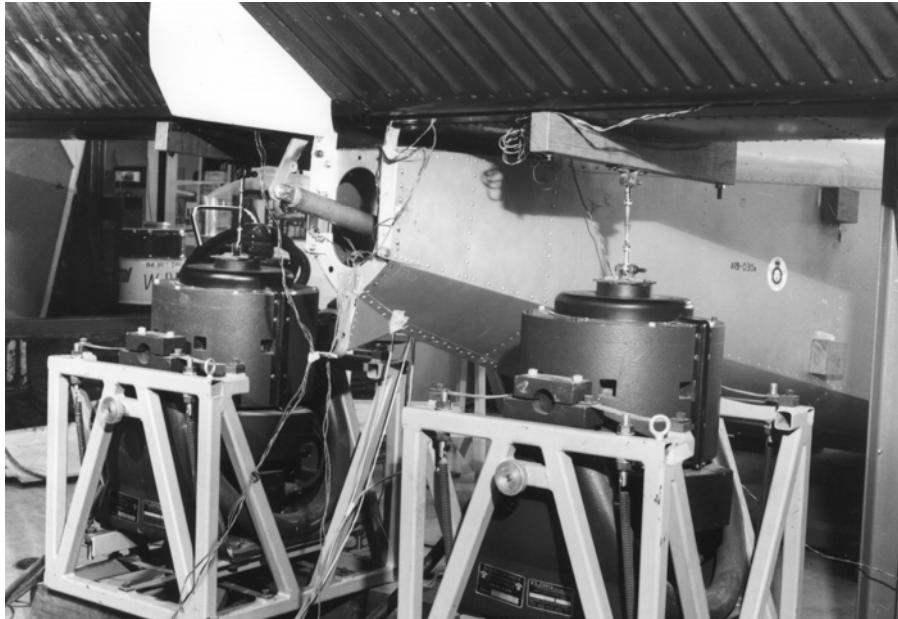
*Figure 20: CT4 horizontal tail resonance test rig*

Prior to commencement of testing it became apparent from flight trials strain data that the majority of high strain measurements recorded in the empennage developed from buffeting during spin recovery manoeuvres which caused resonance. It was decided therefore to include dynamic loads at resonant frequency in the empennage test loading. However, because of many technical difficulties involved in combining resonant loads with manoeuvre loads in a test rig it was decided to separate the two types of loading by applying loads of up to 1 Hz frequency in the main fatigue test rig and the resonant loads of approximately 9 Hz in a specialised dynamic loading rig [47][48].

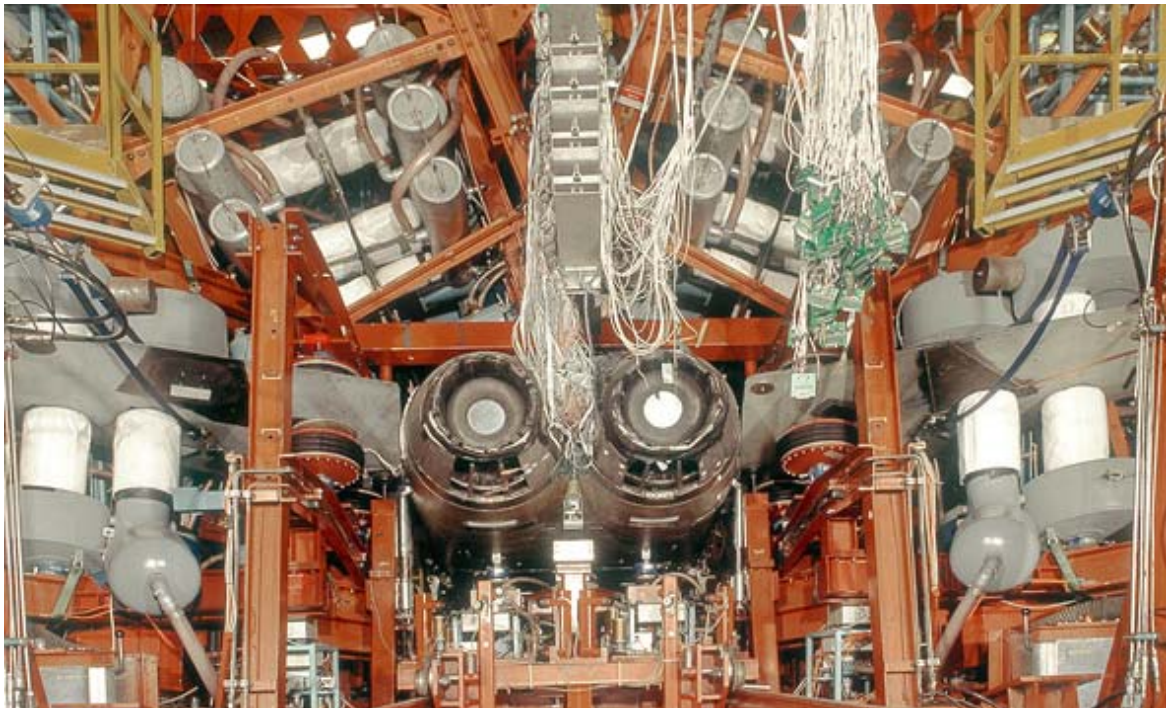
*Figure 23: FT46 in test rig (rear view)*

The test article was instrumented with over 1500 strain gauges and load bridges and as many as 60 accelerometers. Response measurements from these channels as well as command and control channels were recorded on three data acquisition systems: the Buffet Data Acquisition System (BDAS), used to record 112 channels at a sample rate of 606.06 Hz; the Manoeuvre Data Acquisition System (MDAS); used to record 490 channels at each applied load line and; the Control Data Acquisition System (CDAS), used to record various control parameters. The data collected by these systems were synchronised and managed by in-house developed data acquisition and post processing software. At the end of the test it was estimated that if the data CDs (without cases) were stacked on top of each other the column would be approximately 9.3m high.

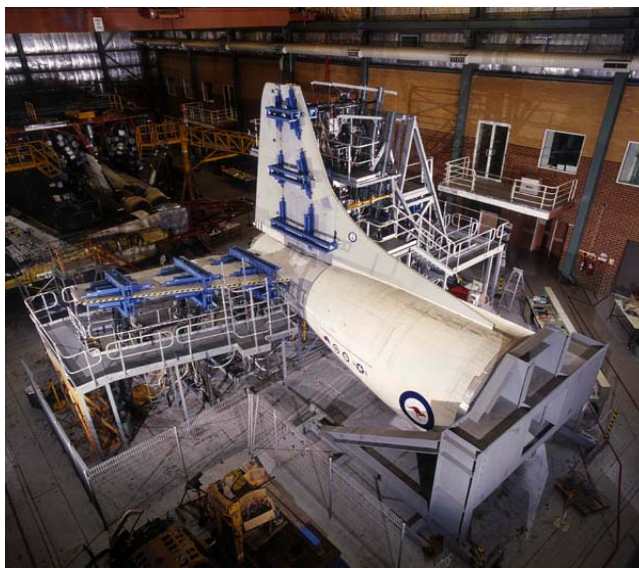
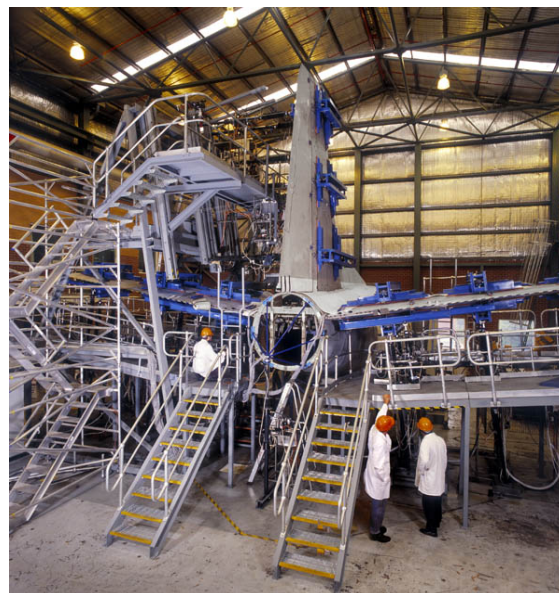
Figure 27: Views of the DSTO P3C test

After reaching the initial test requirement of two lifetimes, little primary structural damage had been found, and a period of augmented test loading was undertaken. The purpose of the augmented testing was to generate structural failures and provide a quick way of inserting additional fatigue damage to cover extended operations of the P-3 aircraft or the need for larger test scatter factors [73]. This consisted of raising all test loads by a factor of 1.6. However, in order to avoid introducing un-representative yielding at known critical locations, the peak loads in the sequence were clipped. This clipping was at a level of 1.1 times the peak load in the baseline sequence for the fin and 1.5 for the tailplane. Such a large load augmentation was both possible and required, due to the large difference between the empennage static limit loads and the test spectrum loads that represented actual in-flight loads experience by the aircraft. One lifetime of this augmented loading was first applied, at the end of which there was a failure of one of the front spar caps at the base of the fin from a fatigue crack that had not previously been detected. Several artificial flaws were inserted into the tailplane at this point to generate additional crack growth data and the test run for a further one lifetime. The third phase of the test consisted of residual strength testing, teardown and inspection. The RST loads consisted of a number of design limit load conditions. A number of additional fatigue cracks were discovered in root locations of the tailplane and fin during teardown. With the fatigue damage left unrepaired, the test article horizontal tail rear spar failed through the inserted artificial flaw at 96.6% of design limit load for the horizontal stabilizer down loading case (which is equivalent to a severe “pull up” manoeuvre in real flight).

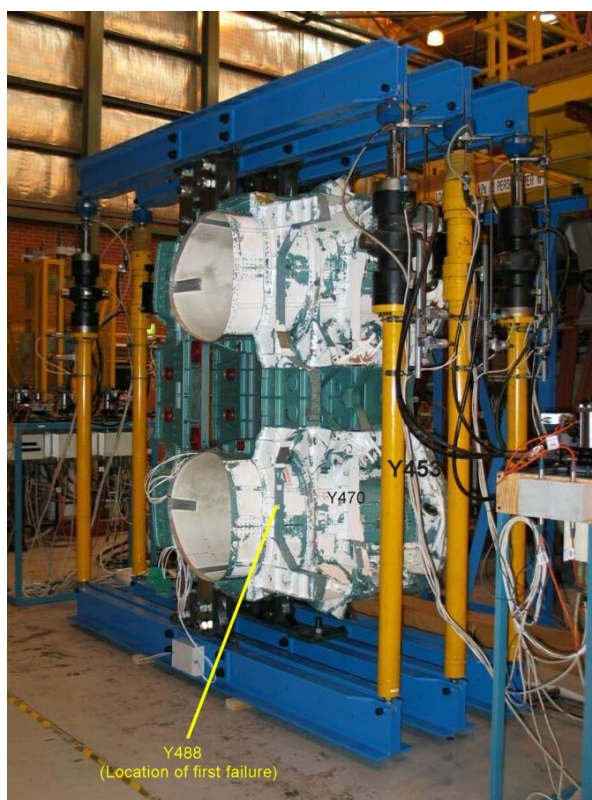
Figure 28: An F/A-18 centre barrel mounted in the FINAL rig (location of first failure highlighted)

A truncated version of mini-FALSTAFF (Fighter Aircraft Loading STandard For Fatigue Evaluation) sequence was applied to the test articles. The FALSTAFF loading sequence was developed to represent the standard load history at the wing root of a fighter aircraft [87]. The sequence is equivalent to 200 flights. The normalised sequence was multiplied by the peak IFOSTP FT55 WRBM of 6462 in-kip to produce a WRBM sequence. At the time of writing 3 CBs had been tested.

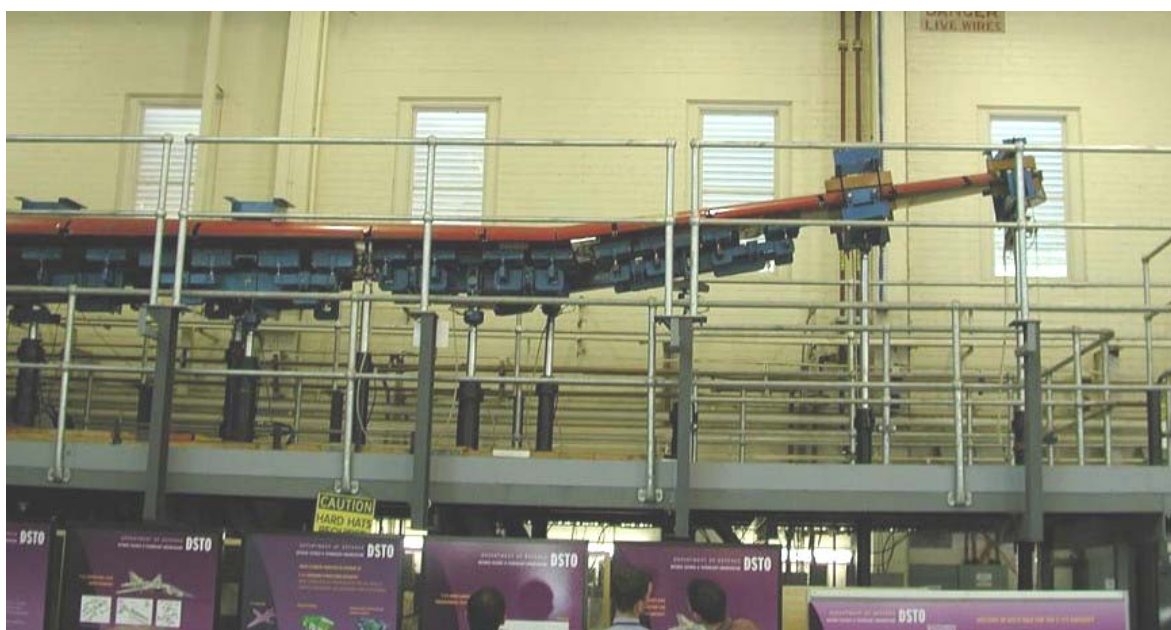
The A15-5 wing test highlighted the fact that poor surface finish in lower wing skin Taperlok fastener holes, combined with lower than specified levels of interference, can be the precursor to fatigue crack growth effectively reducing the fatigue life of the wing structure. Whilst post-test wing build quality studies may have demonstrated that other wing sets may be of better quality, there was still sufficient evidence of build quality variations and anomalies to warrant the implementation of a safety-by-inspection program, to guarantee the ongoing structural integrity of wing sets. It seemed that problems encountered earlier in the MB326H fleet had manifested here again, only with an increased vengeance. The lower wing skin of the F-111 consisted of 1000's of potential equally critical Taperlok fasteners and an automated NDI system was the only solution.

Figure 33: WDET wing failure at approximately wing station 277
