# Use of Residual Compression in Design to Improve Damage Tolerance in Ti-6Al-4V Aero Engine Blade Dovetails

Paul S. Prev y, ([pprevey@lambda-research.com](mailto:pprevey@lambda-research.com))  
N. Jayaraman, ([njayaraman@lambda-research.com](mailto:njayaraman@lambda-research.com))  
Lambda Research, 5521 Fair Lane, Cincinnati, OH 45227

Ravi A. Ravindranath, ([ravi.ravindranath@navy.mil](mailto:ravi.ravindranath@navy.mil))  
NAVAIR, Patuxent River, MD 20670

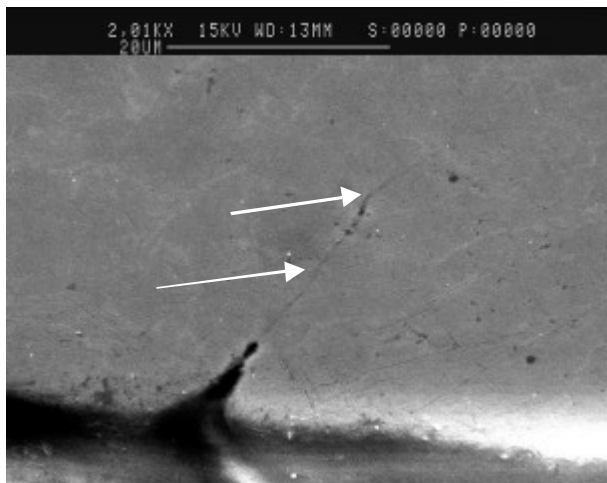
Figure 3. Cross-sectional micrograph of a typical microcrack.

The Ti-6Al-4V 1<sup>st</sup> stage low pressure compressor blade dovetails of a military aircraft turbine engine have a reported fretting-induced microcracking problem in the edge-of-bedding, and are prone to cracking in this region. Figure 1 shows a photograph of the blade, with an arrow indicating the affected region. The microcracks are observed in the dovetail edge-of-bedding as a network of parallel fine cracks of a nominal depth of 0.005 in. Current usage criteria require inspection of these blades after every 30 hours of service which involves removing blades from the assembly and examining each for microcracks using eddy current techniques. Currently there are no repair or refurbishing options, nor have there been major catastrophic failures reported from these microcracks, yet these blades are retired routinely from service when microcracks are detected in the dovetail edge-of-bedding. A network of parallel microcracks in a band over a width of about 0.1 in and length of about 0.5 in. is seen in Figure 2. This region also showed substantial mechanical damage associated with contact fretting. Figure 3 shows a cross sectional micrograph of a typical microcrack, which is less than 0.005 in. deep.

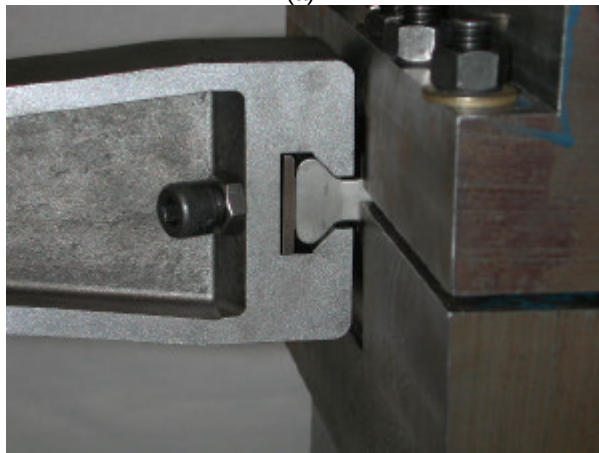
Figure 7 (a). Loading arrangement for the blade dovetail section (b) A close-up view

All fatigue tests were performed on a Sonntag SF-1U machine at room temperature at a frequency of 30 Hz. Figures 6 and 7 show the dovetail feature specimen and the actual blade, respectively, loaded in cantilever bending fixtures. All tests were performed at a stress ratio,  $R$ , of 0.5. The high stress ratio was chosen to simulate the service condition of the dovetail pressure face. HCF tests were conducted to determine the benefits of LPB treatment to mitigate the presence of an EDM notch, which was introduced at the edge-of-bedding to simulate the fretting-induced microcracks. Photographs showing the details of the EDM notch are shown in Figures 8 a and b.
