A NEW JOINING/FABRICATION TECHNIQUE FOR COLLECTIVE PROTECTION: THE DURASEAL™ SEAM

Christine W. Jarvis, Robert Bennett, Danna Blankenship, and Charlotte Pierce
Clemson Apparel Research, 500 Lebanon Rd., Pendleton, SC 29670
cwjrv@clemson.edu, 864-646-8454

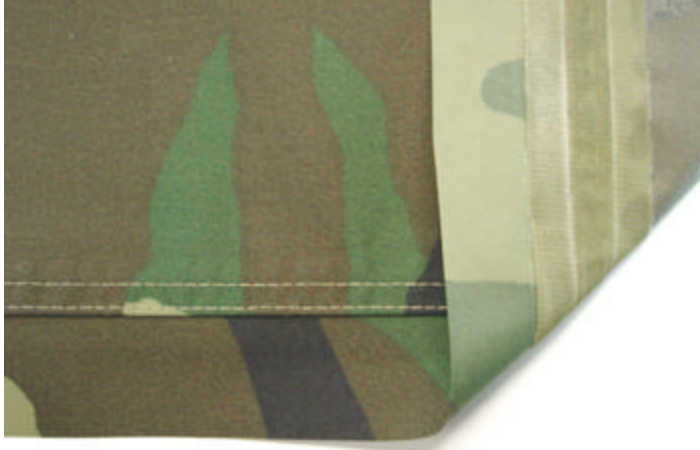
A filler material such as an adhesive-backed fabric tape is used to close over the needle holes in the seam. This step is more time-consuming than the original mechanical seaming process to produce the seam.

Figure 4 Taping of the sewn seam in a vinyl-coated polyester shelter fabric.

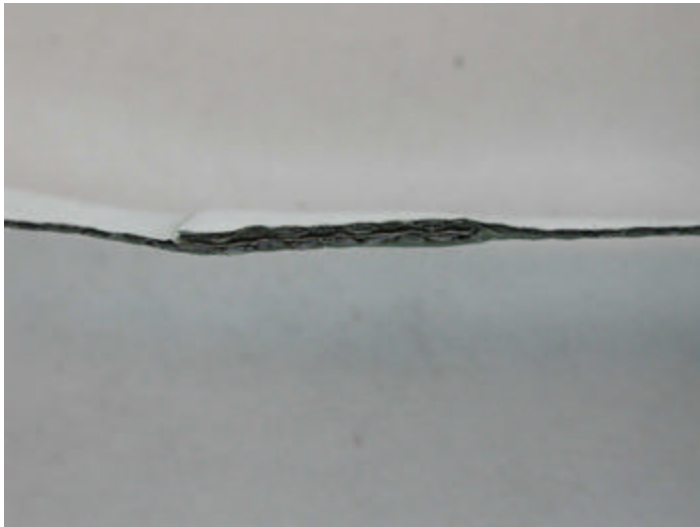
The Duraseal™ seam is approximately one-half the thickness of a typical double needle felled seam (LSa2).

Figure 8 Cross-sectional view of Duraseal™ seam.
