## **Evaluation of Chemical Dust Palliatives for Helipads**

John F. Rushing, Vernon M. Moore, and Jeb S. Tingle

February 2006

Final report

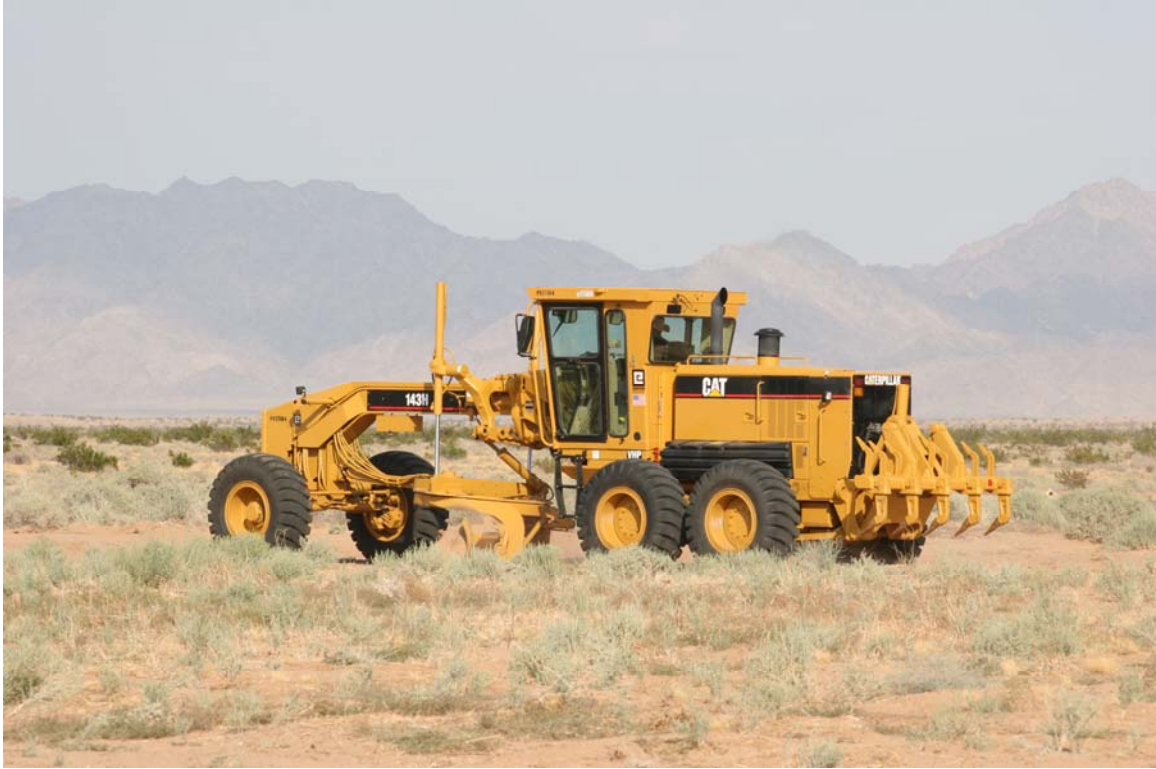
Photo 1. Caterpillar® 143H motor grader clearing native vegetation from testing site

- a.* Mobility was limited on the soft sand for several pieces of equipment. The motor grader had difficulty clearing the vegetation from the site because of poor traction. The High Mobility Multi-Wheeled Vehicle was unable to tow the hydroseeder at the site. The Medium Tactical Vehicle Replacement (MTVR) was suitable for pulling the hydroseeder, but the hydroseeder did not have enough ground clearance to prevent dragging loose soil.

The field tests were conducted at MCAS, Yuma, AZ, on an area of open desert immediately north of the Auxiliary 2 paved landing zone. The area was graded using a model 143H Caterpillar motor grader (Photo 1) to remove all native vegetation. A John Deere 544J four-wheel drive bucket loader was used to backblade the loose sand to create a level and uniform surface prior to applying dust palliatives (Photo 2). Figure 1 provides a layout of the site and the location of the helipads.

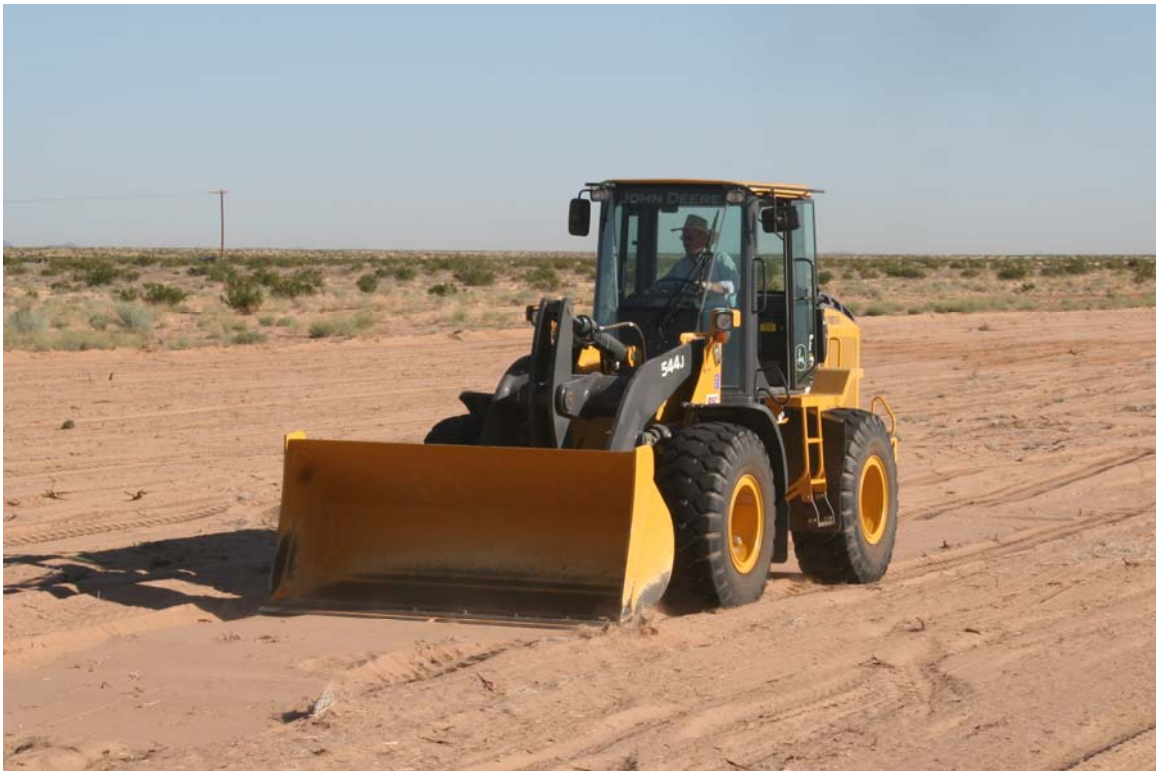
Photo 2. John Deere® 544J bucket loader back blading soil prior to palliative application

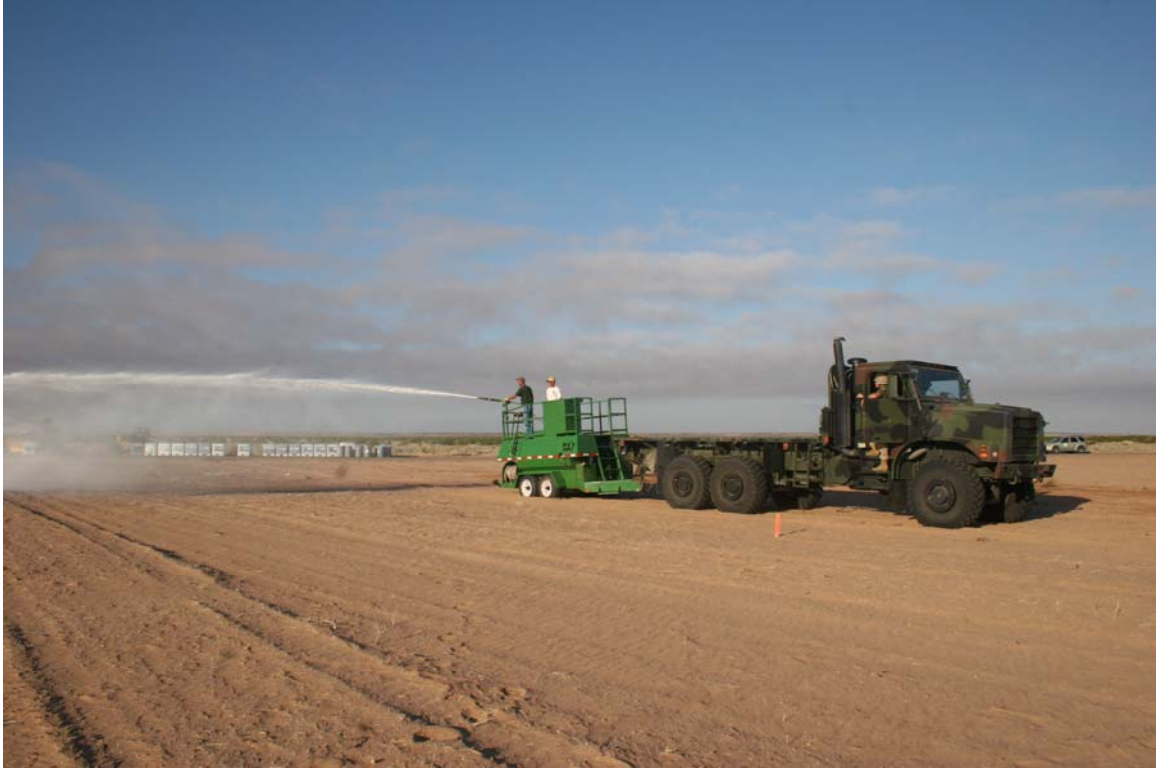
Photo 3. Easy Lawn® C95 trailer-mounted hydroseeder pulled by MTVR

Two commercially available hydroseeders were used to distribute the dust palliatives onto the helipads. Both were transported using a 5-ton Medium Tactical Vehicle Replacement (MTVR) due to the soft soil site conditions. An Easy Lawn® C95 trailer-mounted unit was pulled using an adapted pintle hitch (Photos 3 and 4) to meet connection requirements of the MTVR. A Turfmaker® 800 hydroseeder was removed from its position on a trailer and placed onto the bed of the MTVR for transportation (Photo 5). The Turfmaker® model offers the option of being used as either a trailer-mounted unit or a skid-mounted unit. Specifications for the two hydroseeders are located in Table 1.

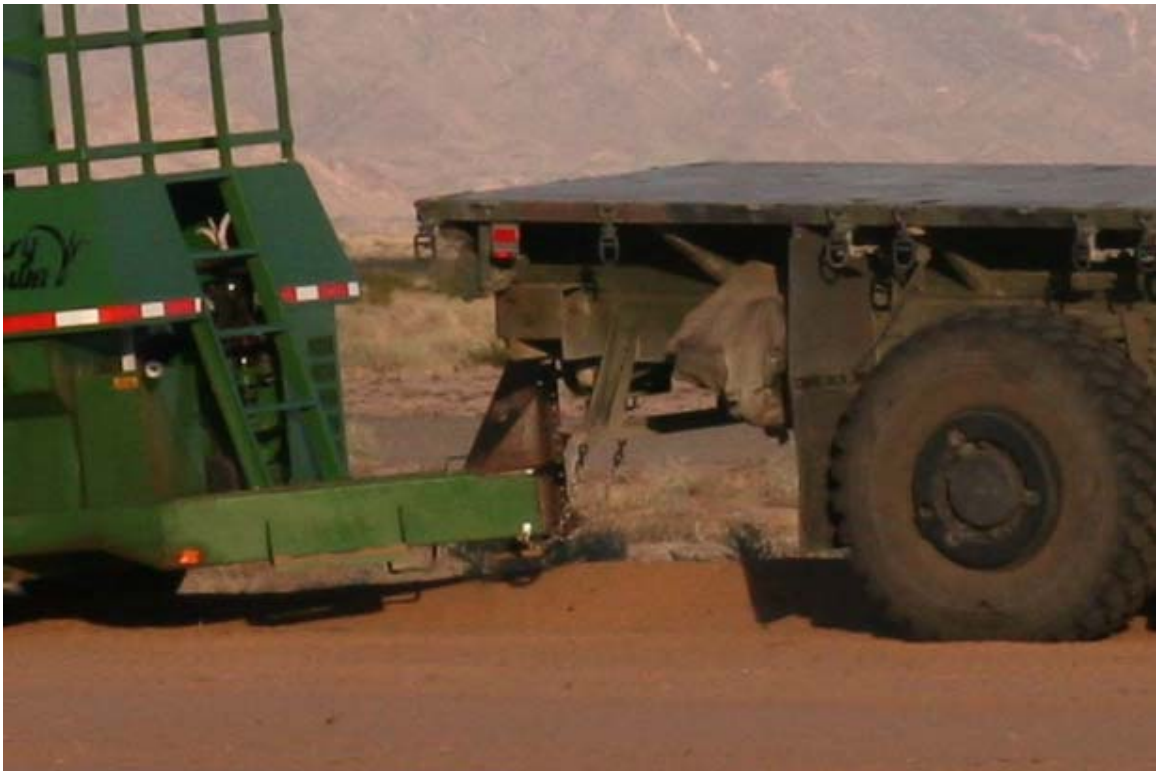
Photo 4. Adapted hitch height on Easy Lawn® C95 hydroseeder to connect to MTVR

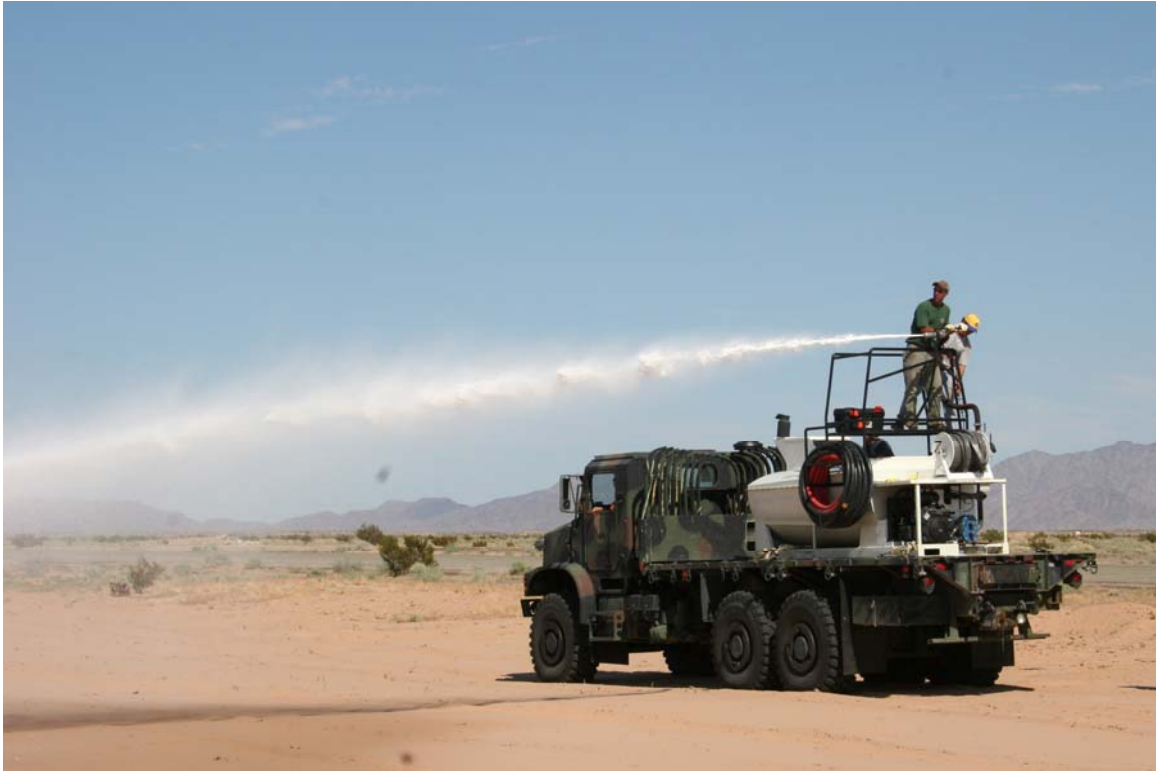
Photo 5. Turfmaker® 800 hydroseeder on bed of MTVR

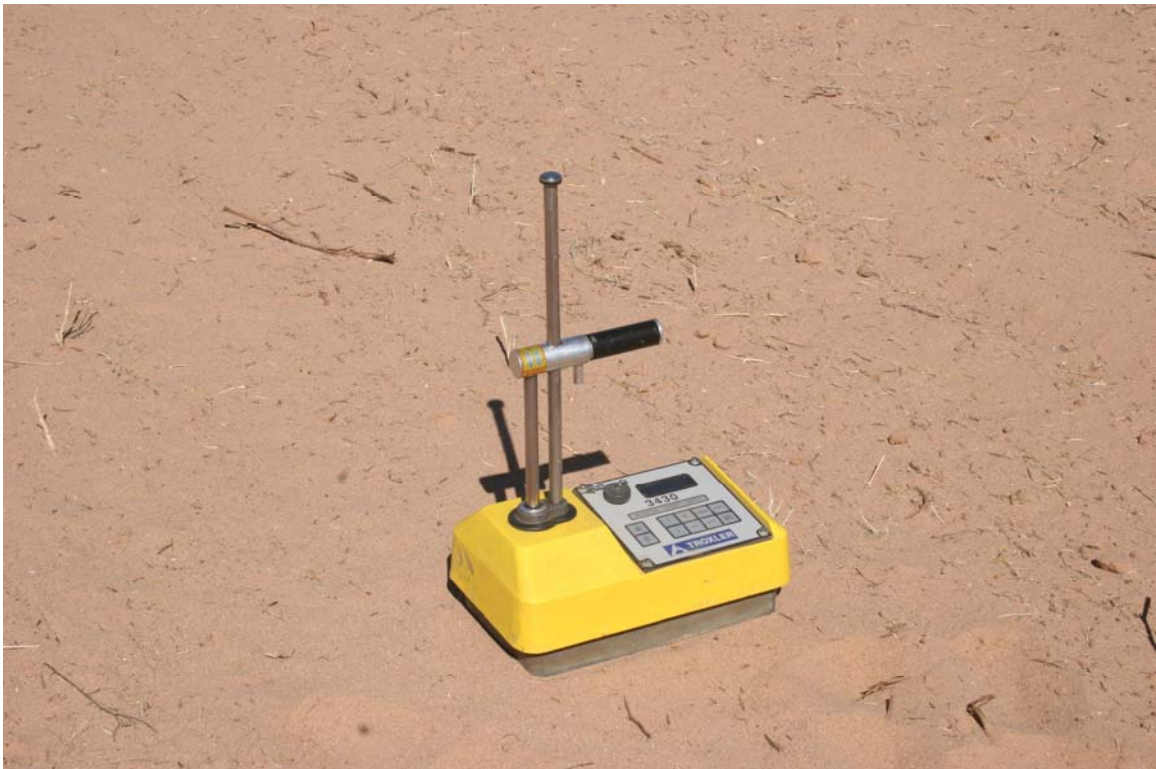
Photo 6. Troxler® 3430 nuclear density gauge for measuring soil density and moisture content

A Troxler® 3430 nuclear gauge was used to collect density and moisture data in the center of each helipad prior to palliative application and after the final day of aircraft landings (Photo 6). The gauge contains two radioactive sources: Cesium-137 for density measurement and Americium-241:Beryllium for determining moisture content. Density measurements were taken in the 6-in. direct transmission mode according to American Society for Testing and Materials (ASTM) D2922. Moisture contents were obtained using procedures outlined in ASTM D3017.

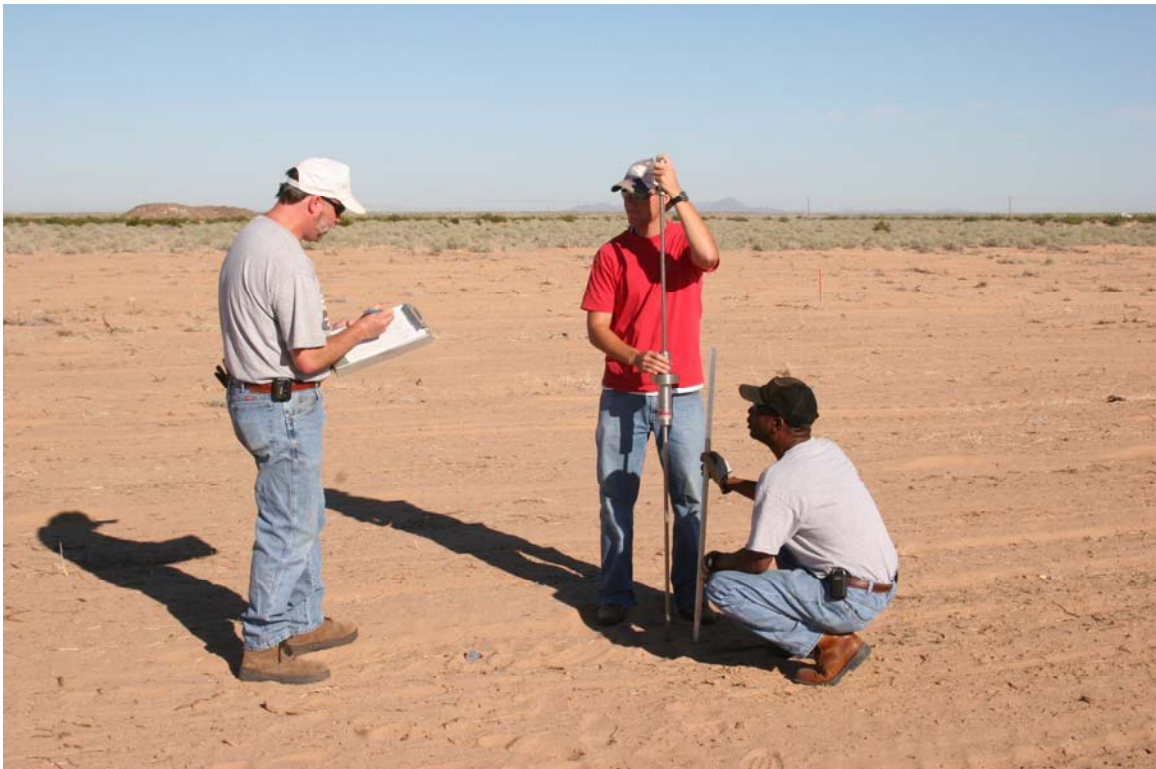
Photo 8. Using the Dynamic Cone Penetrometer (DCP) to measure soil strength

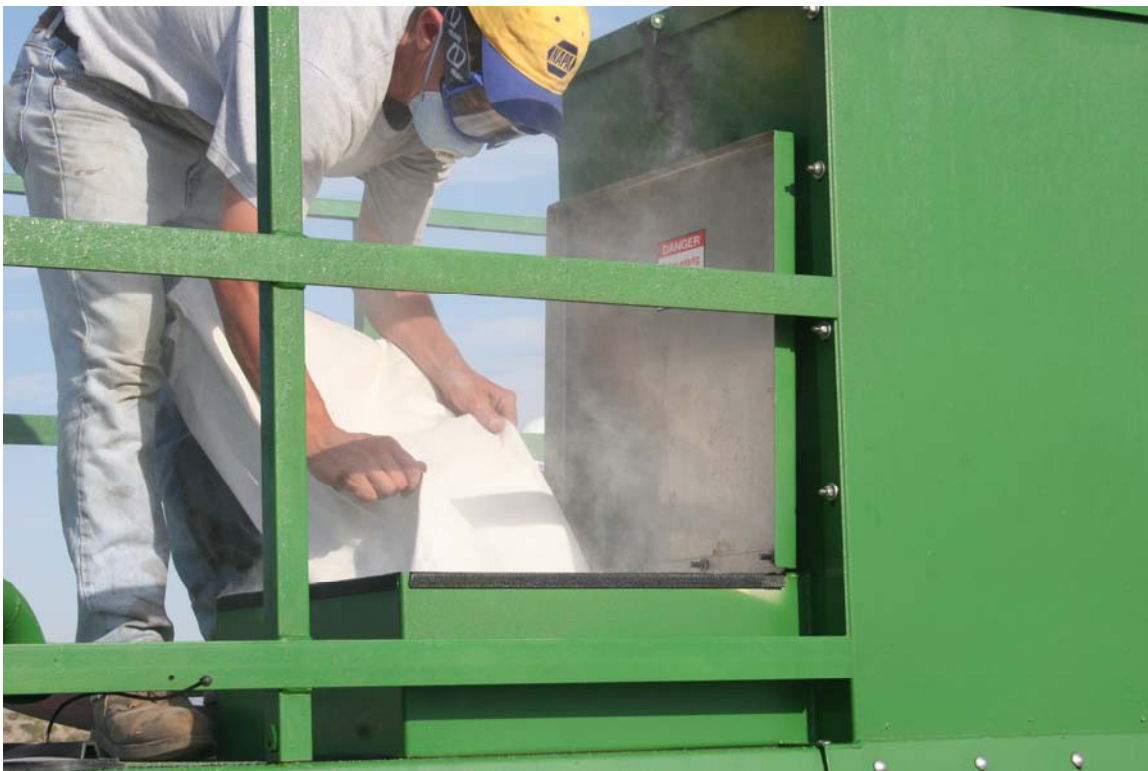
Photo 12. Placing Powdered Soiltac® into Easy Lawn® C95 hydroseeder

The second helipad was constructed using Powdered Soiltac®. Quantities of the powder were chosen to replicate active ingredients found in the liquid Soiltac®. Twenty-two bags (1,100 lb) of the powder were mixed with water in the Easy Lawn® hydroseeder for a total of 750 gal of product (Photo 12). The powder immediately dissolved in the water. The solution was mixed for 5 min and then applied to half of the helipad using the hand-held hose. The other half of the helipad was sprayed with an additional 750 gal of an identical solution to complete the helipad with a 0.60 gsy application rate. Some puddling of the product was observed during application (Photo 13). The process took four men a total of 53 min (including filling and mixing).

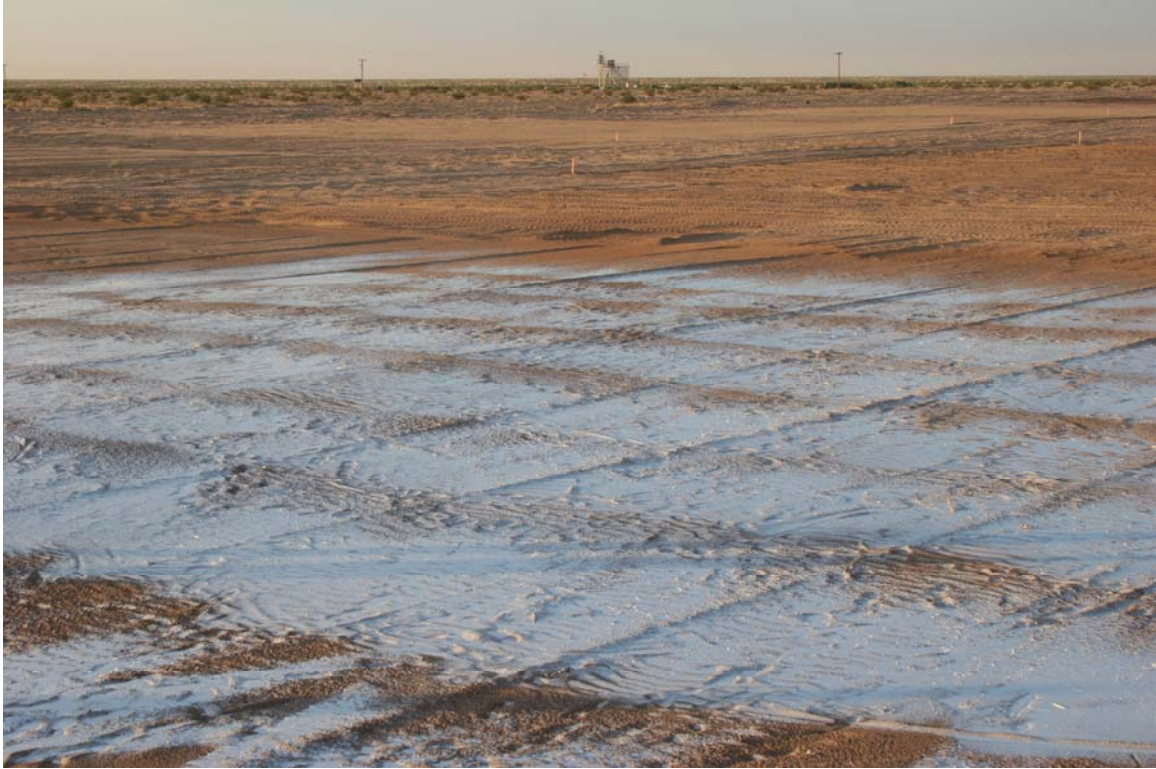
Photo 13. Puddling of Powdered Soiltac® on the surface of Helipad 2 during application

The powdered polymer had the thinnest surface crust of all products. The viscosity of this product was observed to be higher than the emulsified polymers. Also noted was some puddling of the product on the soil surface during application. Its resistance to flow through the soil voids allowed the material to dry and stiffen before reaching penetration depths similar to other materials.

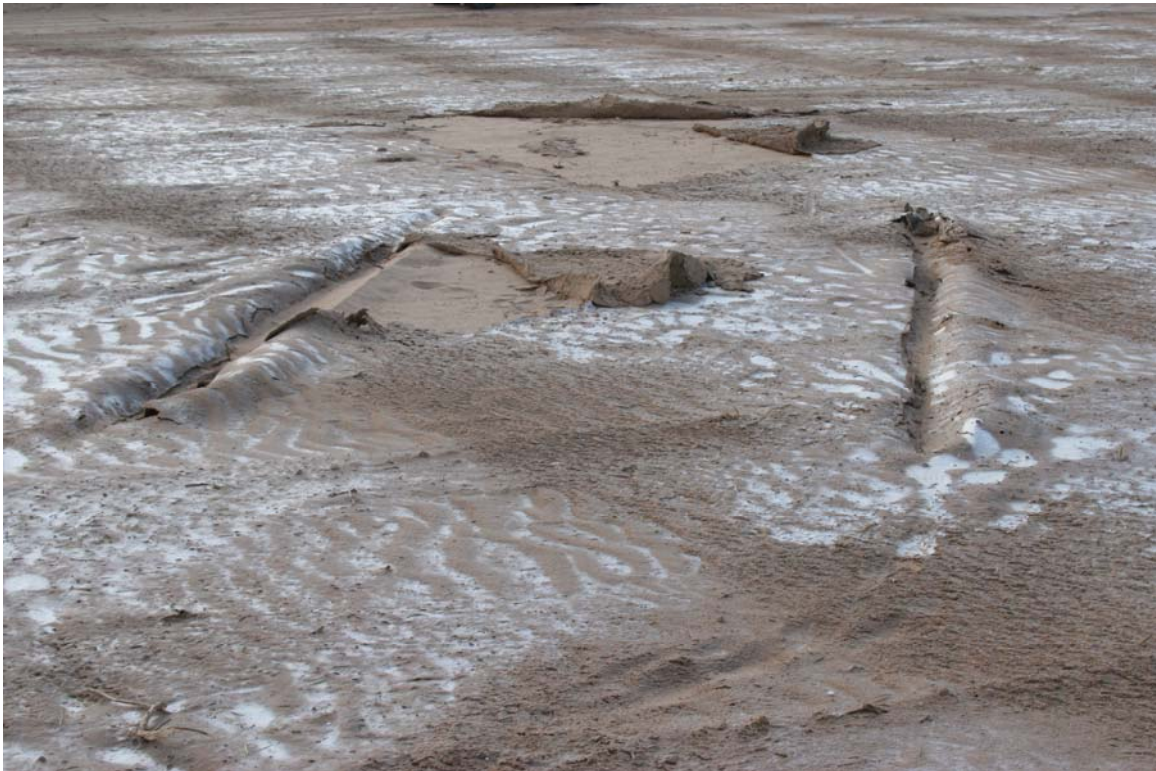
Photo 22. Areas of untreated soil exposed on helipad 2 after UH-1 landings

The pilot operating the UH-1 aircraft indicated helipad 6 as the most effective of the helipads tested at dust reduction. Minimal dust was observed during the landing sequence, and the pilot maintained complete visibility with the ground. Helipad 12 was slightly worse than 6 but still very effective. The soil color was distinctly different from untreated areas, and little dust was produced during landing. Helipad 5 was considered effective, but some minor foreign object damage (FOD) was produced, exposing untreated soil that generated minimal dust. Helipads 3, 2, and 4 were generally equally effective at mitigating dust during landings. However, each of these helipads produced significant quantities of FOD during the landing sequence. Large sheets (greater than 1 sq ft) of bound soil became airborne on each of these helipads. Some locations experienced "peeling" of the surface crust, revealing areas of untreated soil greater than 10 sq ft (Photos 22 through 24). Lighter applications of the same

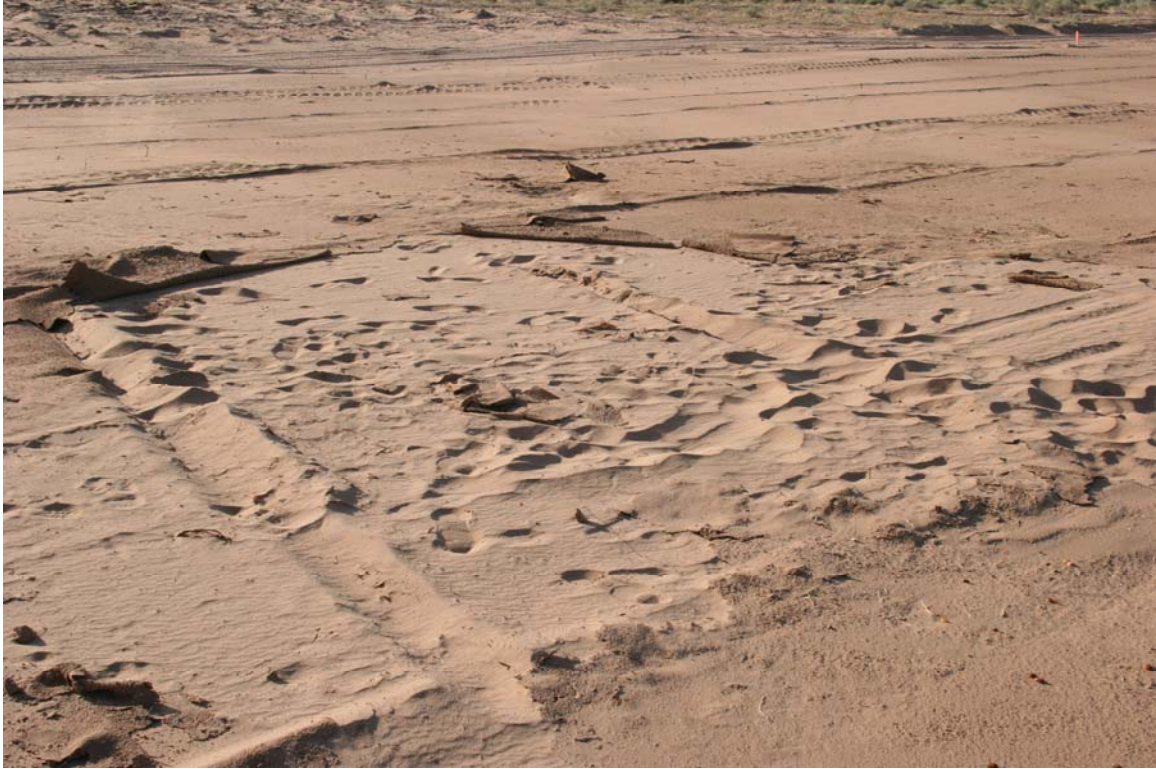
Photo 23. Large area of exposed soil on helipad 4 after UH-1 landings

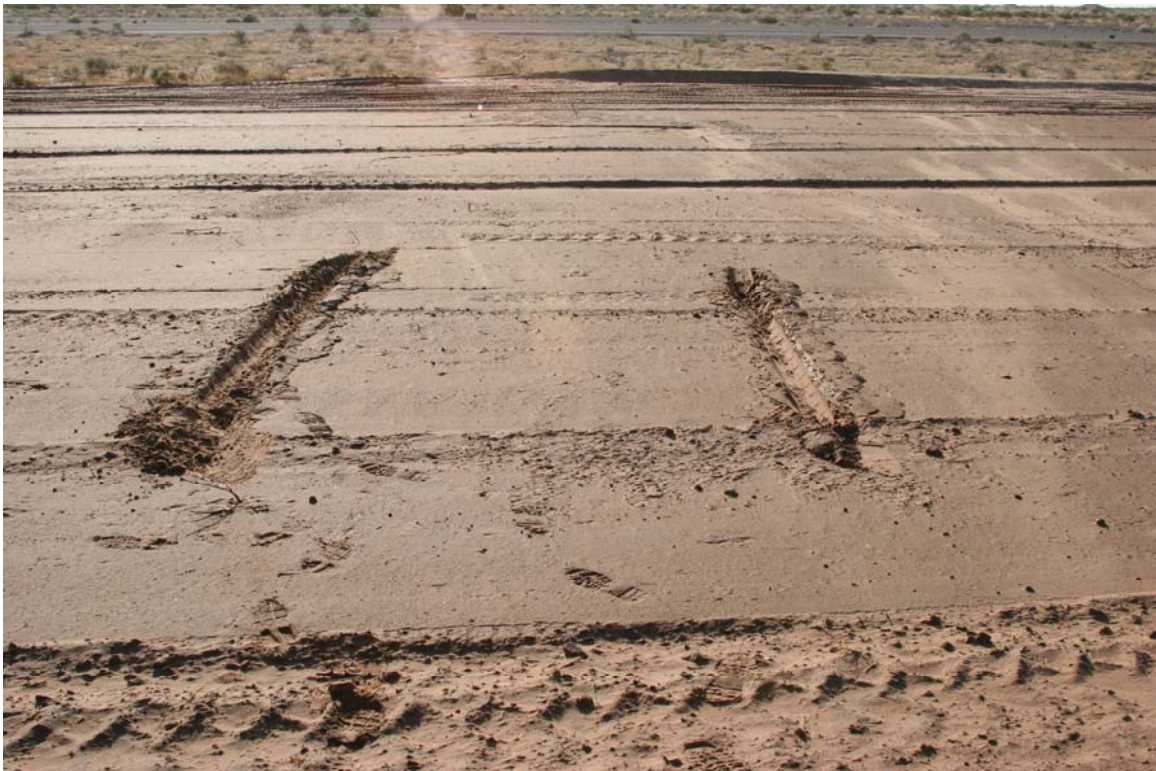
Photo 24. UH-1 landing left depression in soil on helipad 6 but created no FOD

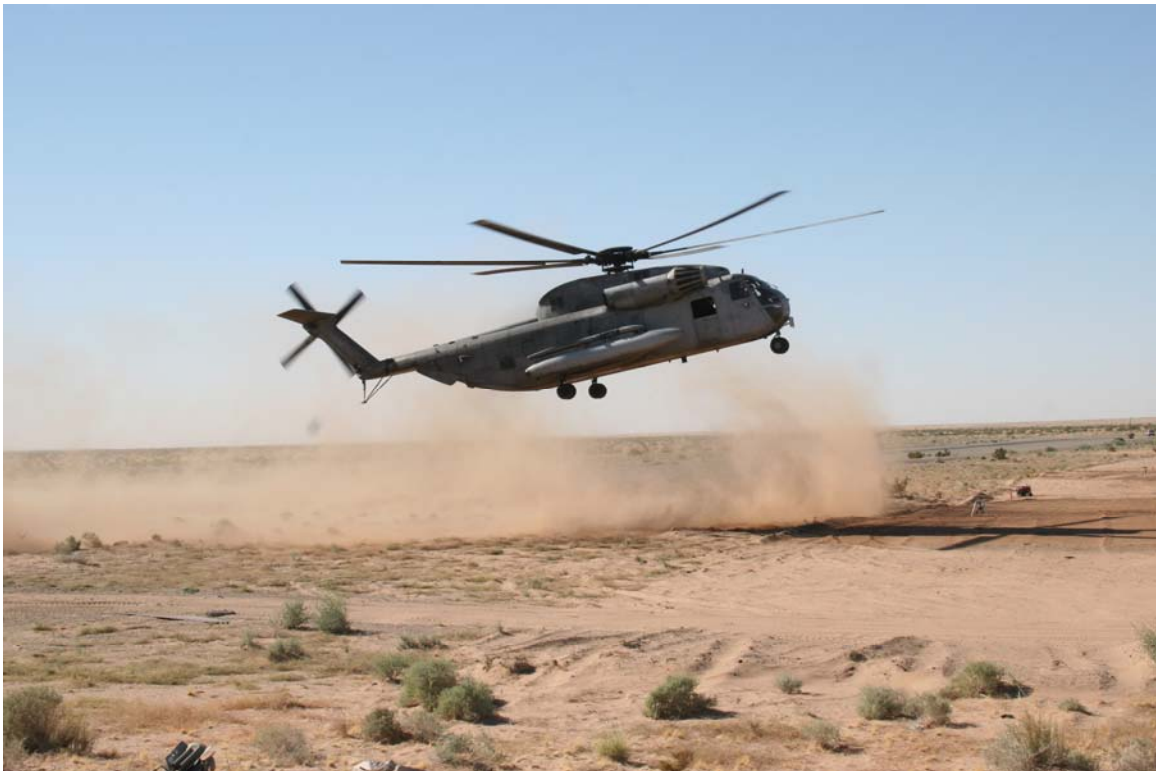
Photo 30. CH-53 forward approach landing disturbing untreated soil adjacent to helipad 7

The 150- by 150-ft helipads treated an area large enough for adequate reduction in dust during the CH-53 landings. The forward approaches did cause large dust clouds to form in front of the aircraft, but these clouds dissipated once the aircraft was located over treated soil.

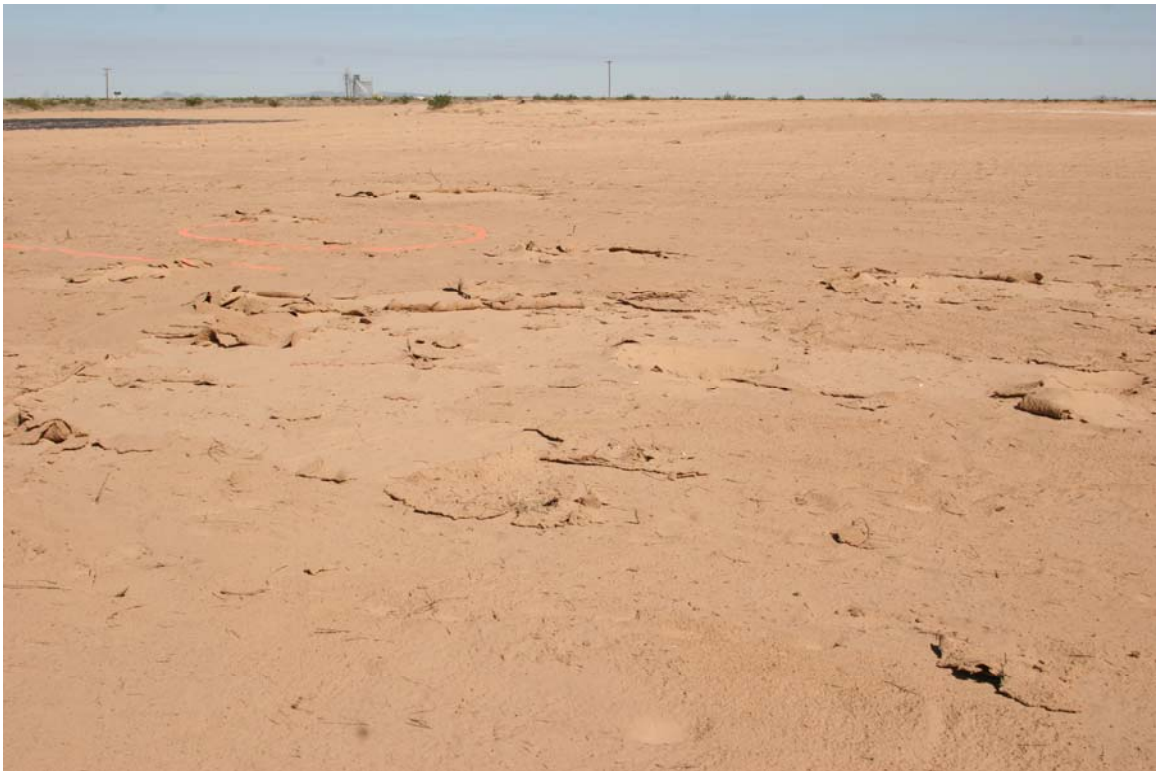
Photo 38. Damage to surface of helipad 10 (Helotron®, 0.6 gsy) during CH-46 landing

The three synthetic fluids performed excellently during this phase of the evaluation, with Durasoil® preventing the most dust. Data also indicate Helotron performed similarly to the synthetic fluids. These data contrast observations made by the pilot. After the initial “dust off” landing, the Helotron helipad began to produce significant quantities of FOD near the center of the helipad (Photo 38). The pilot most likely noted poor performance from the risk of damage to the aircraft. Meanwhile, areas located near the dust collectors were still covered by a film of bound soil particles. Dust concentrations in the air were minimal at these locations, indicating excellent performance as detected by the dust collection system. Due to perceived FOD potential, the lower application rate of Helotron (helipad 11) was not tested to minimize risk to the aircraft.
