# Branchbox Breakwater Design at Pickleweed Trail, Martinez, CA, Section 227 Demonstration Project

*by Stephen T. Maynard, Michael F. Winkler, and David E. Demko*

**PURPOSE:** The objective of this Coastal and Hydraulics Engineering Technical Note (CHETN) is to provide a preliminary design of the branchbox breakwater for the Martinez project site in the National Shoreline Erosion Control Development and Demonstration Program (Section 227) using existing design guidance and lessons learned from previous branchbox breakwater projects. The branchbox breakwater system proposed herein derives stability from both the breakwater and wetland plants between the breakwater and the shoreline. Selection of the type of wetland plants to use behind breakwaters is a critical part of bioengineering bank protection. While this technical note provides some information on plants used at specific projects, the focus of this report is on the design of the breakwater part of the system.

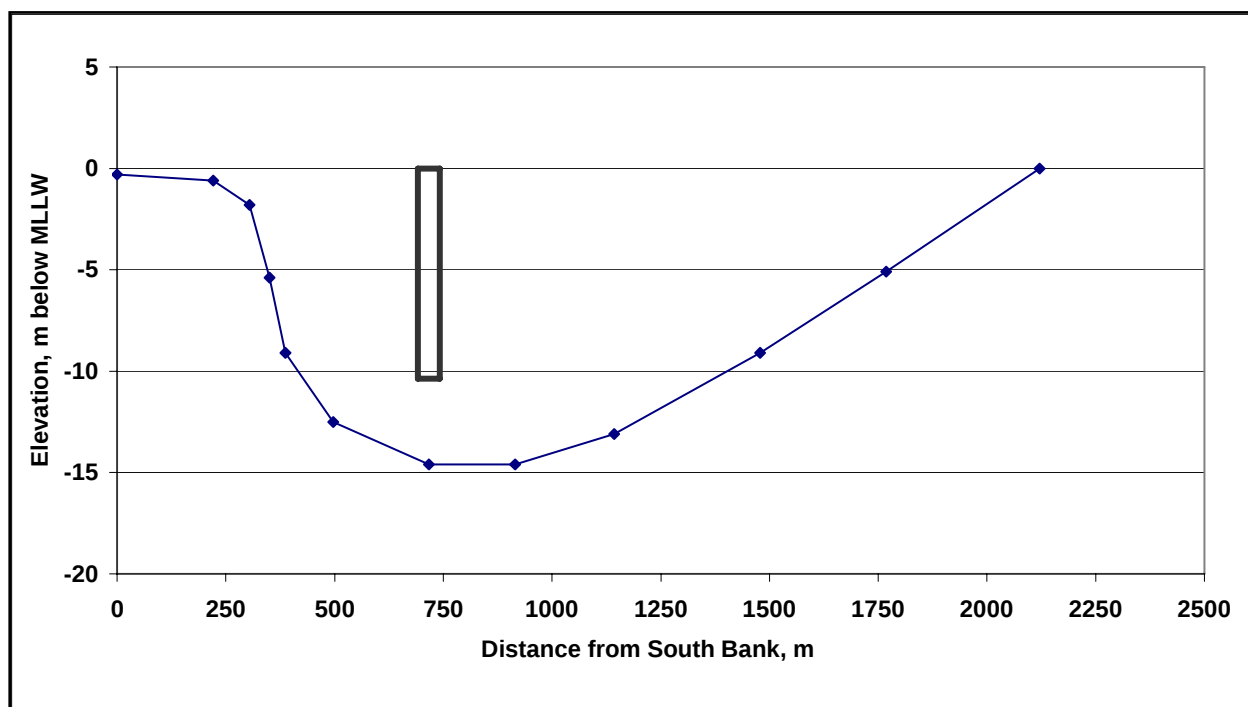
Figure 4. Channel cross section at Pickleweed Trail with 51-m beam by 10.4-m draft ship

- c. *Deep-draft ship effects.* Deep-draft ships pass the Martinez site and produce effects at the shoreline. During the field study, ships up to 254 m in length passed the site. The largest ships at this site are over 274 m in length, 51-m beam, and 10.4-m draft. Ships going upstream of Martinez are limited to drafts of less than or equal to 10.4 m. During the field study, up to eight ships passed the site per day. Ship logs confirm this is not a high ship traffic area. Ships at the Martinez site travel at up to about 12 knots, so the depth Froude number is about 0.5. At this Froude number, ships in channels produce both short period (secondary) waves from the bow and stern and long period (primary) waves related the drawdown around the ship. Water depth limits ship movement to no closer than 400 m from the Pickleweed Trail shoreline and ships typically travel at 600-700 m from the shoreline. Short period waves tend to decay in amplitude significantly before reaching the shoreline at these distances. During the field study, the maximum short period wave amplitude from ships was about 0.2 m. Long period or primary wave effects are a function of the blockage ratio defined as ship cross-sectional area to the channel cross-sectional area. Channels having blockage ratios of greater than 0.05 to 0.10 exhibit significant long period effects that can propagate large distances from the ship and decay far less rapidly than short period or secondary waves. At the Martinez site, the channel cross section is shown in Figure 4 along with the cross section of the largest ship passing Martinez of 51-m beam by 10.4-m draft. This ship has a blockage ratio of about 0.03, which means that long-period wave effects will

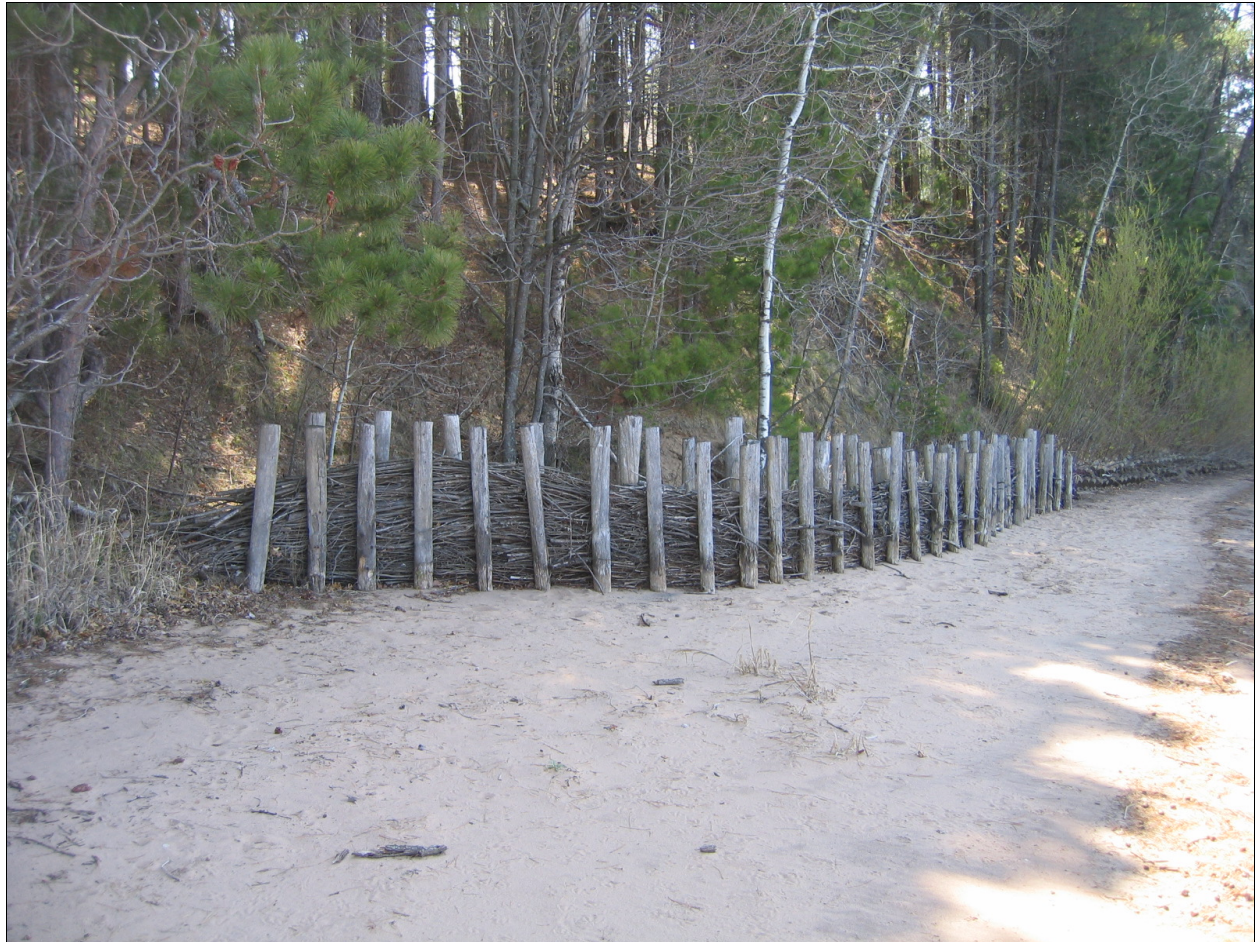
Figure 6. Branchbox breakwater at Rice Reservoir, front view

The overall performance of the branchbox breakwater is affected by several factors. The first factor is that the Wisconsin Department of Natural Resources (WDNR) restricted the placement of the structure in the permit to a distance of 4.5 m outward from the bank line. WDNR has since revised this and now allows a branchbox breakwater to be placed up to 9.0 m from an existing bank line. Though approximately 0.03 m of sediment has been deposited since 1999, Rice Reservoir contains very little suspended sediment, and it was expected that minimal accretion would occur landward of the breakwater. Vegetation was placed in front and behind the breakwater after construction. The vegetation in front of the breakwater was destroyed by wave action within the first year. Because the area behind the breakwater is shaded by shoreline vegetation, some of the vegetation landward of the breakwater was lost. Plant survival and possibly sediment accretion would have improved if the breakwater had been allowed to move further from the bank line. Smaller poles might be possible, but the effects of the ice heave were not known at the time of installation. Overall the branchbox breakwater has lasted over 10 years and has stabilized the bank line. Of all the shoreline stabilization methods tested by WVIC, the branchbox breakwater has proven to be the least expensive. Figures 6 and 7 show the branchbox breakwater in April 2005.

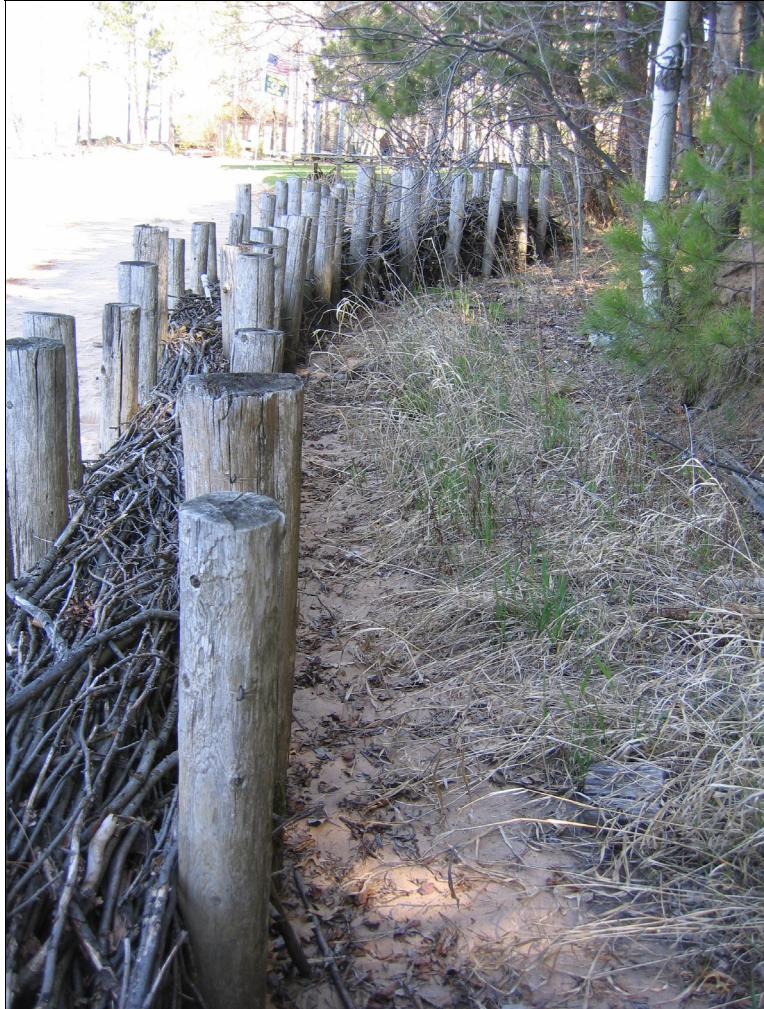
Figure 7. Branchbox breakwater at Rice Reservoir, behind breakwater

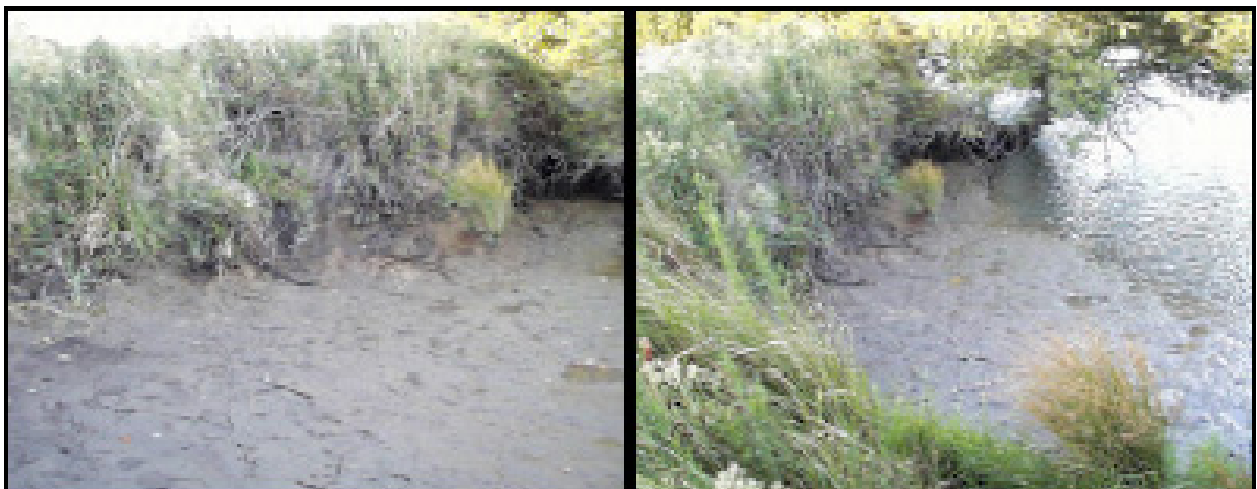
Figure 8. Scalloped bankline along Georgiana Slough

**Georgiana Slough.** The Sacramento-San Joaquin Delta is located in north central California, northeast of San Francisco Bay. Lying in the confluence of the Sacramento and San Joaquin rivers, it is the largest inland delta and the largest estuary on the west coast of North America (Hart and Hunter 2004). Georgiana Slough is located in the northern part of the Sacramento San Joaquin Delta. The slough is about 20 km long, varies from 50 to 100 m wide with an average bed slope of 0.01 percent (Hart and Hunter 2004). Currently, approximately 30 percent of the flow from the Sacramento River is being diverted into Georgina Slough. The shorelines of the slough are also subject to waves from local recreation boat traffic. Wind waves are minor because of limited fetch. The shoreline of the slough is experiencing erosion that can first be detected by the development of semicircular scallops along the shoreline. Figure 8 is a picture of one of the bank scallops.

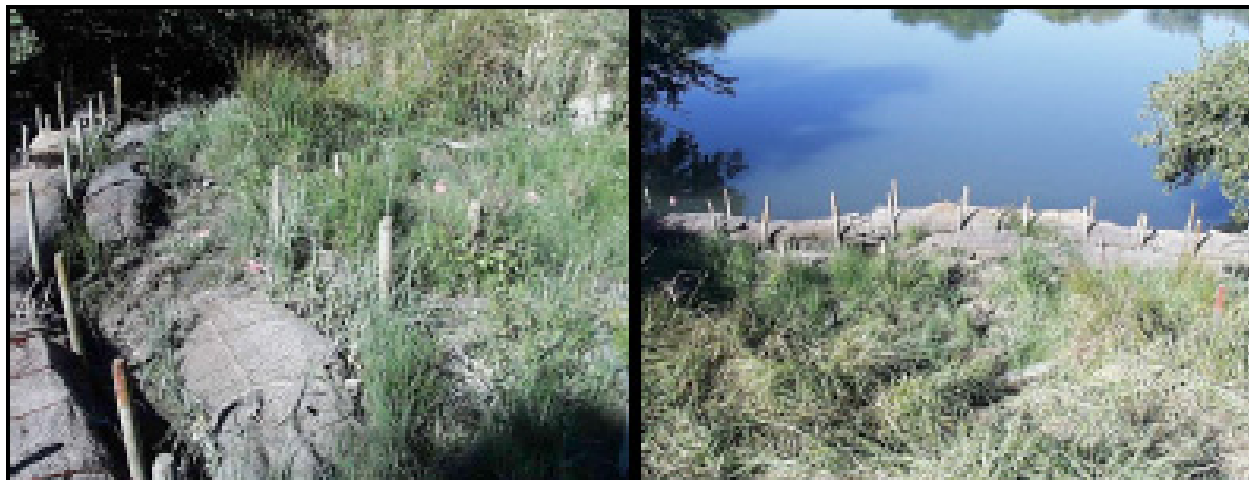
Figure 9. Branchbox breakwater at bank scallop on Georgiana Slough (1 year later from Figure 8)

At Georgiana Slough, additional materials were placed landward of the branchbox breakwater to further reduce wave and current effects at the shoreline. These additional materials included rooted material in blast buckets, brush bundles, and fiber roles in a scallop repair. Hart Restoration also states that a branchbox breakwater is a system where the branchbox breakwater works in conjunction with the aquatic plants. (Personal Communication, 2005, Cathy Wendt, WVIC, Wausau, WI.) The breakwater is the first line of defense and the vegetation acts as a second line of defense to further reduce wave energy and promote sediment deposition. Figure 9 is the same site in Figure 8 site 1 year later after brush bundles and aquatic vegetation had been placed landward of the branchbox breakwater.

On Georgiana Slough, the branchbox breakwaters accumulated significant sediment behind the breakwaters. This accumulation along a river environment may be much greater than along lakes and estuaries because a river can deliver significant amounts of sediment during high flows. The size of the poles and the construction techniques appeared adequate to prevent damage from waves and currents. After construction of a branchbox breakwater, maintenance will be continued for 1 to 3 years or until the scalloped shoreline is determined to be stable.

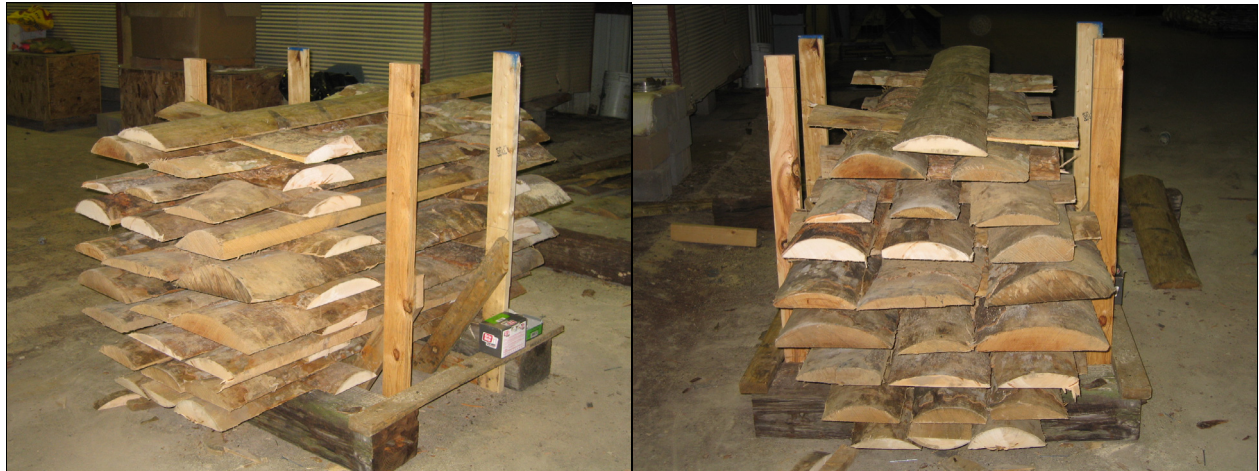
Figure 10. Slab bundle in jig used for building bundle

The slabs varying in width from 20 to 30 cm based on the diameter of the log from which they were cut, were loaded and trucked to a construction site from the lumber mill. They varied in thickness from 2 to 10 cm and were approximately 2.5 m long. A jig was constructed to form the bundles. The bundles were constructed by placing a layer of slabs parallel to the long axis of the bundle and then a layer of slabs perpendicular to the bundle axis. The perpendicular layer made the bundle porous as opposed to an almost solid bundle of wood. The slabs were nailed together with galvanized nails, and this process was repeated until the slab was approximately 0.9 m in height. The jig formed the slab into an elliptical shape with the bundle widest at a height of 0.45 m. Completed slab bundles are shown in Figure 10.

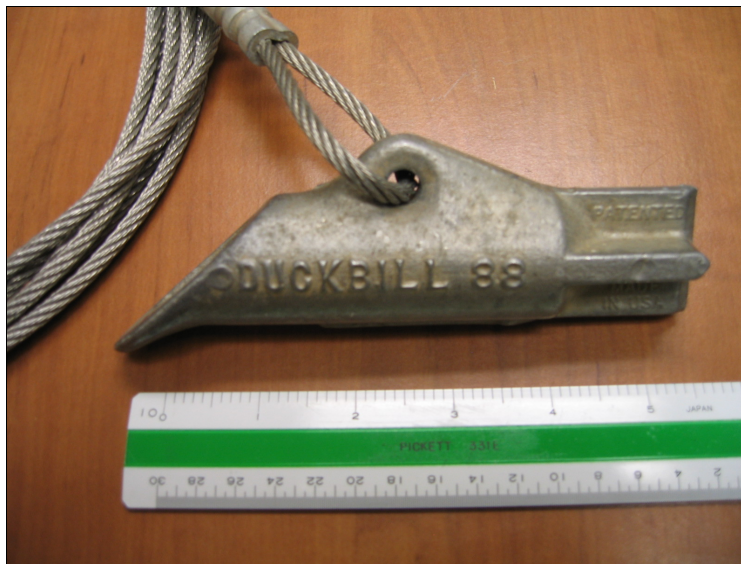
Figure 11. Duckbill anchor used to secure bundles

After the bundles were finished, but still in the jig, they were then bound together with stainless steel strapping. After strapping, they were transported and placed along a predetermined alignment to form a breakwater. The bundles were placed with the top of the bundle just below the normal pool elevation at St. Albans and Quincy. At this vertical position, the bundles were constantly in the water. The bundles were then anchored to the ground using Duckbill No. 88 anchors and 5-mm-diam stainless steel cable (Figure 11). The anchors were driven to about 1.8 m or refusal.

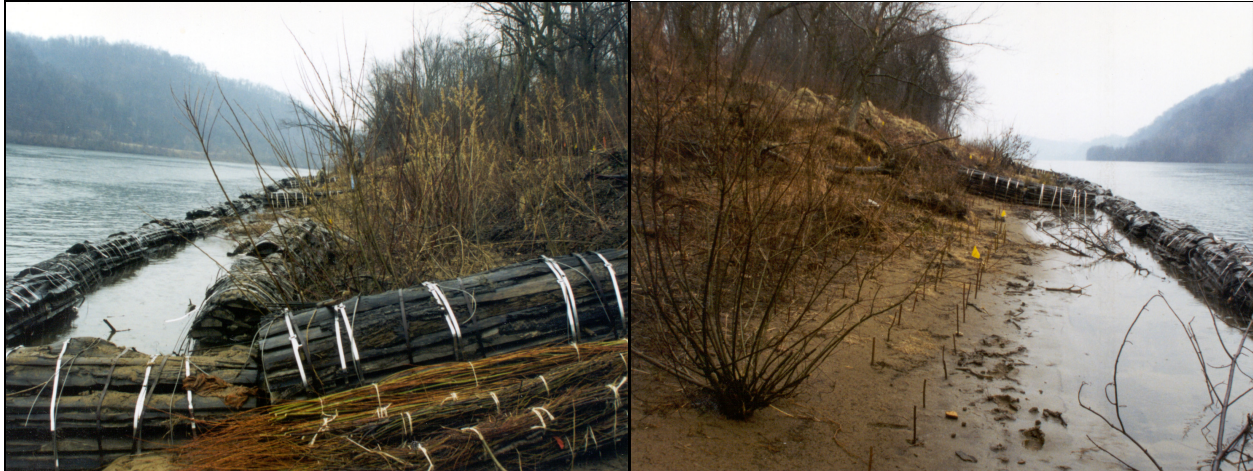
Figure 12. Slab bundles at Bat Grape Island. Notice second bundle placed landward of riverward bundle in left photograph and plantings in right photograph

The spaces in the bundle allowed for waves to pass through as wave energy was dissipated. As with the branchboxes, the slab bundles were a first line of defense. Local plants were selected and planted landward of the slab bundles to absorb the remaining wave energy and allow deposition of suspended sediments. Figure 12 shows slab bundles at Bat Grape Island with plantings shoreward of the bundles.
