# LOW COST CORROSION DAMAGE MITIGATION AND IMPROVED FATIGUE PERFORMANCE OF LOW PLASTICITY BURNISHED 7075-T6

Paul S. Prev  y  
Lambda Research, Cincinnati, OH

John Cammett  
Naval Aviation Depot, MCAS Cherry Point, NC

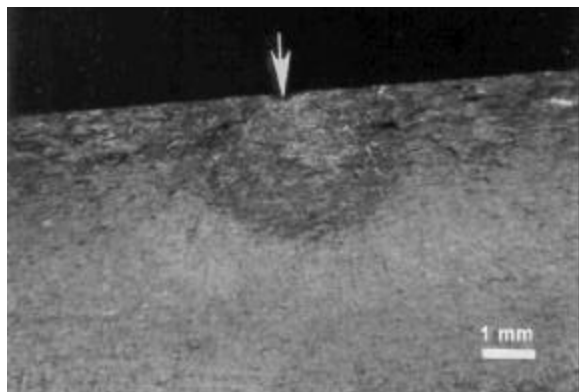
Figure 5A- Arrow indicates macroscopic appearance of fatigue origin at the site of corrosion after 100 hr. salt fog exposure.

The typical macroscopic appearance of a 100-hr. exposure is shown in Figure 5A. Fatigue failures in the salt fog exposed specimens initiated exclusively from corrosion pits. Specimens tested at lower stresses generally exhibited origins from a single pit, while specimens tested at higher stress levels tended to have multiple nucleation sites from separate pits. Pit depths were generally in the range of 0.004 -
