# **High Energy Density Cryogenic Capacitors Final Technical Report (Phase 1)**

**Sponsored by the  
Office of Naval Research  
Contract # N00014-04-C-0297**

**Contractor:** General Atomics  
**Address:** P.O. Box 85608  
San Diego, CA 92186-9784

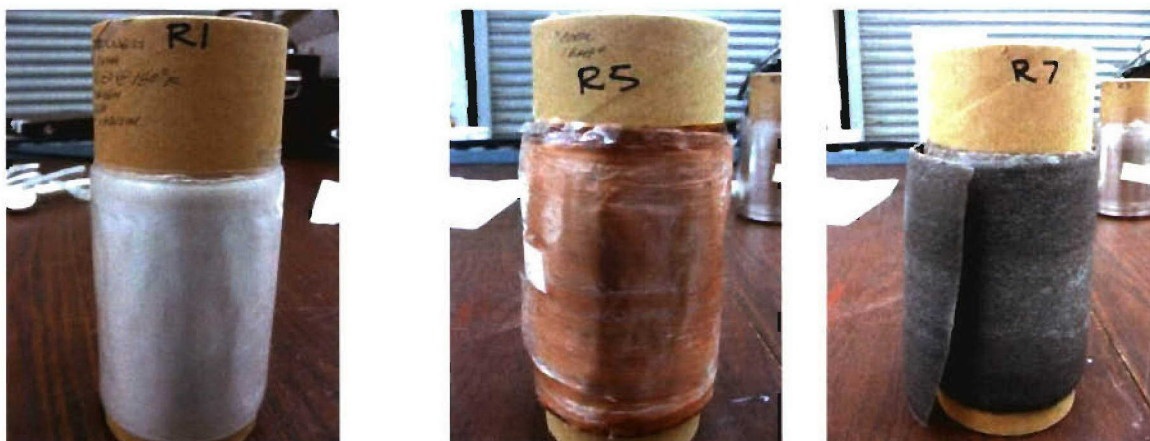
***Fig. 4-3. Photographs of, from left to right, isotactic PMMA, polyvinyl chloride acetate, and chlorinated polyethylene fabricated at Randcastle***

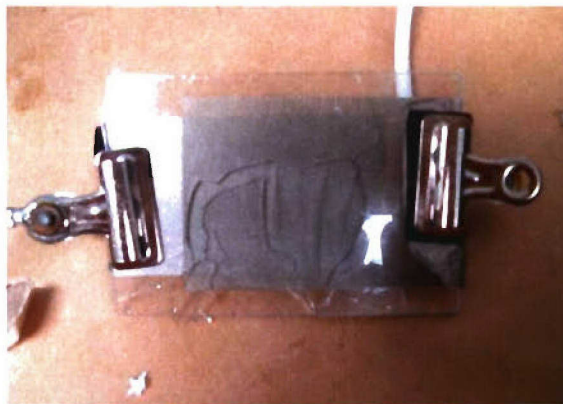
Using the ESI standard room temperature stamp capacitor testing technique for testing in cryogenic conditions resulted in broken glass slides due to the pressure being used to hold them together. A typical broken slide can be seen in Fig. 6-13

*Fig. 6-13. Broken glass slide*

To overcome this problem, the glass slides, which are normally used for stamp capacitor testing, were replaced with thicker polycarbonate slides. These thicker slides can be seen in Fig. 6-14 in a sideways configuration. ESI had several dozen of these custom slides manufactured to the dimension and thickness levels that were deemed necessary for successful cryogenic testing.

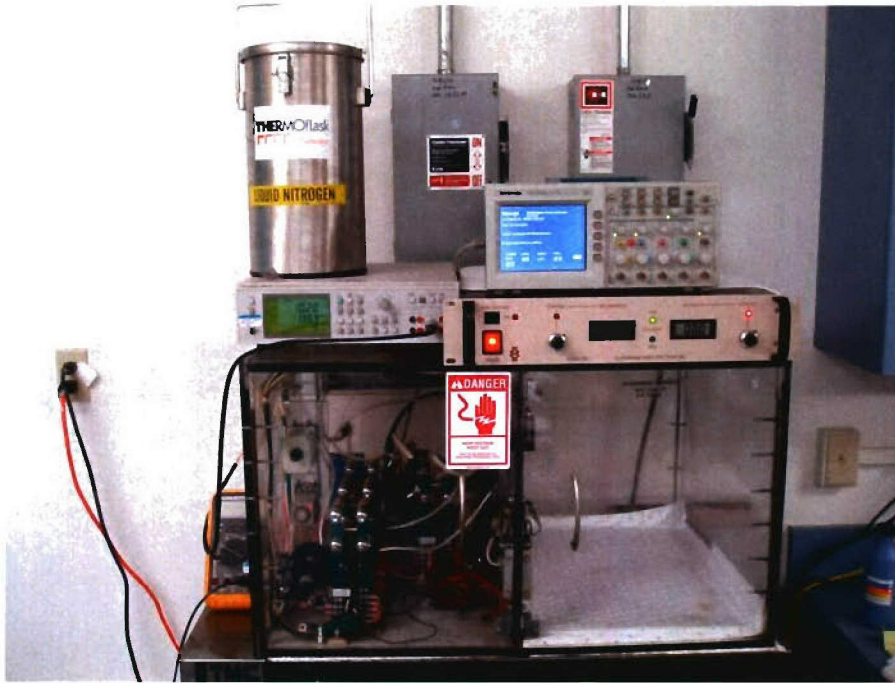
*Fig. 6-16. Stamp capacitor tester*

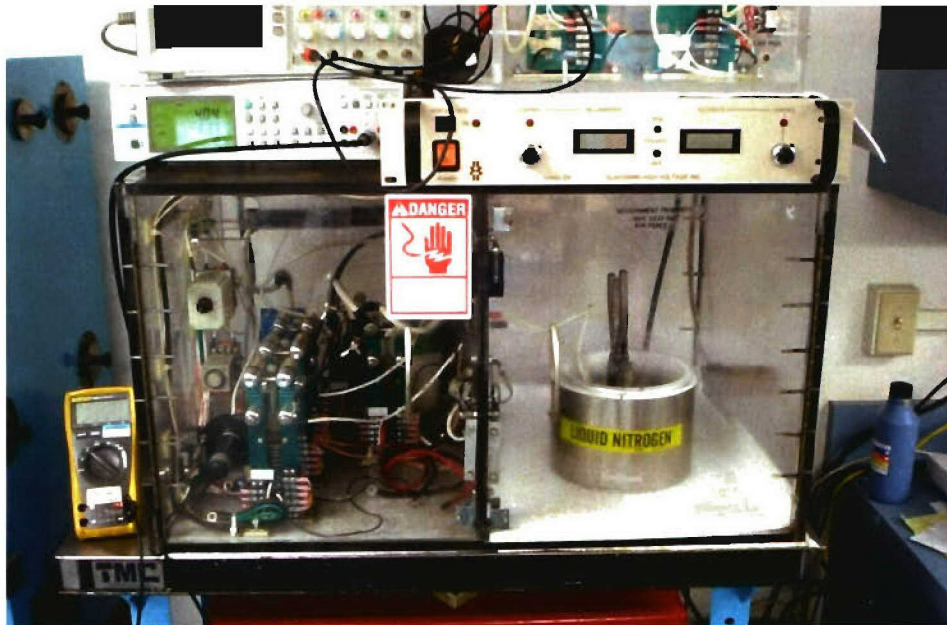
*Fig. 6-17. Stamp capacitor test setup with dewar for cryogenic testing*

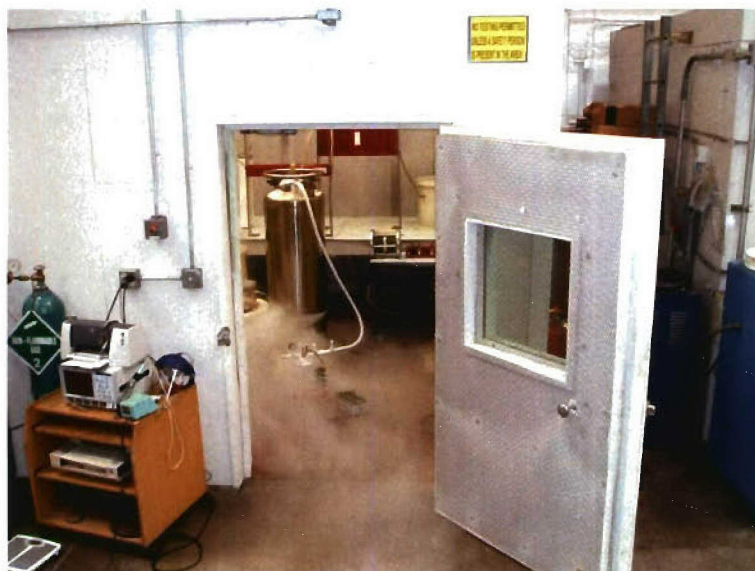
ESI has several large test chambers available for testing at cryogenic temperatures. Pictured in **Error! Reference source not found.**6-18 is one of the test cells with a supply dewar and cryostat after testing. No modification was needed to the test cell other than the addition of the supply dewar.

*Fig. 6-18. Test cells with a supply dewar and cryostat after testing*

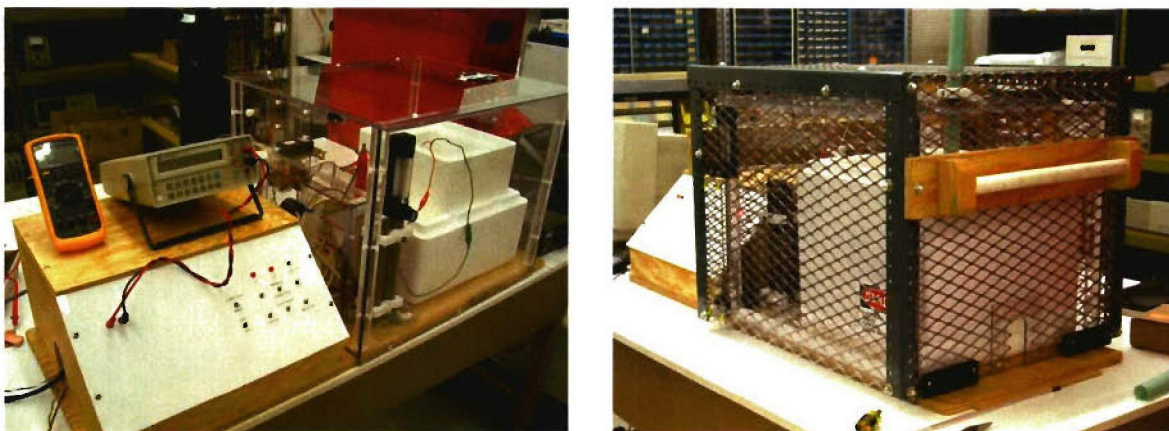
The samples are tested in MTECH's high-voltage capacitor test unit, shown in Fig. 6-24. The test setup consists of a large clear polycarbonate housing for the high-voltage equipment, and a smaller insulated enclosure containing the control electronics. The voltages are scanned and data is recorded and logged by a computer using software developed at MTECH. Relays are used to isolate the user from the high voltage, and to reduce leakage from the capacitor through the measurement equipment (probes, etc.).

***Fig. 6-24. High-voltage test equipment built at MTECH to test voltage breakdown of the stamp capacitors***

The high-voltage box also provides for a dry nitrogen gas environment. The dry nitrogen atmosphere inside the box is used to minimize frost formation on the DUT and its leads during cryogenic testing. All tests are performed with the capacitor housed in a Styrofoam container, which can be filled with liquid nitrogen via a G-10 fill pipe.

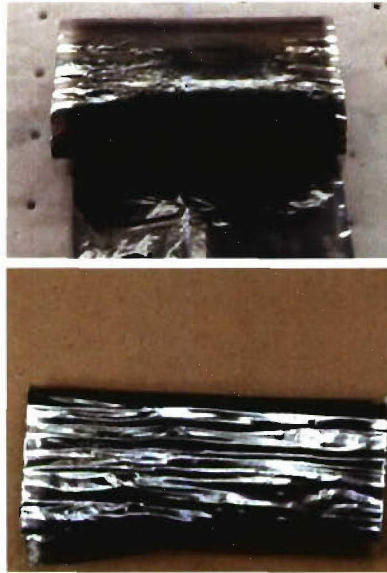
Examination of failed capacitors indicated significant wrinkling of the film. An example is shown in Fig. 7-3. This could lead to degraded performance due to localized enhancement of the electric field or weakening of the film due to mechanical stress. Several theories were put forth as to the possible cause of this wrinkling including:

- the high rate of change in temperature (high  $dT/dt$ )
- the long charge time and the extended time of clearing
- leakage of  $LN_2$  into the case

*Fig. 7-3. Wrinkling of the capacitor film*

A series of tests were conducted on a model 30957 capacitor to try and determine the cause of the wrinkling.

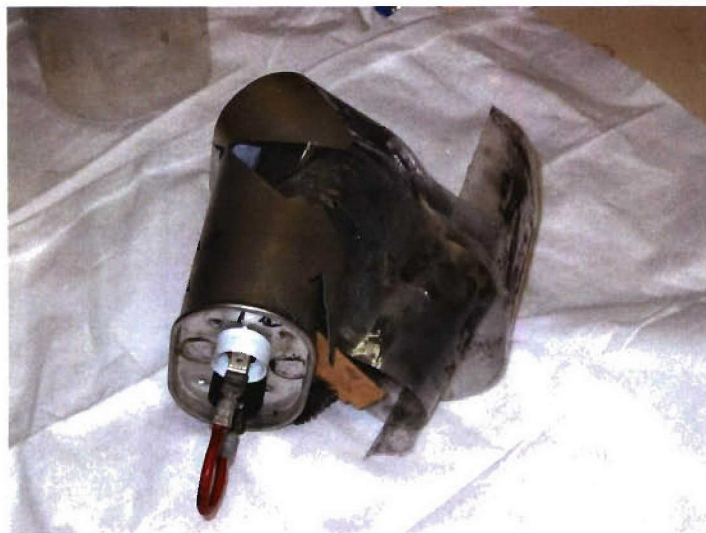
The step-charge testing on the oil filled capacitors was not consistent due to the scatter in the data, but was sufficient to indicate that oil filled COTS capacitors would not reach the program goal for energy density. With one exception, every non-impregnated capacitor tested by the step-charge method failed catastrophically.

***Fig. 7-6. Catastrophic failure of a Model 30956 capacitor during step-charge testing***

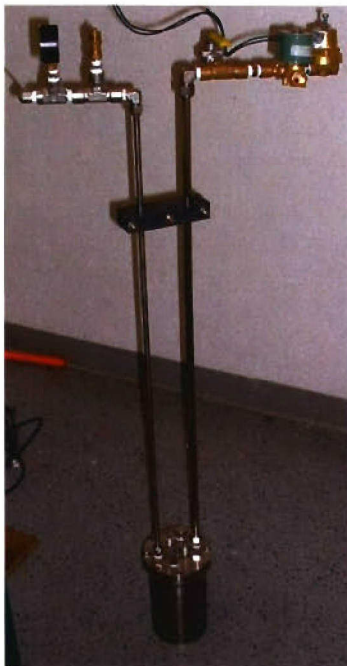
All cryogenic life testing was performed with non-oil impregnated model 30956 capacitors. The capacitors were not dried prior to testing. The testing was done in the reusable pressure vessel shown in **Error! Reference source not found.** 7-7. The capacitor pad was removed from the can and all external insulation was removed. The pad was then attached to the feedthroughs in the lid of the pressure vessel as shown in **Error! Reference source not found.**-7-8. The lid was then bolted to the canister with a gas tight seal.

***Fig. 7-7. Pressure vessel ready for testing***

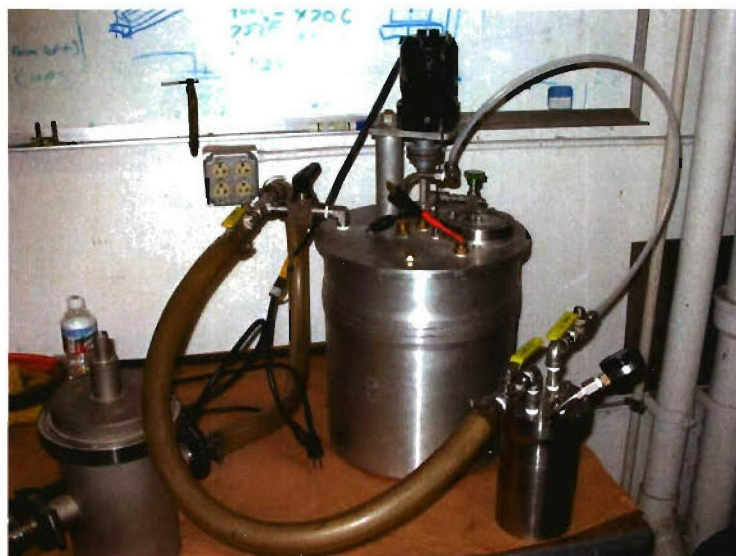
**Fig. 7-20. Photograph of VPI system**
