NAWCWD TP 8598

**Insensitive Munitions Technology Transition
Program Composite Case Captive Carry
Qualification (C⁴Q) Final Report**

**NAVAL AIR WARFARE CENTER WEAPONS DIVISION
CHINA LAKE, CA 93555-6100**

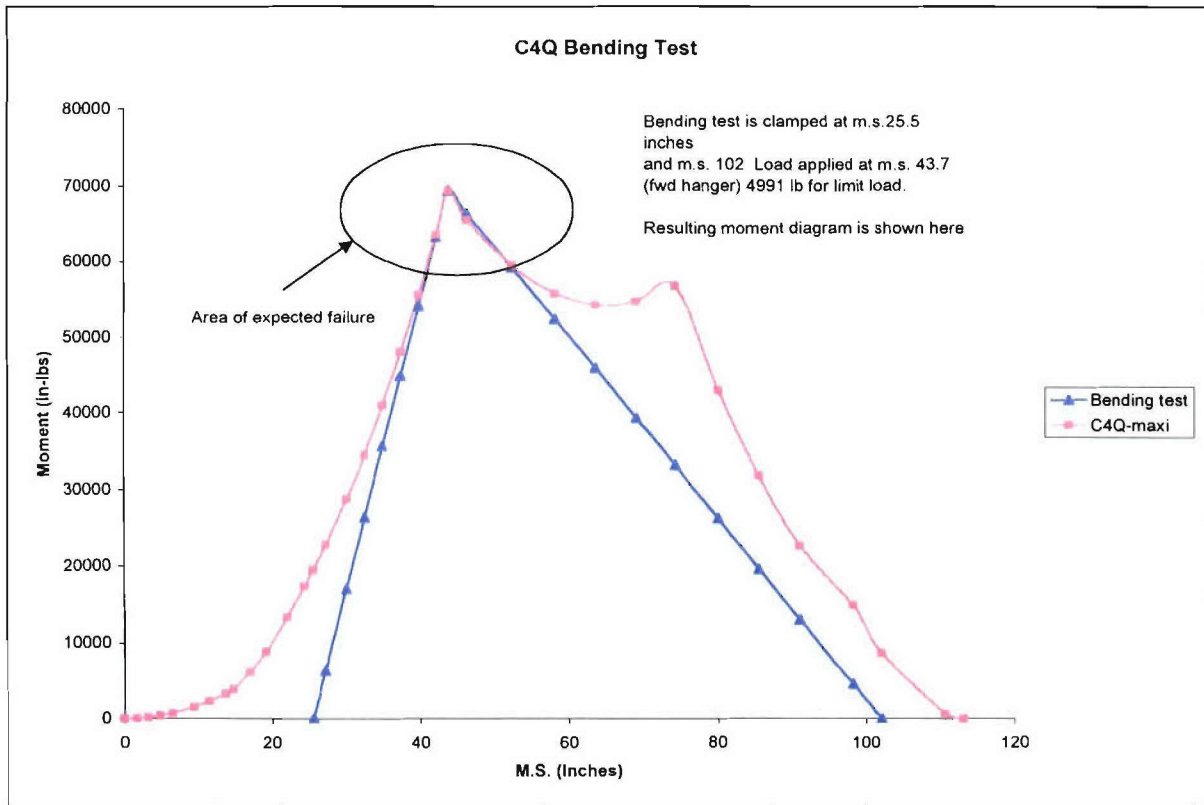
FIGURE B-4. Bending Test Moment Diagram.

The development of the three-point bending fixture and loading values is based on the assumption that the composite tube will fail at or near the forward hanger where the bending moment is most severe. The assumption of simple supports is used due to the geometry of the clamps and the clearance with the tube. The clamp locations were estimated by fitting a triangular moment diagram (typical for three-point bending) onto the maximum moment envelope. The peak at the forward hanger is for the Mk 84 release condition (worst-case limit load). Figure B-4 shows the results. Note that the locations of the base corners of the triangle correspond to the clamping locations.

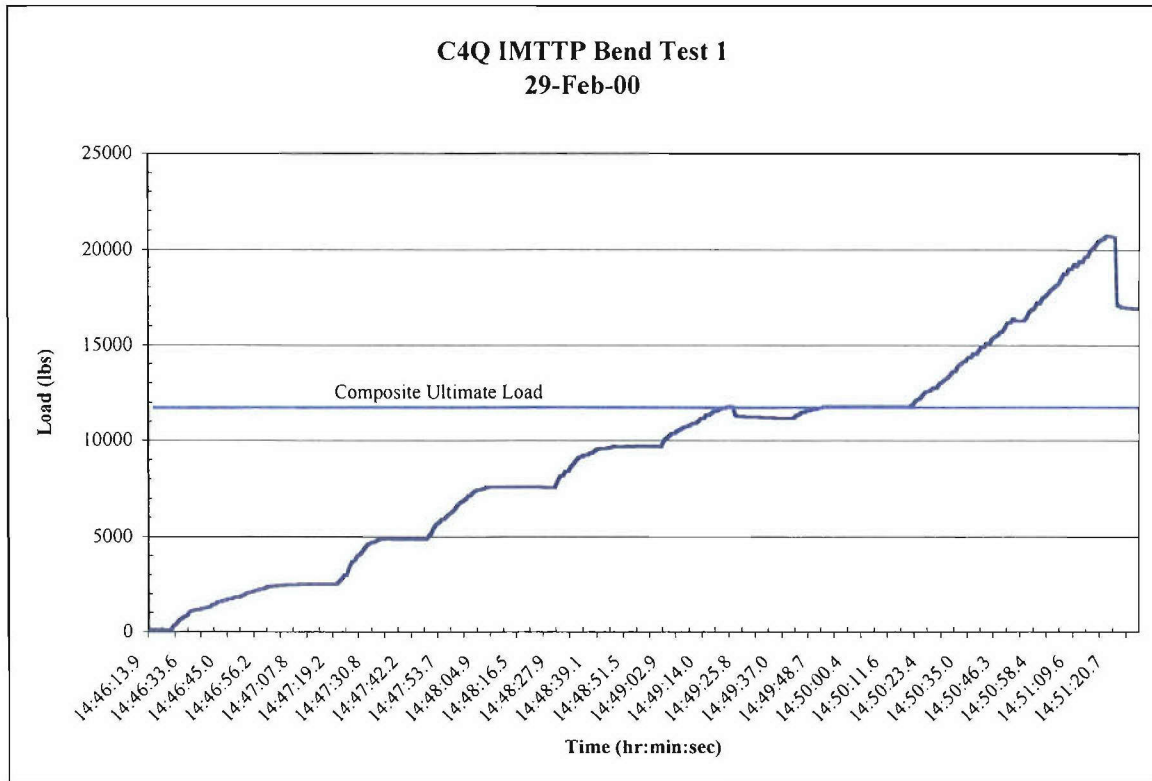
FIGURE B-8. Ultimate Test Load History.

The next stage in the test was to increase the load on the tube until failure. The load application history is shown in Figure B-8.

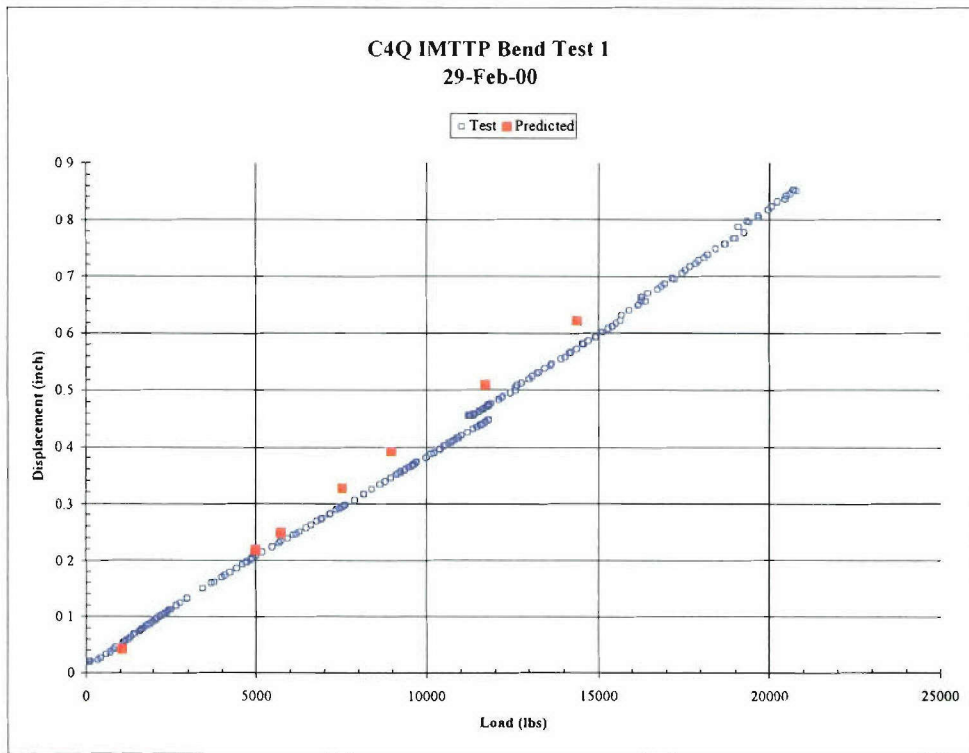
FIGURE B-9. Ultimate Load Test Displacements.

Figures B-9 and B-10 provide the ultimate load test displacements and selected strain data, respectively. Figures B-11 and B-12 show gage 2.

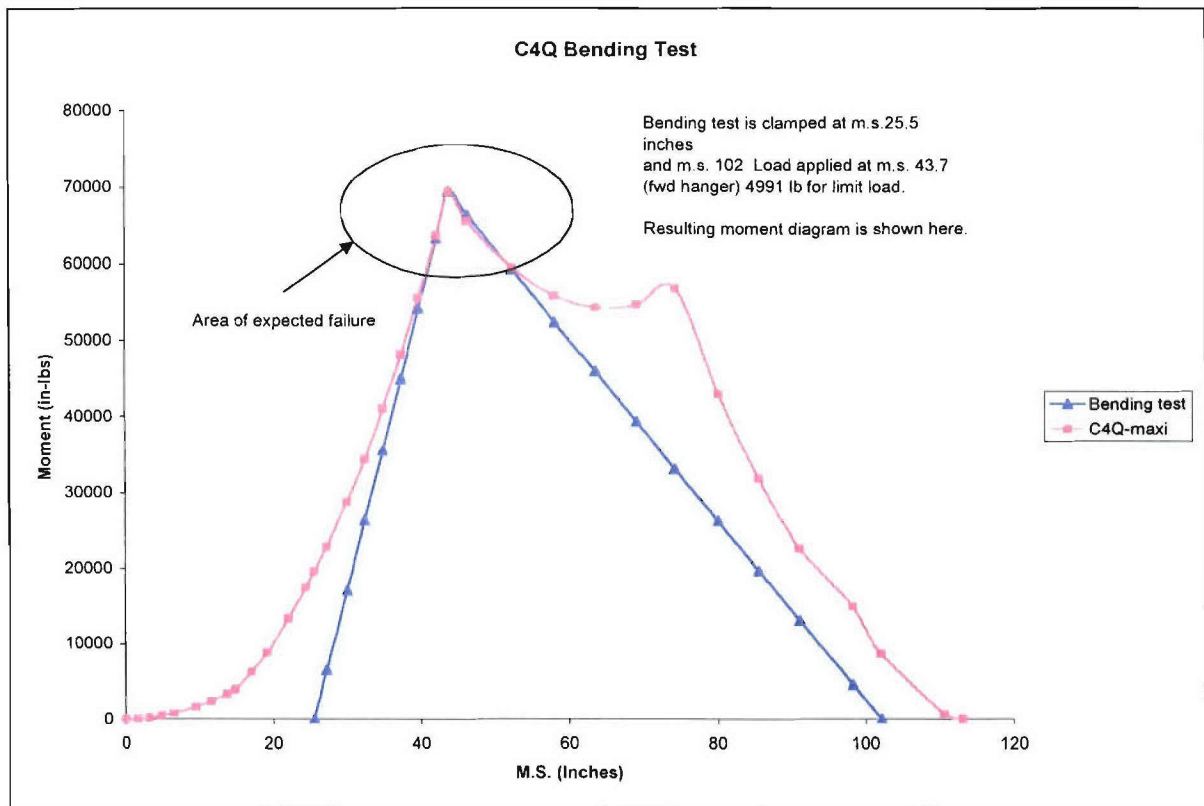
FIGURE D-9. Bending Test Moment Diagram.

The development of the three-point bending fixture and loading values is based on the assumption that the composite tube will fail at or near the forward hanger where the bending moment is most severe. The assumption of simple supports is used due to the geometry of the clamps and the clearance with the tube. The clamp locations were estimated by fitting a triangular moment diagram (typical for three-point bending) onto the maximum moment envelope. The peak at the forward hanger is for the Mk 84 release condition (worst-case limit load). Figure D-9 shows the results. Note that the locations of the base corners of the triangle correspond to the clamping locations. This test uses the same fixtures as the bending test of C⁴Q tube Serial Number 001 (room temperature, dry bending test).

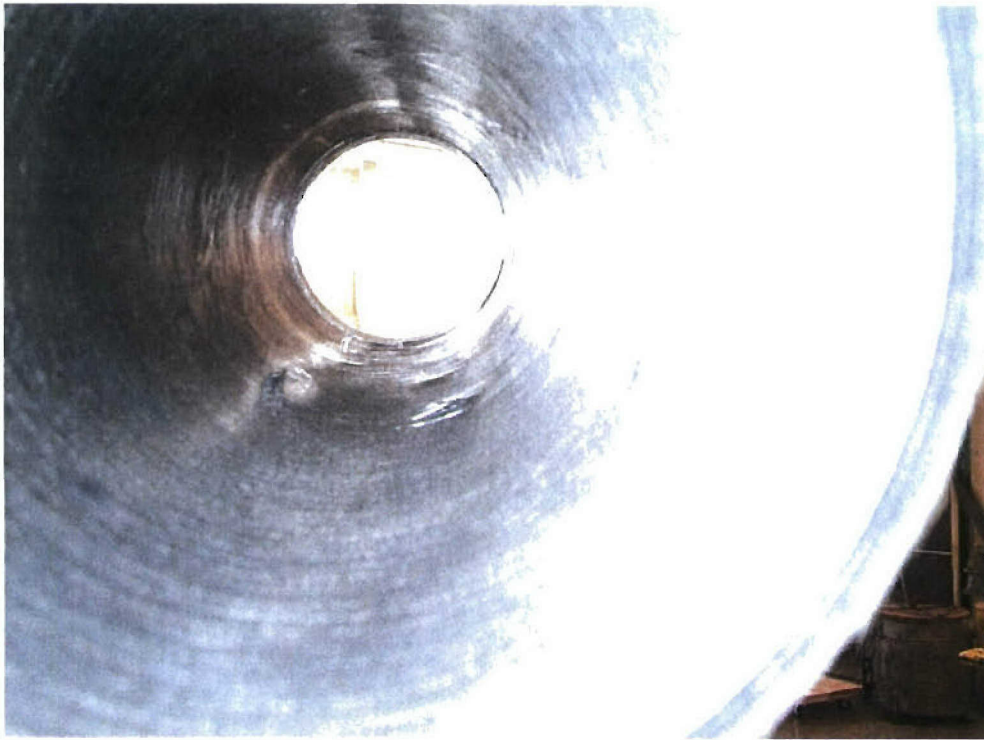
FIGURE J-9. Middle Hanger Failure (No Release), Inside View.

Both tubes failed in a similar manner. The failures were initiated inside the composite tube, along the edge of the wound in hanger pad, and then failed in the fasteners. Both failures were comfortably above the ultimate load. In addition, there was insignificant difference between the regularly manufactured article and the test article with a built-in disbond between the wound-in pad and the composite case. This confirms the mechanically locked-in design functions as expected, despite a bond failure. Figures J-9 through J-12 show the failures.

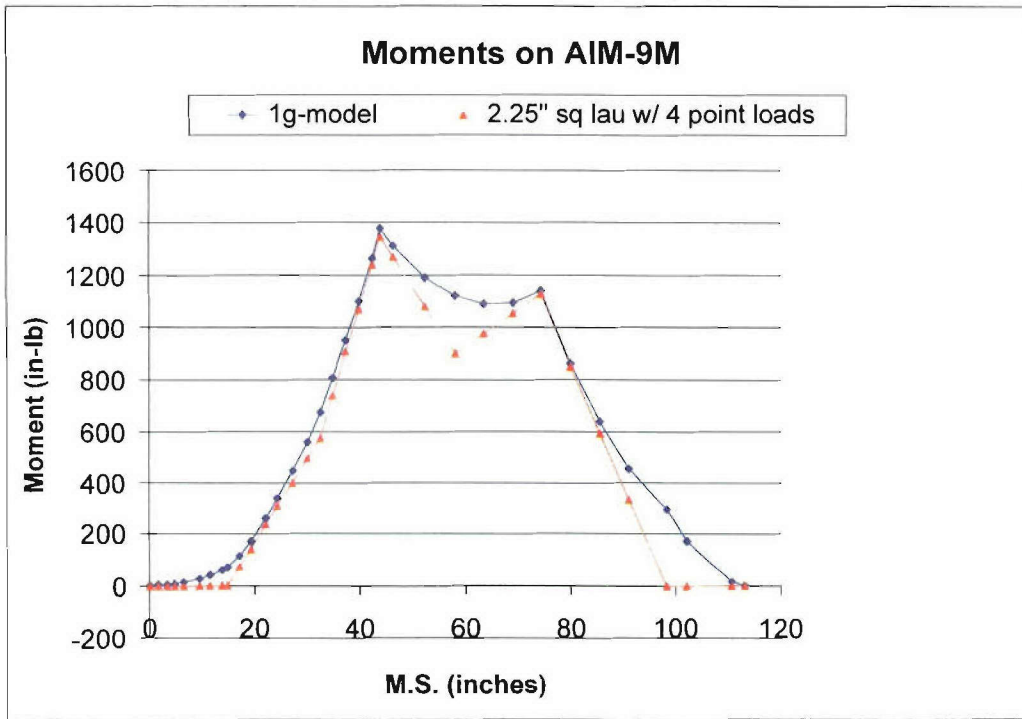
FIGURE P-4. Test and Actual Moment Diagram (1 g).

The wiffle tree and launcher fixture were designed to produce a representative moment diagram on the missile and to produce appropriate loads on the three hangers for a given *g* level. With a few iterations, it was found that four loading points would sufficiently simulate response to the flight inertial loading. Comparisons of structural response were made using the C⁴Q finite element model (see the C⁴Q design criteria report). Figure P-4 shows the results of the moment diagram comparison, and Table P-1 shows the comparison of the hanger reaction loads.

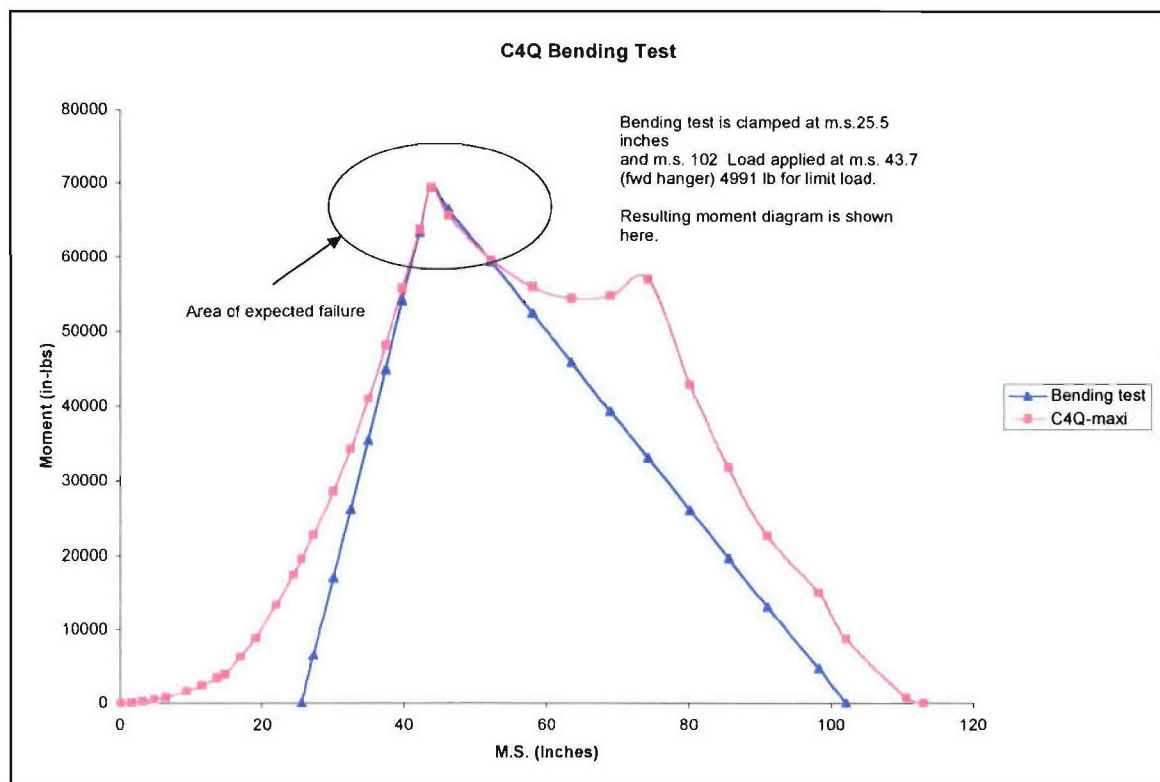
FIGURE S-3. Bending Test Moment Diagram.

The development of the three-point bending fixture and loading values is based on the assumption that the composite tube will fail at or near the forward hanger where the bending moment is most severe. The assumption of simple supports is used due to the geometry of the clamps and the clearance with the tube. The clamp locations were estimated by fitting a triangular moment diagram (typical for three-point bending) onto the maximum moment envelope. The peak at the forward hanger is for the Mk 84 release condition (worst-case limit load). Figure S-3 shows the results. Note that the locations of the base corners of the triangle correspond to the clamping locations.

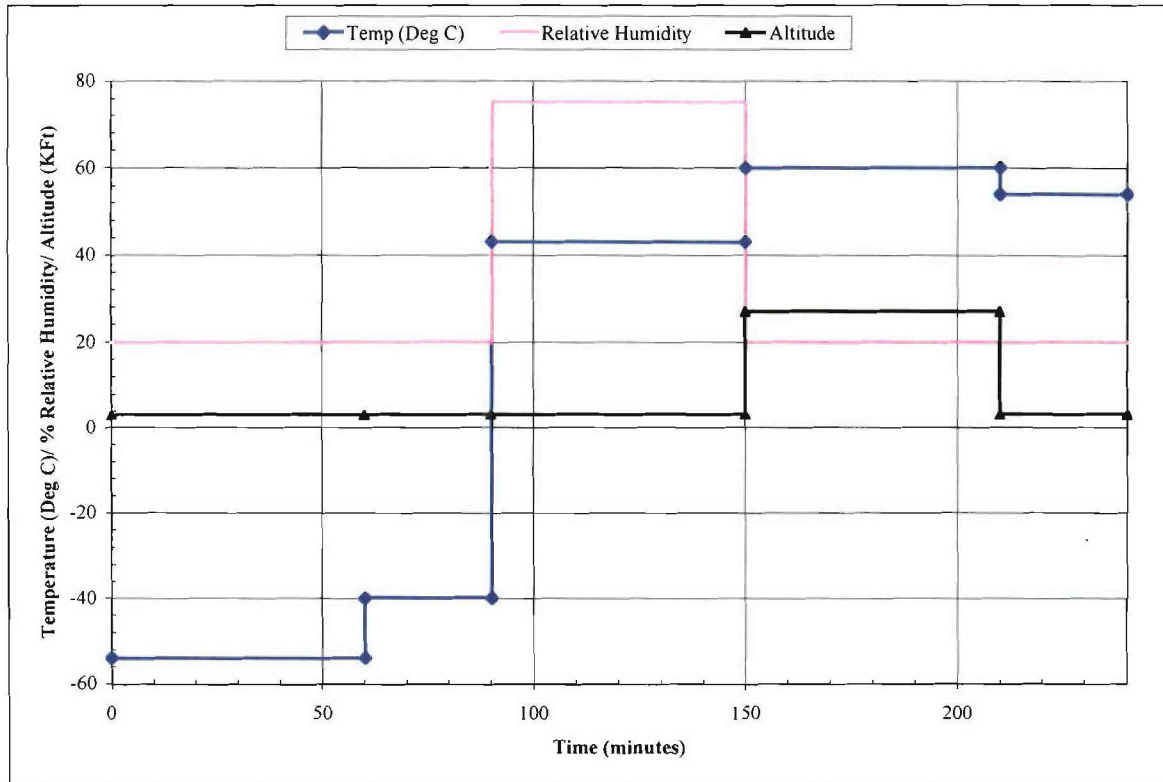
FIGURE U-2. Temperature, Altitude, and Humidity Test Cycle.

The test item was subjected to a temperature, altitude, and humidity test performed in accordance with MIL-STD-810, Method 520.1. Ten cycles were performed using the condition sequence shown in Figure U-2.
