# **LIMITED EVALUATION OF AN 802.11b AIR-TO-GROUND WIRELESS DATALINK (PROJECT "HAVE HALO")**

FINAL TECHNICAL INFORMATION MEMORANDUM

AIR FORCE FLIGHT TEST CENTER  
EDWARDS AIR FORCE BASE, CALIFORNIA  
AIR FORCE MATERIAL COMMAND  
UNITED STATES AIR FORCE

This Technical Information Memorandum (AFFTC-TIM-06-03, Limited Evaluation of an 802.11b Wireless Datalink, Project "HAVE HALO") was prepared and submitted under Job Order Number M06C0400 by the HAVE HALO test team, US Air Force Test Pilot School (USAFTPS), Edwards Air Force Base, CA 93524-6485.

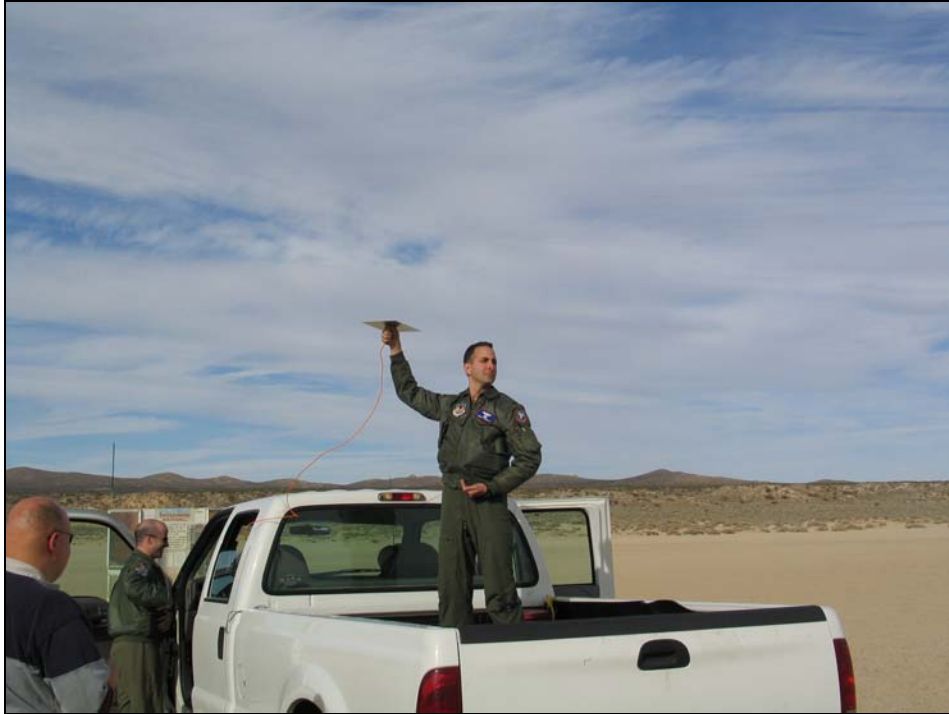
**Figure I-2: Test team member performing ground checkout antenna placement**

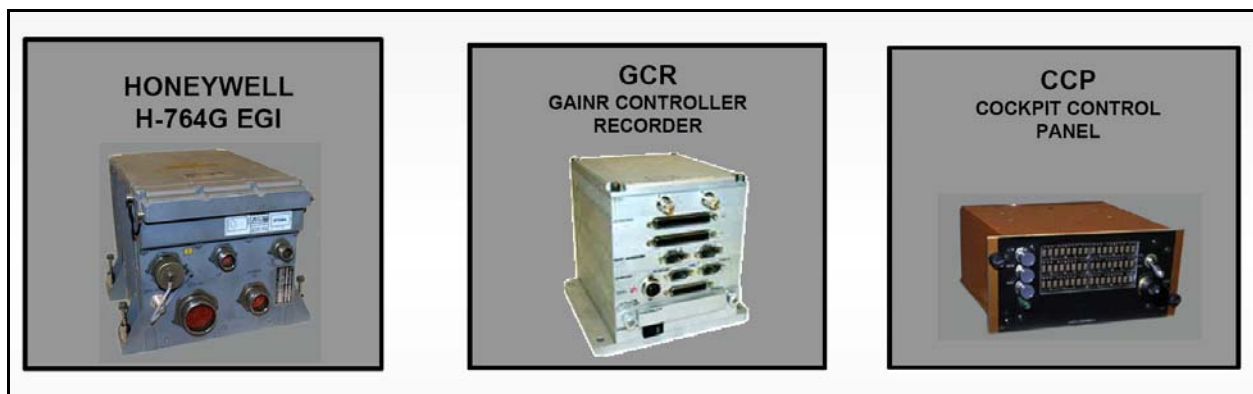
**Figure A-5: Components of the GPS Aided Inertial Reference System**

The test support hardware consisted of one truth source supplied by 412th Test Wing, Range Support Division Edwards AFB (412 TW/ENR). A GPS Aided Inertial Reference (GAINR) system was the truth source on C-12C #73-1215. According to Reference 5, the GAINR-II accuracy was identified at 1 foot accuracy. Figure A-5 illustrates the three components of the GAINR system.
