# Transparent Armor Cost Benefit Study

Lisa Prokurat Franks  
RDECOM (TARDEC)  
and

David Holm and Rick Barnak  
TACOM Cost & Systems Analysis Directorate

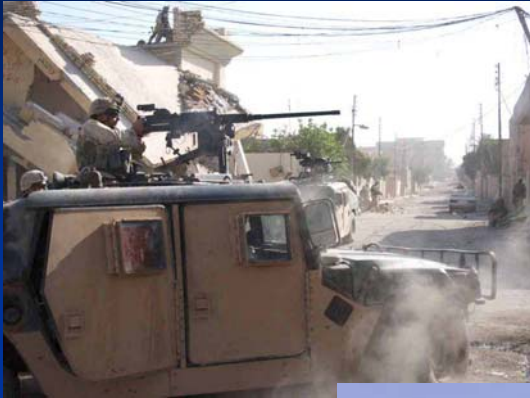
Early OIF

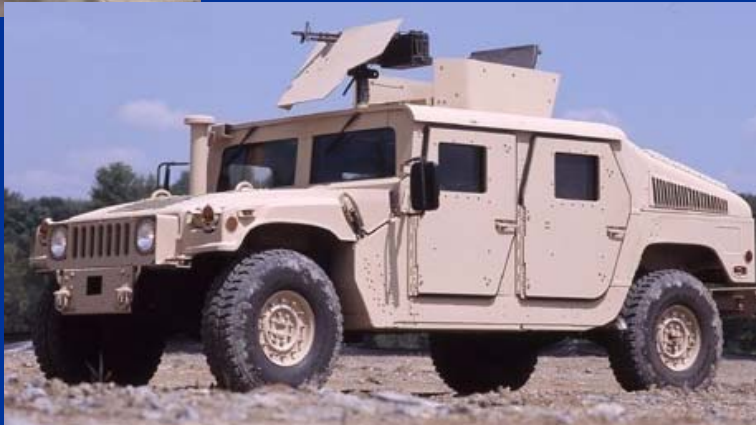
2004-2005 - GPK

Curb Wt: 10,300lbs  
GVW: 12,100lbs

2006

“Iraqi Pope Glass”

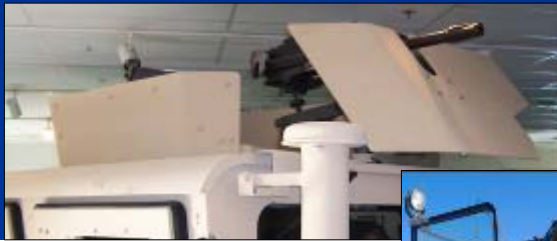
AH1 GS & GPK

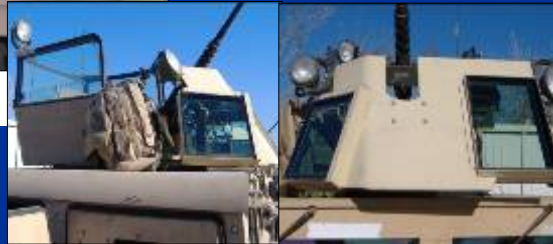
Field Modified GS & APK

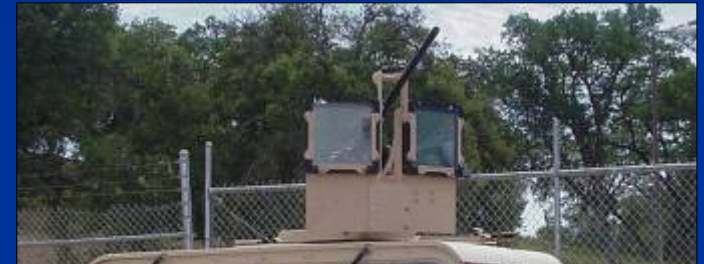
Upgraded Gunner Shield – Transparent Armored Gun Shield (TAGS)

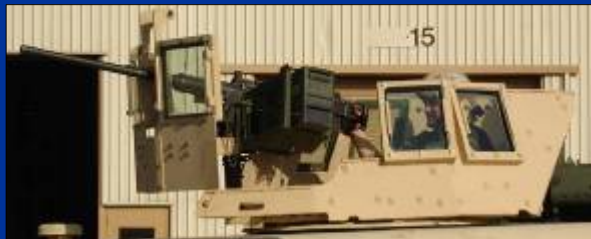
Interim Solution – Marine Corps TAGS (MCTAGS)

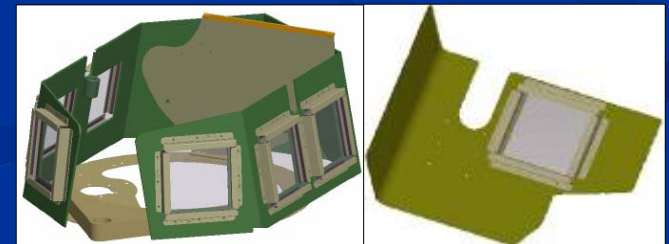
Future Solution – Modified Solution based upon theater recommendations

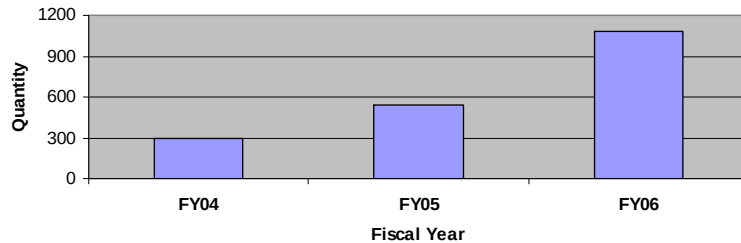
Left Windshield Average Monthly Demand

- Over \$5.2 Million was spent per month in FY05 for the Up-Armored HMMWV windshields and door windows.
- Demand for both right and left windshields increased 133% and 101% respectively from FY05 to FY06.
- Demand for door windows increased 658% from FY05 to FY06.

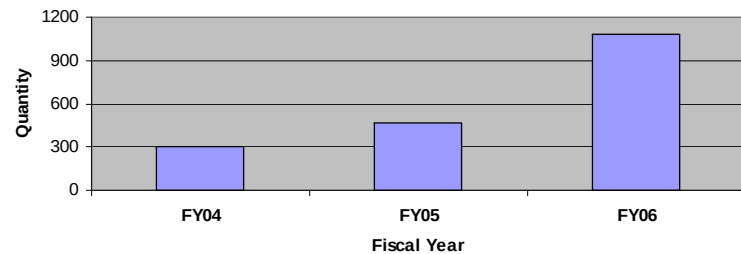
Right Windshield Average Monthly Demand

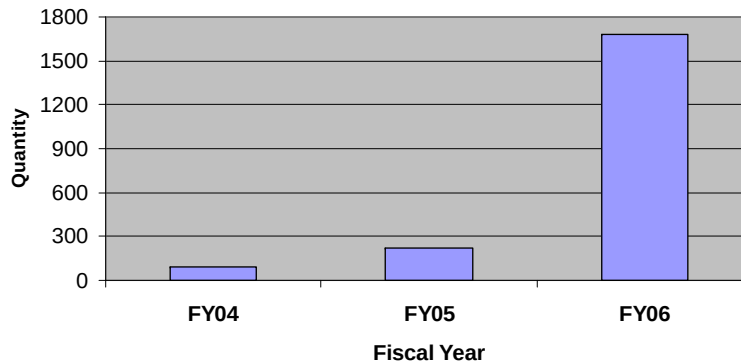
Door Window Average Monthly Demand

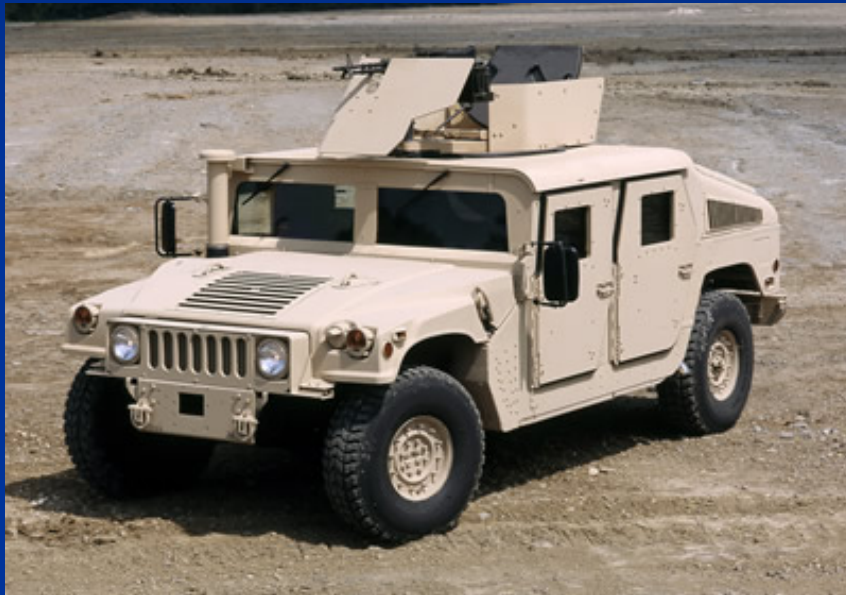
- Soldiers are adding another piece of glass to each door for added protection.
- Adds additional weight to an already overweight vehicle and reduces payload capacity!

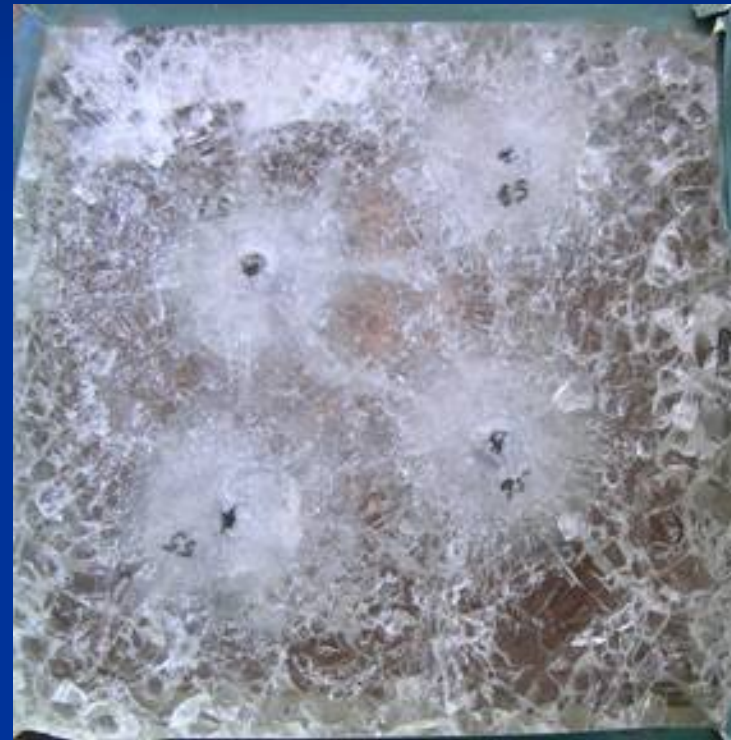
- Insurgent Attacks  
(with a wide range of threats)
- Sandstorm Damage
- Rock Strikes
- Improper removal and installation
- Clouding
  - Delamination caused by environmental degradation
  - Improper curing process
  - Improper cleaning techniques

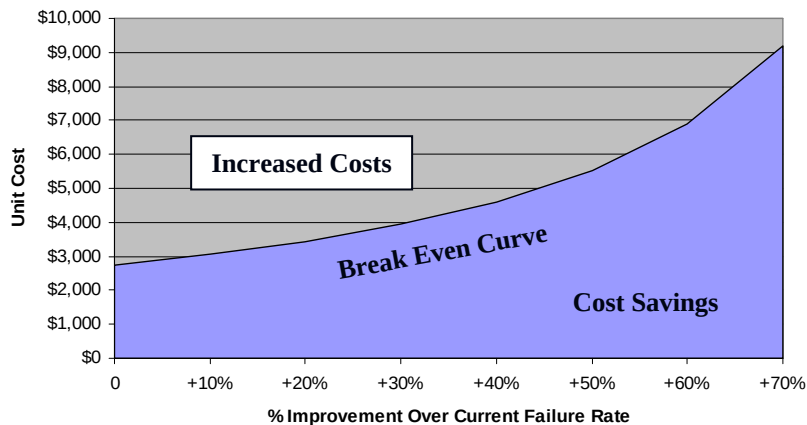
LH Windshield Unit Cost vs. Improved Reliability

Curves Based on the FY05 Demand Data

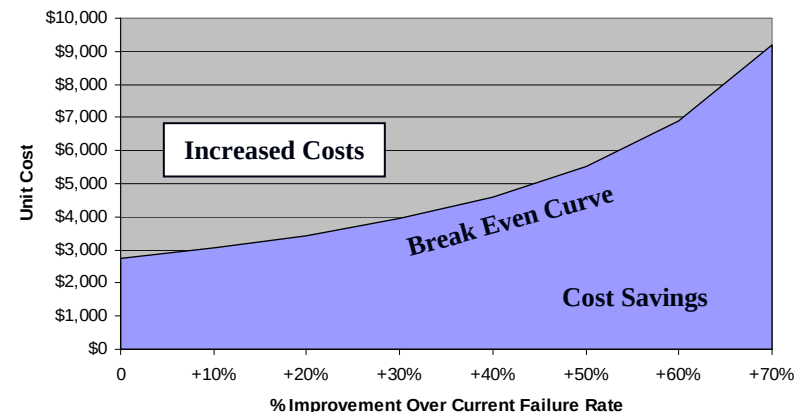
RH Windshield Unit Cost vs. Improved Reliability

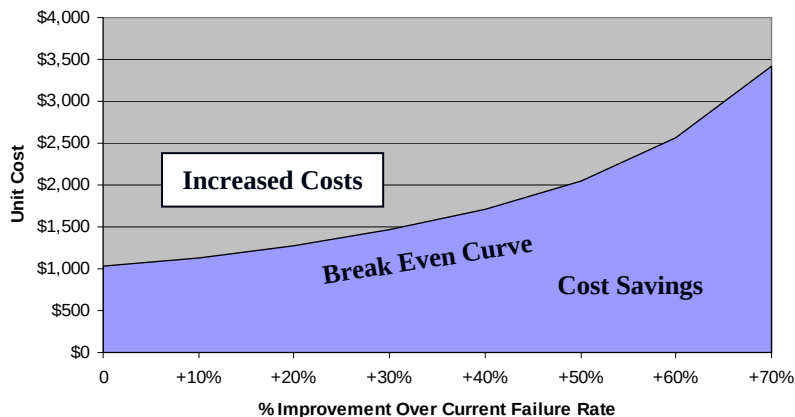
Door Window Unit Cost vs. Improved Failure Rate
