# EDGEWOOD

ECBC-TR-510

**VAPOROUS HYDROGEN PEROXIDE (VHP) DECONTAMINATION  
OF A C-141B STARLIFTER AIRCRAFT:  
VALIDATION OF VHP AND MODIFIED VHP (mVHP)  
FUMIGATION DECONTAMINATION PROCESS  
VIA VHP-SENSOR, BIOLOGICAL INDICATOR, AND  
HD SIMULANT IN A LARGE-SCALE ENVIRONMENT**

March 2007

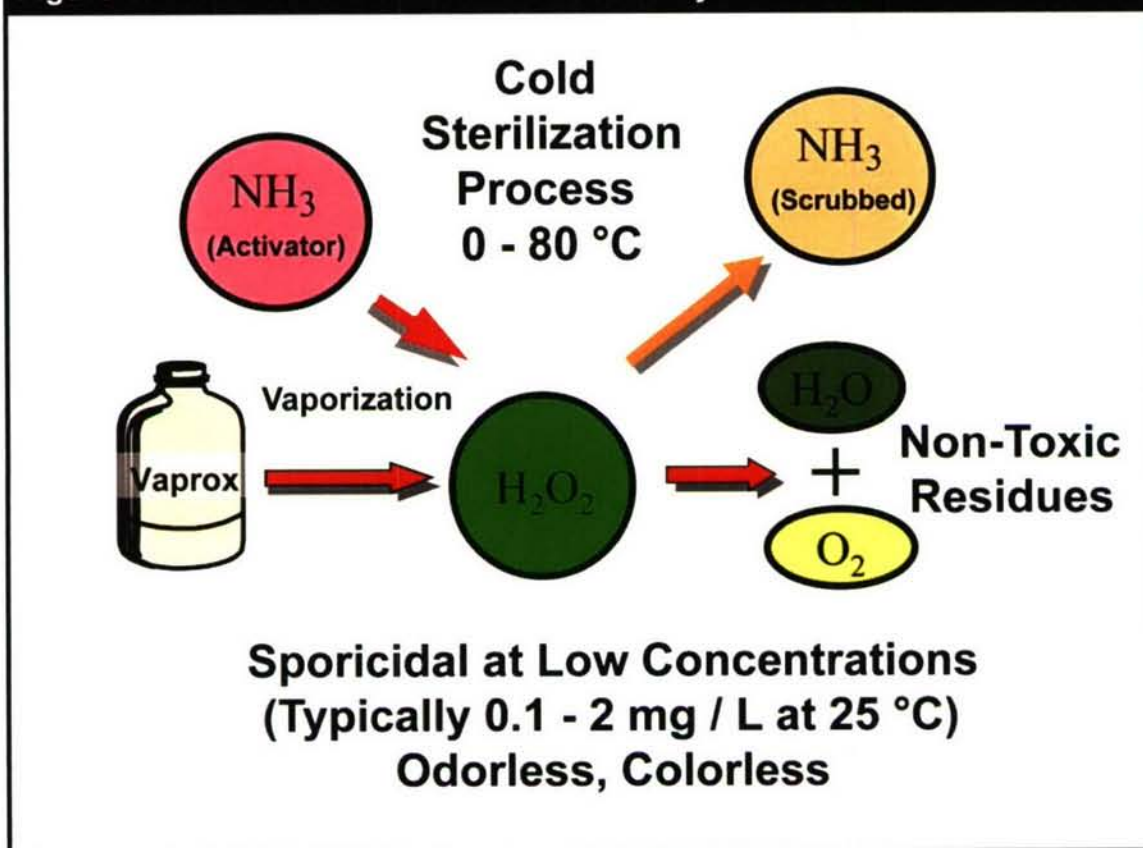
**Figure 1: mVHP<sup>®</sup> Decontamination Chemistry**

The mVHP decontamination process is effective at atmospheric pressure within a broad range of ambient temperatures. Unreacted hydrogen peroxide readily decomposes to form water and oxygen, leaving no toxic residues (Figure 1). The ammonia concentration used is well below the Permissible Exposure Limit (PEL) of 50 ppm and is scrubbed out of the exhaust air through an appropriate filter.

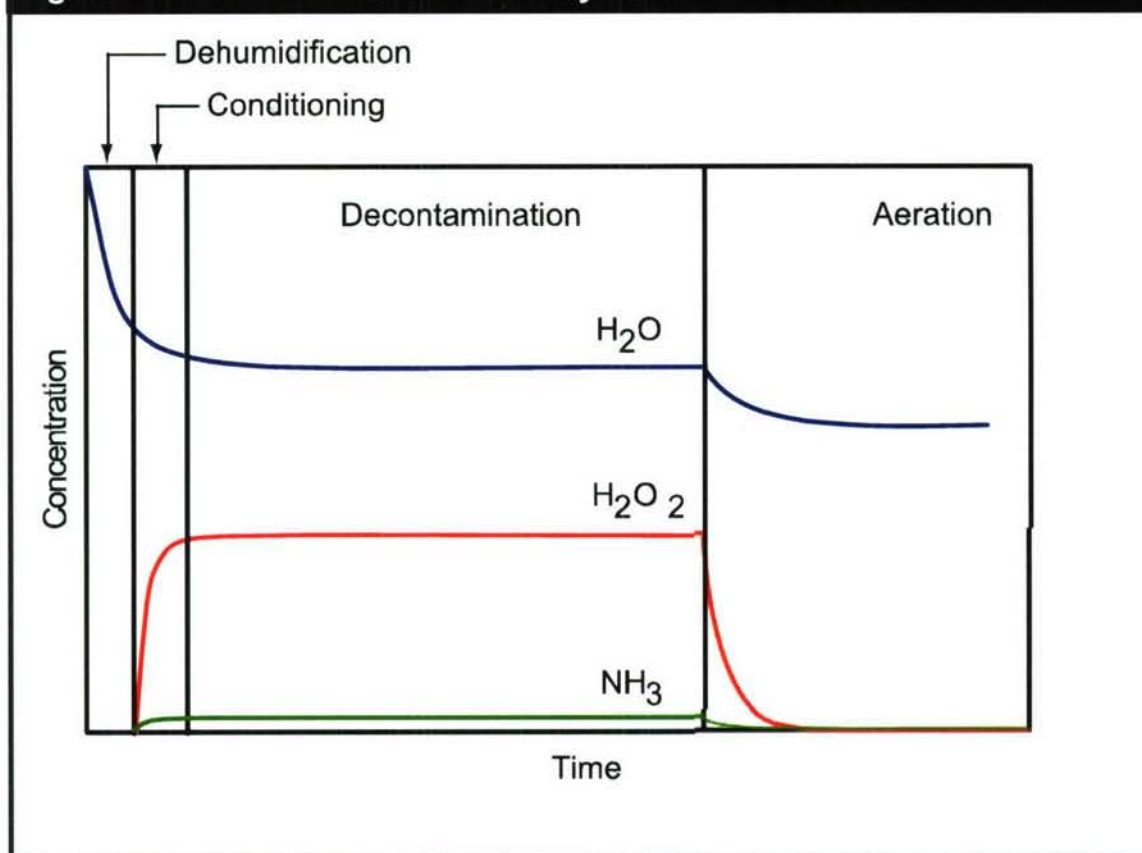
**Figure 2: mVHP® Decontamination Cycle**

Decontamination of an interior space using the modular mVHP system is a four-phase process involving preparation of the interior air (dehumidification), achieving a steady state decontaminant level (conditioning), performing the decontamination, and then aerating the interior space for safe entry (Figure 2).

#### Dehumidification

Hydrogen peroxide vapor can co-condense with water vapor producing an undesired condensate high in hydrogen peroxide. If ambient conditions are likely to permit condensation – high humidity and/or cold temperatures – potential condensation can be prevented by circulating dry, heated air through the interior space prior to injection of the hydrogen peroxide vapor. The target humidity level is determined by the concentration of vapor to be injected and the desired steady state concentration for the decontamination. The lower relative humidity permits a higher hydrogen peroxide concentration without reaching a saturation point.

#### Conditioning

During the conditioning phase, injection of ammonia and hydrogen peroxide vapor is initiated. Injection rates are selected to rapidly raise the concentrations to the desired set point without condensation. Internal sensors measure and report the ammonia and hydrogen peroxide concentrations to the control system. When the set-point concentrations values are reached, the ammonia and hydrogen peroxide injection rates are lowered to maintain the set-point concentrations. Once all the interior monitors reach or exceed the set point concentration, the system proceeds to the next phase.

Decontamination is a timed phase dependent on the hydrogen peroxide vapor concentration, ammonia vapor concentration and temperature. A decontamination timer counts down from the preset decontamination time. The timer stops if the concentration or temperature values fall below the set-point. The timer ensures that during the decontamination phase, the interior space is exposed to at least the minimum decontamination conditions for the desired exposure time.

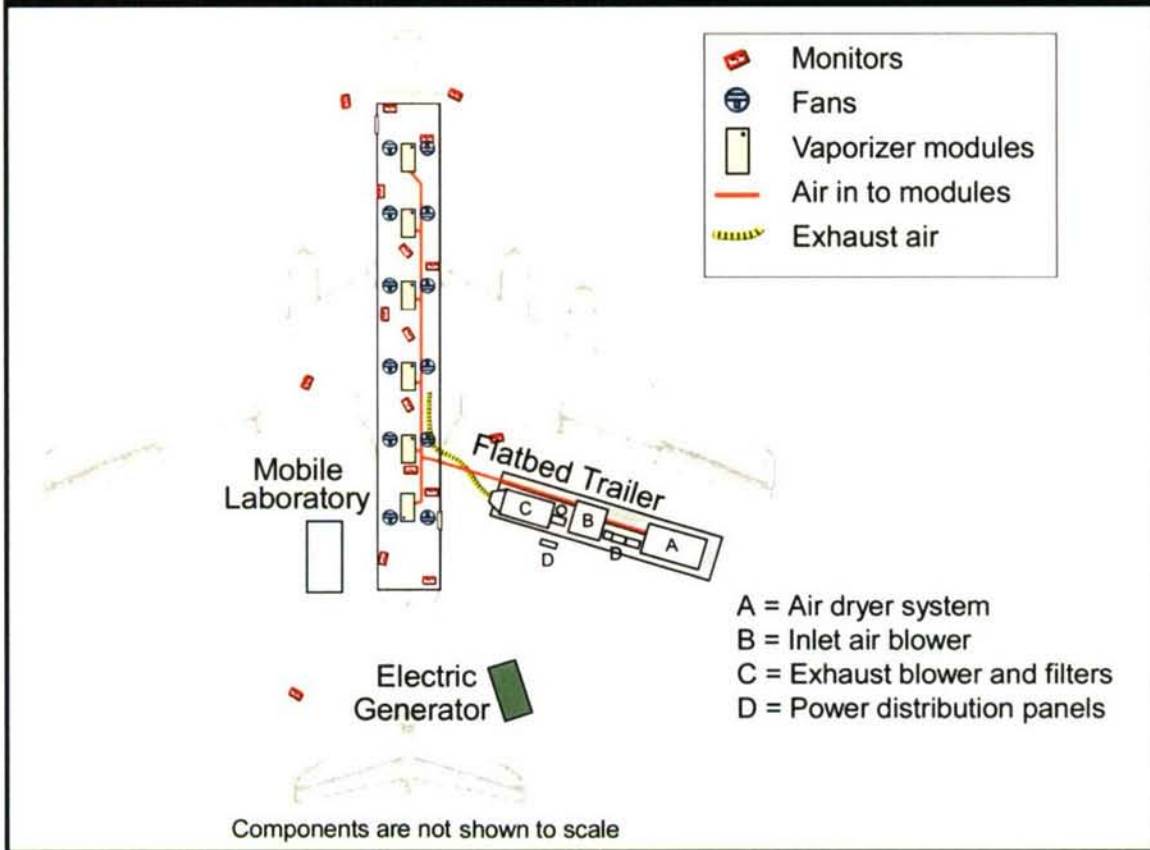
**Figure 3: Modular mVHP® System Components for C-141B Demonstration**

The modular mVHP system was used to deliver, distribute and monitor both the VHP and mVHP fumigants to the interior of the C-141B aircraft. The major mVHP system components and their orientation relative to the aircraft are presented in Figure 3 and are discussed in detail in Section 2.2. The decontamination results discussed in Section 3 demonstrate that the modular mVHP system can successfully decontaminate complex spaces such as a C-141B Starlifter aircraft cargo interior.

The modular mVHP system components include:

- Air handling system (air dryer and blower) – provides dehumidified process air to the vaporizer modules, ensuring that mVHP condensation will not occur.
- Ducting – delivers process air from the air handling system to each of the vaporizer modules, and exhausts interior air to the negative air system.
- Vaporizer modules – heat the process air, generate mVHP from hydrogen peroxide and ammonia solutions, control the fans, and provide process control and monitor data to and from the central control system.
- Vapor distribution fans – distribute mVHP throughout the interior space.
- Exhaust/Negative air system – draws air out of the interior space at a slightly higher flow rate than it enters, to prevent breach of containment. The air is filtered through a HEPA filter, catalyst bed and carbon filter before release into the environment.

- Control system – provides a single point of control for all modules and system components. The user interface enables the system operator to view sensor readings, set or modify process parameters, and monitor trends.
- Internal monitors – continuously monitor hydrogen peroxide concentration, ammonia concentration, temperature, and relative humidity throughout the interior space and provide real-time feedback to the central control system.
- External monitors – stand ready to trigger an alarm at the central control system, notifying the operator if hydrogen peroxide or ammonia levels above Permissible Exposure Limits (PEL) are detected outside the containment zone perimeter (i.e., containment failures are detected).

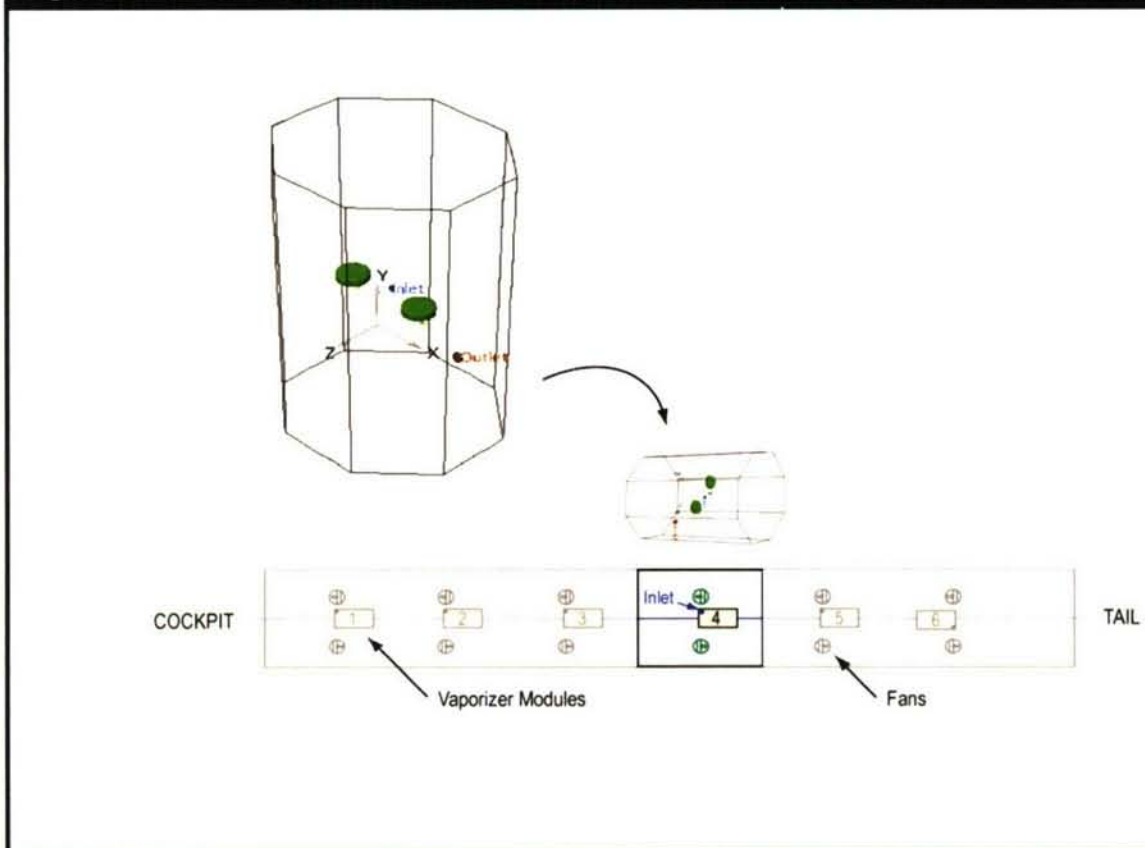
**Figure 4: Inlet, Outlet and Fan Placement within One Cargo Area Segment**

The vapor nozzle, inlet, of the vaporizer module was positioned near the center of the cross-sectional diameter at a location on the Z axis corresponding to 54 inches. The experience gained in the building decontamination demonstrations at APG suggested that the best distribution would be obtained by creating a circular flow pattern. A fan was positioned on each side of the vaporizer nozzle (X axis). The two fans associated with each module were positioned to move air in opposite directions to promote uniform fumigant concentration. The model did not account for gravitational effects (-Z axis) or the anti-gravitational orientation of the nozzle (+Z axis).

Based on experience gained from the building demonstrations, the model injection rate was set at 3 g/min  $\text{H}_2\text{O}_2$  with airflow of 133 cfm. The temperature of air within the enclosure was assumed to be 25 °C and the temperature of the inlet air was set at 95 °C (> 90 °C is required for vaporization).

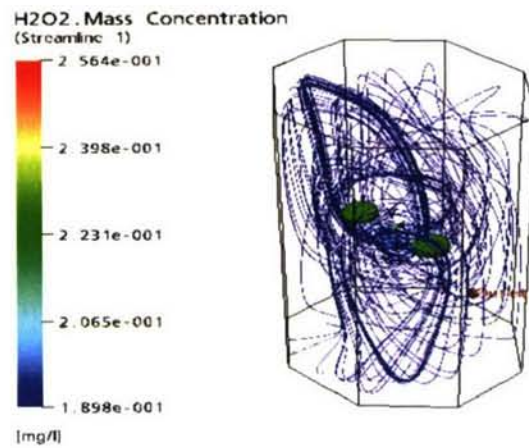
**Figure 5: Streamline Concentration Distribution (Top View)**

Although the model considered the cross-sectional ends of the segment to be closed, resulting streamlines were expected to be representational, as modeling conducted with two sets of fans showed that each pair set up its own convection cell, along with some cross-flow (Figure 5).

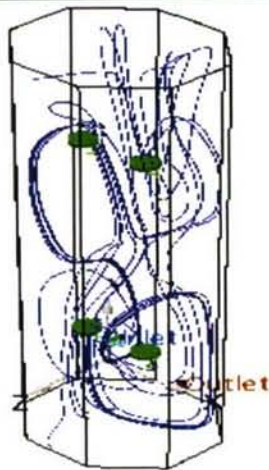
**Figure 6: Convection Cells for Two Sets of Fans**

For the single inlet, two fan configuration, predicted VHP concentrations at the walls of the cylinder, cargo hold surfaces, are indicated by concentration distribution plots (Figure 6).

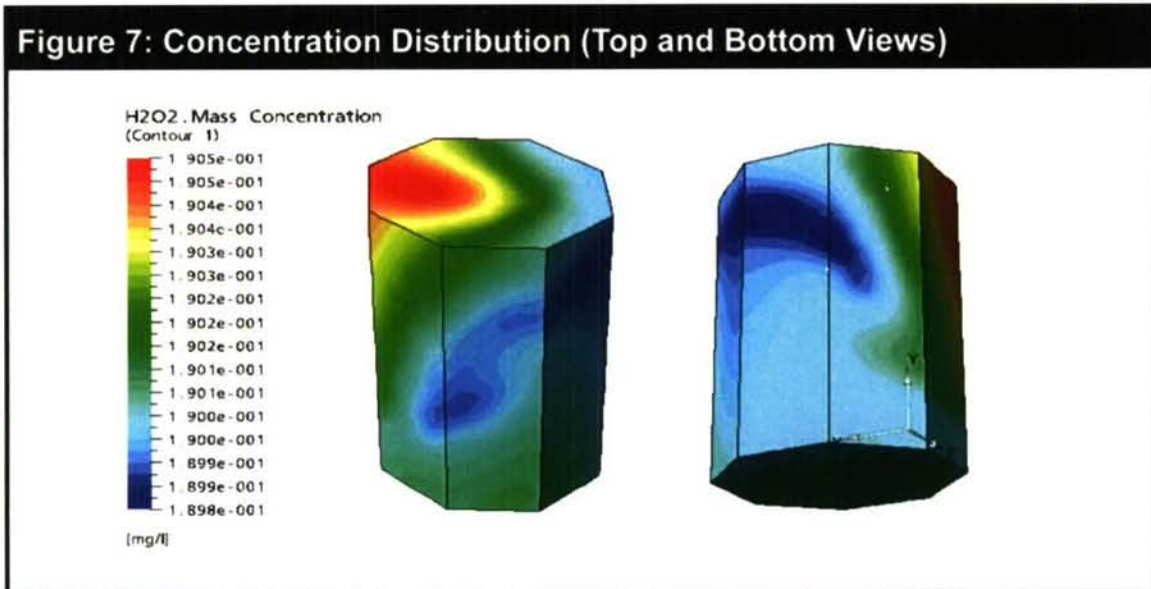
The difference between the maximum and minimum mass concentration presented in Figure 7 (1.905e-001 and 1.898e-001) illustrates that for this configuration and fan placement, the CFD model predicted complete mixing to within less than half a percent.

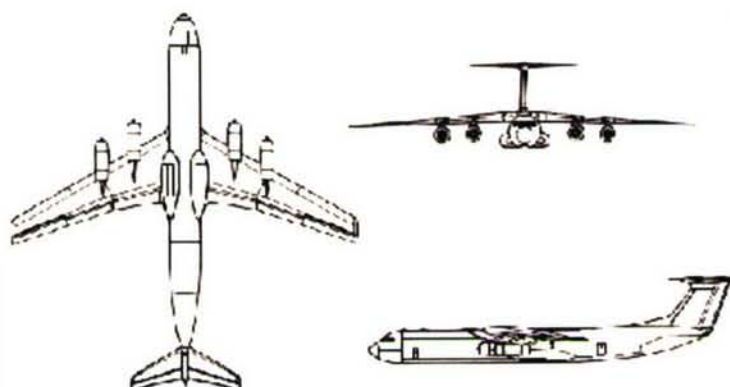
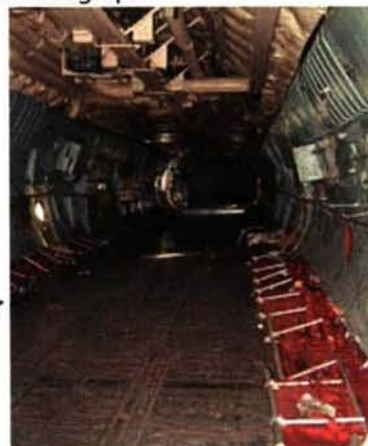
**Figure 8: C-141B Aircraft Cargo Area**

a) Schematic and Dimensions

b) Photograph

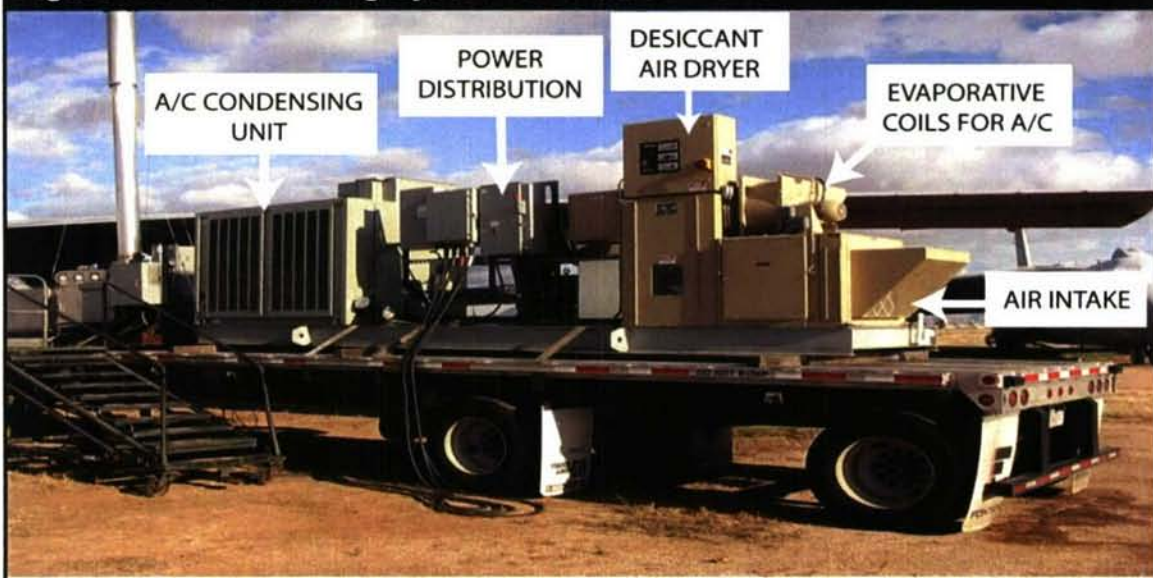
**Figure 10: Air Handling System on Flatbed Trailer**

The air handling system consists of an air dryer and a blower (Figure 10). The air dryer, a Trane air conditioning unit and a Munters industrial desiccant dehumidifier, removed the majority of the water vapor from the incoming air throughout the decontamination process. The Sonic Air System 350 blower provided forced air circulation. An anemometer, located downstream of the main blower, measured and recorded the airflow generated by the mVHP system. The location of the blower is depicted in Figure 12.

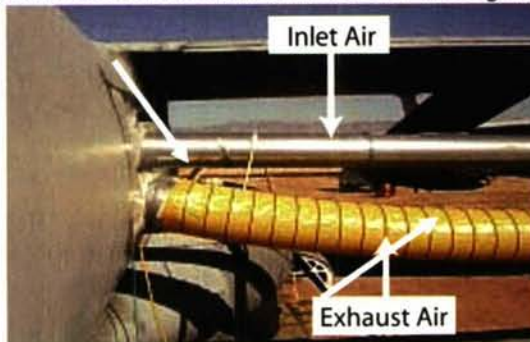
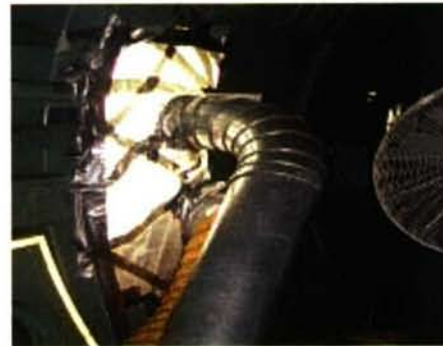
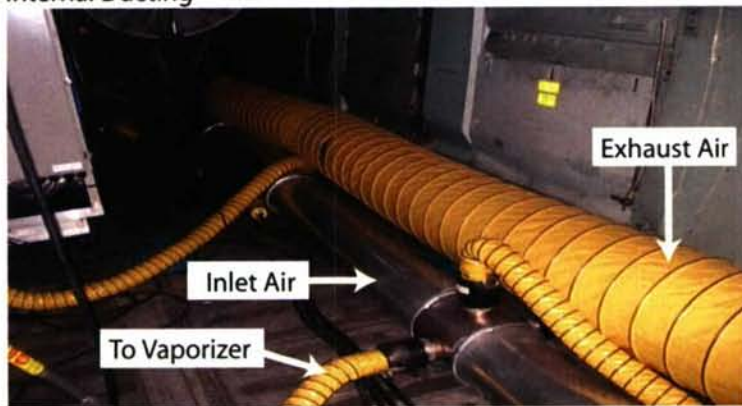
**Figure 11: Ducting**

Modular rigid and flexible ducting provided the capability to tailor the air handling system to a wide variety of interior configurations (Figure 11a). Dehumidified air was delivered from the air handling system into the aircraft through a galvanized steel duct. As illustrated in Figure 11b, flexible ducting inside the aircraft was used for both the exhaust system and for delivering conditioned air to each vaporizer module.

a) Air Inlet and Exhaust Manifold Pass-Throughs

b) Internal Ducting

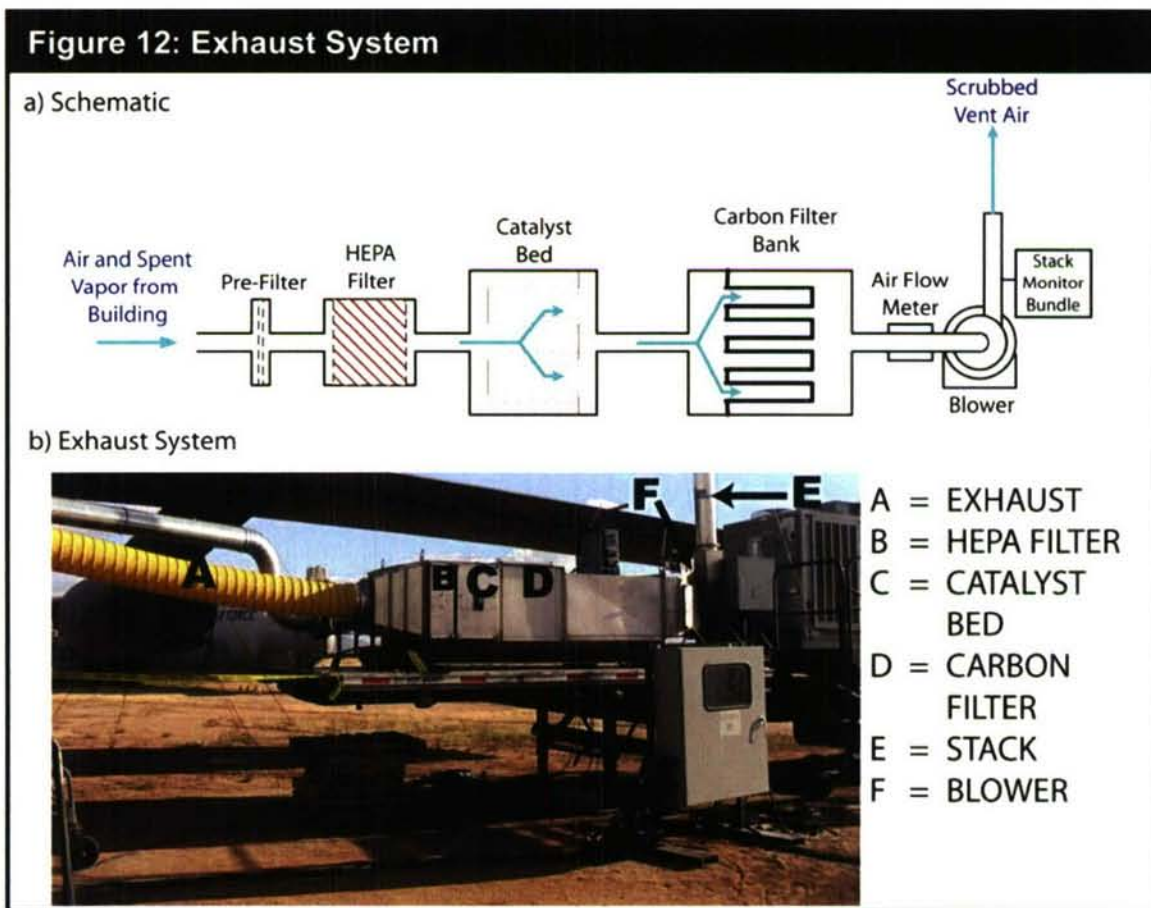
Spent vapor was exhausted from a central location within the aircraft through the flexible ducting. The blower attached to the exhaust unit drew air from the aircraft at a slightly higher flow rate than the air entering the aircraft via the air handling unit. Maintaining negative pressure inside the aircraft ensured the containment of the VHP/mVHP fumigant, even when the aircraft was not fully sealed (during the 24-hr VHP run, air flowed into the aircraft through leaks at the tail).

Spent vapor passed through a high efficiency particulate air filter for microbial retention prior to exhausting the air. Any remaining hydrogen peroxide was reduced to water and oxygen during passage through a palladium/platinum catalyst bed, and a carbon filter removed ammonia from the exhaust stream before it was vented through the stack (Figure 12). A control system warning alarm was set to trigger if hydrogen peroxide, ammonia, or the chemical agent simulant were detected at levels above the permissible exposure limits (PEL) in the stack.

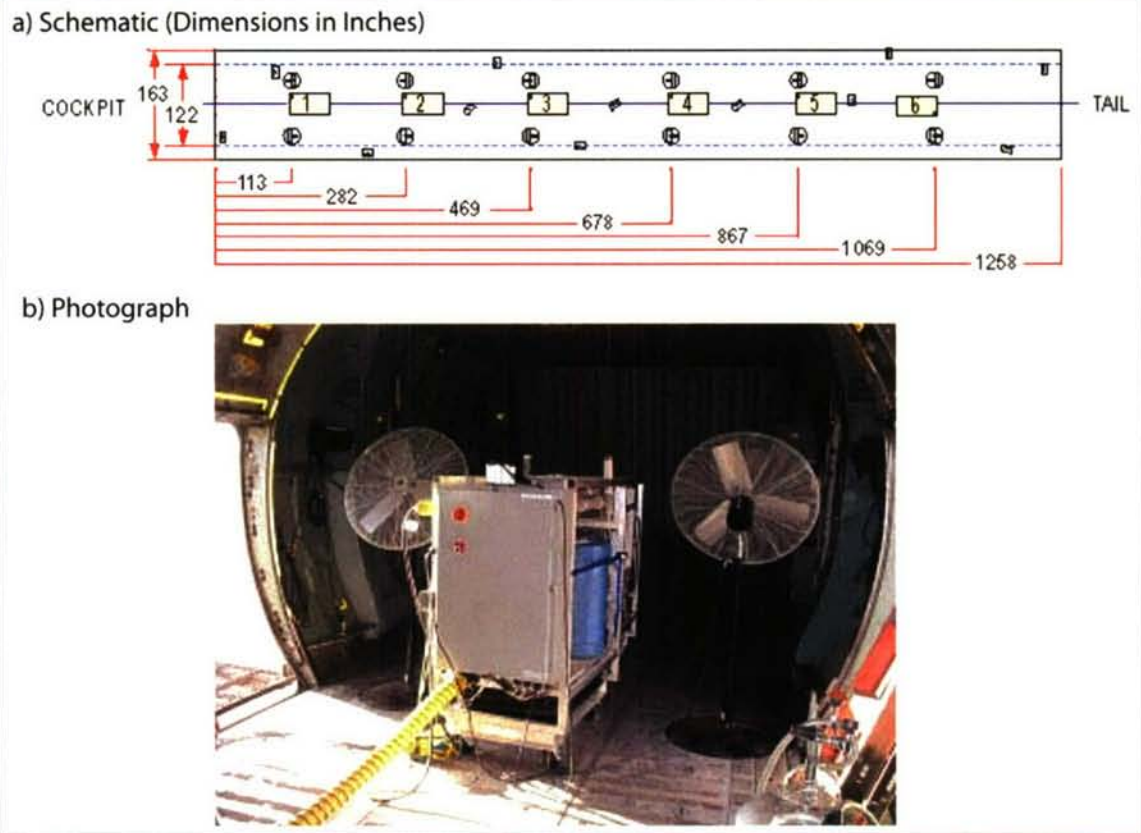
**Figure 13: Vaporizer Module and Fan Placement**

Six vaporizer modules were positioned along the length of the cargo bay, approximately centered along the longitudinal axis (Figure 13a). When the 24-hr VHP run showed low vapor concentration at the tail of the aircraft due to air leakage around the aft cargo door, the problem was successfully corrected by moving units five and six and boosting the unit injection rates. For the 5- and 10.5-hr VHP runs and the 24-hr mVHP run, the vaporizer locations were as follows: Vaporizer 5 was taken offline, monitors 5A and 5B were attached to Vaporizer 6, and monitors 6A and 6B were attached to Vaporizer 7. The new designations in the tables are Vaporizers 6\* and 7\*. The new configuration relocated the two vaporizers toward the rear of the aircraft to counteract the dilution of the incoming air. Moving a vaporizer unit further aft than 1069 in. was not possible because the loading ramp sloped at a sharp angle (Figure 16).

Each vaporizer module controlled two high capacity (~7000 cfm) floor fans that distributed the mVHP vapor throughout the interior. The fans were a special build (230-V motors were employed to provide compatibility with the power distribution systems of the modules) manufactured by Marley Engineered Products.

The vaporizers were relocated to meet the challenge of the aircraft tail space. Vaporizer modules five and six were relocated closer to the tail of the aircraft to counter aircraft leakage and maintain target fumigant concentration.

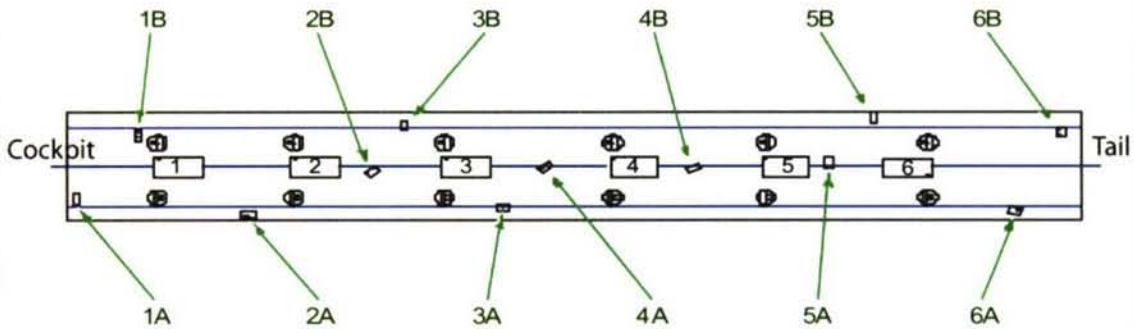
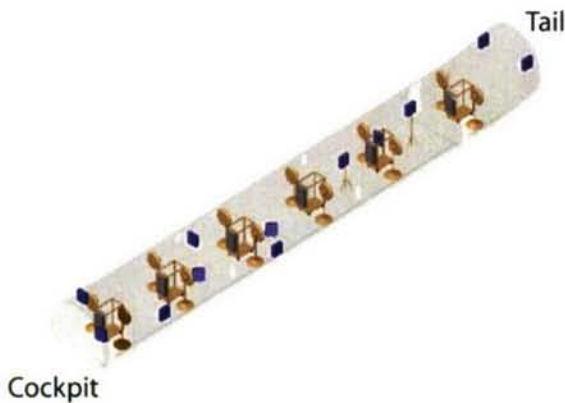
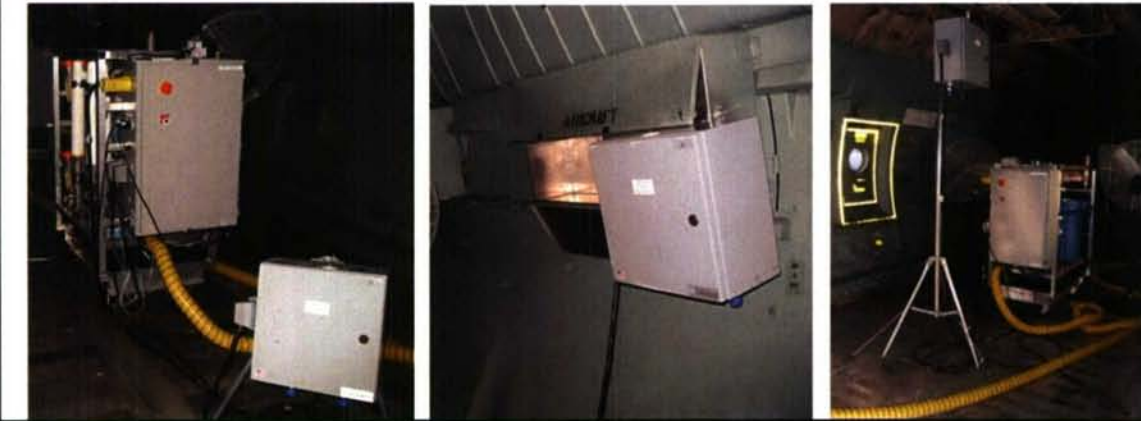
**Figure 14: Internal Monitor Placement**

Internal and external monitors provided continuous feedback to the control system regarding the measured temperature,  $\text{H}_2\text{O}_2$  concentration (ppm),  $\text{NH}_3$  concentration (ppm), and relative humidity. Tracking vapor concentration and water saturation prevented conditions where condensation could occur, and the VHP/mVHP injection rate was accordingly adjusted. This ensured that vapor concentration was steadily maintained at the target concentration level throughout the duration of a decontamination run.

The water vapor sensors, manufactured by Vaisala, were packed with manganese oxide ( $\text{MnO}_2$ ) catalyst to protect the sensing element from cross sensitivity to the hydrogen peroxide vapor. The temperature within the aircraft was measured using stainless steel-sheathed platinum resistance temperature devices.

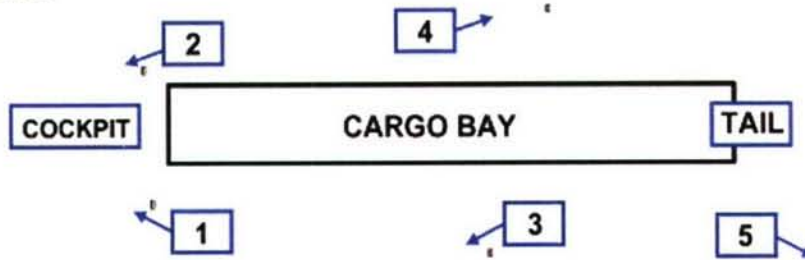
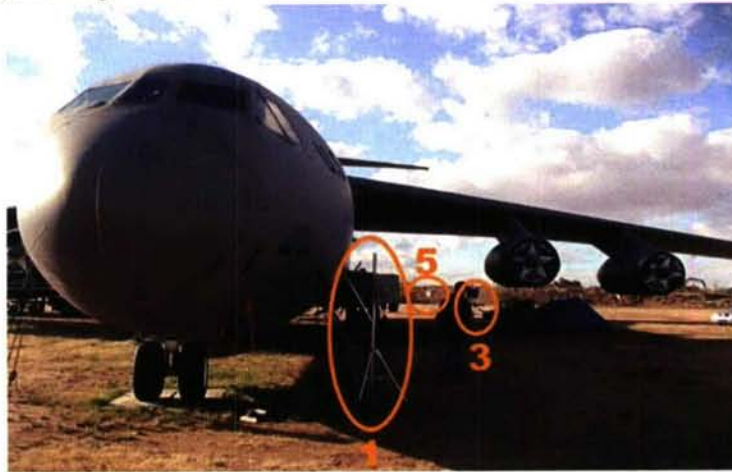
**Figure 15: External Monitor Placements**

Five external monitors were placed around the perimeter of the aircraft to ensure that decontaminant levels remained below PEL (Figure 15a). Figure 15b depicts monitor one positioned near the cockpit of the aircraft. Monitors three and five can be seen in the distance. ATI and A12 sensors were used for tracking both VHP and ammonia during each phase of the decontamination process. Alarms were set to trigger at the PEL for either component of the VHP/mVHP fumigant: 50 PPM for  $\text{NH}_3$ , 1 ppm for  $\text{H}_2\text{O}_2$

b) Photograph, Showing Monitor 1 and Monitors 3 and 5 in distance

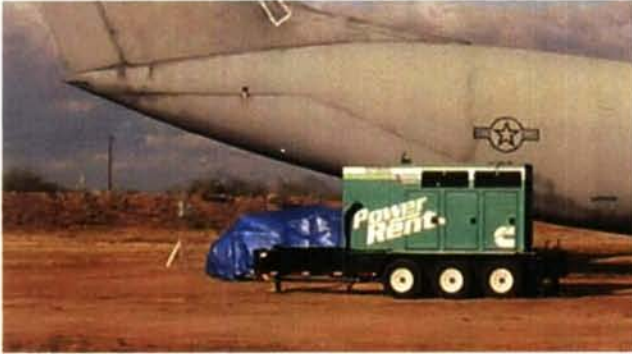
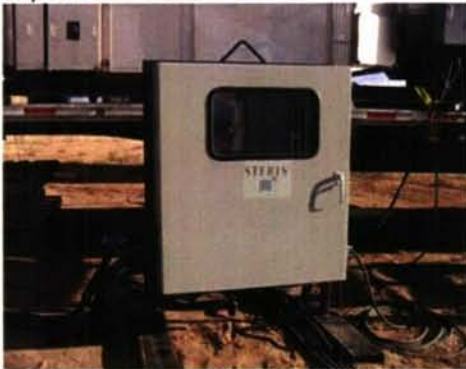
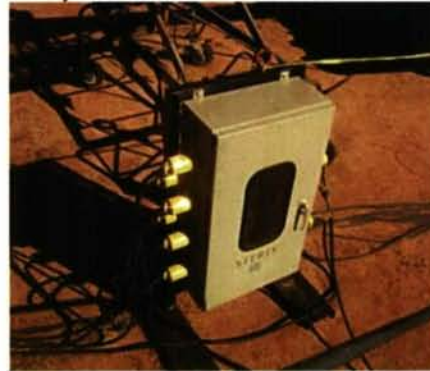
**Figure 16: Electrical Generator and Power Distribution Panels**

Power for the mVHP system was supplied by a 230-V, 3-phase, 250-kW mobile electrical generator located external to the aircraft (Figure 16a). All connections to the generator were weatherproof. A power distribution module supplied power to the air handling system and exhaust unit (Figure 16b). A second power distribution module routed power from the generator to the vaporizer modules inside the aircraft (Figure 16c). Circuit breakers on both power distribution modules were rated for each component. The generator also provided power to the office trailer, the mobile chemical laboratory, and the floodlights.

a) Electrical Generator

b) Power Distribution Panel to Vaporizer Modules

c) Power Distribution Panel to Air System and Exhaust

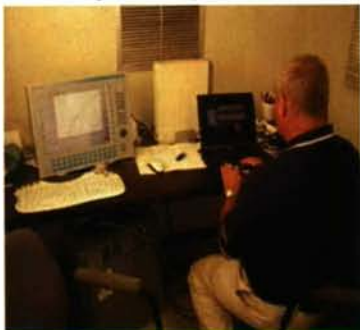
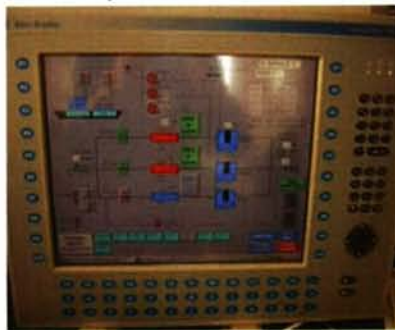
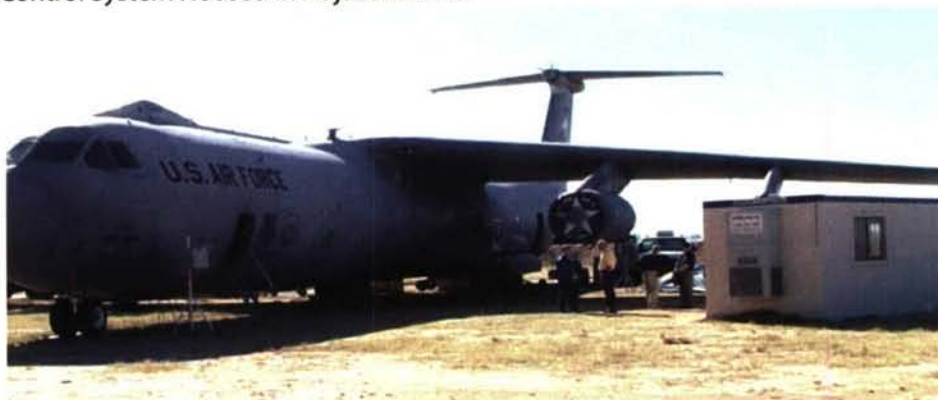
**Figure 17: Integrated Control System**

The control system (Figure 17a,b) was located adjacent to the aircraft in a climate controlled rented office trailer (Figure 17c). All the components of the control system operated under a single controller. The control system monitor displayed and recorded all monitored process variables, which enabled real-time adjustment during the process and the detailed analysis conducted following the process.

- Air flow rates through the air handling and exhaust units;
- Hydrogen peroxide and ammonia concentrations;
- Relative humidity readings accumulated at the aircraft interior monitors; and
- Temperature of the vaporizer module heaters.

Although the decontamination process was automated, the system operator could monitor and adjust conditions within different areas of the aircraft interior; activate or deactivate individual components; and adjust settings at any point during the process.

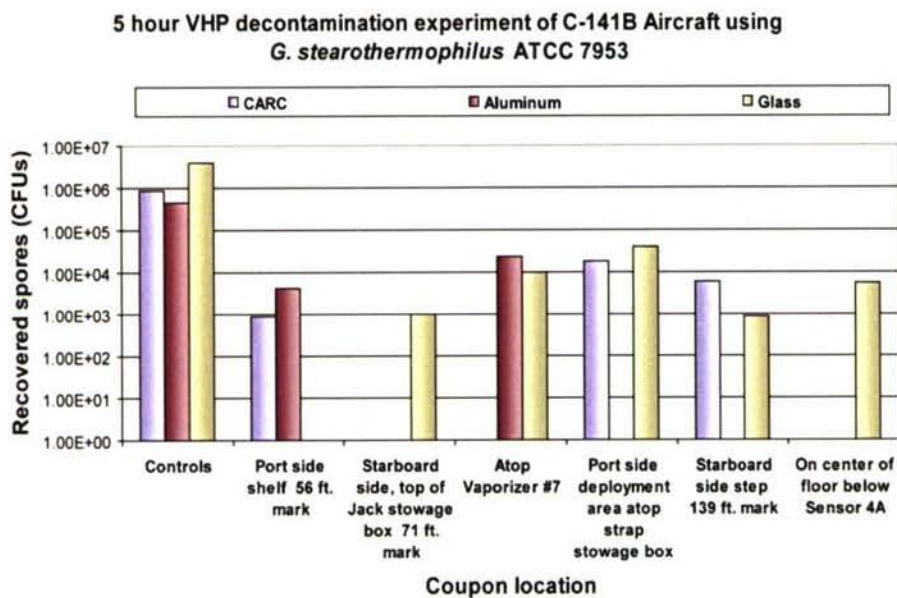
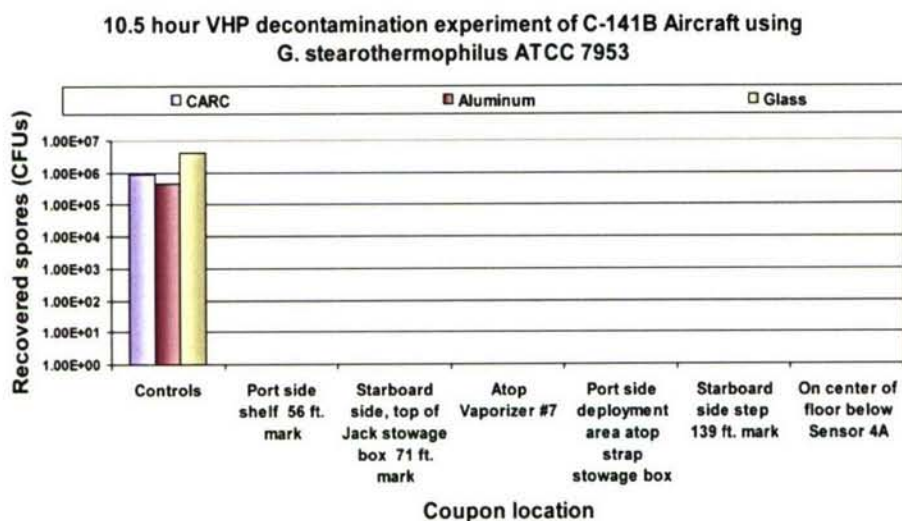
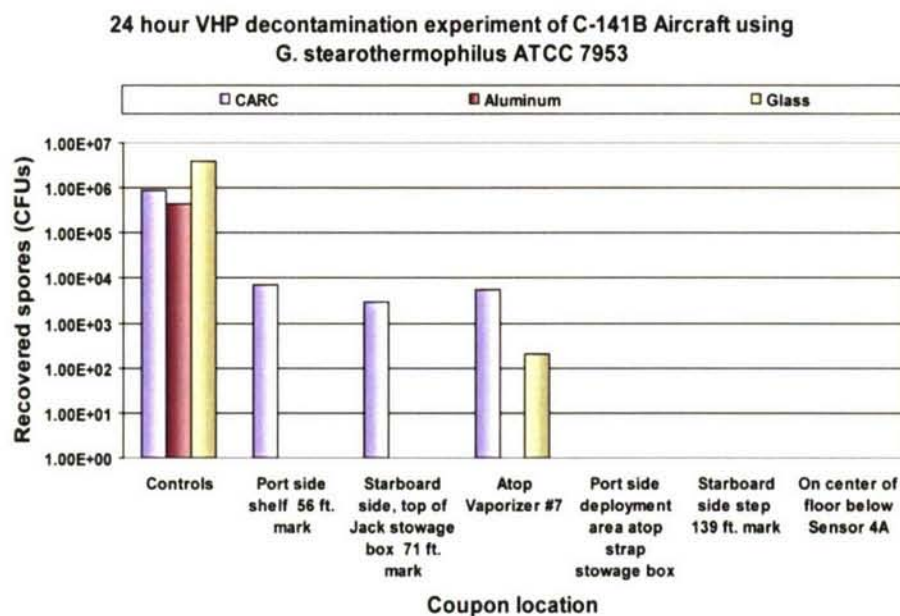
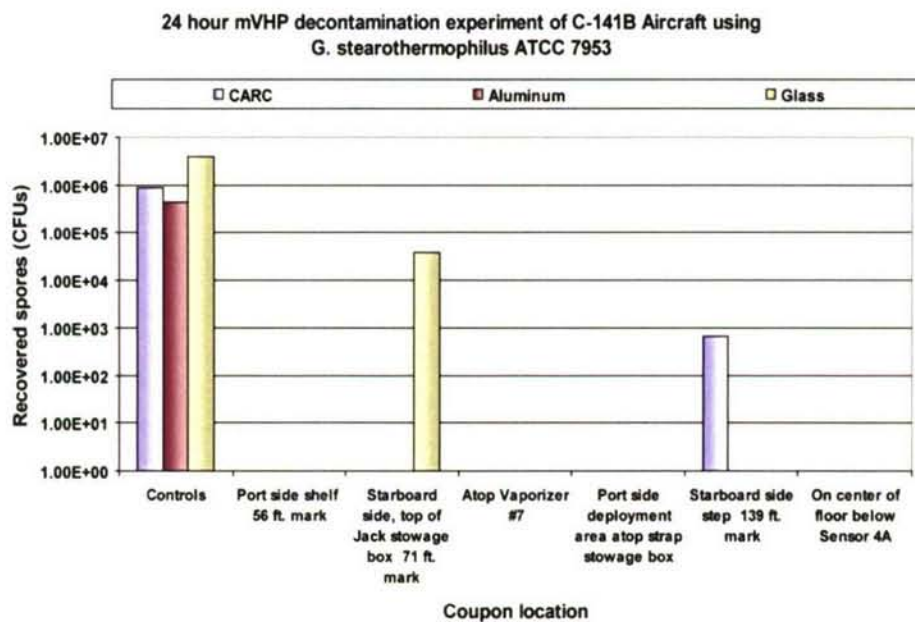
**Figure 18: *G. stearotherophilus* ATCC 7953VHP Exposure Test Results**

**a) 5-Hour VHP Decontamination Experiment**

**b) 10.5-Hour VHP Decontamination Experiment**

c) 24-Hour VHP Decontamination Experiment

d) 24-Hour mVHP Decontamination Experiment

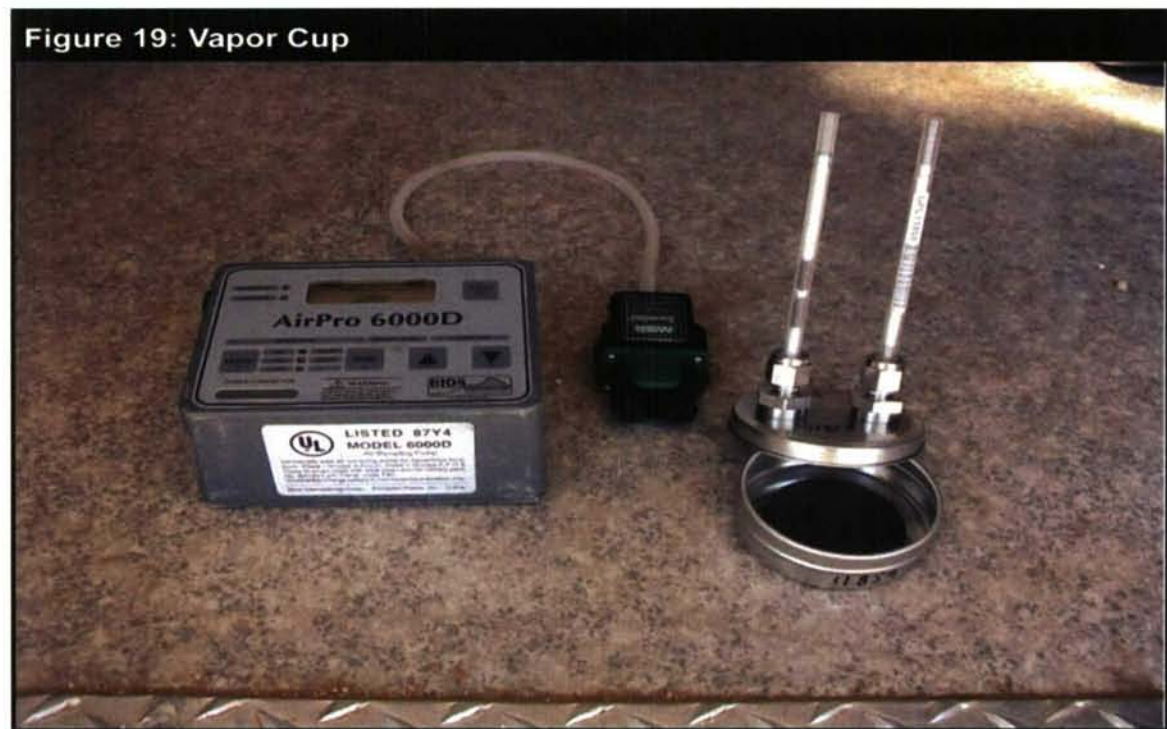
Vapor cups were prepared for residual chemical agent surrogate analysis of the decontaminated coupons. The cups, fashioned from seamless tin cans with lids (3-in. diameter x 1-in. height), were purchased from McMaster-Carr. Two 7/16-in. holes were punched in each lid to accept two stainless steel, ¼-inch fitting, male bulkhead Swagelok® connectors obtained from the Baltimore Valve Company. A ¼-in. Teflon® furrell was inserted into each fitting to accept a depot area air monitoring system (DAAMS) tube at one end of the cup and a charcoal filter at the other (Figure 19).

The coupons were removed from the aircraft following the indicated decontamination period and immediately placed in the vapor cups for analysis. Vacuum lines were instantly connected to the exit ports and the timed cup evacuation was started. Ambient air, conditioned through a charcoal (BPL 30 to 40 mesh) trap, was forced into the cups and made to flow at a pre-set rate of 80 mL/min. The air stream leaving the cup exited through a DAAMS tube to absorb any CEPS that off-gassed (volatilized) from the test coupon. Each sample period lasted 60 min to yield a total volume of air at 4,800 cm<sup>3</sup>. The DAAMS tubes were then removed and stored in capped glass containers until analyzed.

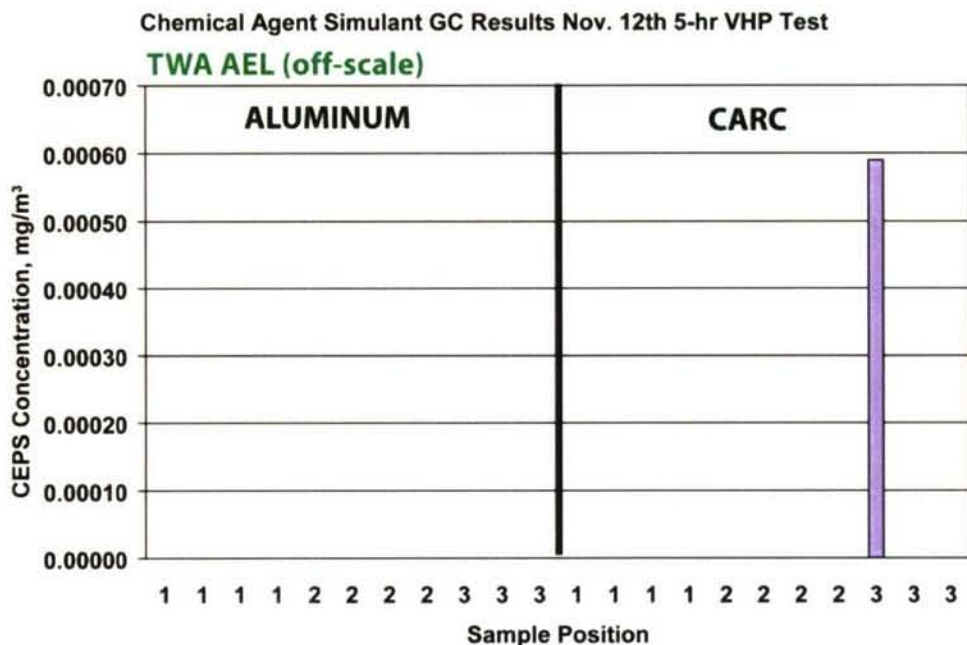
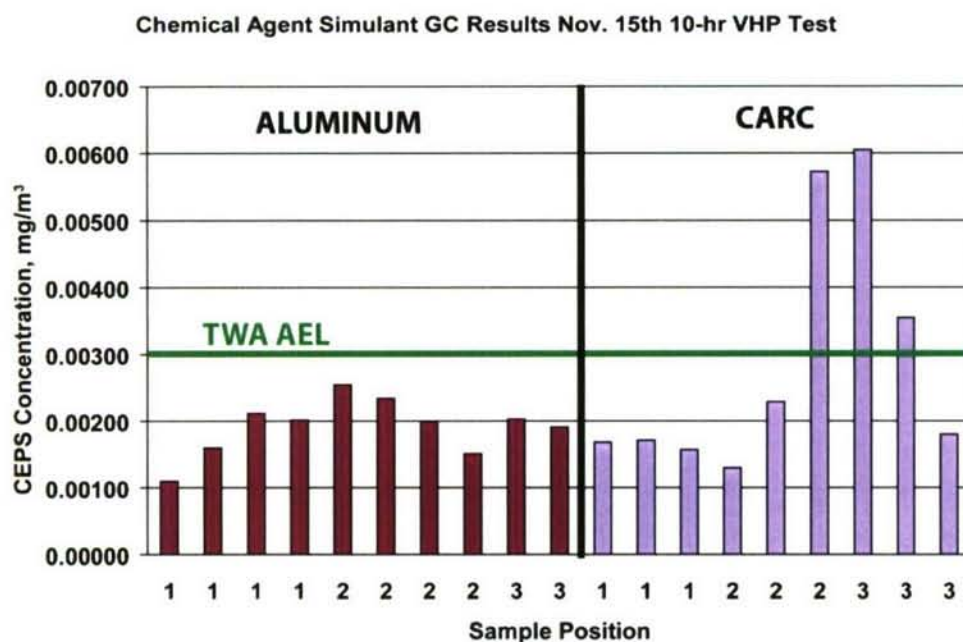
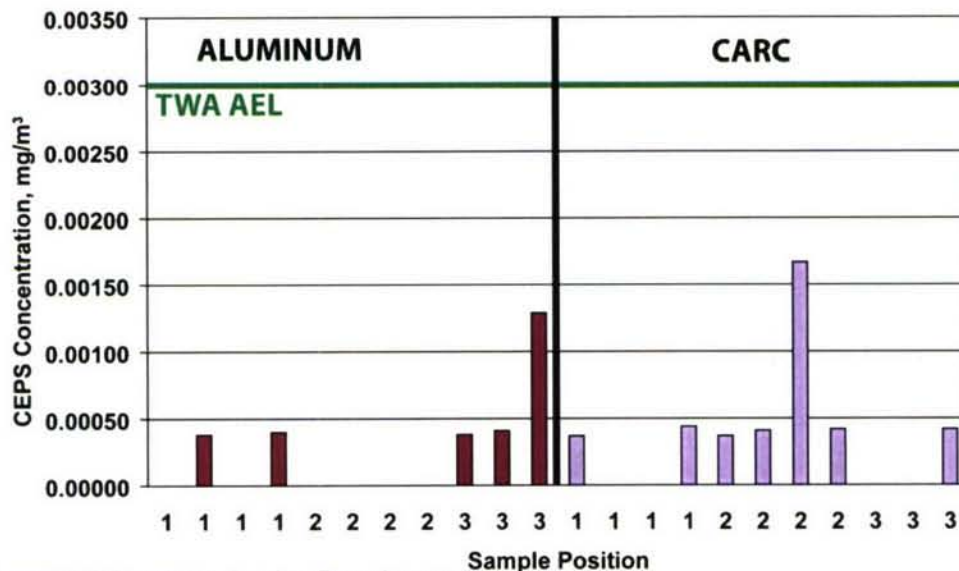
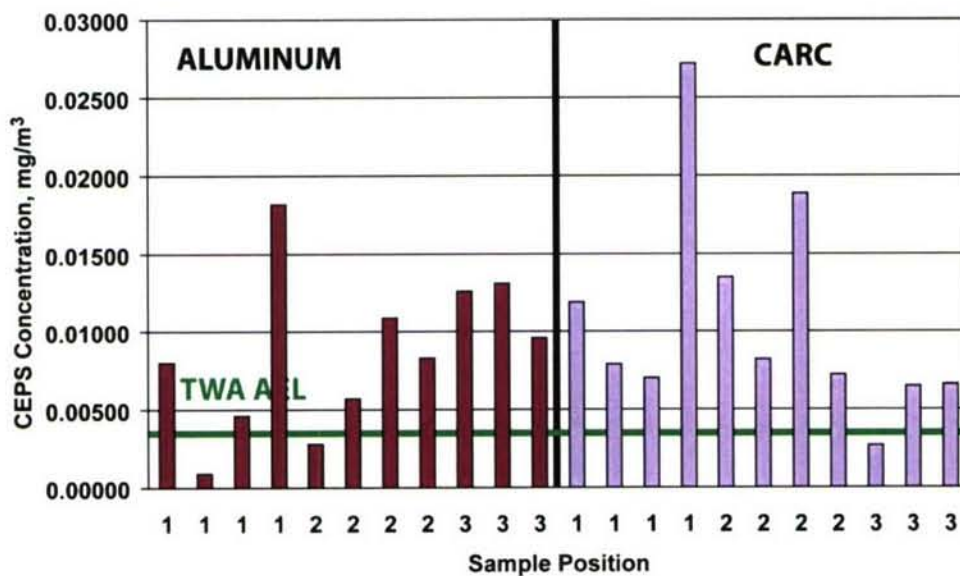
**Figure 20: Chemical Agent Simulant GC Test Results**

a) 5-Hour VHP Decontamination Experiment

b) 10.5-Hour VHP Decontamination Experiment

c) 24-Hour VHP Decontamination Experiment

d) 24-Hour mVHP Decontamination Experiment

The post-decontamination CEPS vapor hazard was measured for each coupon. The results are compared against the one TWA vapor hazard value for HD. The one TWA HD vapor hazard value is 0.003 mg/m<sup>3</sup>. The results from the 5-hr VHP test, Table 10 and Figure 23, illustrate that CEPS was not detected on any of the surfaces except for one CARC replicate located at location three. The CEPS results are below the corresponding one TWA for HD.

The masses and concentrations of CEPS detected in the 10.5-hr (Table 8) and second 24-hr (Table 9) runs are inconsistent in the 5-hr (Table 7) with the first 24-hr VHP run (Table 6). The results of both the first 24-hr test and the 5-hr test indicated that the concentrations of CEPS were below the detectable concentration limit on all substrates and sample locations. This discrepancy can be explained from the preparation of the vapor cup set-up. The cans used to fashion the vapor cups and Swagelok® connectors employed during the first two tests were never used prior to the test. During the 10.5-hr and second 24-hr test, the connectors were re-used. An attempt was made to clean each of the connectors in the field using acetone and then baking them in the GC oven over night at 120<sup>0</sup>C. Unfortunately, the issue with cross-contamination was not discovered until well into the analysis of the second 24-hr test, due to a lag time required to analyze all of the DAAMS tubes.

Once this issue was discovered a blank was run to determine if in fact cross-contamination could occur with re-using the connectors. Three connectors were selected at random and then cleaned using a procedure similar to that was for cleaning and re-using connectors during the test. The connectors were washing 2X in acetone and dried in the GC over overnight at 120 °C. Attached to a new vapor can and 1-hr air sample was pulled through the DAAMS tube and then analyzed. Small amounts of CEPS were detected.
