# EDGEWOOD

ECBC-TR-510

**VAPOROUS HYDROGEN PEROXIDE (VHP) DECONTAMINATION  
OF A C-141B STARLIFTER AIRCRAFT:  
VALIDATION OF VHP AND MODIFIED VHP (mVHP)  
FUMIGATION DECONTAMINATION PROCESS  
VIA VHP-SENSOR, BIOLOGICAL INDICATOR, AND  
HD SIMULANT IN A LARGE-SCALE ENVIRONMENT**

March 2007

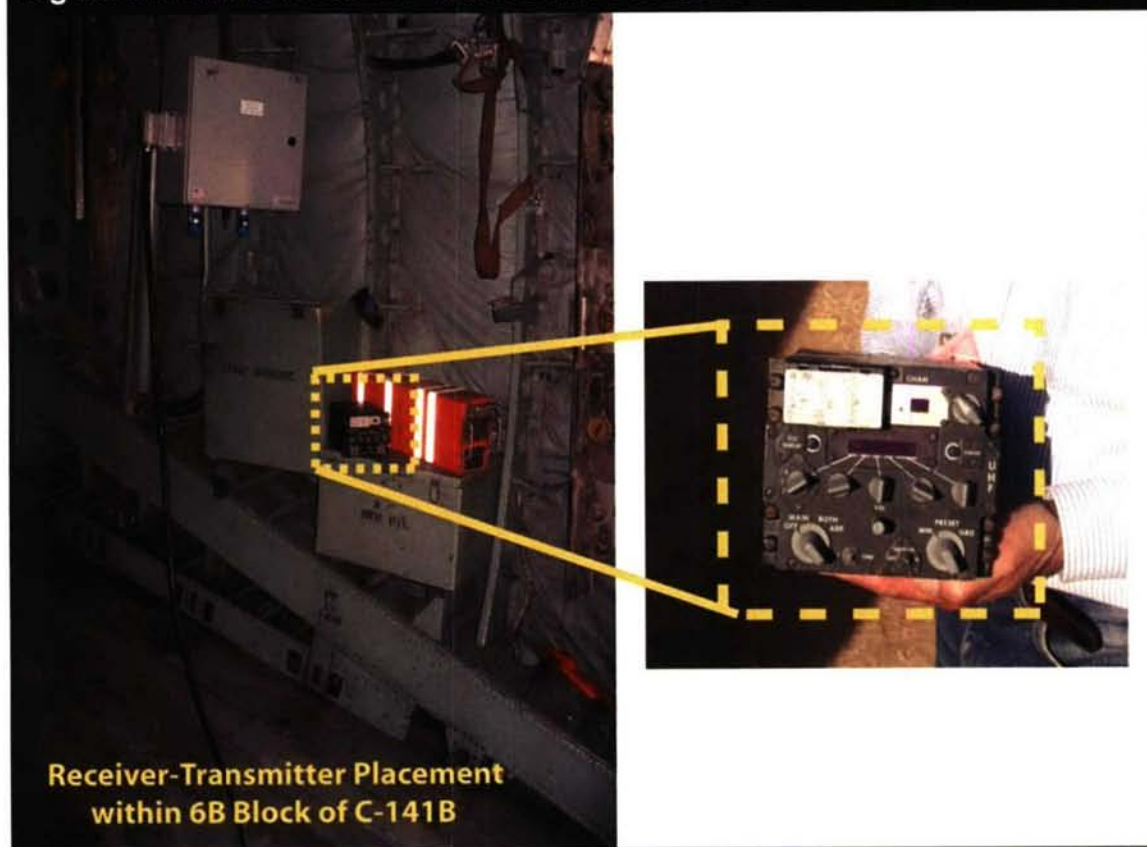
**Figure 21: Radio Receiver-Transmitter Placement**

A new PC desktop computer and a Web Cam were exposed to mVHP for 34 hr to test sensitive equipment compatibility to mVHP. The computer and Web Cam were powered and running during testing. A new digital camera received 10 hr of exposure. A radio receiver-transmitter was placed in the tail section of the aircraft near Internal Monitor 6B during the 5-, 10.5-, and 24-hr runs (Figure 21). The transmitter was fully operational during the test runs. Preliminary sensitive equipment fumigant compatibility results demonstrated that no decontamination process adverse effects from the VHP/mVHP exposure were experienced. In addition, there was no loss of preexisting electronic data and each test article functioned before and after fumigant exposure.

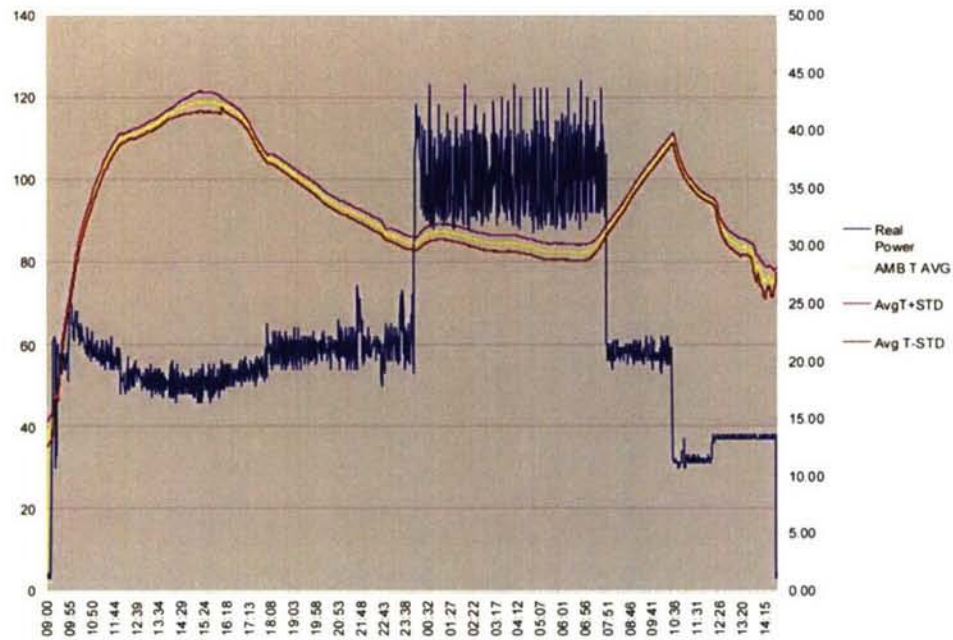
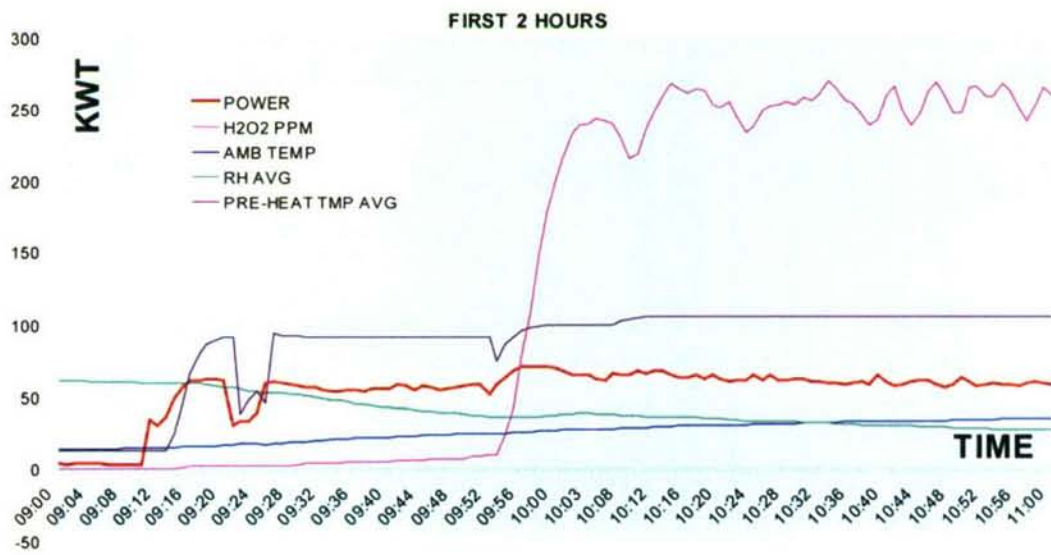
Figure 22: Power Consumption

a) 24-Hour VHP Decontamination Experiment Temperature and Power Consumption

b) Initial Conditioning Phase of 24-Hour Run

The 24-hr mVHP run showed approximately four times the power consumption of the 5-hr run. This was probably due to the predominance of the heaters in power consumption. About 6 hr of the Nov. 12 run required heaters, compared to the 25 hr required by the Nov. 16-17 run. The power consumption during the aeration phase of both runs was of comparable length as only the blowers were activated then. Another factor in the 24-hr mVHP run was the low nighttime temperature, which required more heat input to maintain the necessary conditions to prevent vapor condensation. To increase heat generation, the heater of the desiccant dryer in the dehumidification system was activated between midnight and 8 AM. The heater required an additional 50 kW of power (Figure 24a, blue trace). The temperature inside the aircraft during the run was calculated as the average of the 12 sensors distributed throughout the interior (Figure 24a, yellow trace, with standard deviation indicated). The high at approximately 4 PM on Nov. 16 matches the external temperature high as recorded by the National Weather Service, and to a correspondingly lower power requirement from the system heaters. Once the pre-heaters reached maximum capacity, power consumption remained steady at just under 60 kW. However, since the temperature continued to fall during the night, the supplemental desiccant heater was in constant use.

Power consumption of individual system components was determined during the dehumidification and conditioning phases as the components were activated sequentially. The results for the 24-hr run conditioning phase are provided in Table 16.
