**A SYSTEMS ENGINEERING PROCESS
FOR AN INTEGRATED STRUCTURAL
HEALTH MONITORING SYSTEM**

THESIS

AFIT/GSE/ENY/07-M02

AIR FORCE INSTITUTE OF TECHNOLOGY

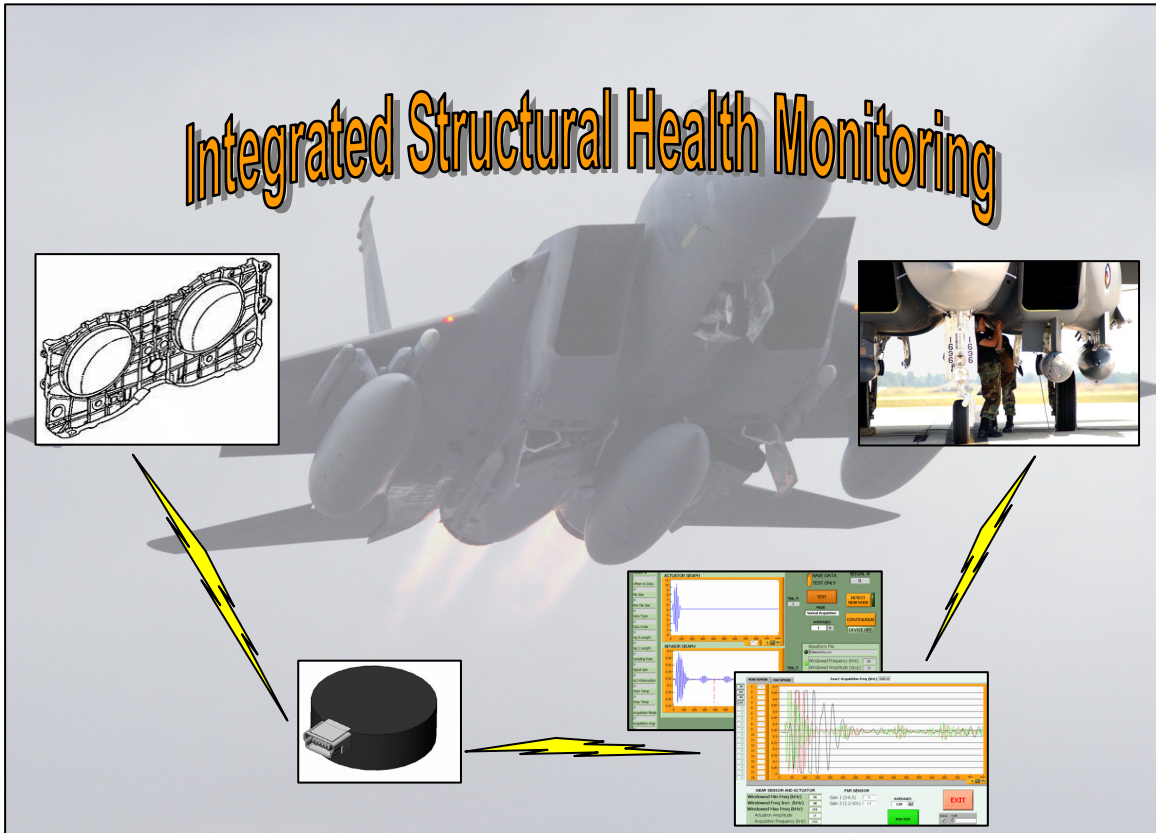
Figure 3.3: OV-1 Architecture

lightning bolts represent a generic form of interaction. The sensor then sends its data to a software program shown on the bottom right and the software is then used to generate maintenance action. Finally, on the far right side of the diagram, maintainers are performing the recommended action on the aircraft.

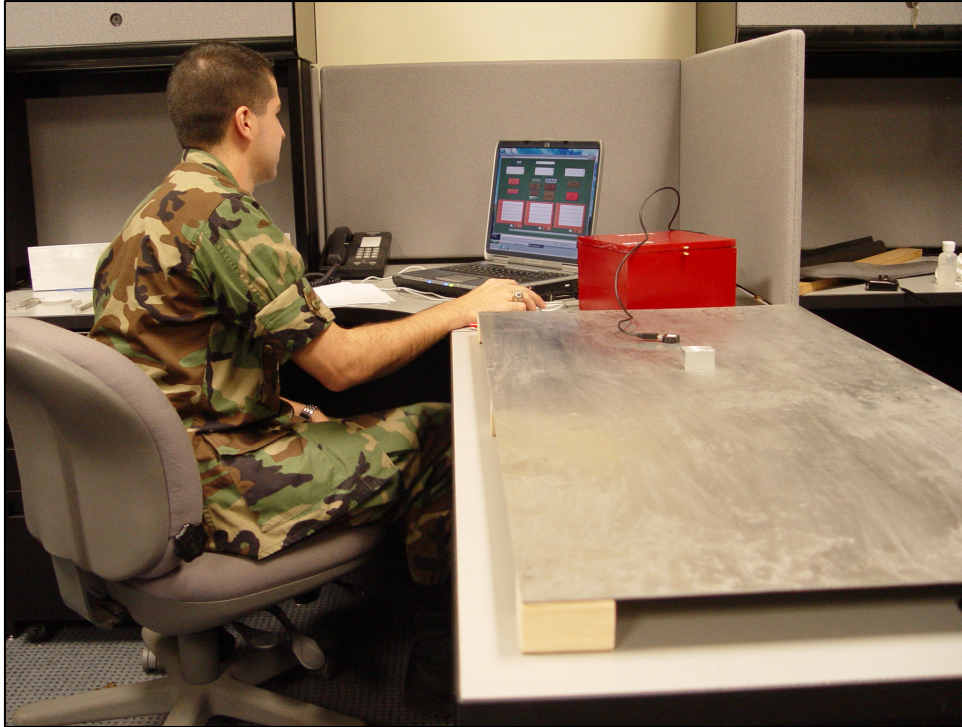
Figure 3.18: Picture showing the laboratory setup of the test plate

These sensors would be used for the pitch-catch method of testing. Again, damage would be simulated between the sensors, eventually progressing to actual damage as the technology is understood further. Now that the thesis group had chosen a sensor suite, the next step was to design the data collection device. Due to the requirements imposed on the data collection device, the group simply needed a laptop with a USB port and sufficient storage capacity. Finally, a software package would need to be designed for the system. One of the benefits of choosing this specific sensor was that the manufacturer had also developed a software package. This software package was able to read the data from the sensors and display it on the screen. It also saved the data in an array, making it easy to manipulate. The only portion of the software that needed to be designed further was the analysis package. The software that came with the sensors had no capability to input multiple signals from different tests for comparison. Capt Steve Crider had been working with these sensors on some different tests and had developed a Matlab code that would read in data files from a healthy and damaged specimen and display them simultaneously. It would also display a difference plot that was useful in determining where the damage was located. His software also allowed you to input the location on the plate that was damaged, and it would predict where the major differences would appear. Through data sharing and cooperation, the thesis group was able to use his code to generate test results in exchange for the thesis group running multiple tests for him to use. The entire lab setup is shown in figure 3.18

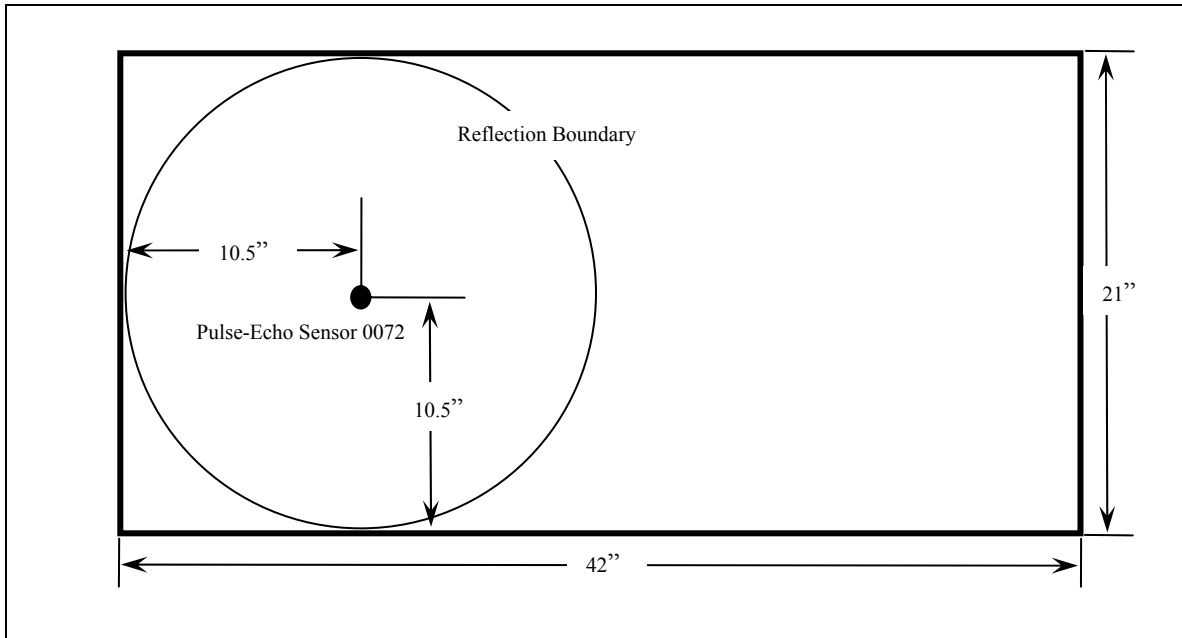
Figure 4.5: Large Plate with First Generation Sensor Installed

purposes of testing, the plate was divided into two areas, separated by what is referred to as the “reflection boundary” (see figure 4.5). This boundary was defined by a circle, centered on the sensor that extends to the 3 nearest edges of the plate.

Damage that occurs inside the reflection boundary will produce a reflection that should be observed before the first primary edge returns, and should produce attenuation effects within the primary edge return. Damage outside the reflection boundary should have no observable effect on the primary edge returns (or the secondary edge returns depending on the location of the damage). This result was important because it gave us a clue as to whether damage could be identified in a return signal from a more complicated structure, with multiple sources of reflections and interference. The final case occurs when the damage lies on the reflection boundary (or some whole number multiple of the reflection boundary distance) which will only generate a change in the edge returns. The group’s initial test runs involved taking multiple sets of baseline data with the clean plate,

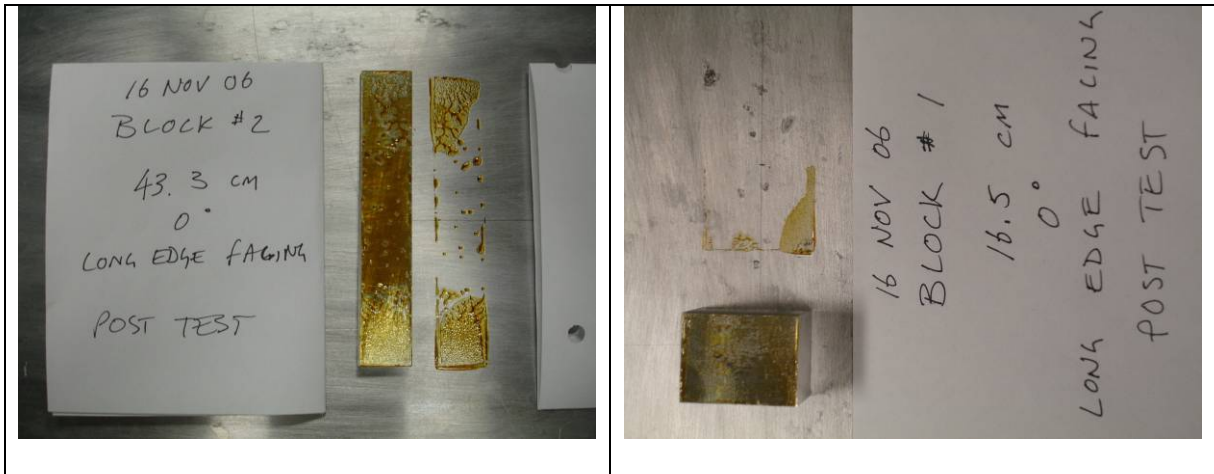
Figure 4.6: Post-Test Pictures Showing Partial Contact of Damage Blocks

blocks. This effect was first seen in some of the post-test pictures taken of the damage blocks after they had been removed (see figure 4.6).

The pattern of the shear gel on the plate gave the group a clear indication that the blocks were not making uniform contact with the plate, especially when they were placed along the center axis of the plate. After considering the problem, the group decided to address the problem by modifying the damage position. To address the contact issue, the group conducted a series of tests at different locations and orientations on the plate to minimize the effects of the sagging plate. In addition, a selection of steel blocks was obtained in order to increase the magnitude of the simulated damage by simply increasing the magnitude of the local change in stiffness of the plate. Although both of these changes produced the desired effects, the data plots generated using Capt. Crider's program did not show any significant improvement. At this point, the group had been resigned to the possibility that the first generation sensor simply did not have enough output capability to "see" damage in this large plate. The next step was to begin actually damaging the plate. Due to the groups' suspicions that the sensor might lack the output

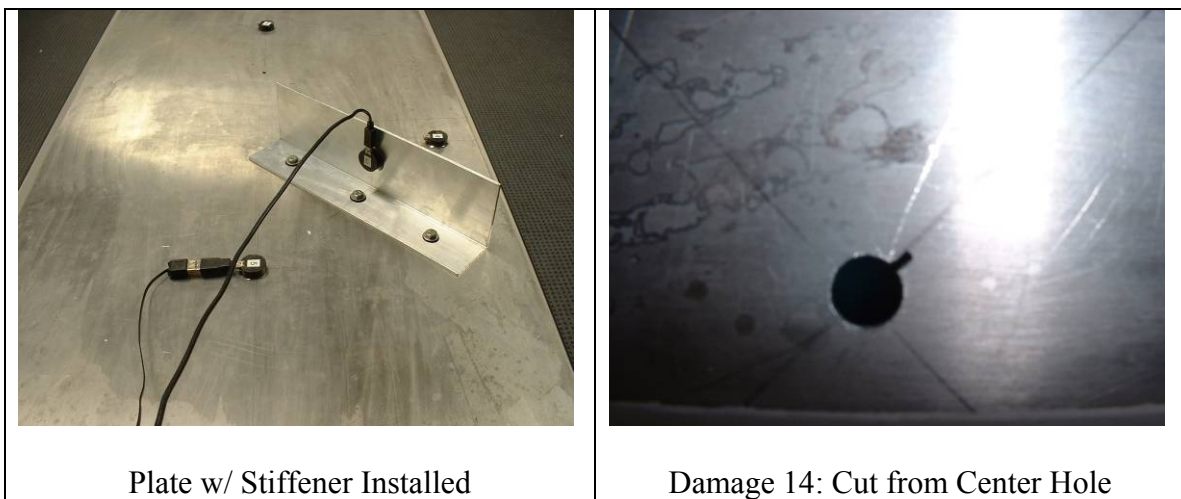
Figure 4.12: Damage Testing w/ Stiffener Installed

At this point, additional damage was added to the plate between the stiffener and sensor 005, and under the stiffener, originating from the center hole location. This final configuration would provide the answer to the question of whether or not the sensors had the capability to detect damage in a more structurally complex environment (see figure 4.12).
