## Cracking-Induced Mistuning in Bladed Disks

Jian Hou

Air Vehicles Division

Hou, J. (2005) Cracking-Induced Mistuning in Bladed Disks. In *Evaluation, Control and Prevention of High Cycle Fatigue in Gas Turbine Engines for Land, Sea and Air Vehicles* (pp. 37-1 – 37-12). Meeting Proceedings RTO-MP-AVT-121, Paper 37. Neuilly-sur-Seine, France: RTO. Available from: <http://www.rto.nato.int/abstracts.asp>.

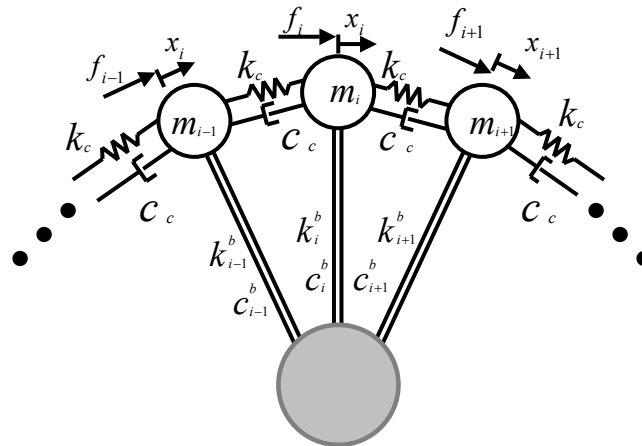
A lumped-mass-spring model grounded using a massless beam was used as a baseline of a bladed disk without a crack as shown Figure 1.

Figure 1. A lumped-mass-spring model of a bladed disk

This model has been used to study various aspects of mistuning in the literature and shown to be effective in capturing the essential dynamic characteristics of a mistuned bladed disk<sup>2-3</sup>. The equation of motion for the  $i^{th}$  mass representing the  $i^{th}$  blade ( $i = 1, \dots, N$ ) can be described as:

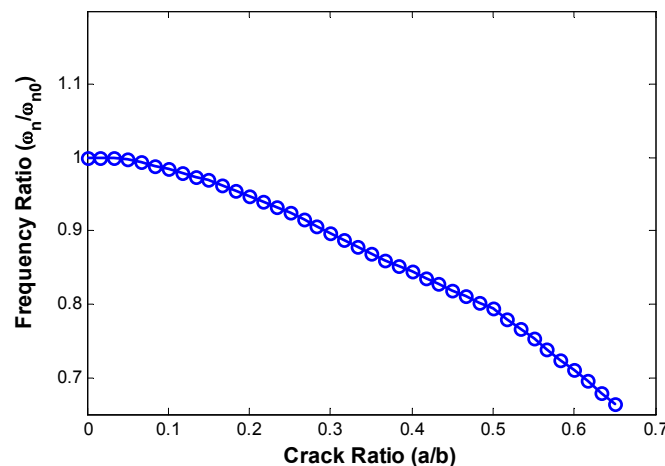
The effect of a cracked blade on mode localisation was investigated by considering different crack length ratios  $a/W$ , defined as the ratio between the crack length  $a$  and the blade root width  $W$ .  $a/W$  was in a range from 0.0 (without a crack) to 0.7 (the crack was 70% of blade width). The baseline model has the parameters of  $b=85$  mm,  $h=5$ mm,  $l=170$ mm,  $m=0.37$  kg. The relation between the fundamental frequency of a cracked blade and the crack length ratio was calculated using MatLab<sup>15</sup>, as shown in Figure 3. The frequency ratio is defined as the value of the fundamental frequency of a cracked blade normalised by the blade frequency without a crack. As expected, the frequency of a cracked beam decreased monotonically with increasing crack length ratio due to the fact that a crack in a blade introduces only local flexibilities, which is consistent with the observations in the literature<sup>7-11</sup>.

**Figure 3. Relation between the fundamental frequency of a cracked blade and the crack length ratio**

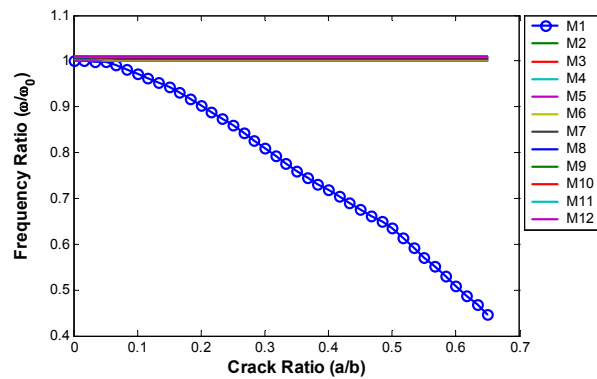
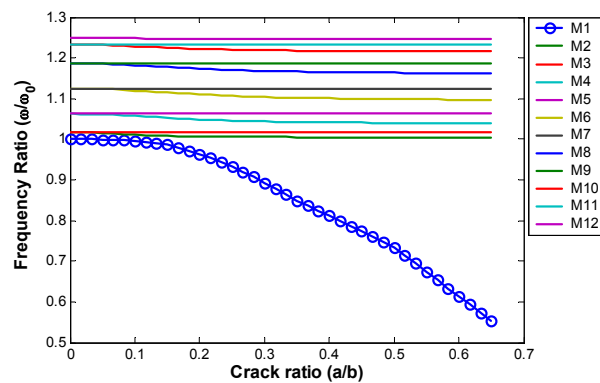
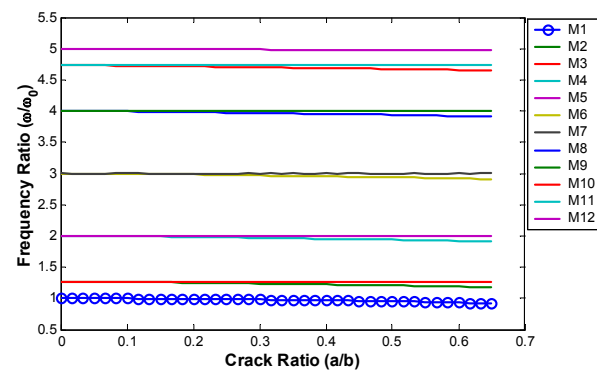
Figure 4 shows the relation between the natural frequencies of a 12 bladed disk and the crack length ratio. Three different disk-to-blade coupling ratios are considered, including weak coupling ( $R=0.05$ ), moderate coupling ( $R=0.25$ ) and strong coupling ( $R=1$ ). The introduction of a crack mainly reduces the fundamental frequency of the bladed disk (one of a repeated pair) for both weakly and moderately coupled bladed disks. However, the reduction in the fundamental frequency is insignificant for a strongly coupled disk even if the crack length ratio is close to 0.7. For both weakly and moderately coupled bladed disks, the reduction in fundamental frequency is not noticeable when the crack length ratio is small, and only becomes significant when the crack length ratio is larger than 0.2. The fundamental natural frequency lowers dramatically after the crack length reaches 25% of the blade width. Note that the relation between a decrease in the fundamental frequency and the crack length ratio may not be considered as an eigenvalue loci veering phenomenon because of the monotonic decrease in the frequency with increase in the crack length ratio<sup>2</sup>. Therefore a system for the blade crack detection relying on monitoring relative changes in frequency may not be sufficient for the weakly or moderately coupled bladed disks until the crack is larger enough (larger than 25% of the blade width). In the case of strong coupling, the change in frequency cannot be used as an indicator for the presence of crack even if the crack is quite long (70% of blade width in this case).

Figure 4. Variation of the 1<sup>st</sup> natural frequency with the crack length ratio

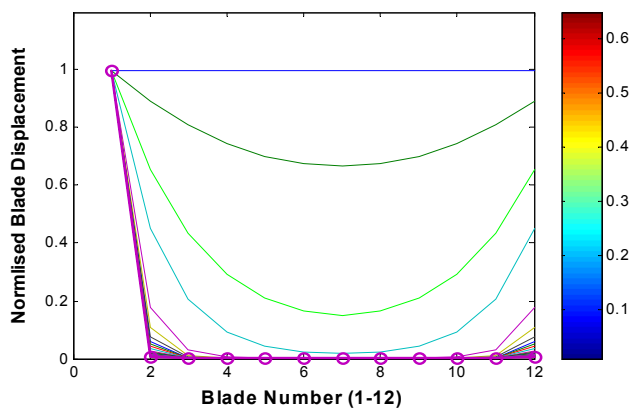
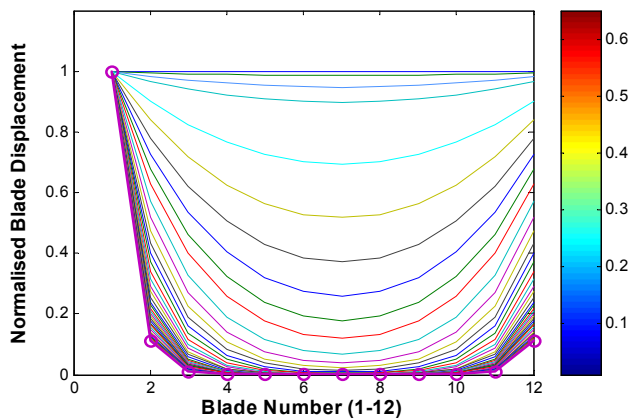
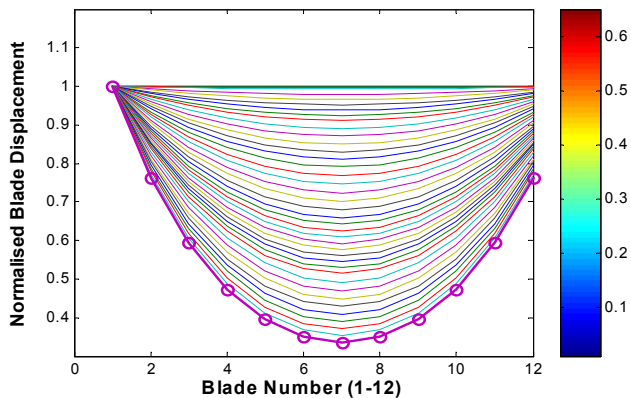
The relation between the normalised mode shapes (to 1 for each mode) and the crack length ratio for the fundamental frequency is shown in Figure 5. The mode shape for the tuned case (based on a crack length ratio  $a/W=0$ ) is a straight line corresponding to the zero nodal diameter. This straight line is gradually distorted with increase in the crack length for all three coupling ratios until the peak displacements are finally localised to the cracked blade (Blade 1). Note that variation rates differ for the different coupling ratios and are more sensitive in weakly and moderately coupled systems. Hence mode localisation occurs for all three coupling ratios although a weakly coupled system is more sensitive than the other two systems.

Figure 5. Mode variation with crack length ratio

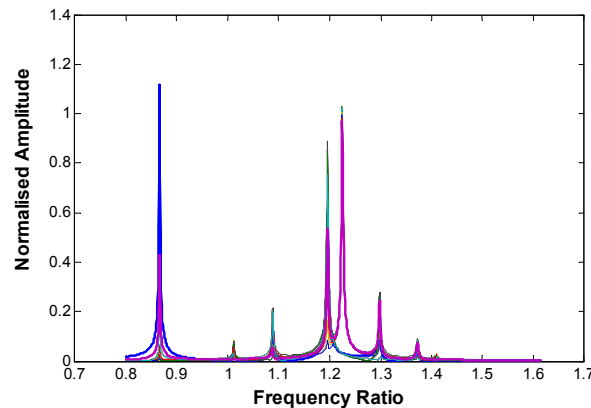
The effect of the cracked blade on the blade response amplitude was investigated by performing frequency response analyses of the bladed disks with different crack ratios. Figure 6 shows typical vibration response amplitudes of the blades for a weakly coupled system, normalised to the maximum tuned amplitude. Clearly, mistuning has been introduced by a cracked blade.

**Figure 6. Frequency Response Amplitude of a bladed disk with a cracked blade ( $E=3$ ,  $R=0.25$ ,  $a/b=0.05$ )**

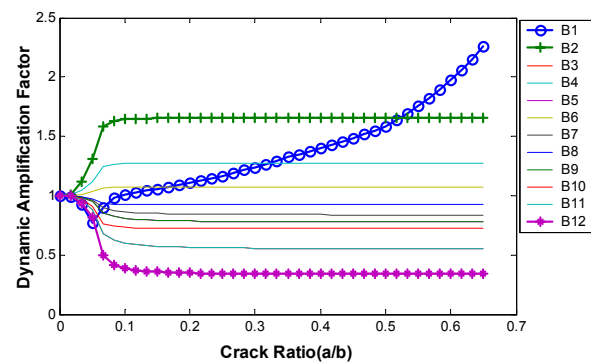
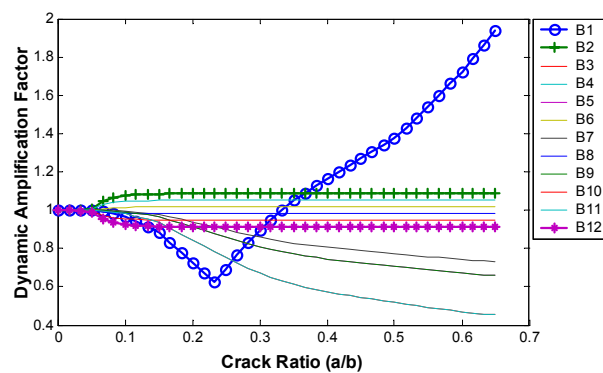
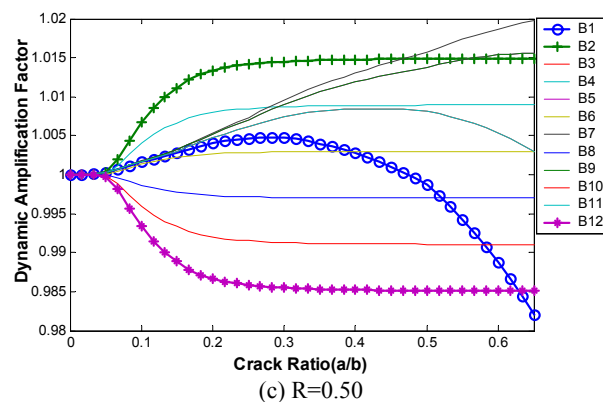
Figure 7 shows the normalised maximum response amplitudes for all 12 blades in the bladed disk under three coupling ratios. It is found that the response amplitude of the cracked blade (Blade 1) is less than those of other blades under all the three coupling ratios when the crack length ratio is small. For a weakly coupled system, the vibration amplitude of the cracked blade becomes larger than the amplitude of the adjacent maximum responding Blade 2 only when the crack length ratio approaches to a limit value of 0.55. For the moderately coupled system, the limit value of the crack length ratio is 0.35. However, the limit value is greater than 0.6 for the strongly coupled system. Therefore, the cracked blade does not necessarily experience the maximum response in all scenarios, and the maximum responding blade varies depending on the crack length ratio. This may impose significant difficulties for vibration-based crack detection techniques if only the maximum responding amplitude is sought.

Nevertheless, the response variations of the two blades adjacent to the cracked blade show an interesting trend. Blade 2 (with a phase lag of  $2\pi E/12$ ) experiences the maximum response amplitude for the crack length ratios approximately less than 0.5 for all three coupling ratios. Blade 12 (with a phase advance of  $2\pi E/12$ ) experiences the minimum response amplitudes for ratios less than 0.5 for a weakly or strongly coupled system. However, this trend is not apparent for a moderately coupled system. This suggests that the cracked blade is only likely to be the maximum responding blade when a crack is sufficiently large. When the crack is small, the response amplitudes of adjacent blades are better indicators for detecting the existence of a cracked blade. This finding has an important implication for vibration-based blade crack detection and prognostic analysis as the cracked blade can be related to the response signatures of only a few blades in the whole bladed disk. Also the detection of the changes in vibration levels is an essential indicator for crack detection rather than the absolute response amplitude. As a cracked blade inevitably introduces mode localization and associated mistuning to a bladed disk, a cracked blade can cause higher response amplitudes to uncracked

Figure 7. Frequency Response Amplitude of Each Individual Blade ( $E=3$ )
