| 4. TITLE AND SUBTITLE<br><br>Rapid Assessment of the Roll of Microstructural Variability in the Fatigue Behavior of Structural Alloys using Ultrasonic Fatigue | | 5a. CONTRACT NUMBER |

**RAPID ASSESSMENT OF THE ROLE OF MICROSTRUCTURAL  
VARIABILITY  
IN THE FATIGUE BEHAVIOR OF STRUCTURAL ALLOYS USING  
ULTRASONIC FATIGUE  
AFOSR GRANT NO: F49620-03-1-0069**

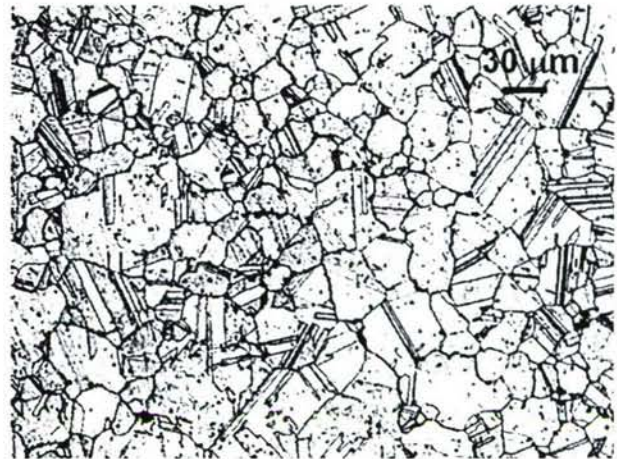
Figure 6: Optical micrograph of Rene' 88 DT.

An optical micrograph showing the microstructure of Rene' 88 DT is shown in Figure 6. This micrograph is representative of the grain structure variation associated with the circumferential orientation in the forging. Annealing twins are prevalent in the microstructure. The supersolvus heat treatment leads to a relatively coarse and equiaxed distribution of grains. In order to determine the grain size distribution, 500 grains were measured using the intercept method and the results of this procedure are summarized in Figure 7. The grain-size distribution is log-normal with a long tail and an average size close to 18.3  $\mu\text{m}$ . The results indicate that there is a finite probability of finding grains with as much as five times the average grain size.

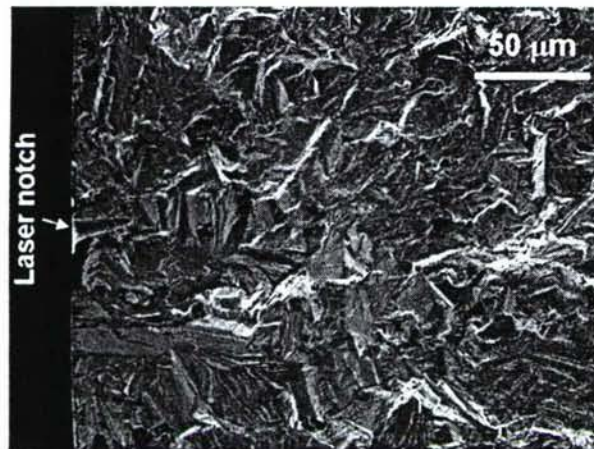
Figure 12(a) Features of crack initiated from a laser micronotch and (b) higher magnification image of the notch.

Figure 12(a) shows the fractographic features associated with a crack that initiated from a laser micronotch in as-machined specimen with a maximum stress of 850 MPa at room temperature. Details of the notch are shown in Figure 12(b) and, as anticipated, there are no indications of a damaged area around the notch. The shape of this notch on the fracture surface is a half-cone and its maximum width is approximately 10  $\mu\text{m}$  with a depth of about 25  $\mu\text{m}$ . Fractographic observations suggest that the cracks that initiate from these notches quickly assume a semi-circular shape like cracks that naturally initiate from surface flaws. Similar behavior has been observed in other studies of crack initiation and growth from laser micronotches [27].
