**REPORT NO. 06-23**

**TRANSPORTABILITY TESTING OF THE MARINE CORPS  
LIGHT WEIGHT PRIME MOVER (LWPM)  
TP-94-01,  
“TRANSPORTABILITY TESTING PROCEDURES”**

**Transportability Testing of the Marine Corps  
Light Weight Prime Mover (LWPM)  
TP-94-01, Revision 2, June 2004 "Transportability Testing Procedures"**

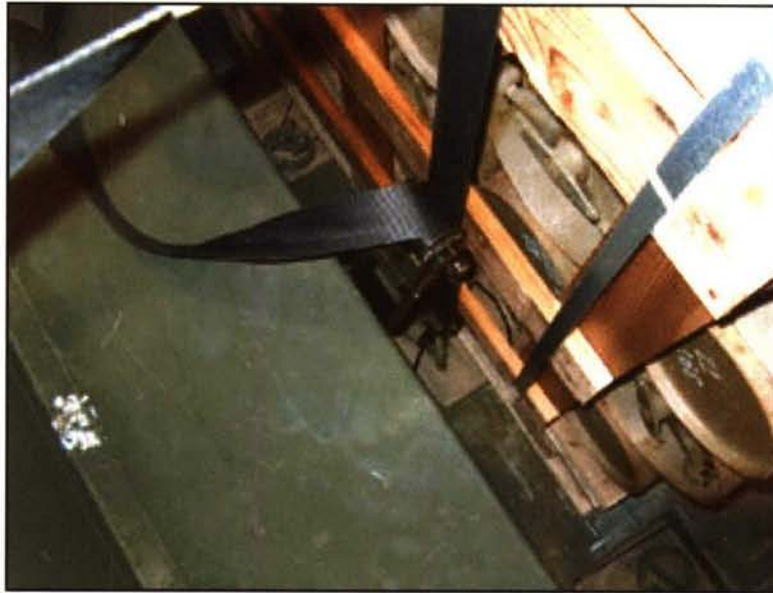
2. The minimal distance between the outside of the pallet and the interior wall of the vehicle made it difficult to engage the strap hooks in the tiedowns.

3. Ratcheting of the straps was difficult due to the ratchet handles being located between the interior wall of the vehicle and the pallets.

**Photo 2. Limited Access for Straps**

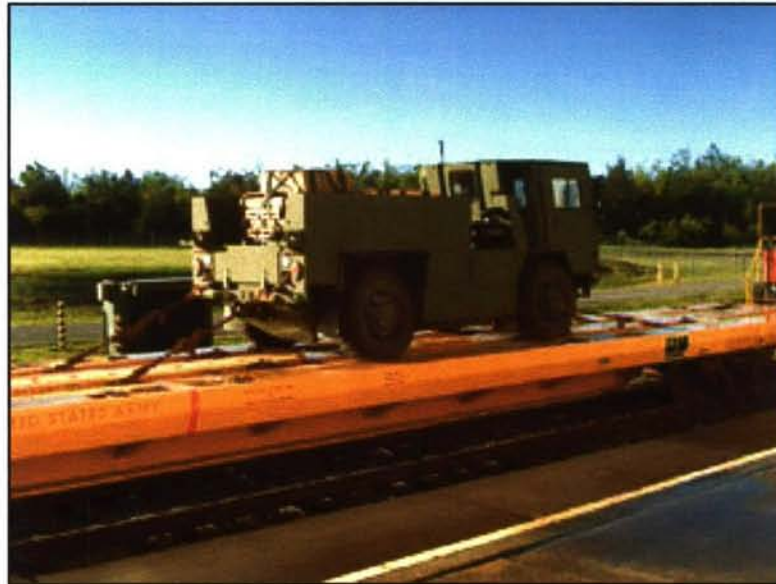
**Photo 3. Rail Impact Testing of the LWPM (Prior to Testing)**

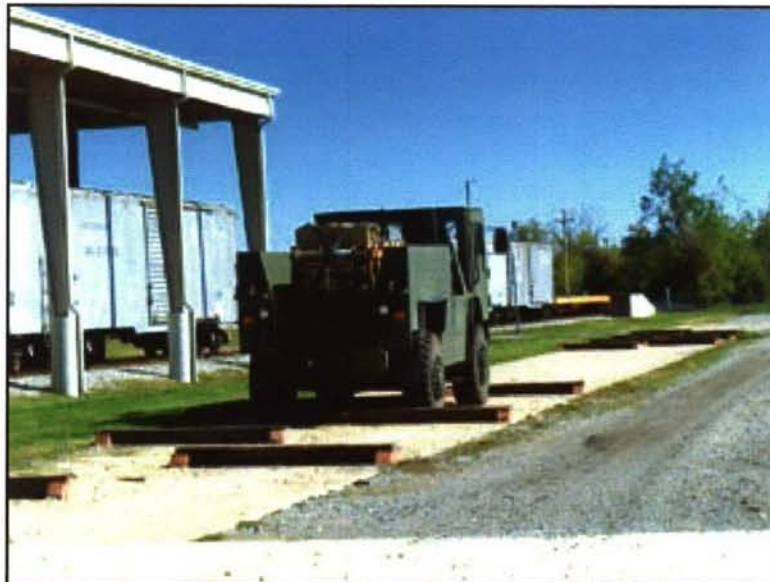
**Photo 4. Hazard Course Testing of the LWPM**

1. Figure 6 lists the average speeds of the test load through the Hazard Course.
2. Inspection following each pass did not reveal any damage to the payload, tie-down rings, anchors or LWPM.

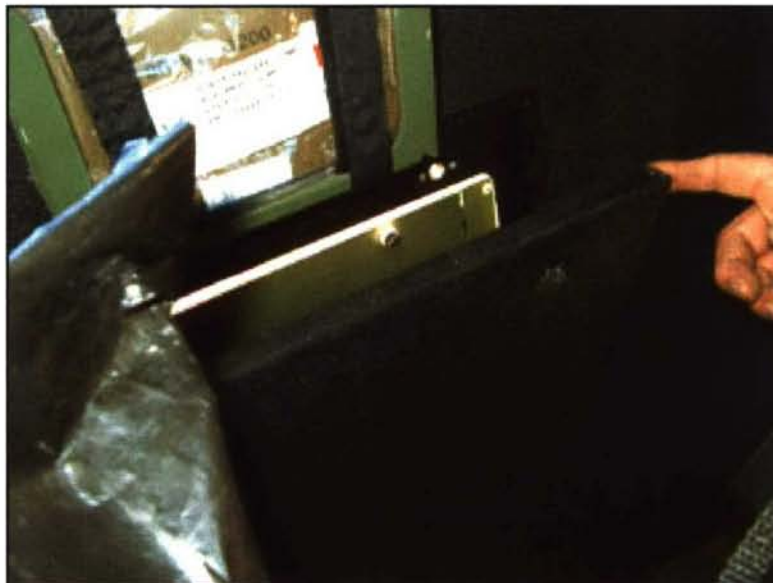
1. The Road Trip was conducted between the Road Hazard Course Passes #2 and #3.
2. Inspection following each pass did not reveal any damage to the payload, tie-down rings, anchors or LWPM.
3. The panel at the back of the vehicle cab would not stay closed.

Photo 5. Rear Cab Panel Not Staying Closed

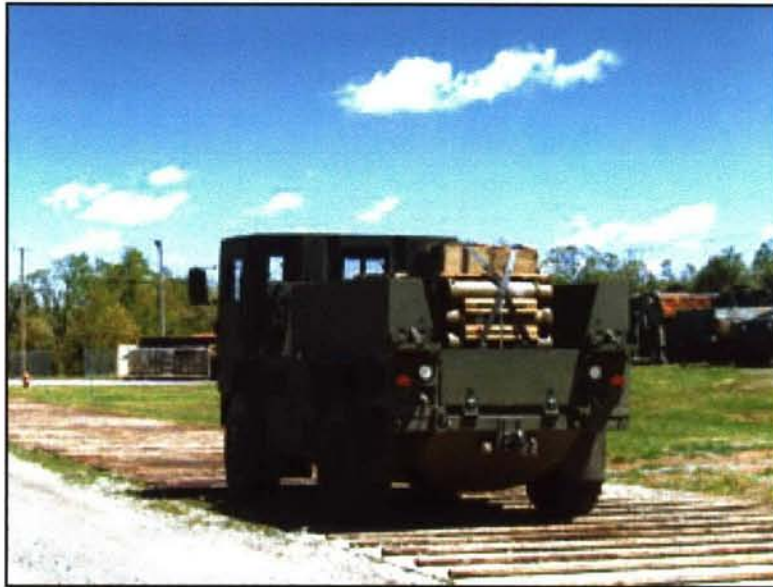
**Remarks:** Inspection following each pass did not reveal any damage to the payload, tie-down rings, anchors or LWPM.

**Photo 6. Washboard Course Testing of the LWPM.**
