# **Cold Regions Data Acquisition and Analysis for Section 227 *National Shoreline Erosion Control Development and Demonstration Program* Miami Park South, Allegan County, Michigan**

Michael G. Ferrick, Lawrence W. Gatto, and  
Christopher R. Williams

September 2005

*U.S. Army Engineer Research and Development Center  
Cold Regions Research and Engineering Laboratory (CRREL)  
Hanover, NH 03755-1290*

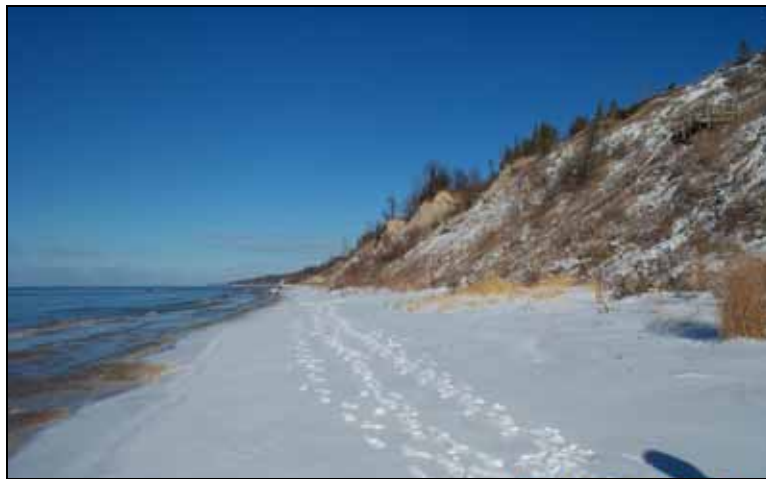
**Figure 1. Bluff at Allegan, Michigan looking north. The remediated portion of the bluff is in the right foreground adjacent to the wooden stairway. Lake Michigan is on the left.**

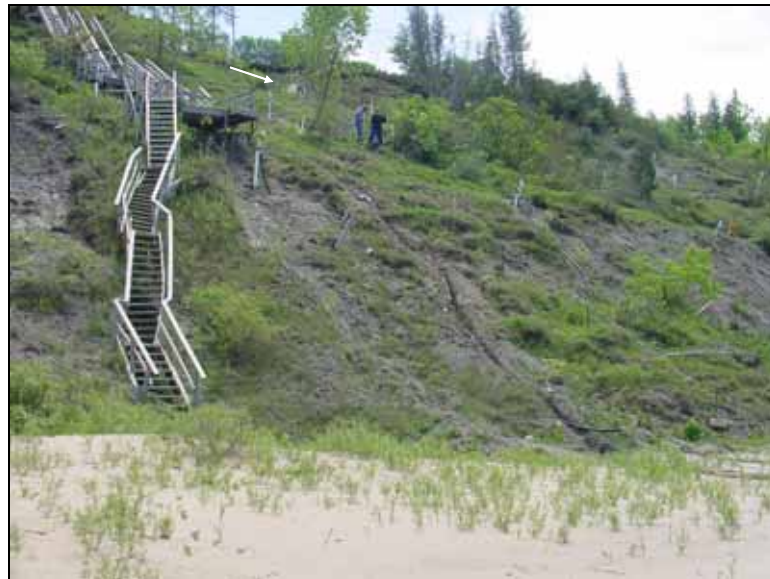
**Figure 2. View from below of the remediated section of bluff containing pumping wells, piezometers, and our temperature, soil moisture and resistivity instrumentation. The arrow points to our data logger and web camera.**

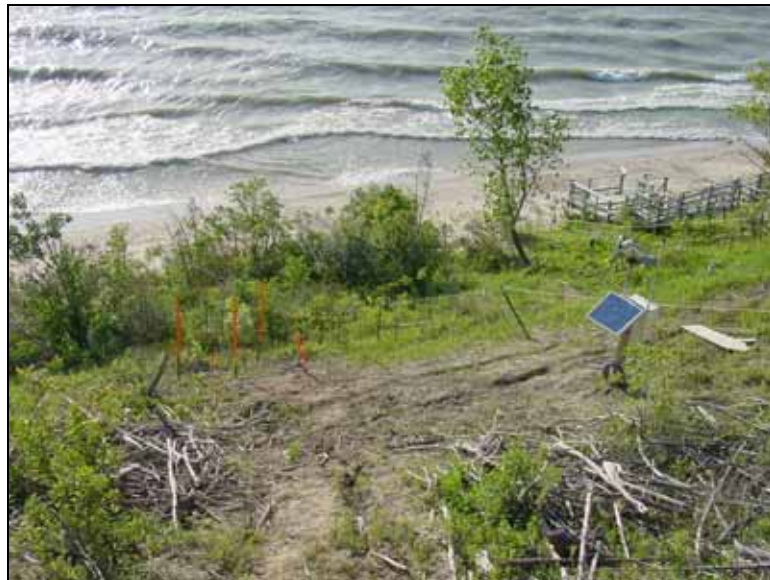
**Figure 4. View from above of our site in the remediated part of the bluff. Soil temperature, moisture, and resistivity instrument profiles in the bluff are marked by orange stakes, with solar panel, data logger, and web camera visible in a cluster on the right.**

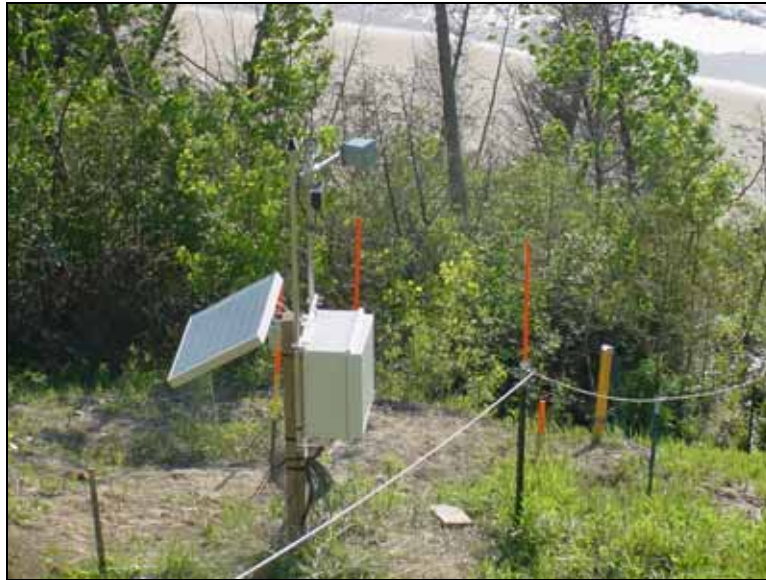
**Figure 5. View from above of our site in a nearby control section of the bluff. Soil temperature, moisture, and resistivity instrument profiles in the bluff are marked by orange stakes, with solar panel, data logger, and web camera visible as a cluster in the foreground.**
