**Naval Surface Warfare Center  
Carderock Division**

**NSWCCD-50-TR-2007/030** June 2007

**Experiment to Characterize Sea Fighter FSF-1 Wave  
Slamming**

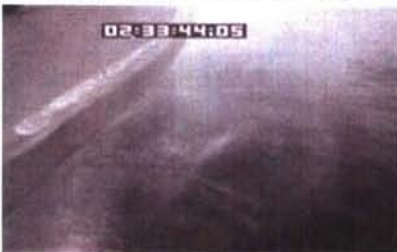
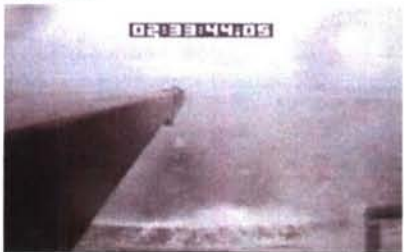
1<sup>st</sup> crest: Small slam

1<sup>st</sup> trough: Bow lifts out of water

2<sup>nd</sup> crest: Slam

2<sup>nd</sup> trough: White water from previous slam

3<sup>rd</sup> crest: White water from previous slam

Figure 30. Slam Event 1: Snapshots of on-board cameras. The first row shows the small slam due to the first crest and the third row shows the second, more violent slam.

Figure 30 shows this sequence of events using the on-board bow center and starboard cameras respectively. The first row of snapshots show the first crest which causes a small slam, but it is not large enough for white water to be seen by the center

camera. The second row of photos shows the first trough that lifts the bow out of the water just before the second slam. The third row shows the second crest slamming into the bow, which is the most violent slam of the three crests. The intensity of the slam can be seen by the large amount of whitewater in the bow camera view in both the third and fourth row photos. The fourth row shows the following trough and the remnants of the previous slam can still be seen by the white water and spray that is still present in the bow center camera. The last row shows the last crest which is the largest crest in the wave height plot, but it does not produce a slam.

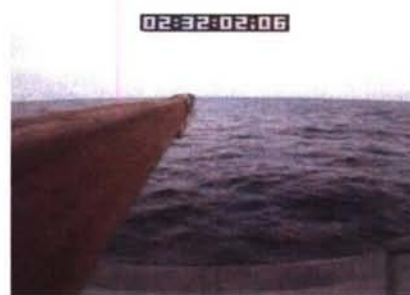
Figure B3. Diagram of view from center bow camera.

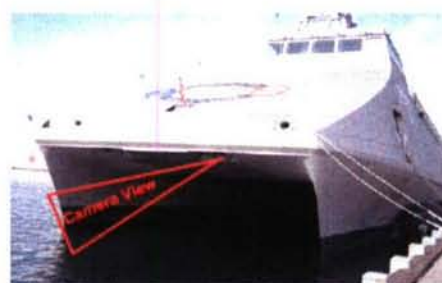
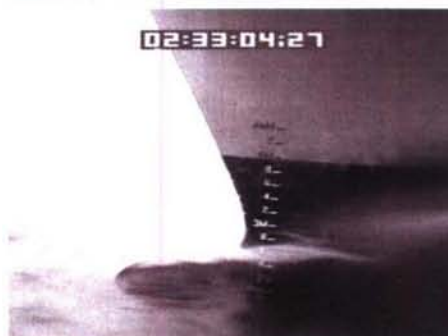
Figure B4. Diagram of view from port anchor well camera.
