# MineWolf Tiller Test and Evaluation

DRDC Suffield TR 2007-164

November 2007

Canadian Centre for Mine  
Action Technologies

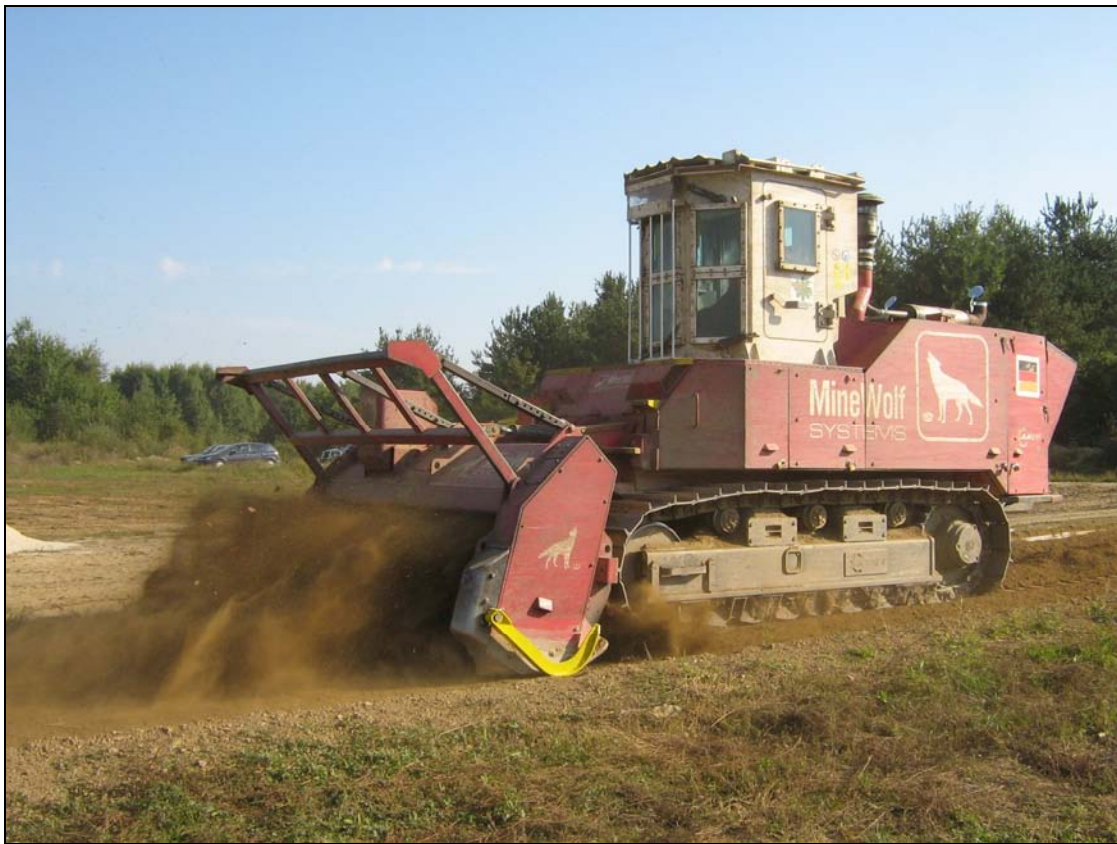
*Figure 1. MineWolf tiller*

The MineWolf tiller is reported to weigh 25.5 tonnes. It has an overall width of 3.48 metres and an active width (the width across the ground engaging section of the tiller head) of 2.8 metres. A machine this size is generally classed as a heavy machine. Figure 1 and Figure 2 provide general views of the MineWolf and the tiller head.

The machine is equipped with a Deutz diesel engine rated at 270kW (367hp). The tiller head is fitted with 72 chisels along a shaft rotating at up to 480 rpm. The chisels are arranged around the shaft on 12 plates.

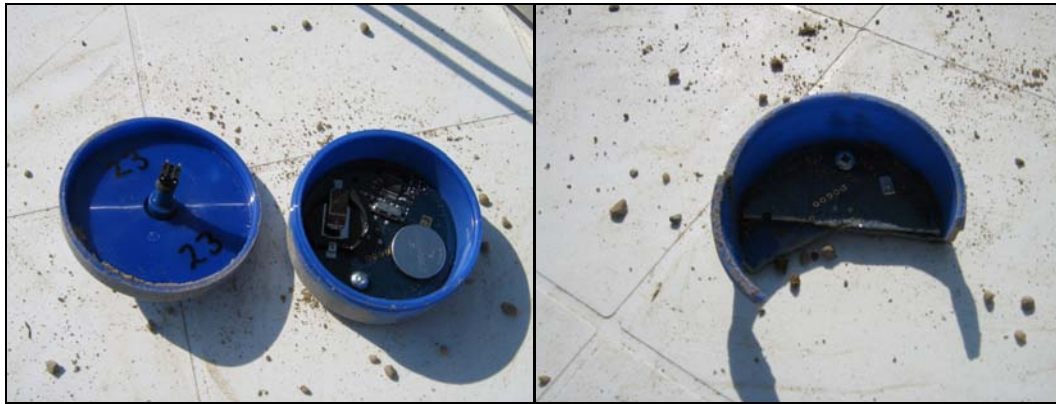
**Figure 5.** *Debris of Interest – Gravel, 0cm DOB*

Mechanically neutralised

The images in Figure 5 through Figure 13 show some of the debris collected following each trial. The test data sheets contained in Annex D describe the status of each WORM target. The reader is invited to draw his or her own conclusions about the type of the debris left in and around the area where the MineWolf has been used.

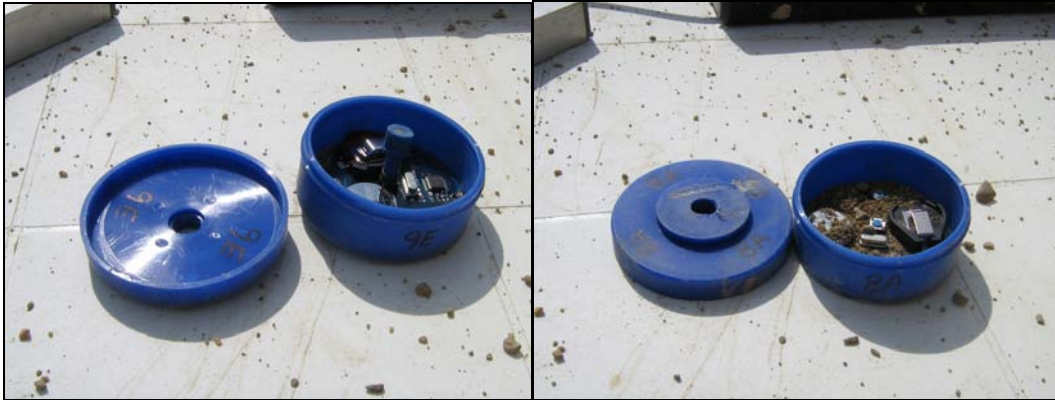
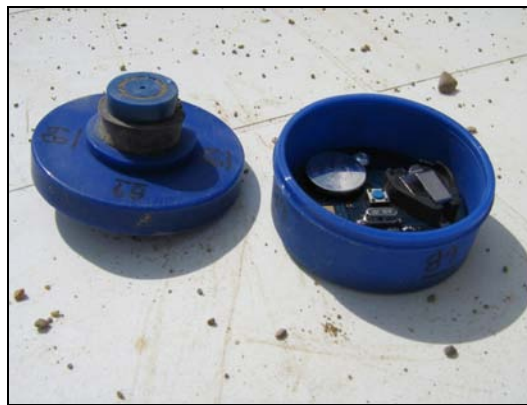
**Figure 6.** Debris of Interest – Gravel, 10cm DOB

Live damaged

Mechanically neutralised

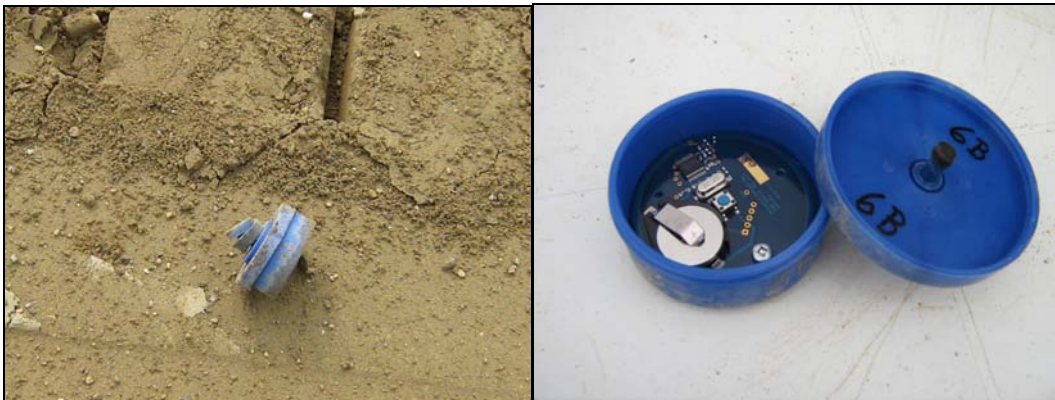
**Figure 7.** Debris of Interest – Gravel, 15cm DOB

unknown serial thrown outside  
of test lane

Live damaged

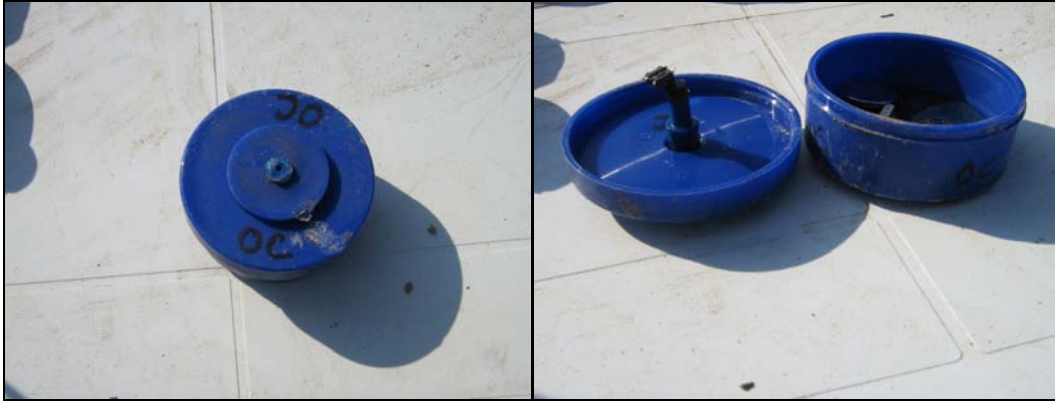
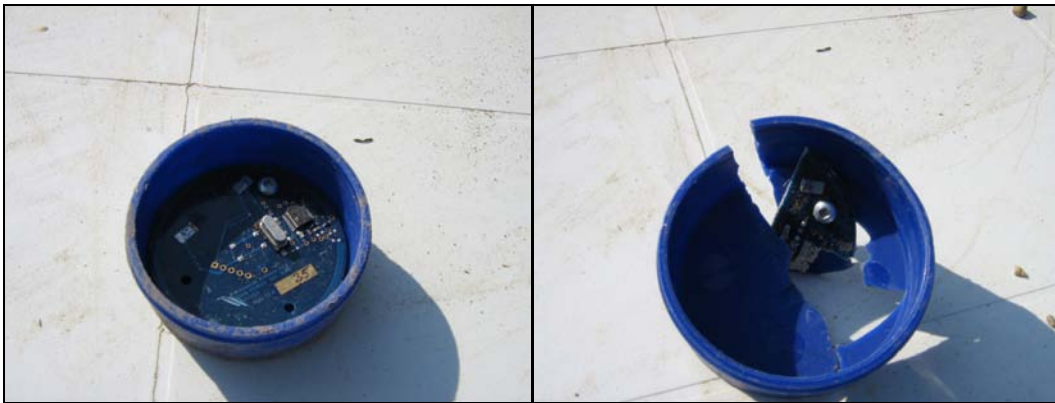
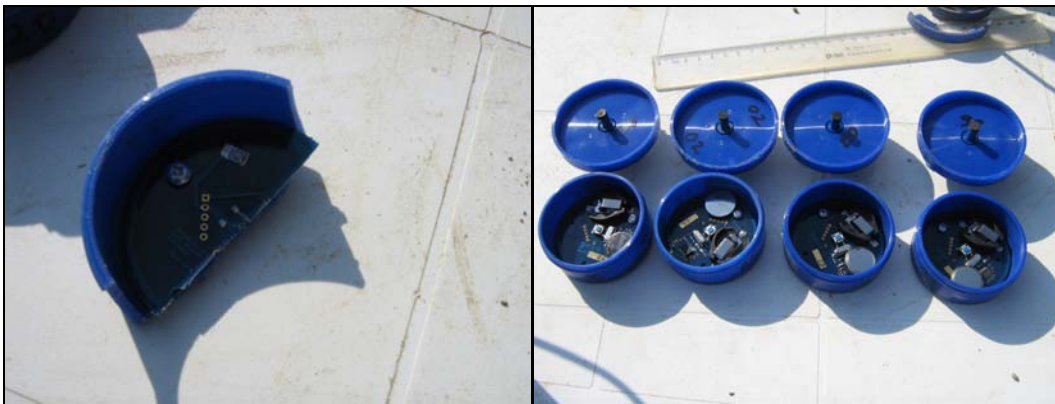
**Figure 8.** Debris of Interest –Sand, 0cm DOB

Triggered (same target)

Triggered

Mechanically neutralised

Live damaged

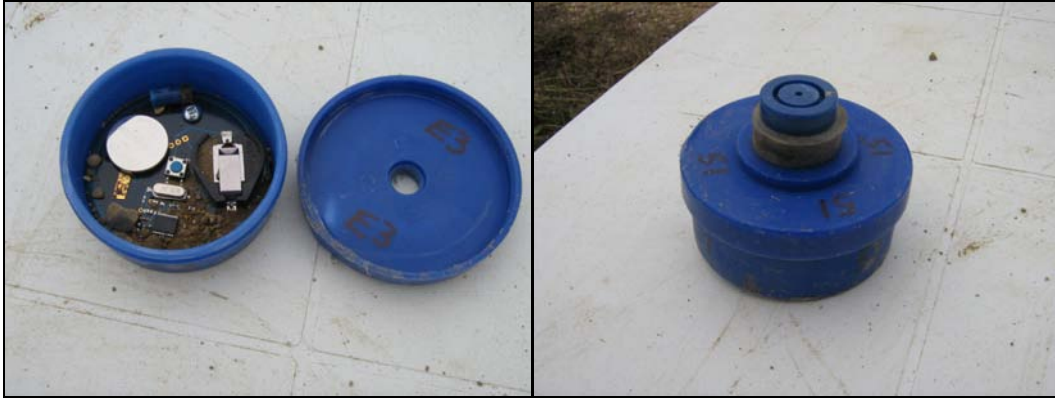
**Figure 9.** Debris of Interest – Sand, 10cm DOB

Live damaged

Live

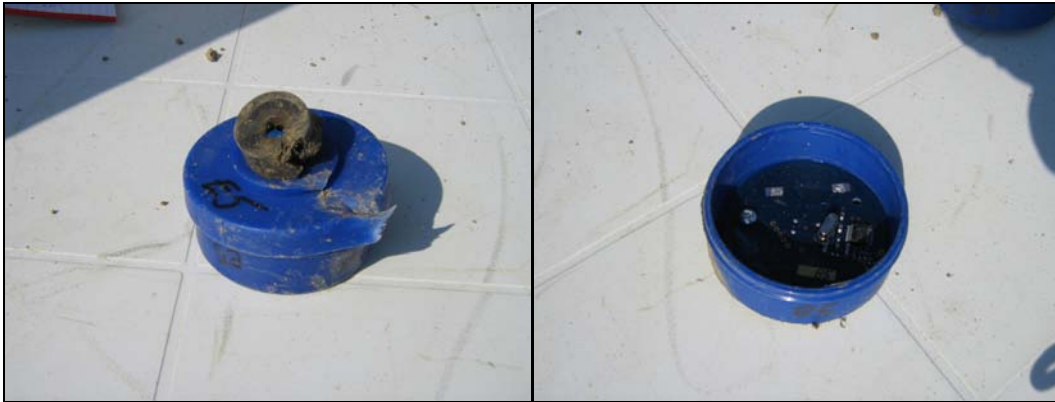
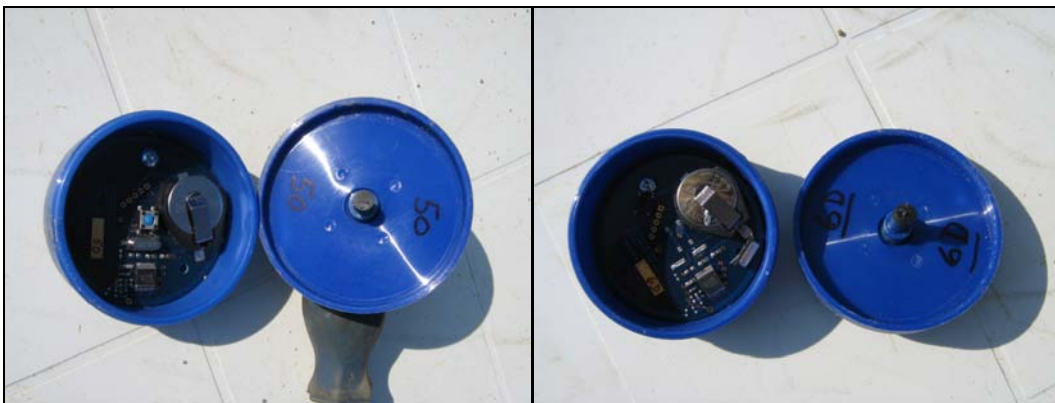
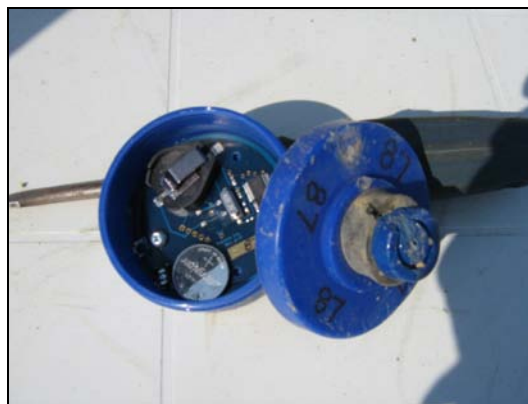
**Figure 10.** Debris of Interest – Sand, 15cm DOB

Triggered

Mechanically neutralised

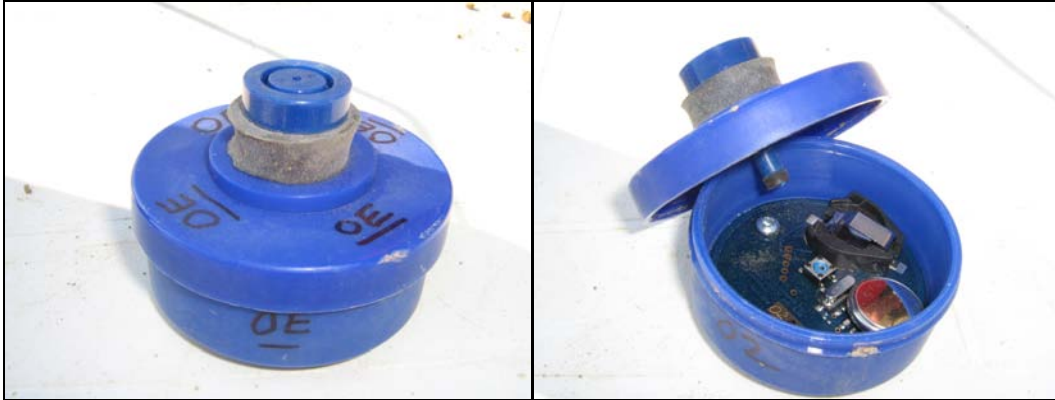
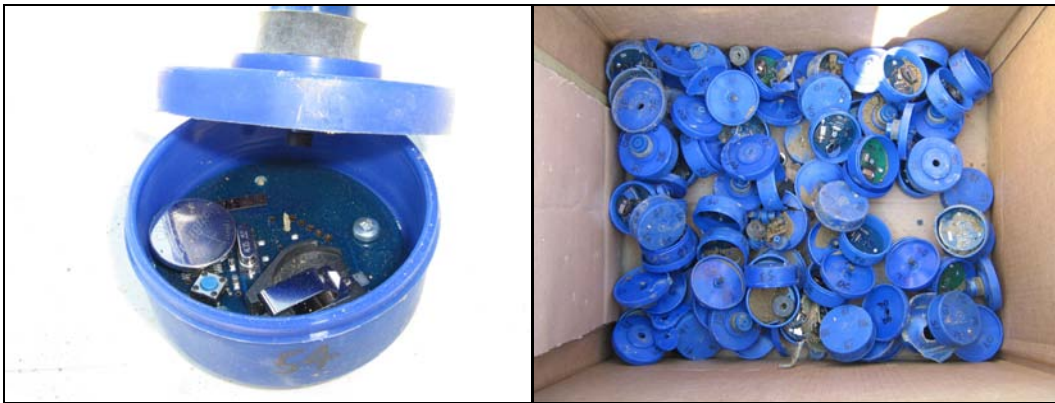
**Figure 11.** Debris of Interest – Topsoil, 0cm DOB

Live damaged

Triggered

General debris from trial

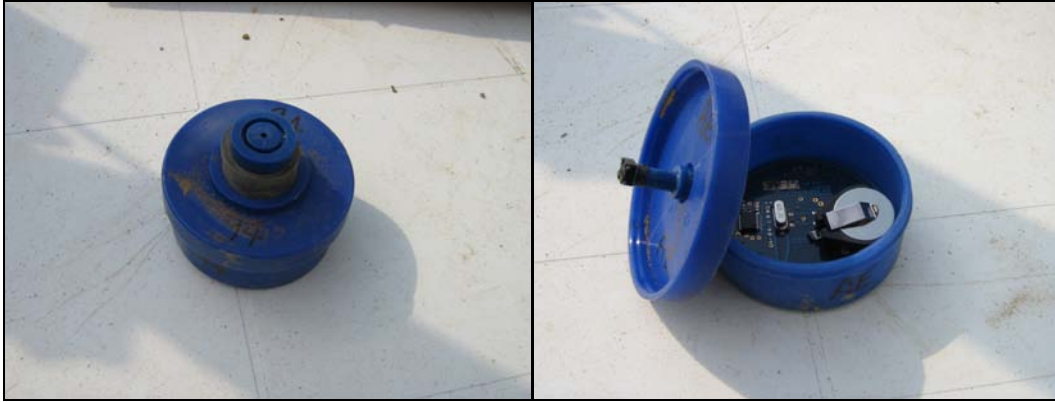
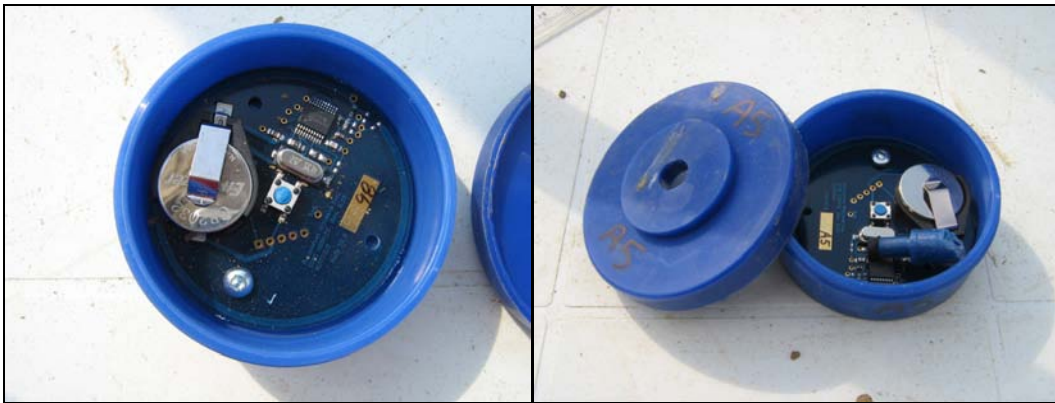
**Figure 12.** Debris of Interest – Topsoil, 10cm DOB

Live

Triggered

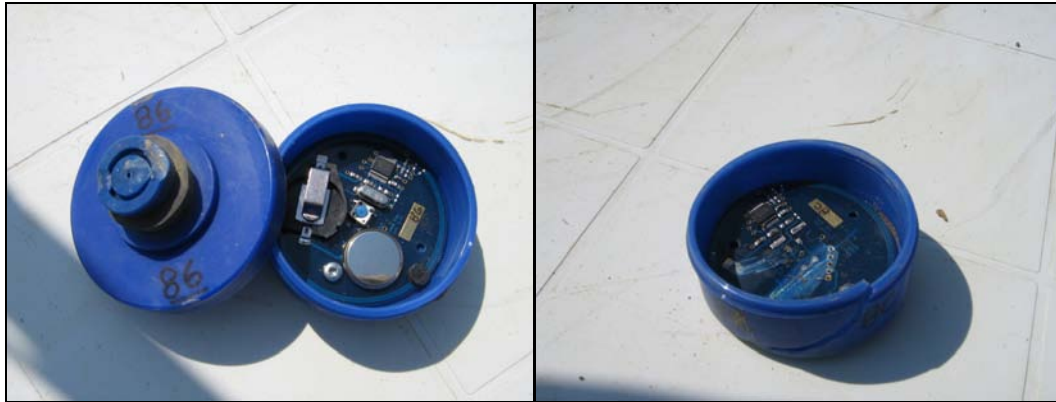
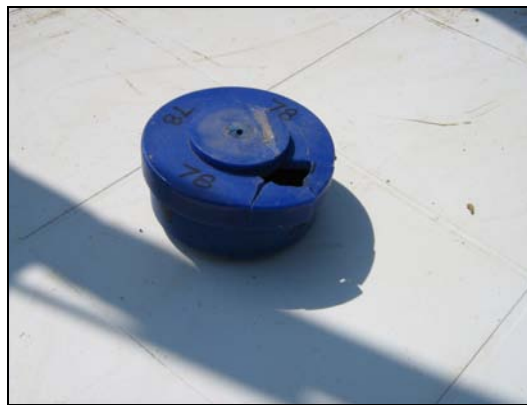
**Figure 13.** Debris of Interest – Topsoil, 15cm DOB

Triggered

Mechanically neutralised

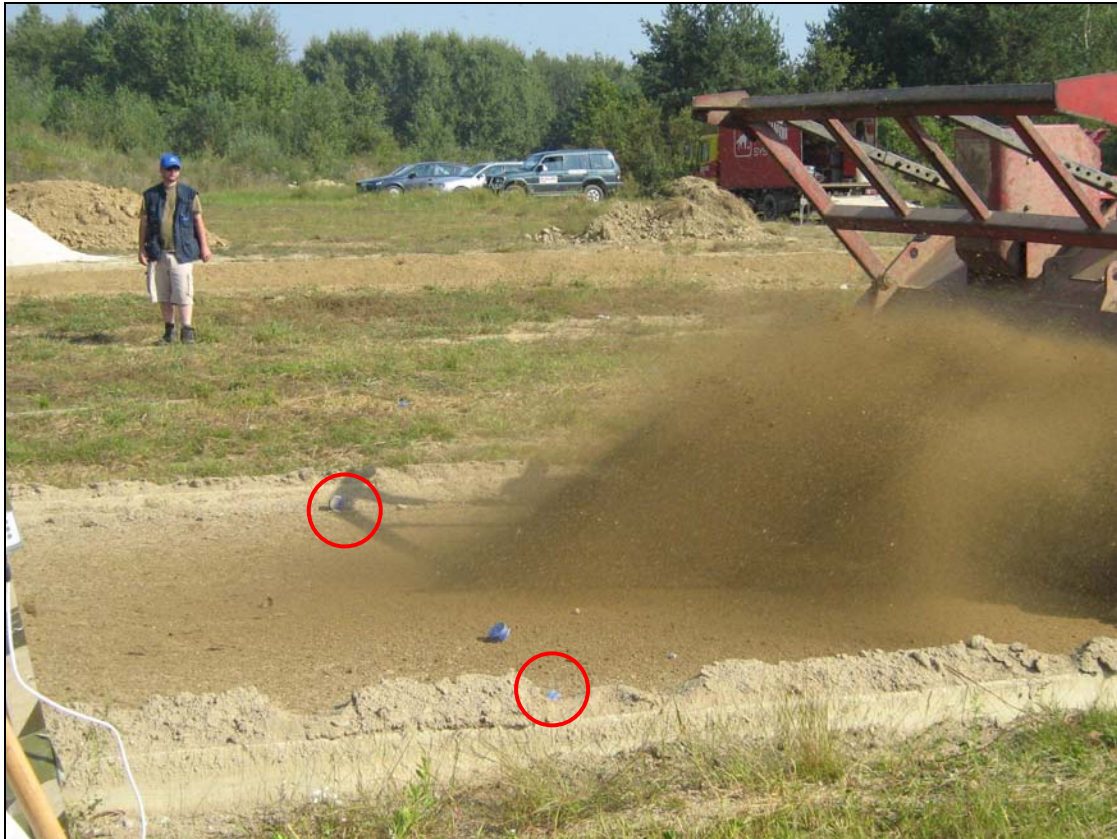
*Figure 14. Debris Thrown from Tiller After Processing*

Along with the items shown above, remains from the targets which were completely destroyed could be found in and around the test lanes. Although not as vigorous in throwing debris as a conventional chain flail, the MineWolf is prone to throwing soil, mine fragment debris, and potentially vegetation (see Figure 14) to a limited extent.

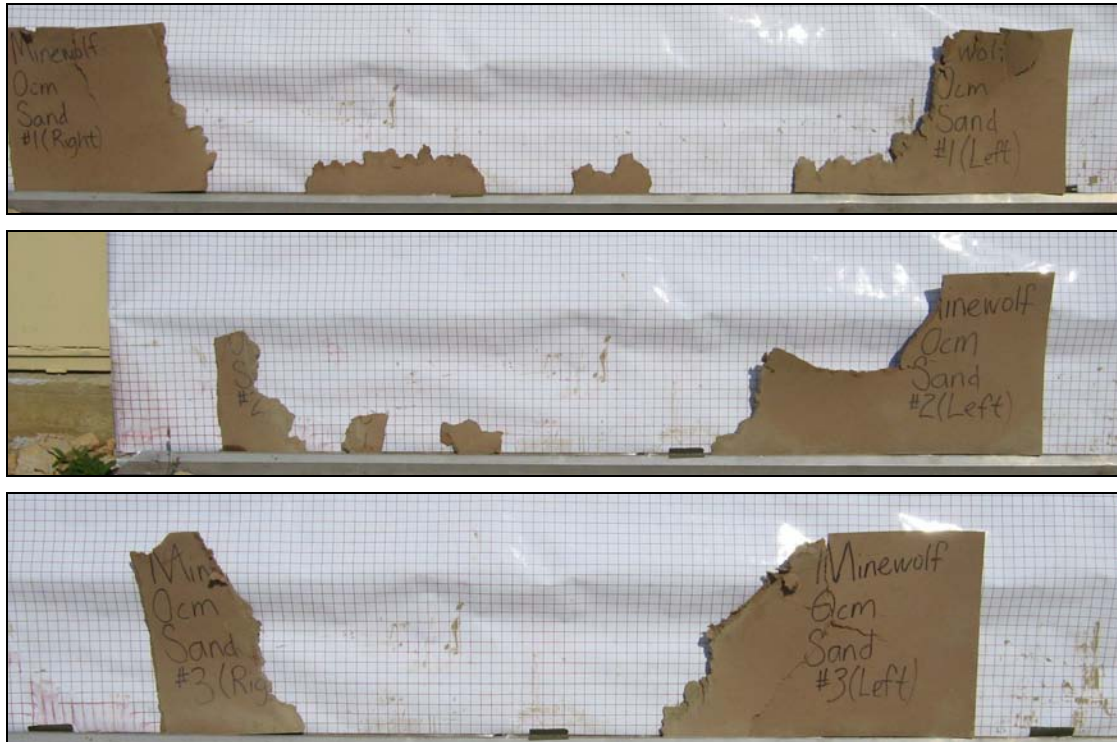
The fibreboards in Figure 15, Figure 16 and Figure 17 show an even depth penetration of 12cm or deeper. The fibreboards for the test lane at 10cm show the poorest performance; the remainder of the test lanes show digging to at least 30 cm and 26 cm where the test targets were at 0cm and 15cm respectively. There is no other apparent evidence of skip zones or lateral inconsistency in this test.

Only one out of three boards for both the 0cm and 15cm test lanes were intact. The other two boards in each test lane were only partially recovered as the machine dug deeper than the entire depth of the fibreboards.

As described in Annex A, fibreboards were used to measure the depth and consistency of penetration across the path of the vehicle. Note that the grid on the paper behind the fiberboard in each of the photographs measures 2cm x 2cm. For situations where most of the fiberboard is missing, the photograph was taken from a shorter distance; the grid in the background is still 2cm x 2cm.

The machine was able to penetrate consistently and uniformly to a depth of 12cm or greater in the sand conditions used in these tests. There was no evidence of skip zones in the sand.

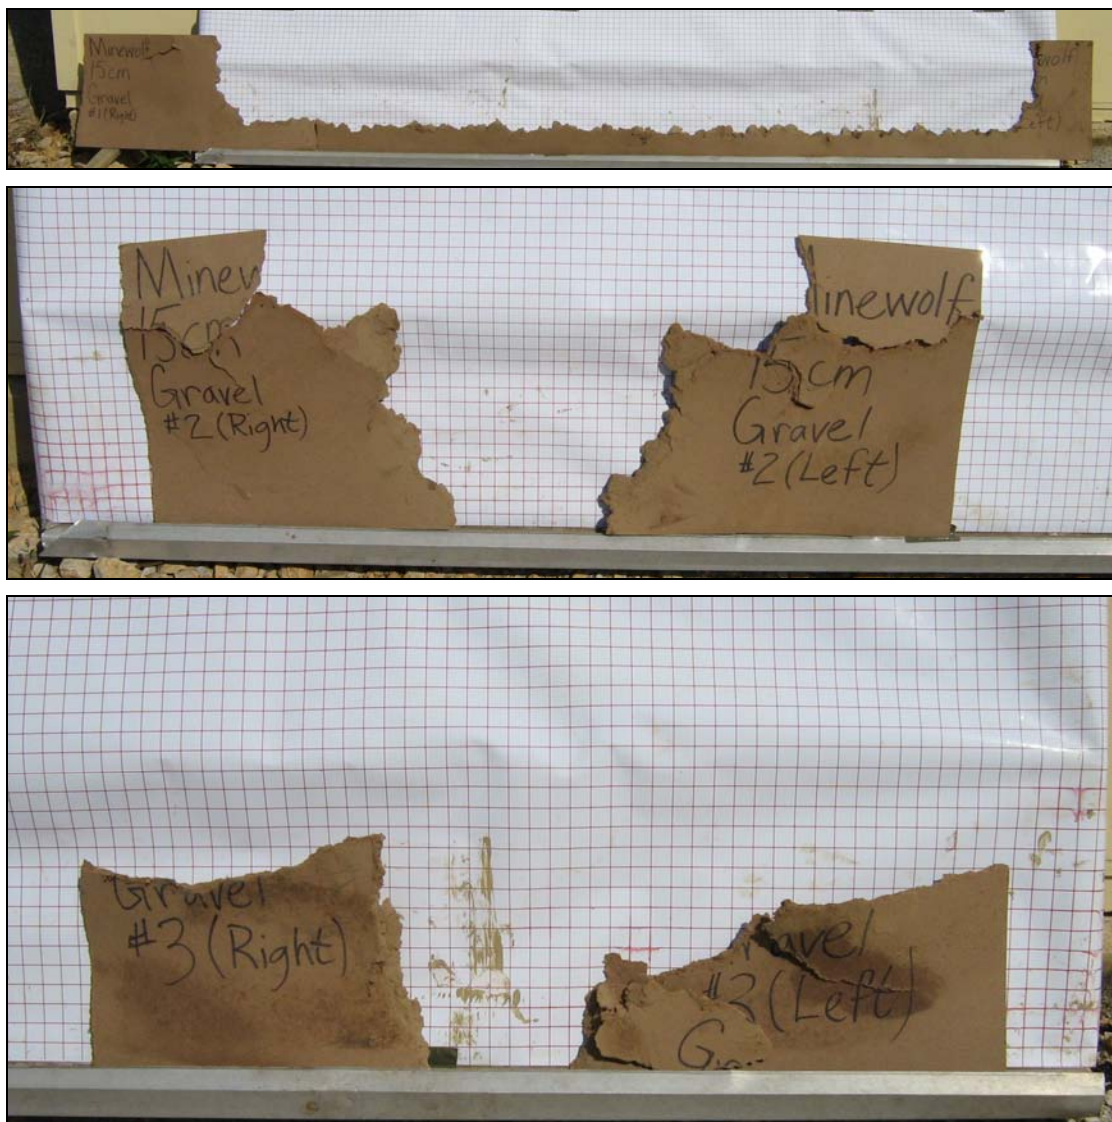
The fibreboards in Figure 18, Figure 19 and Figure 20 show an even depth penetration of 14cm or deeper. As with the sand, the test lane with the targets buried at 10cm showed the least penetration, with the 0cm and 15cm test lanes recording 24cm and 30cm penetration respectively. There is no other apparent evidence of skip zones in this test.

Similar to the sand test lanes, only one out of the three boards in each of the 0cm and 15cm test lanes were recovered intact. Again the machine dug deeper than the boards.

The machine also was able to penetrate consistently and uniformly to a depth of 14cm or greater in the gravel conditions used in these tests. Again, there was no evidence of skip zones.

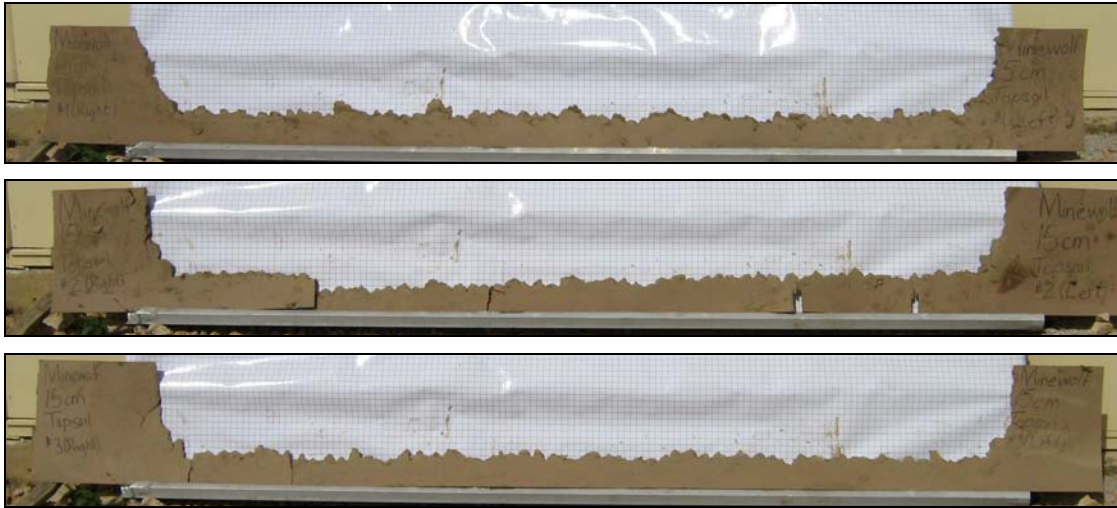
The fibreboards in Figure 21, Figure 22 and Figure 23 show an even depth penetration of 16cm or deeper. As with the sand and gravel, the test lane with the targets buried at 10cm showed the least penetration, with the 0cm and 15cm test lanes recording 30cm and 28cm penetration respectively. There is no other apparent evidence of skip zones in this test.

Unlike the sand and gravel test lanes, all of the fiberboards were recovered intact and the depth of penetration could be seen on all of the fiberboards.

The machine also was able to penetrate consistently and uniformly to a depth of 16cm or greater in the topsoil conditions used in these tests. Again, there was no evidence of skip zones.

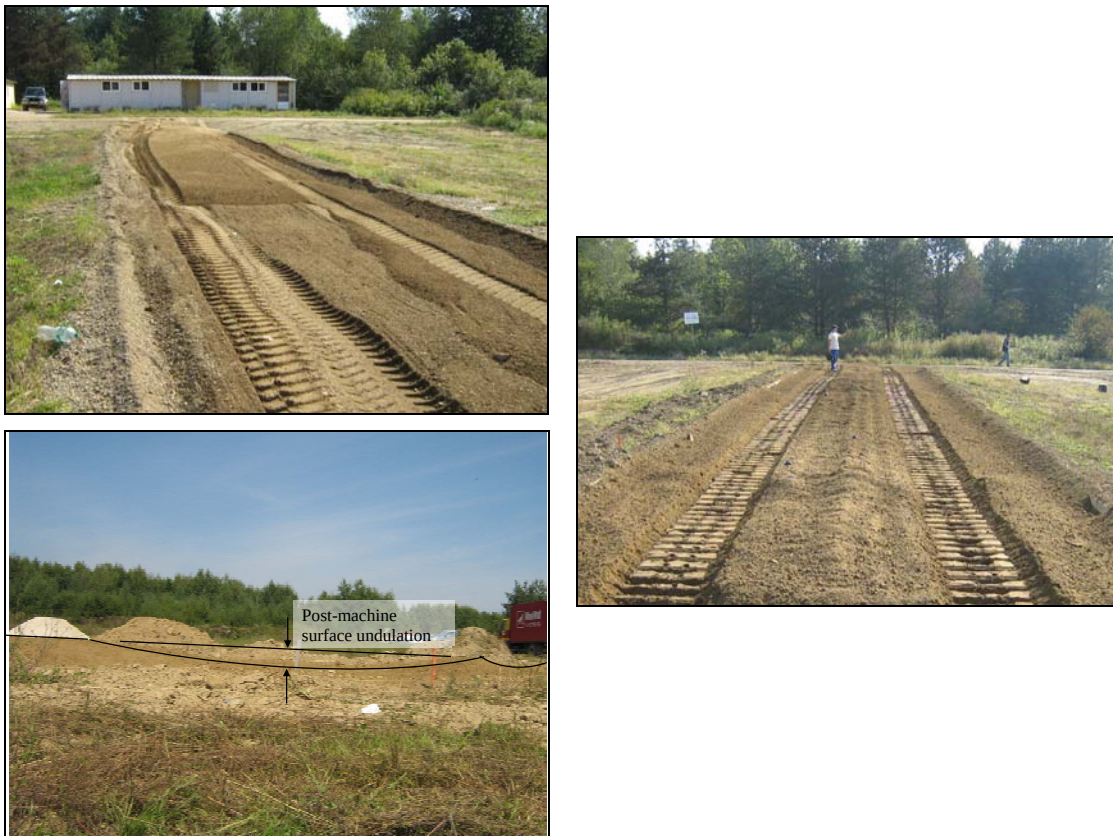
**Figure 24.** Terrain After Passage Of MineWolf Without (Left) and With (Right) Automatic Depth Control

The difference in surface soil profile following the passage of the machine with and without automatic depth control is interesting to note (Figure 24). The differences are quite significant as terrain which was originally flat and level shows a sinusoidal pattern following the passage of the machine without automatic depth control. The photograph shown in Figure 24 has terrain undulations in excess of 15cm after the passage of the MineWolf without depth control over almost completely flat terrain. This is corroborated by the videos taken of the trials that clearly show the tiller head moving up and down by what appears to be 15cm. Conversely, the soil surface following the passage of the MineWolf with automatic depth control is quite flat with no significant undulations.

4. As the MineWolf descends the rise created from the higher pile of soil, the tiller head digs in more, resulting in a larger pile of soil behind the tiller head as in (1) above.

The cycle listed above in Steps 1 to 4 repeats itself along the length of the test lane. Since there is no sudden increase or decrease in the height of the ground or tiller head, the operator has no indication that this sequence is occurring. A long, gentle, sinusoidal pattern is created in the surface of the ground following the passage of the tiller, presumably resulting in a similar trend in the maximum digging depth of the machine. Even if the operator is able to recognize that the undulation is occurring, any correction will likely exacerbate the problem as the machine will be on a different part of the undulating pattern than the working head.

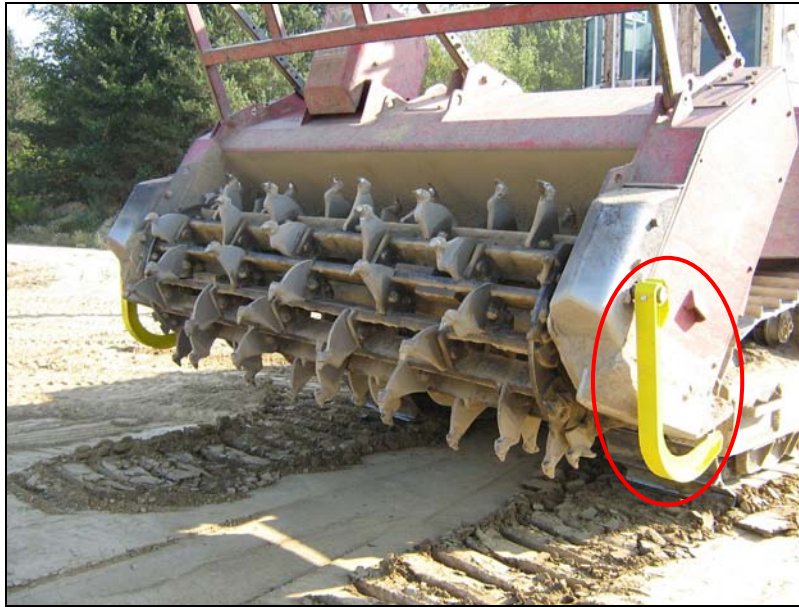
**Figure 25.** Automatic Depth Control Hardware

With the automatic depth control system, the tiller head is kept at a relatively constant height with respect to the original ground surface. The small skis outboard and on each side of the tiller head shown in Figure 25 provide a ground height signal to control depth of cut. The control system proved effective at eliminating the sinusoidal pattern of the ground resulting from manually controlling tiller depth. This system was not tested in undulating terrain but is presumed to be effective for the reasons discussed above.

Clearly the depth control skis are quite open and may be exposed to damage from vegetation and blast in their current configuration. As a result, MKA reported that they do not routinely employ them. The incorporation of some sort of protection, particularly from vegetation from the front and side would probably help to alleviate this problem.

The depth control on the MineWolf appears to be effective *when used*. Additional effort should be placed on making the depth control system sufficiently rugged that the user (MKA Demining in this case) does not remove it due to frequent damage.

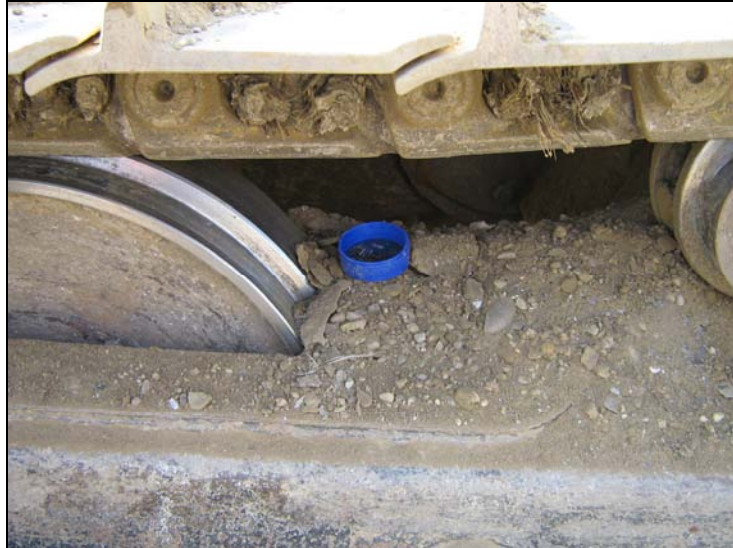
*Figure 26. Debris Collects Around Tracks*

The track of the MineWolf causes concern with respect to trapping potentially hazardous debris. Figure 26 shows the area under the track where one of the targets was found after a trial. Although this target had been neutralised, it is not difficult to imagine a situation where this could have been a hazardous piece of UXO or a live mine as not all of the targets were neutralised or triggered by the tiller. Modifying the profile of the structural members within the track system may help to eliminate this problem.

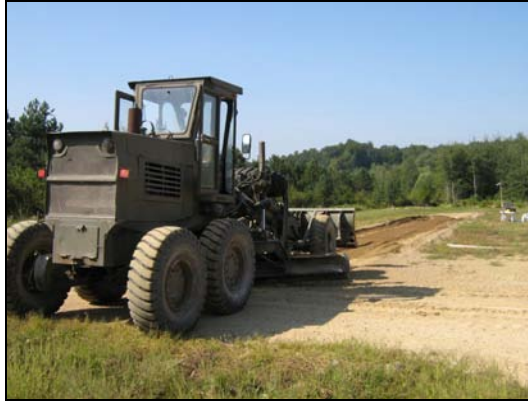
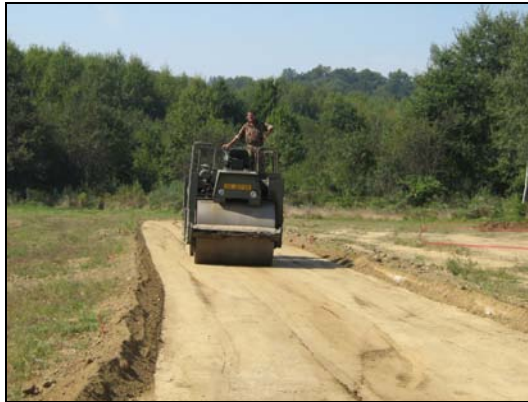
**Figure A-1.** *Soil Preparation – Grading and Compacting The Soil*

The soil in each test lane was prepared as follows. Prior to a test the soil was loosened with a piece of ground engaging equipment, such as the flail or tiller under test. The soil was then levelled using a grader and compacted using the vibratory compacter as shown in Figure A-1. The soil compaction and moisture content were monitored to ensure consistent test conditions.

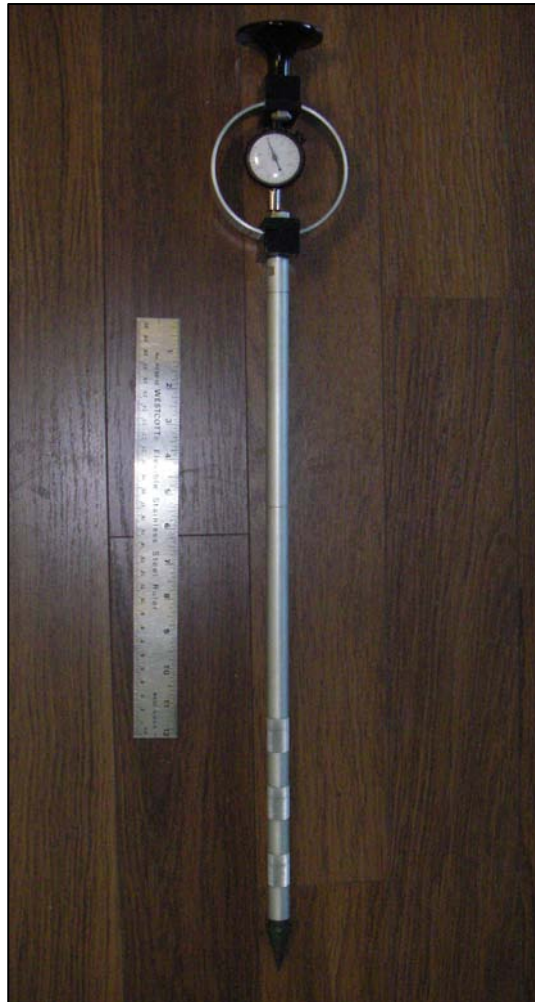
**Figure A-2.** *Soil Cone Penetrometer*

The maintenance of consistent soil conditions for each passage of the machine was critical to ensure that useful test data was collected. During the soil preparation operations, a cone penetrometer was used to determine the consistency of the soil. An example of a cone penetrometer is shown in Figure A-2. Cone index readings in excess of approximately 100 psi were considered acceptable to proceed with the trial as soil conditions with lower cone index readings would not be trafficable by a significant number of vehicles. Excessively low cone index readings generally occurred when the moisture content of the soil was very high; these test areas were left to dry until higher cone index readings were obtained.

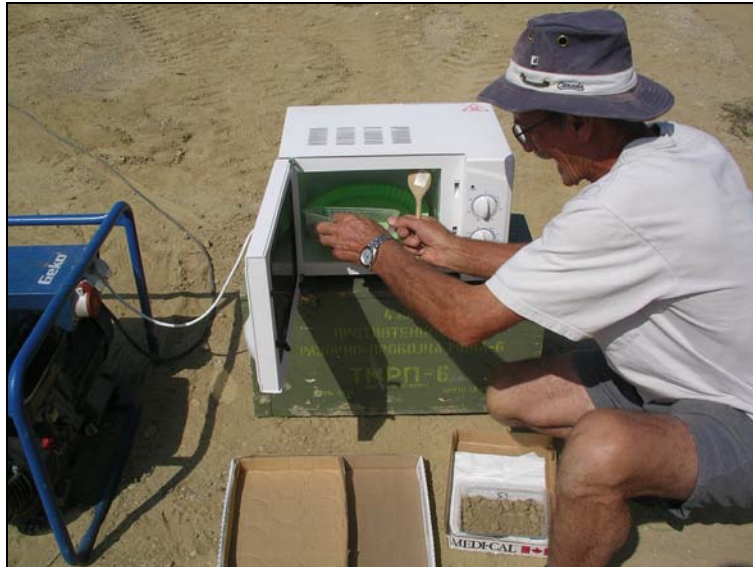
**Figure A-3.** Soil Drying Using a Microwave

Compaction and moisture content were measured using manual methods described in Annex C. Photographs of the soil drying are shown in Figure A-3. For each test lane, three samples were taken.

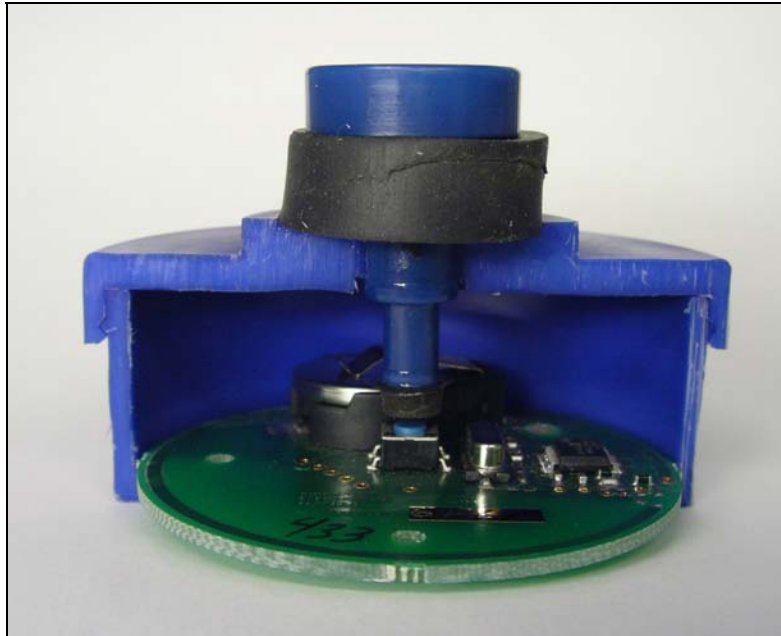
**Figure A-4** Cut-away View of WORM Test Target

During the machine trial, signals from the triggered WORMs were recorded on the computer. Following the completion of that test lane by the machine, it was then necessary to recover the test targets. The key recovery priority was test targets from which no radio frequency signal was received. These targets were examined for further categorization.

Test targets that were mechanically damaged to the point of being non-functional were recorded as mechanically neutralised. Test targets that were damaged but still functional were recorded as live damaged. Occasionally, examination of the recovered target indicated that the target should have initiated based on damage to the switch or plunger, but no signal was received. These targets were recorded as neutralised. Test targets that were recovered intact, with no damage and from which no signal was received, were considered live.

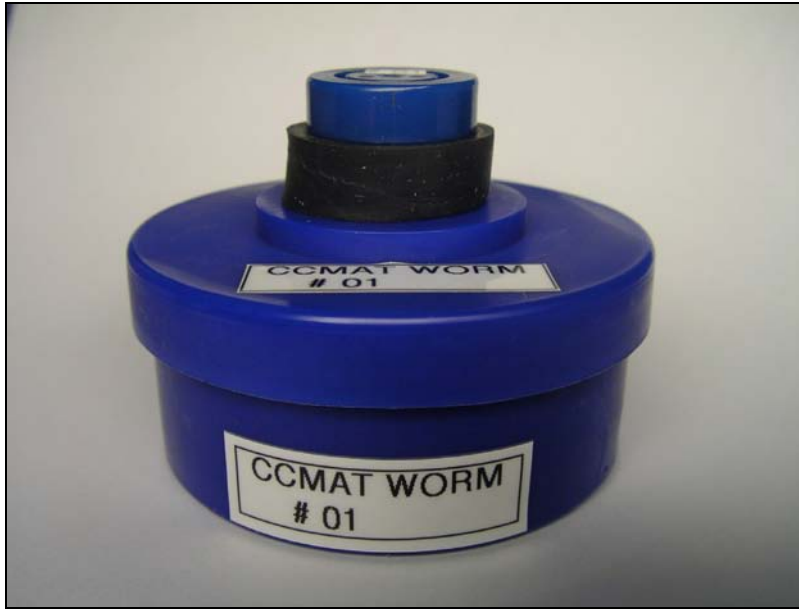
*Figure A-5. WORM Antipersonnel Mine Surrogate*

CCMAT has developed a type of target called the Wirelessly Operated Reproduction Mine (WORM) that was used for these trials. Additional detail on these test targets is provided in Annex A. These test targets were evaluated based on four categories; ‘live,’ ‘live damaged,’ ‘mechanically neutralised,’ and ‘triggered.’

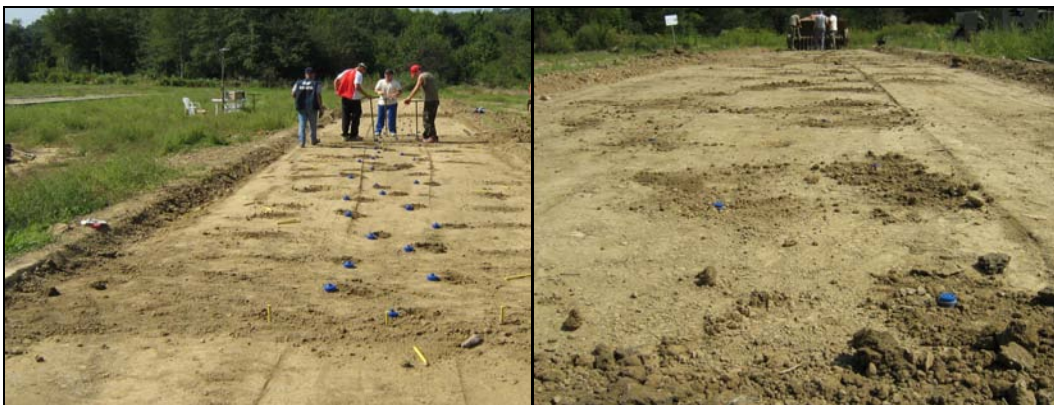
*Figure A-6. WORM Test Lane Layout*

The targets were located approximately 0.5m apart to minimize the possibility of more than one target triggering at once. They were laid in a path whose width was approximately 50% of the width of the machine working tool. In other words, a machine with a 2 metre wide tool would have targets spread approximately 0.5m on either side of the machine centreline, for a total path width of 1 metre. The layout of the test targets is shown in Figure A-6.

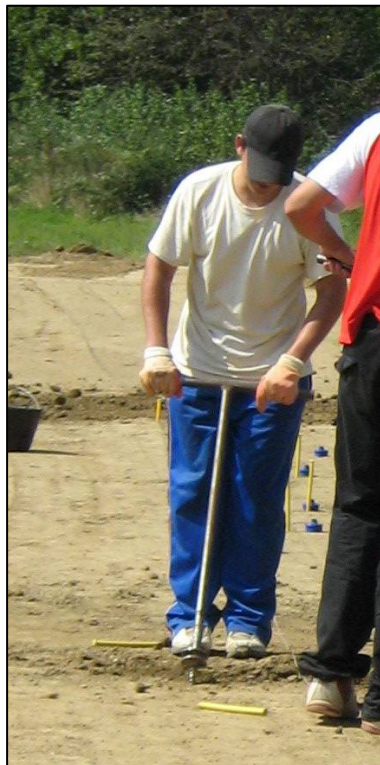
**Figure A-8.** Mine Target Burial Tool To Minimize Soil Disturbance

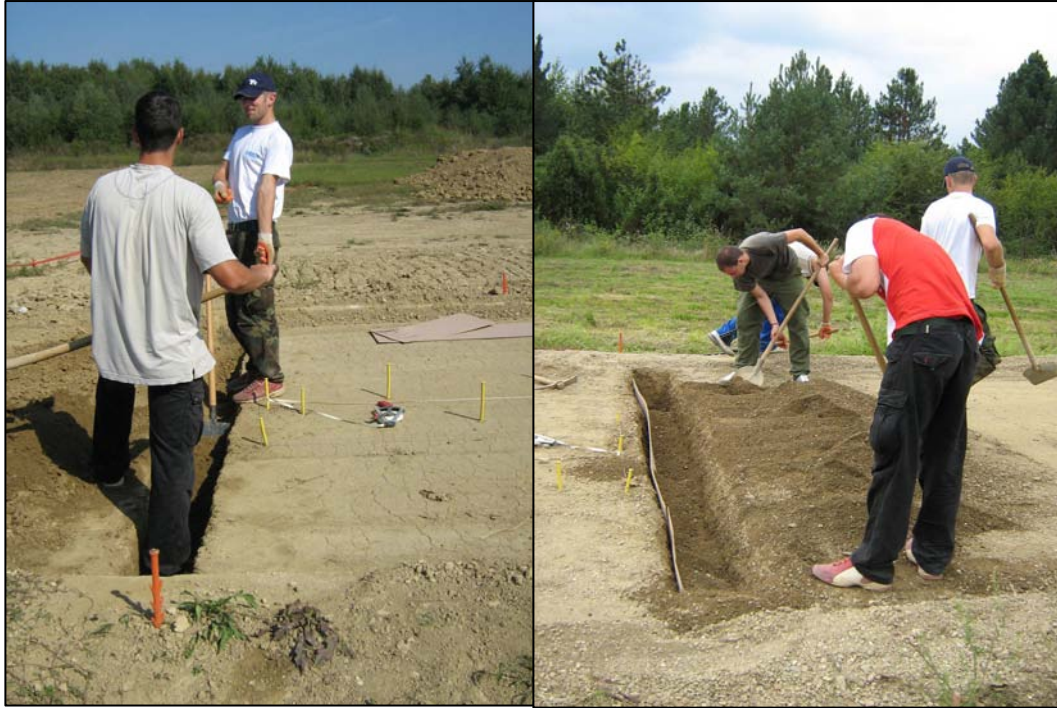
**Figure A-10. Witness Board Installation**

Along with the mine targets, witness boards were installed at three locations across each lane. At the 0, 12.5m and 25 m point of each test lane, 0.3cm thick, 40cm tall fibreboards were installed across the full width of the tiller head. The witness panels were buried flush with the surface of the ground as shown in Figure A-10, in order to record the consistency of penetration of the tiller across the width of the machine.

A narrow trench was dug by hand across the width of the test area to accommodate the witness boards. The width of the trench was kept to a minimum to reduce the effects of the softer replacement soil on tiller penetration. The fiberboard was placed against the side of the trench nearest the start line of the machine. This technique reduces the chances of the witness board being removed by the tool rather than simply cutting into it. Figure A-10 illustrates a trench being dug.

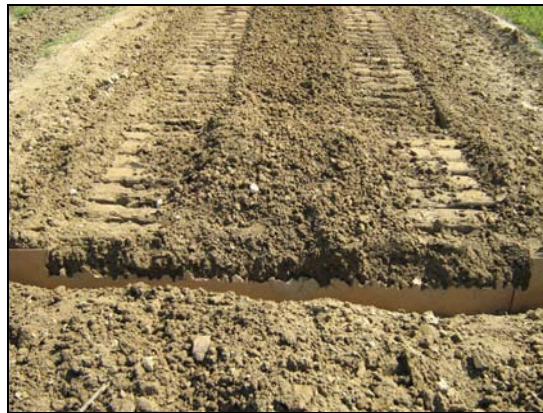
**Figure A-11. Witness Board Partially Excavated**

The witness board was buried flush with the surface, acting as a witness panel to record the depth of penetration of the tool. A photograph of a partially excavated witness board is shown in Figure A-11. No direct indication of the force or neutralisation effectiveness of the tool at any depth is provided, however a clear indication of the consistency of soil cutting is provided. This indicator is obviously only useful for soil penetrating machines such as flails and tillers and cannot be used for low-disturbance tools such as rollers.

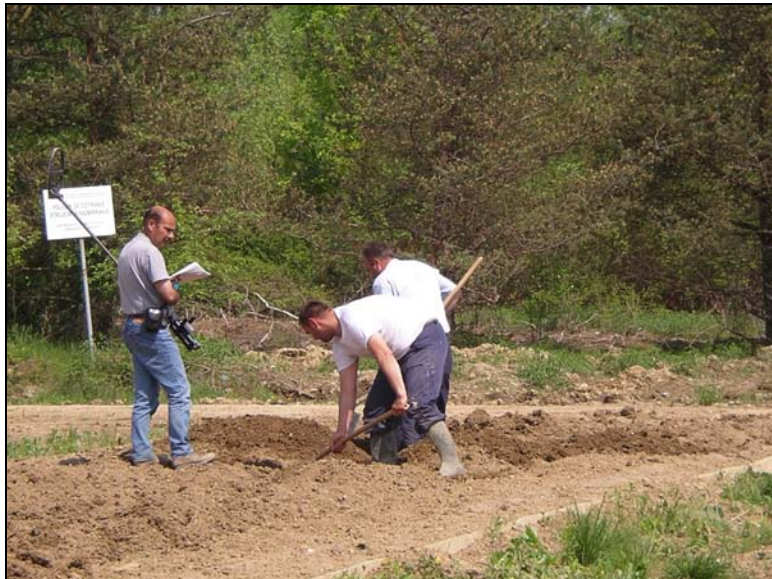
**Figure A-12.** *Locating Test Targets After Passage of the Machine*

After the passage of the machine through the test area, the computer recording of WORM trigger signals was stopped. The test lane was examined and visible test targets removed. The computer operator began developing a table of data, such as those shown at Annex D. Recovered test targets were examined to establish status. Other personnel continued to recover test targets using a metal detector to locate them. Once the target recovery team had been through the test lane once, the computer operator noted the targets from which no signal had been received and no status determined. Special attention was given to recovering these targets.
