**FINAL REPORT
DECEMBER 2007**

REPORT NO. 06-25

**TRANSPORTABILITY TESTING OF THE MARINE CORPS
LOGISTICS VEHICLE SYSTEM REPLACEMENT (LVSR)
TP-94-01, REV. 2, JUNE 2004,
“TRANSPORTABILITY TESTING PROCEDURES”**

**DEFENSE AMMUNITION CENTER
VALIDATION ENGINEERING DIVISION
MCALESTER, OKLAHOMA 74501-9053**

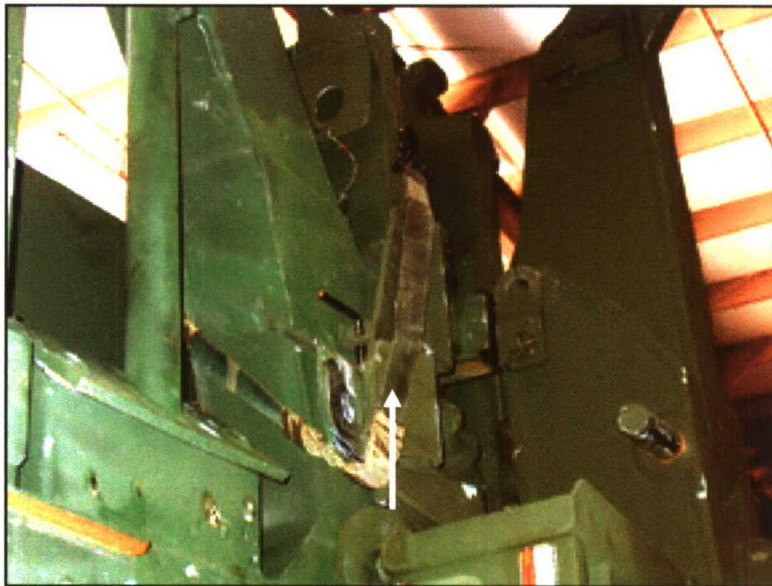
3. When loading/unloading the flatrack, the winch hook would catch on the flipper arms of the front lift adaptor (FLA). A strap was added to hold the flipper arms back.

Photo 3. Strap Holding Flipper Arms

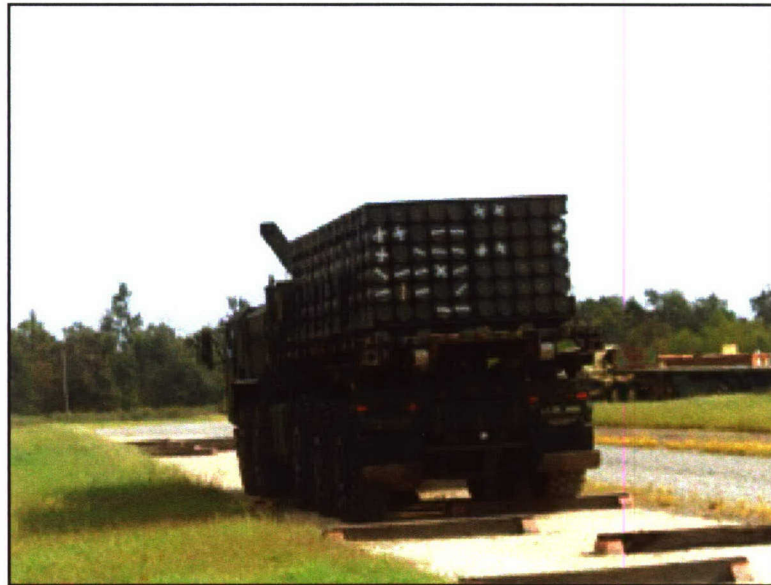
Photo 4. Hazard Course Testing of the LVSR

1. Figure 4 lists the average speeds of the test load through the Hazard Course.
2. Inspection following each pass did not reveal any damage to the payload, flatrack, or LVSR.

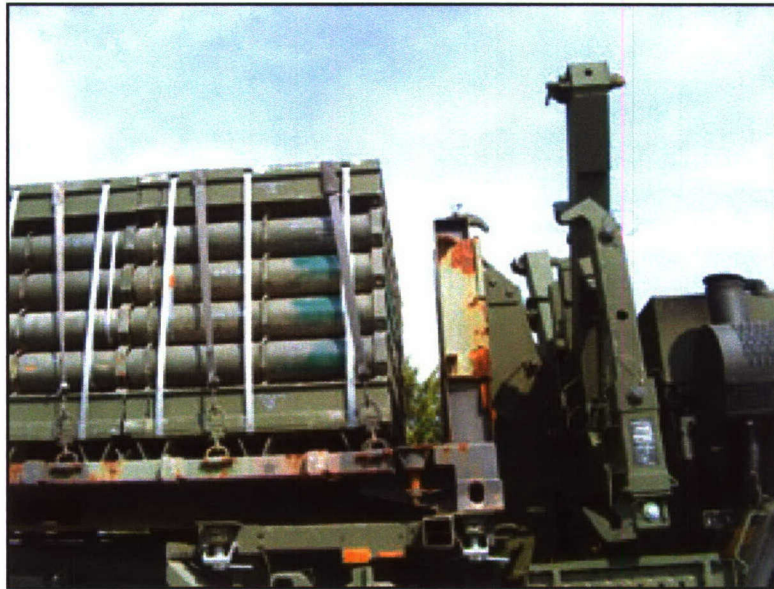
4. During the reverse Panic Stops, the payload moved excessively and the rear pallet posts were damaged and web straps failed when secured in accordance with AMC Drawing 19-48 4903. Different strapping configurations were follow-on tested, and the strapping configuration used on

10/10/2007 was minimally adequate to properly restrain the ammunition payload. See Photos 5 and 10 for ammunition movement and Photos 6, 11, and 14 for strap failures and pallet damage.

1. The Panic Stops were conducted during the Road Trip.
2. Prior to the start of the Panic Stops, the “check fluids” light came on and diagnostics showed that the transfer case fluid was low. One (1) quart of fluid was added to the transfer case using the onboard system. Also the “check filters” light came on prior to adding the fluid to the transfer case. Once the vehicle was restarted, the “check filters” light was no longer illuminated.
3. Following the forward 5 MPH Panic Stop, the flatrack moved in the direction of the stop 1-inch.
4. Following the reverse 5 MPH Panic Stop, the load shifted in the direction of the stop 9-inches. The pallet posts were damaged during the reverse Panic Stop. See Photo 5 for payload movement and Photo 6 for pallet post damage.
5. Official testing was stopped due to excessive movement of the payload and pallet damage.

Photo 5. Movement of Payload from Front Wall.

6. An additional forward Panic Stop was conducted and the straps were retightened.

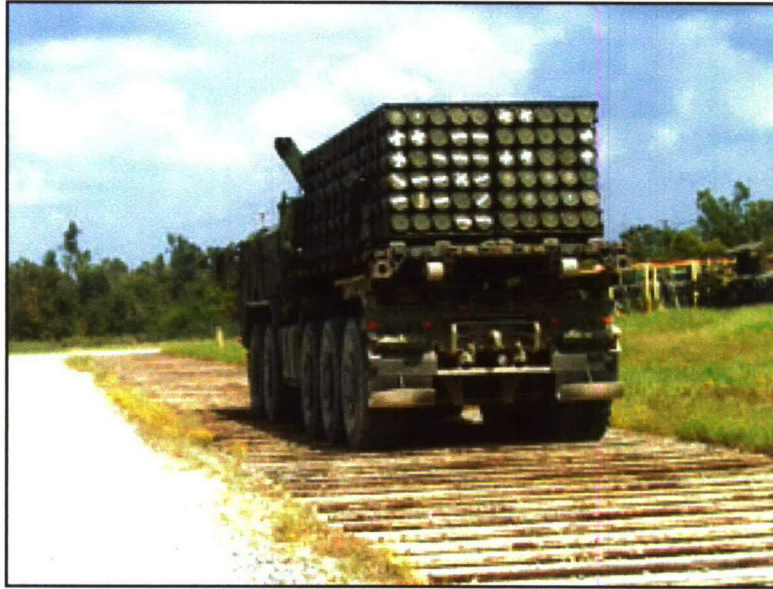
1. Inspection following the completion of the Washboard Course did not reveal any damage to the payload, flatrack, or LVSR. Inspection did reveal that the flatrack had moved forward 1-inch.
2. The rear slider pins were damaged during the unloading operation due to operator error.

Photo 7. Washboard Course Testing of the LVSR.

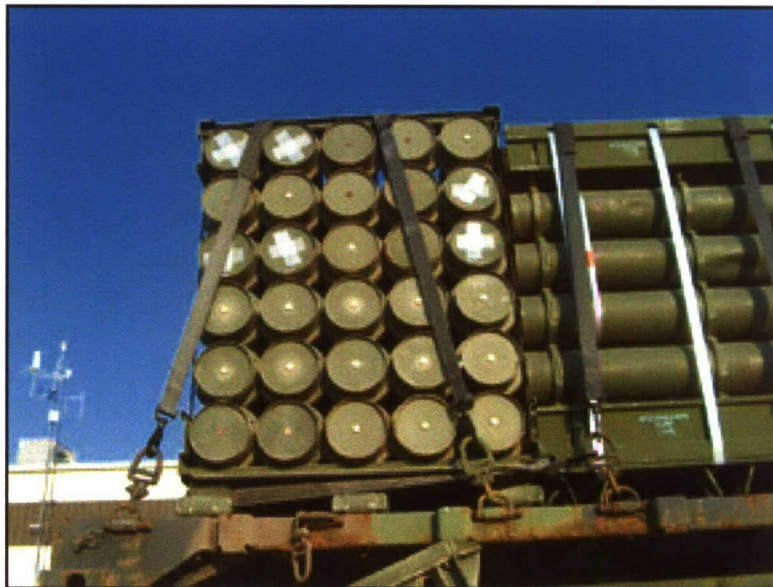
Note: The rear pallets of the test load were turned at 90 degrees from the previous tested orientation and strapped. See Photo 8.

Photo 8. Rotated Rear Pallets

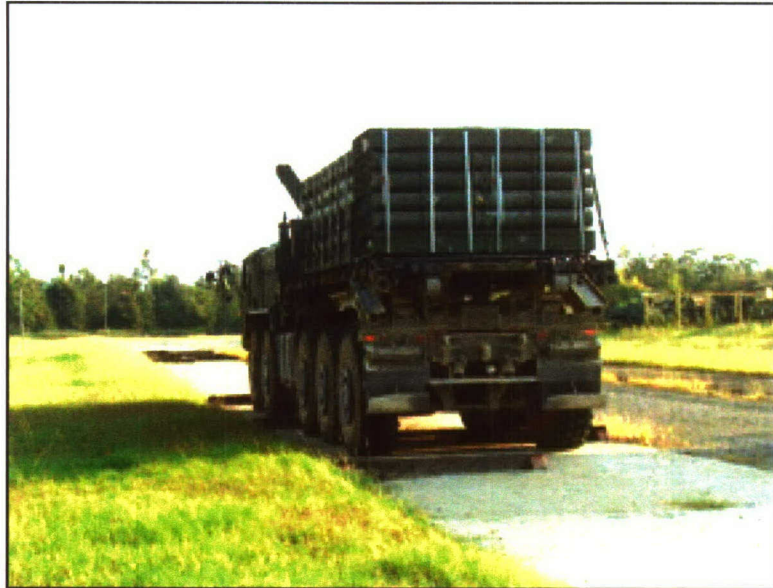
Photo 9. Hazard Course Testing of the LVSR

1. Figure 6 lists the average speeds of the test load through the Hazard Course.
2. Inspection following each pass did not reveal any damage to the payload, flatrack, or LVSR.
3. The M1077 flatrack moved side-to-side at the rear of the LVSR vehicle up to 1-inch during Passes #1 & #2.

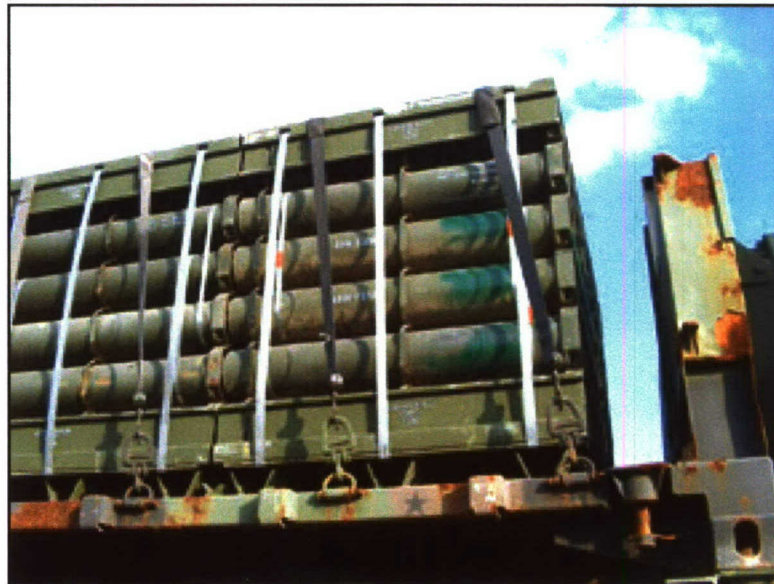
1. The Panic Stops were conducted during the Road Trip.
2. Following the reverse 5 MPH Panic Stop, the load shifted in the direction of the stop 10.5-inches and sheared the bottom strap. The rear pallet posts fatigued. See Photo 10 for payload movement and Photo 11 for sheared bottom strap.
3. Testing was stopped due to the excessive movement of the payload and the pallet damage.

Photo 10. Movement of Payload from Front Wall.

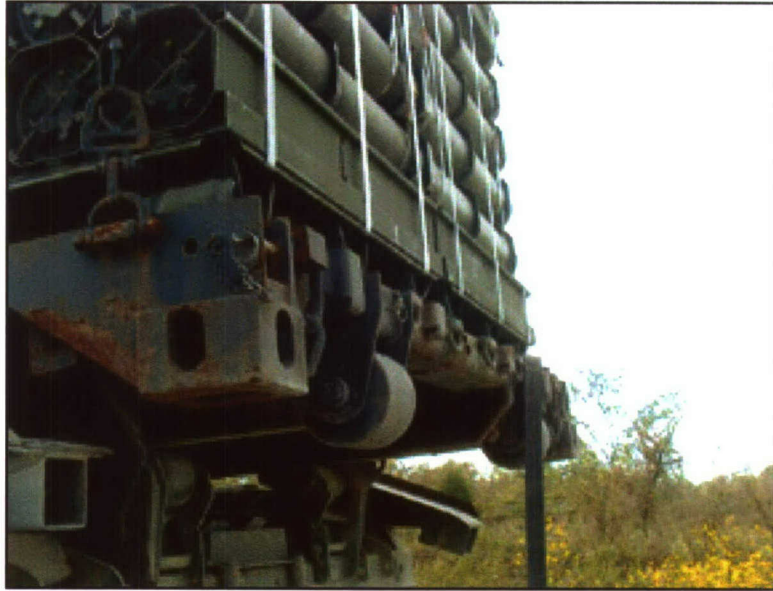
Photo 11. Sheared Bottom Strap.

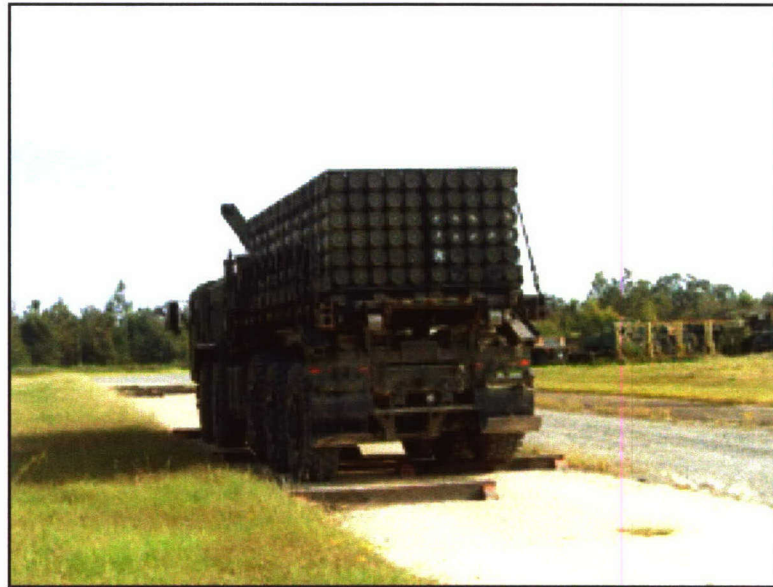
Photo 13. Hazard Course Testing of the LVSR

1. Figure 7 lists the average speeds of the test load through the Hazard Course.
2. Inspection following each pass did not reveal any damage to the payload, flatrack, or LVSR.
3. The M1077 flatrack moved side-to-side at the rear of the LVSR vehicle up to 1-inch during Passes #1 & #2.

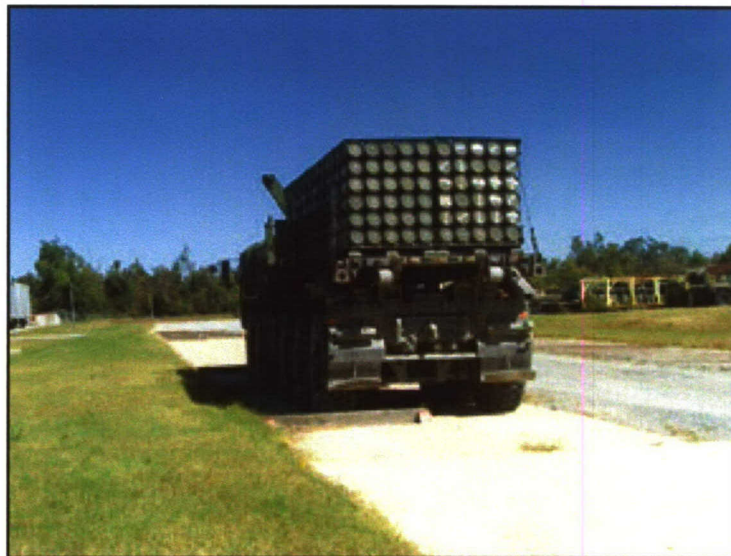
Photo 16. Hazard Course Testing of the LVSR.

1. Figure 8 lists the average speeds of the test load through the Hazard Course.
2. Inspection following each pass did not reveal any damage to the payload, flatrack, or LVSR.
3. The M1077 flatrack moved side-to-side at the rear of the LVSR vehicle up to 1-inch during Passes #1 & #2.

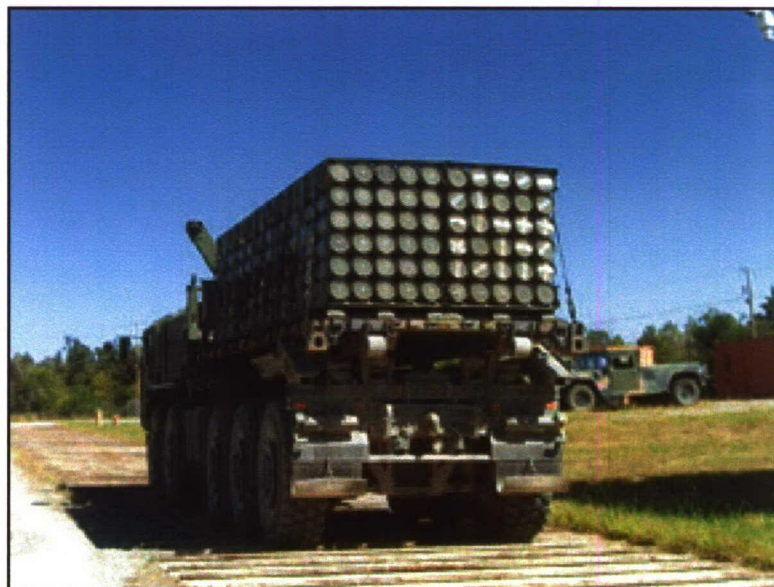
Remarks: Inspection following completion of the Washboard Course did not reveal any damage to the payload, flatrack, or LVSR.

Photo 17. Washboard Course Testing of the LVSR.

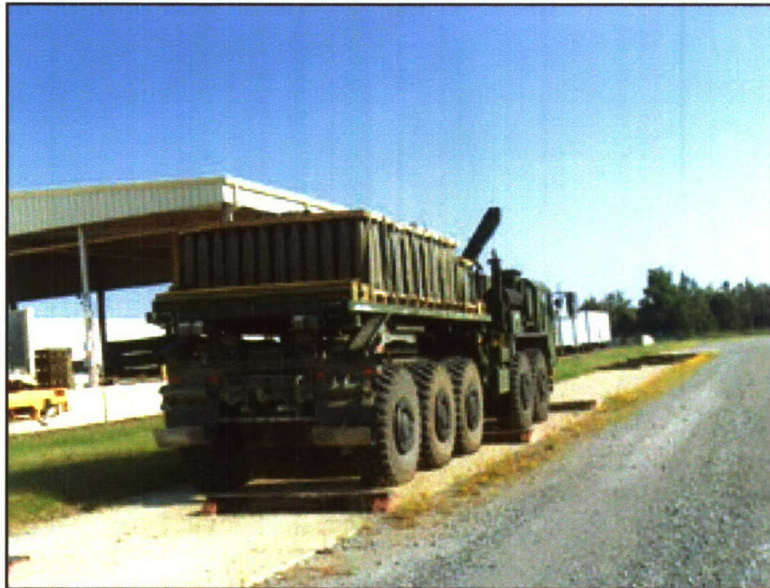
Photo 19. Hazard Course Testing of the LVSR

1. Figure 10 lists the average speeds of the test load through the Hazard Course.
2. Inspection following each pass did not reveal any damage to the payload, flatrack, or LVSR.
3. The CROP moved side-to-side at the rear of the LVSR vehicle up to 1-inch during Passes #1 & #2.

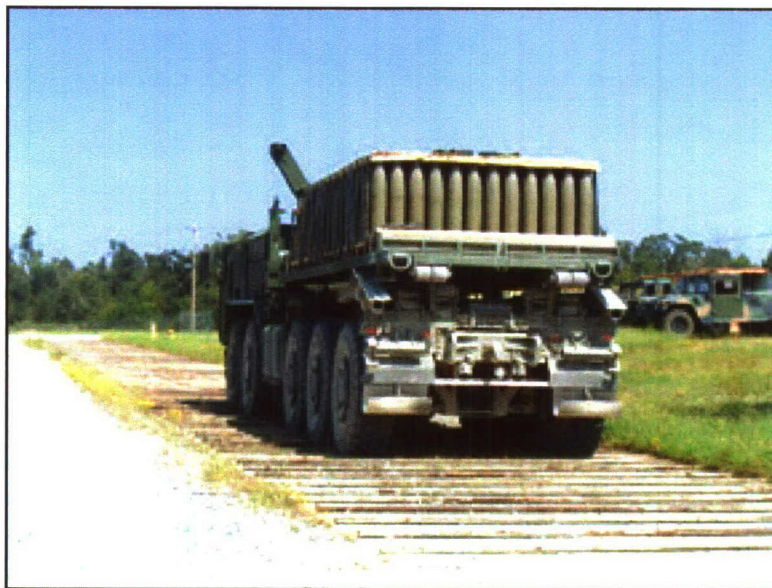
Remarks: Inspection following the completion of the Washboard Course did not reveal any damage to the payload, CROP, or LVSR.

Photo 20. Washboard Course Testing of the LVSR.

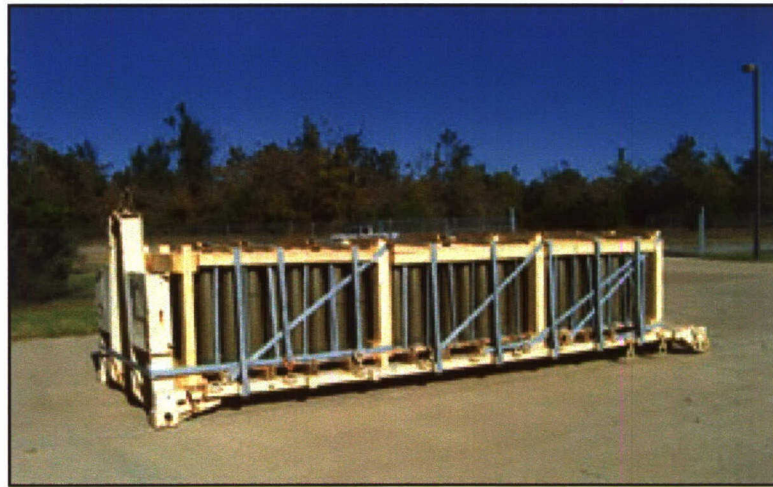
Photo 21. Flatrack Loaded with 155MM SLPs Secured with Steel Banding.

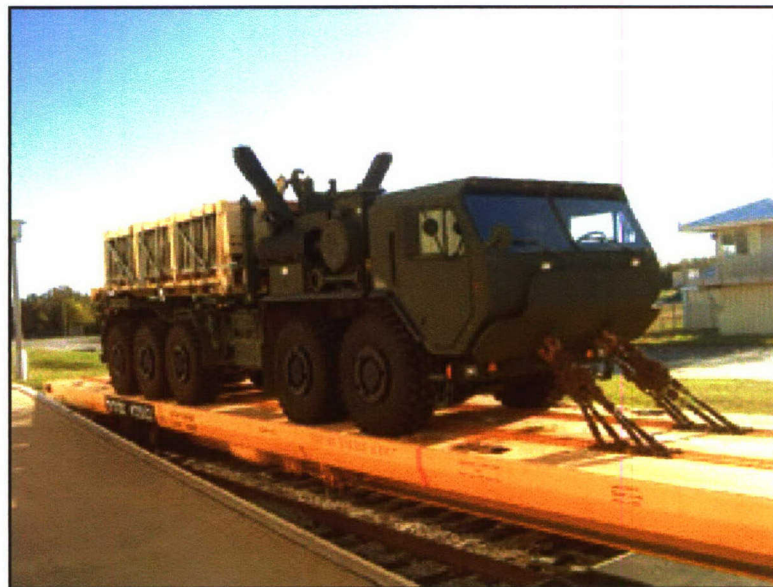
Photo 22. Rail Impact Testing of the LVSR (Prior to Testing).

4. Following Impact #4, the flatrack moved 1-1.25 inches in the direction of impact. The payload moved 0.5 inches in the direction of impact.
5. Inspection following each impact did not reveal any damage to the payload, flatrack, tiedowns, or LVSR.

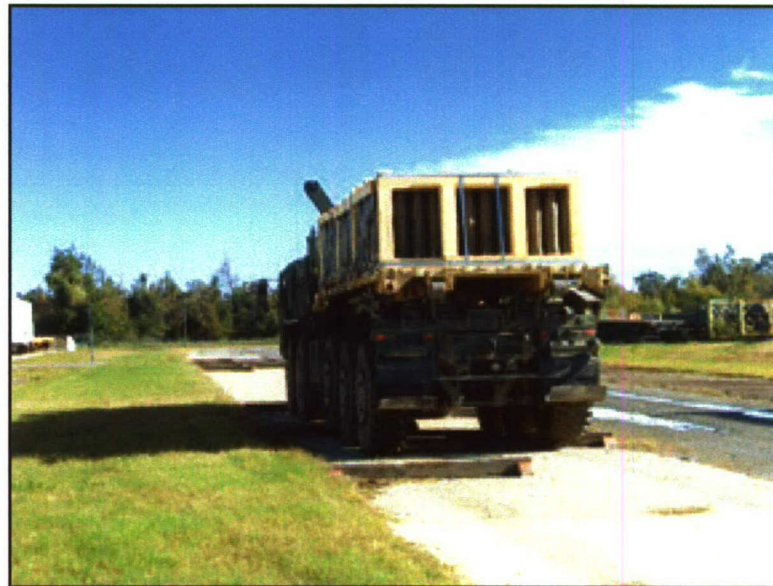
Photo 23. Hazard Course Testing of the LVSR.

1. Figure 14 lists the average speeds of the test load through the Hazard Course.
2. The flatrack moved side-to-side at the rear of the LVSR vehicle up to 1-inch during Passes 1 & 2.
3. Inspection following each pass did not reveal any damage to the payload, flatrack, or LVSR.

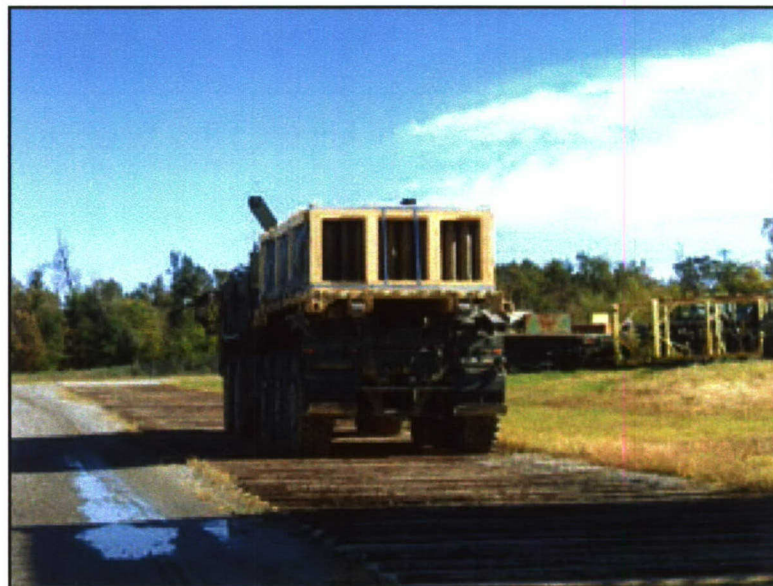
Remarks: Inspection following completion of the course did not reveal any damage to the payload, flatrack, or LVSR.

Photo 24. Washboard Course Testing of the LVSR

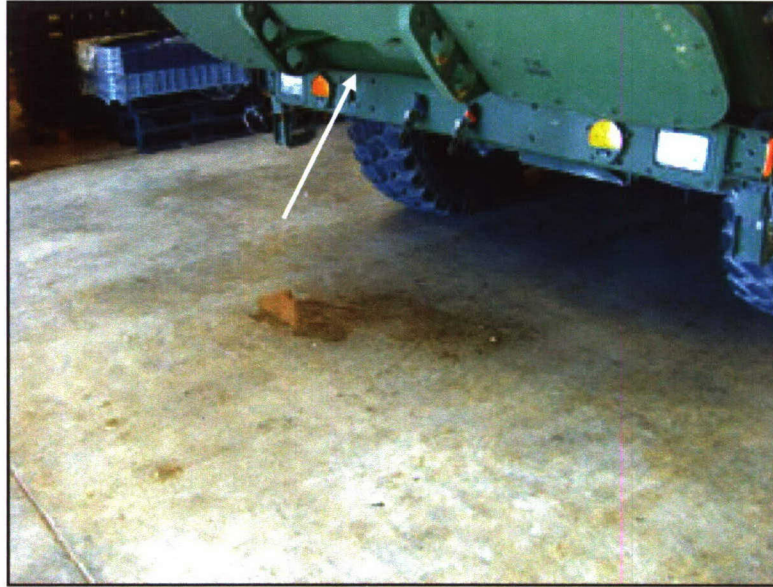
- c. Throughout testing the vehicle leaked fluid from around the center of the front bumper. (See Photo 26). The center console was removed and the hoses and clamps were inspected. The blue hose in the center console was wet with fluid. The hose clamp was tightened and re-inspected with no additional leakage noted. Prior to and upon completion of testing, water was added to the coolant system.

3. Throughout testing, the vehicle leaked fluid from around the center of the front bumper. (See Photo 26). The center console was removed and the hoses and clamps were inspected. The blue hose in the center console was wet. The hose clamp was tightened and re-inspected and no additional leakage noted. Prior to and upon completion of testing water was added to the coolant system.

Photo 26. Coolant Leakage Point.
