# **MDA Ice Detection and Measurement Camera Development and Validation for NASA-KSC (2004-2007)**

## **Final Report**

Visual Perception Laboratory  
US Army TARDEC  
6501 East Eleven Mile Rd.  
AMSRD-TAR-R, MS 263  
Warren, MI  
48397-5000

August 17, 2007

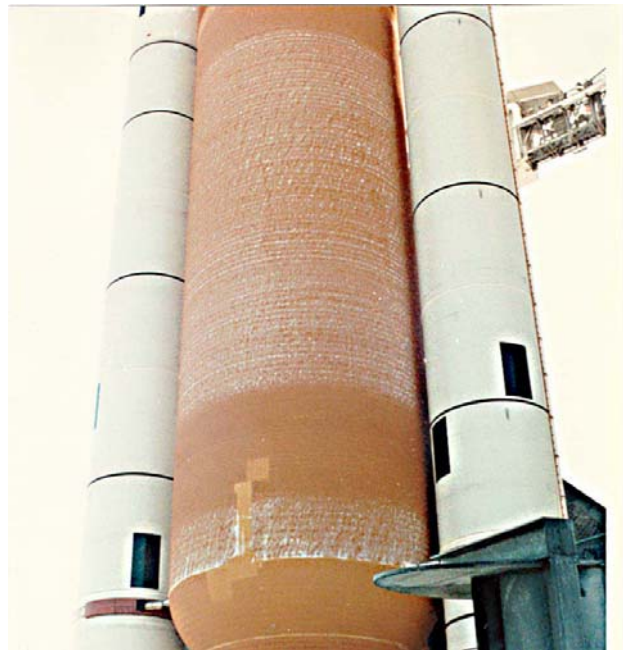
**Figure 1. Ice/frost formed on an ET**

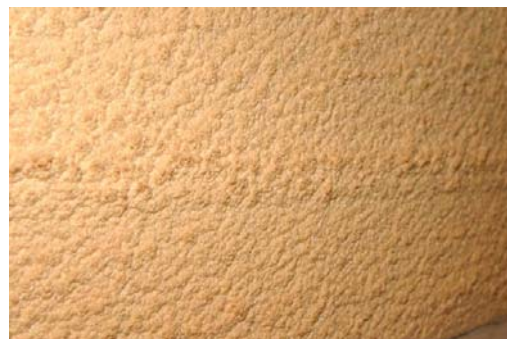
**Figure 4. A section of ET SOFI showing its roughness**

It should be noted that the ET foam’s external surface (the exposed side away from the ET metal structure) is convoluted (in this case “bumpy” with foam peaks and valleys). See Figure 4. Actual SOFI has the same texture as the test samples. For this reason, for this first series of tests, ice thickness values were averaged using measurements taken from near the four corners and from the center of the samples. Unfortunately and critical to this investigation, the variance in the height of ET foam surface “bumps” is of the same order of magnitude as the LCC ice thickness limitation—1/16th (0.0625) of an inch.

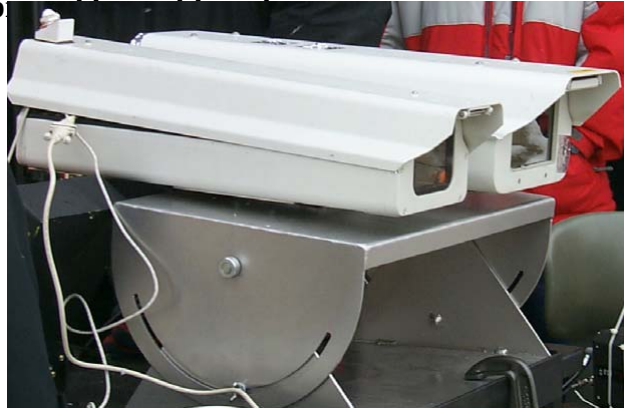
**Figure 5. Concept MDA test system with enclosed IR sensor and video camera**

density ice (i.e.  $< 37 \text{ lb/ft}^3$ ), one of the last snowfalls of the Warren winter occurred in March 2004 and the week before a planned MDA second test period. In anticipation of the need for low-density ice samples for the tests, a container was placed outside the VPL and snow collected. For several samples, collected snow was applied by hand to ET foam surfaces. For other tests, collected snow was applied to various surface shapes for low density simulated ice testing. Figure 5 pictures the concept MDA ice camera. This early version consists of enclosures for an IR sensor and a video camera.

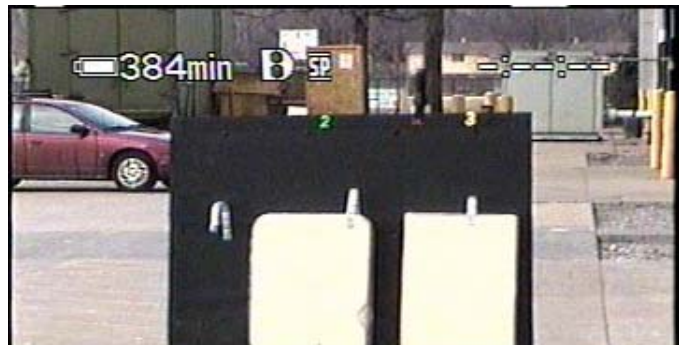
**Figure 9. Iced SOFI samples shown supported on an easel for measurement**

For imaging with the ice camera, some SOFI samples were placed on a plywood board and easel. The board and associated metal brackets were painted black to reduce

any background noise. See Figure 9. Hooks were attached to some samples for hanging on the board, and a 1-5/8 in. ledge at the bottom of the board held others up. Large samples were set on the ledge and attached to the top with flexible metal straps. Since the MDA camera works in the IR, normally visible labels would be invisible. Plastic refrigerator magnet numbers/letters were hung near each sample as they were imaged for identification later in video recording.

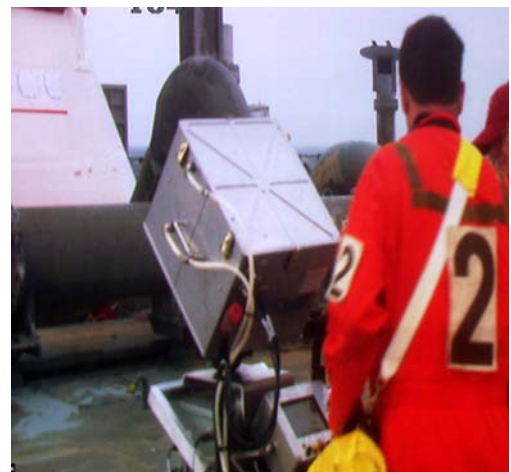
**Figure 13. Ice camera on launch pad being used in support of STS-116**

The modified prototype ice camera was shipped to KSC for support of STS-116 T-3 hour inspections and operated by NASA engineer Bob Speece—once for a launch attempt on December 7, 2006 and again for the successful launch on December 9, 2006. See Figure 13. NASA representatives indicated that during the second launch countdown, there were high winds up to 35 knots in the area. Wind at that speed restricted ET ice acreage formation by reducing condensation on the ET. However, two hours prior to launch the wind died down to acceptable levels, and the MDA was taken to the pad.

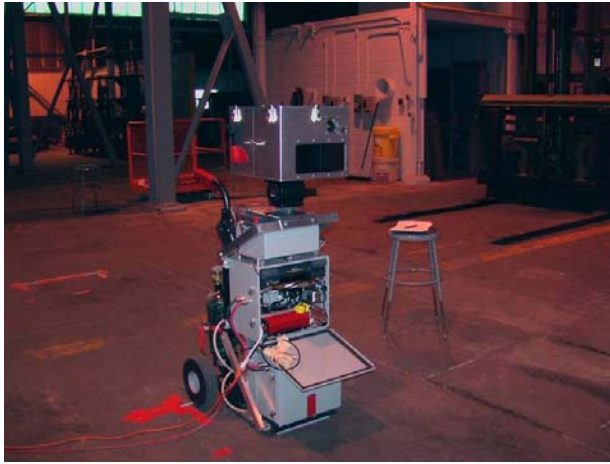
**Figure 16. Supply Dewar, ice covered SOFI target ice with a Kaman measurement grid, and Wagner water sprayer**

Figure 15 is another view of the MDA cart-mounted system with an open front panel. Figure 16 shows the ice covered SOFI sample with fish line grid references mounted on the CTC, a LN2 supply Dewar, and supporting test equipment including the Wagner paint sprayer that was used for controlled ice creation. Additional test panel pictures and information are contained in Appendix 6.

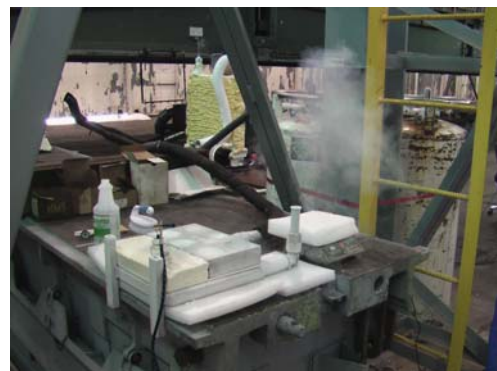
**Figure 18. Horizontal Dewar and ice molds**

The challenge was to create simulated ET thin shell ice balls consisting of a thin ice coating over a frost center. Thin shell molds having female and male half sections were fabricated at KSC and shipped to Selfridge. Visible in Figure 18 is a 12 in. x 12 in. Dewar on its back, with ice ball molds on top. Procedures were developed for ice ball creation and data collection, as was a Selfridge *Ice Ball Test Plan* dated 5/1/07 developed by NASA (Thomas Moss). (Reference Appendix 11 for the thin shell ice ball development procedure.)

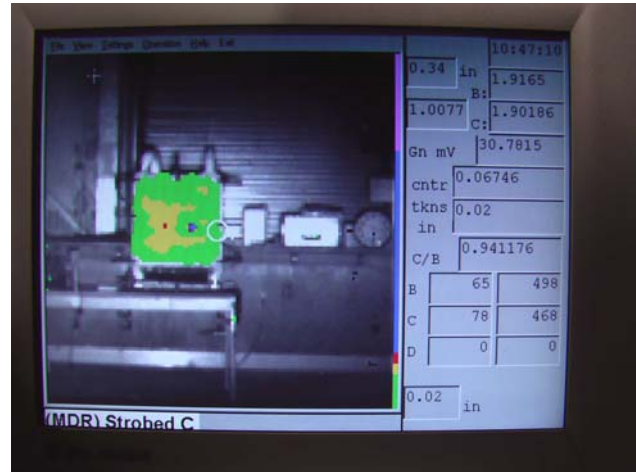
**Figure 19. Thin shell ice balls of 2 in. (in red) and 3 in. diameters (in blue) detected at 40 ft. and 90 degrees (left)**

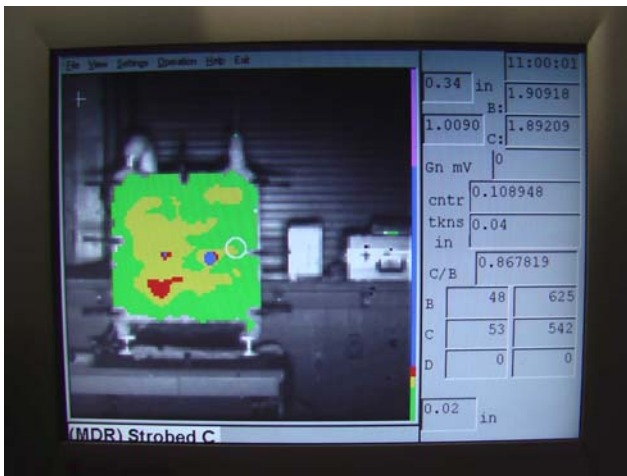
**Figure 20. Thin shell ice balls of 2 in. (in red) and 3 in. diameters (in blue) detected at 25 ft. and 90 degrees (right)**

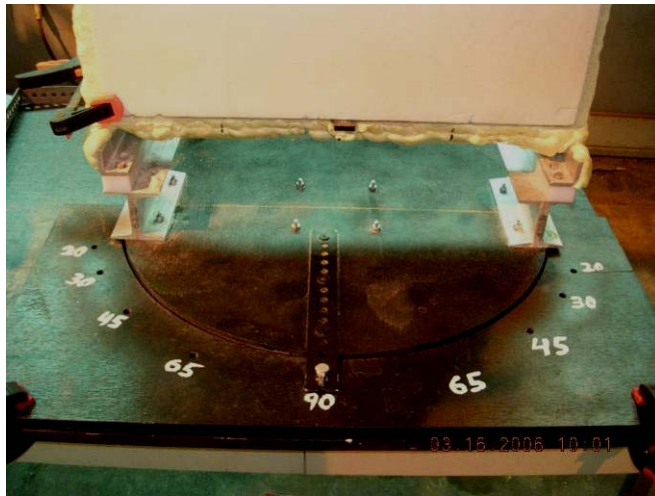
**Figure 6-4. Turntable with CTC mounted on top in 90-degree position**

new welded aluminium tangs were added on the top of the CTC for hanging the grid and these straps.

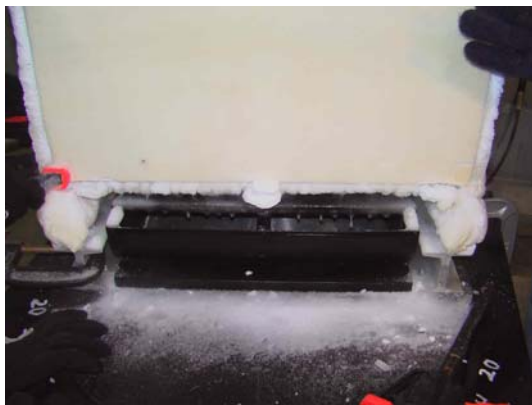
**Figure 6-5. Front view of fan assembly**

**Air convention fan:** designed to counteract thermal convection currents on the front of the sample panel to minimize density variations in the ice from top to bottom across the panel surface.

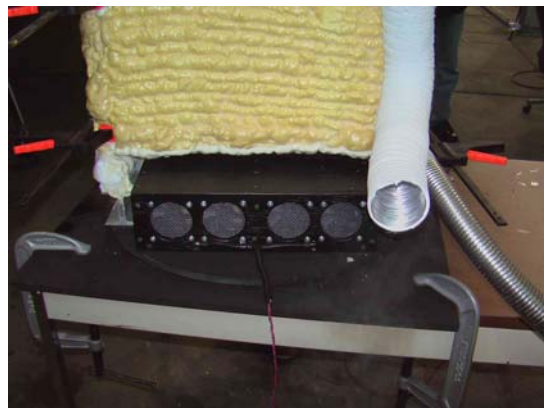
**Figure 6-6. Rear view of fan assembly**

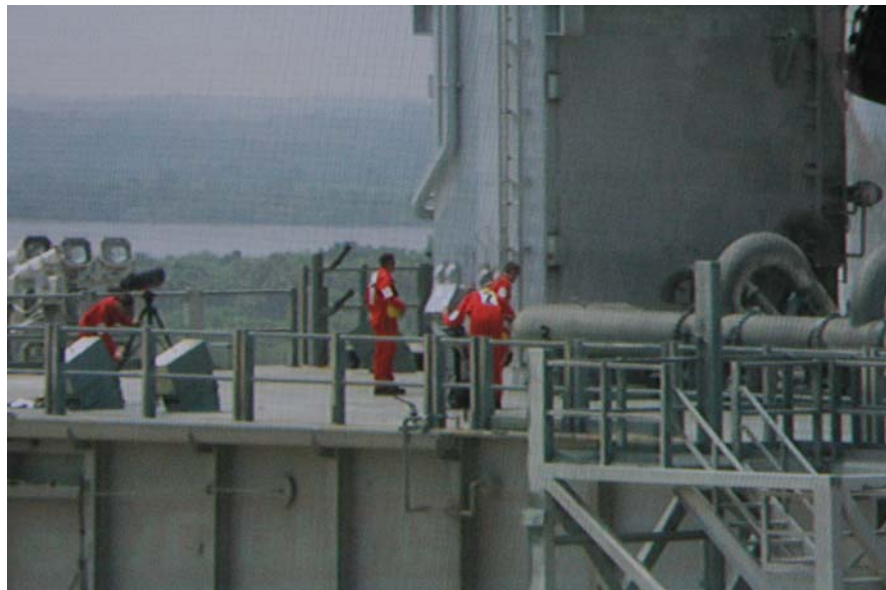
**Fig 17-2. The ice camera being used by the ice and debris team during the walk-down inspection**
