## Boat-Wave-Induced Bank Erosion on the Kenai River, Alaska

Stephen T. Maynard, David S. Biedenharn, Craig J. Fischenich,  
and Jon E. Zufelt

March 2008

Final report

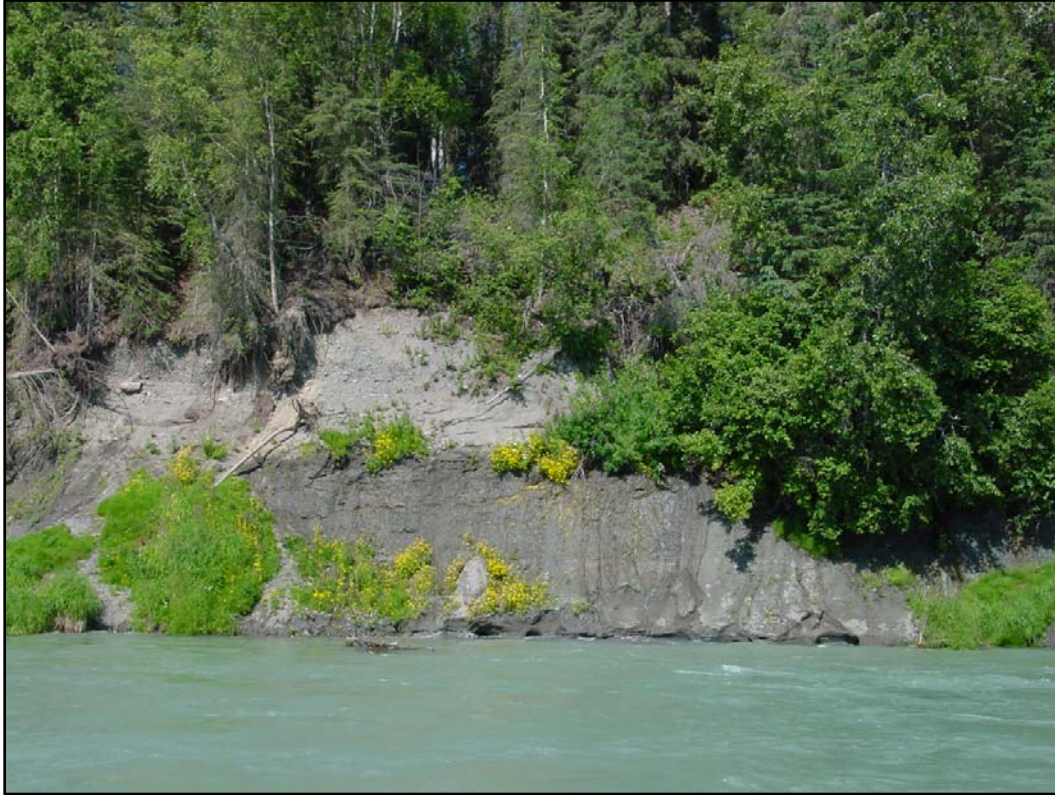
Figure 6. Typical failure of banks along the Kenai River includes loss of vegetative cover and increased erosion at water surface.

Bank erosion destroys important habitat in the riparian zone. Accelerated erosion rates have been observed along the Kenai River between Beaver Creek at RM 10 and the Soldotna Bridge at RM 21. Figure 6 shows an example of an eroded bank in this reach. A possible cause of this erosion has been attributed to increased boat traffic. In order to test the validity of

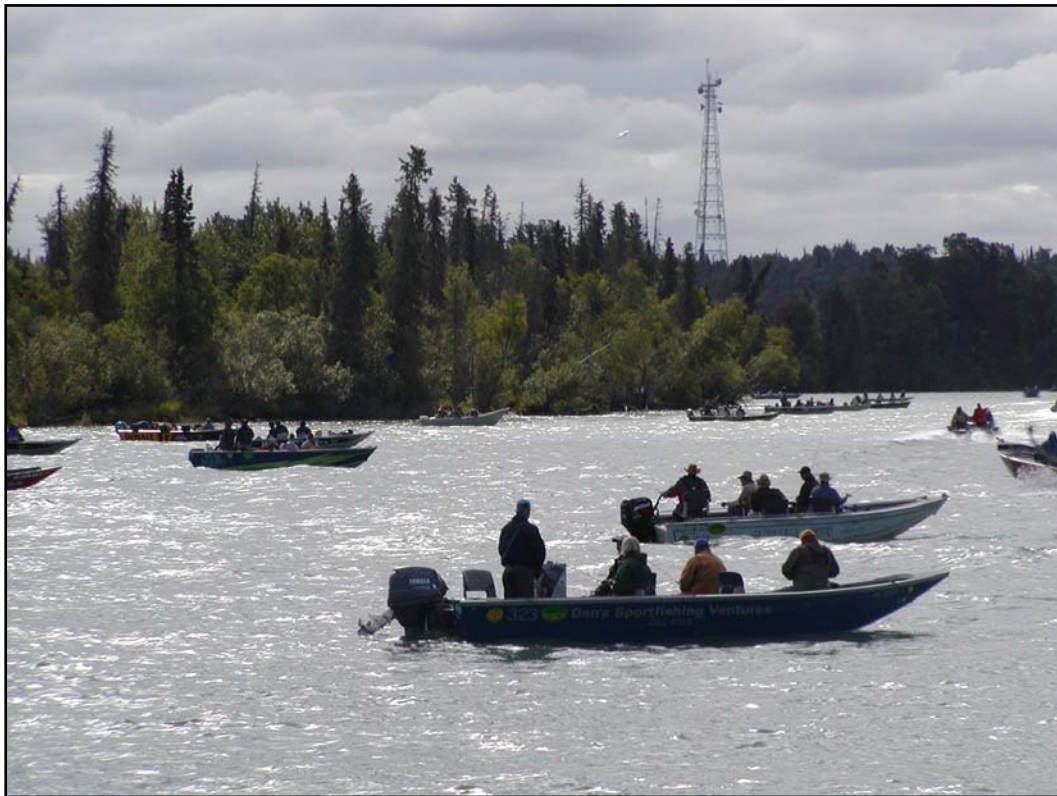
Figure 7. Kenai River, looking upstream from boat count and wave measurement site on right descending bank at RM 11.3. Picture shows the major drift area in the study reach. Boats generally drift down the right descending bank and motor up the left descending bank.

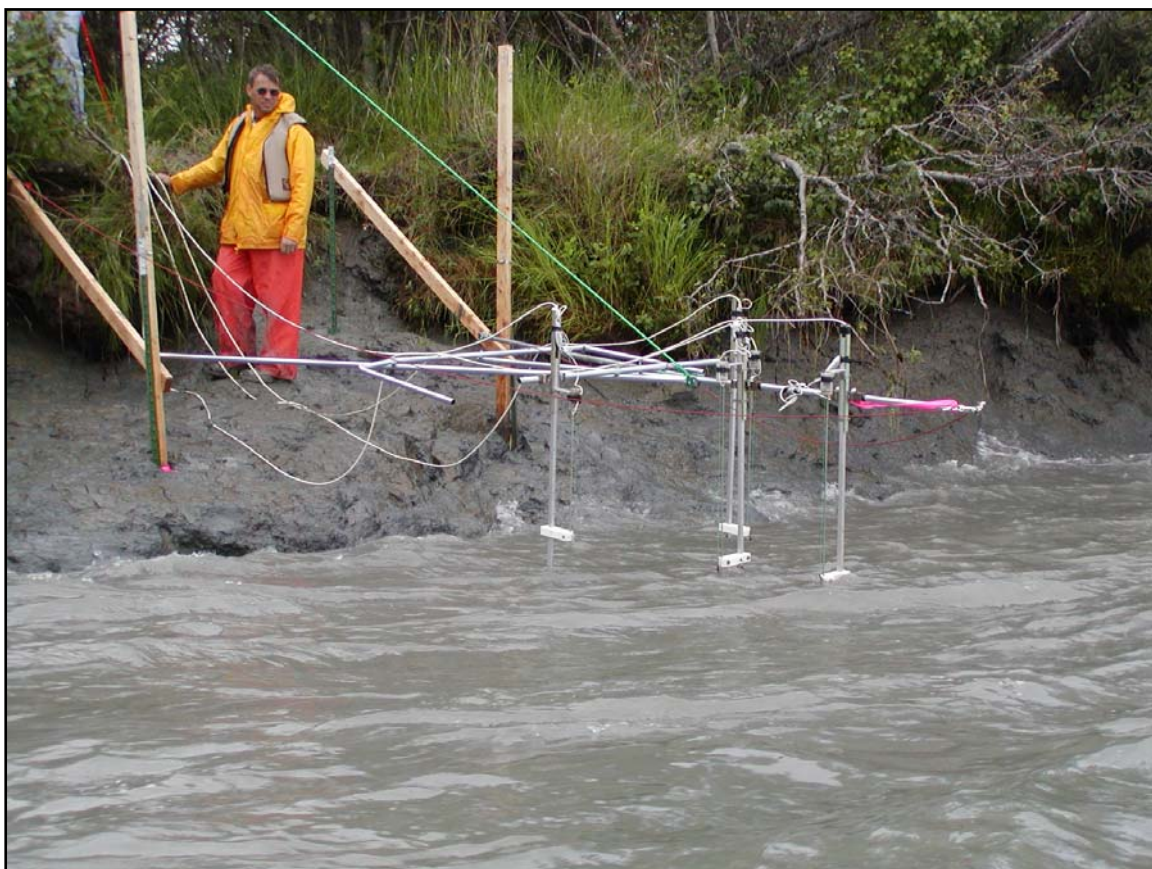
Figure 23. Wave stand supporting four wave rods used in wave measurements at RM 10.5. This site is on the left bank (looking downstream) about 0.5 mile upstream of Beaver Creek. Green rope used to raise and lower wave stand for installation, repair, and cleaning of gages as well as raising and lowering to deal with varying water level due to tides.

The wave measurements were conducted as described in Table 2. Two of the five sites were subject to up to 8.5 ft of tidal variation, which required that the gages be raised and lowered during the tidal cycle. The wave team developed a gage mounting stand that could be easily raised and lowered for gage installation, gage cleaning (because of aquatic vegetation), and to deal with the tidal variation. The stand is shown in Figure 23. Capacitance wire and capacitance rod type gages were used to measure waves for 4 days at five different sites.

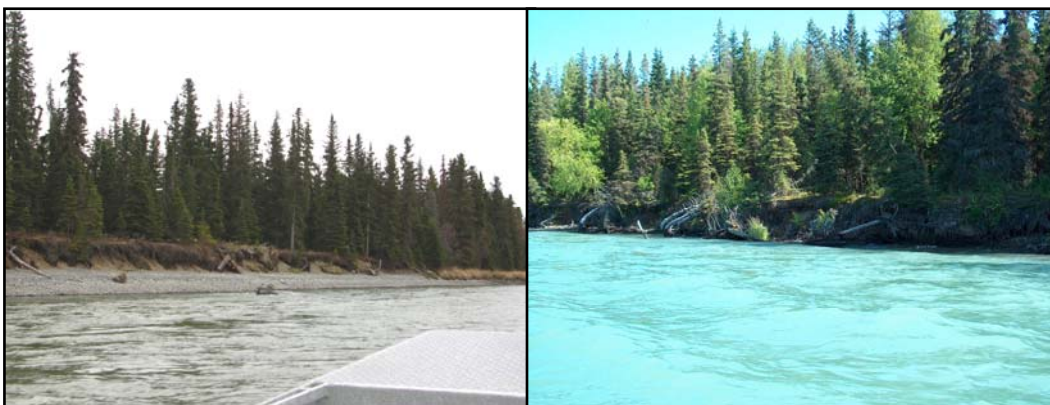
Figure 42. Stage at RM 13 (4 May 2005 and 22 July 2005).

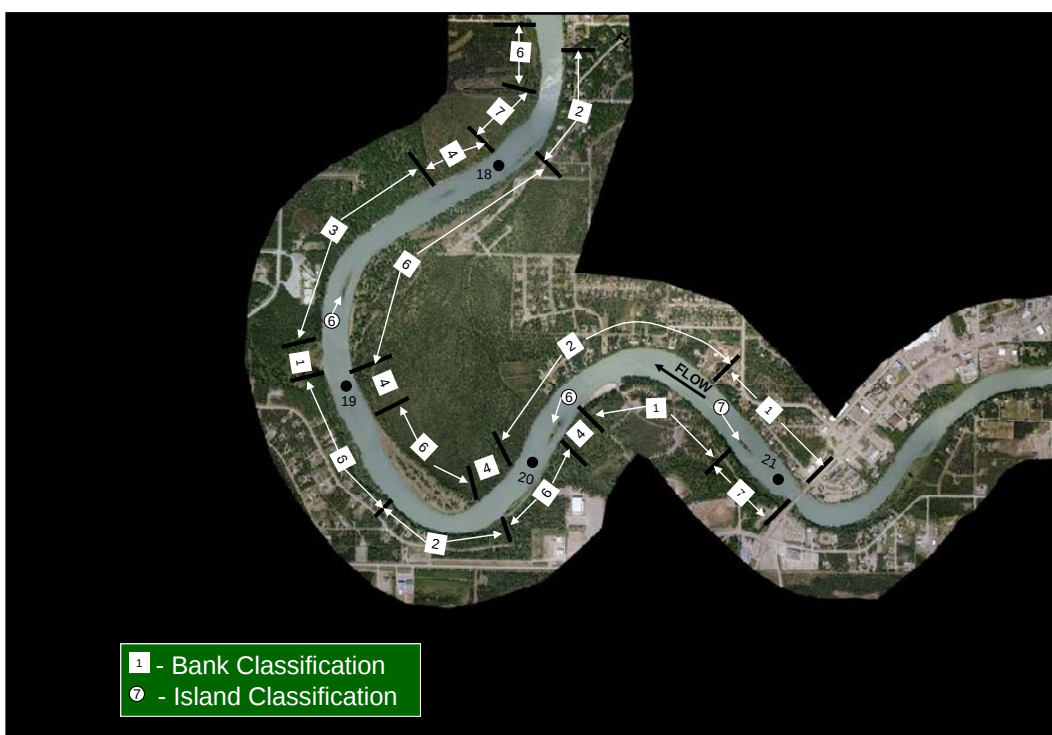
Figure 44. Bank and island classifications for approximate RM 21 to 17.5.

One component of the Kenai River study was to identify the various bank classifications along the study reach. The classification scheme developed by Fischenich (2004) was modified to include seven categories of banks. Bank classifications were assigned to both the right and left banks along the entire study reach and are shown in Table 13 and Figures 44–46. The limits for the bank classification reaches shown in Table 13 and Figures 44–46 reflect the dominant bank type for that reach. It should be noted that any reach may have short, localized areas that exhibit different bank characteristics than the reach as a whole. It is also important to recognize that a transition zone often exists between bank types, which makes it difficult to establish exact reach limits. The seven categories of banks are summarized below.

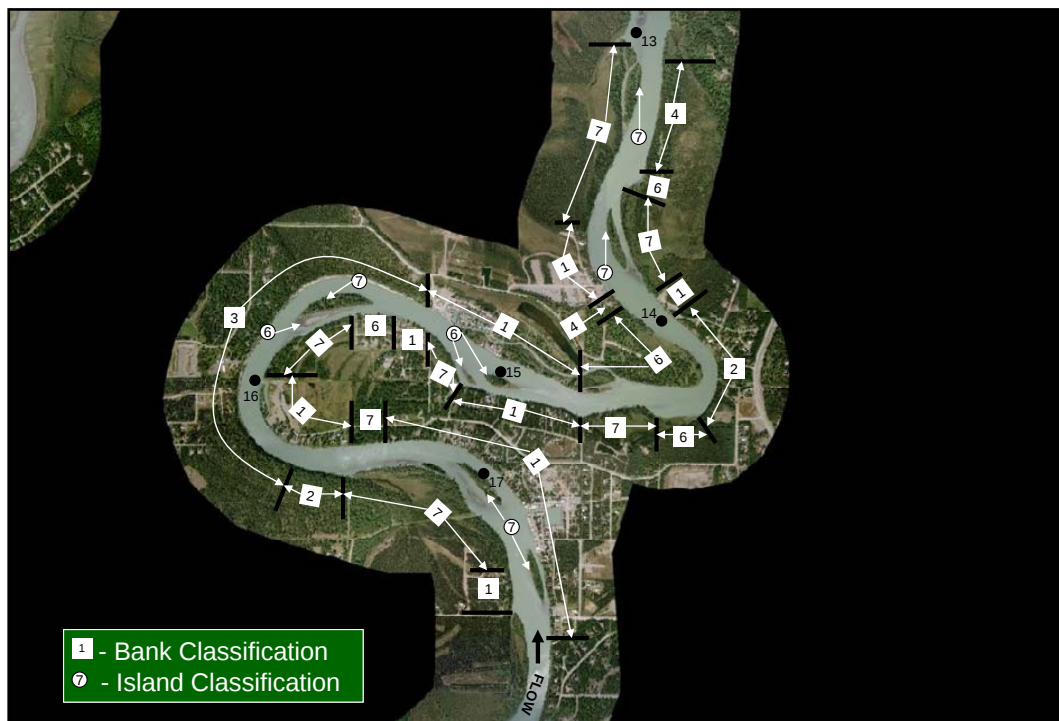
Figure 45. Bank and island classifications for approximate RM 17.5 to 13.

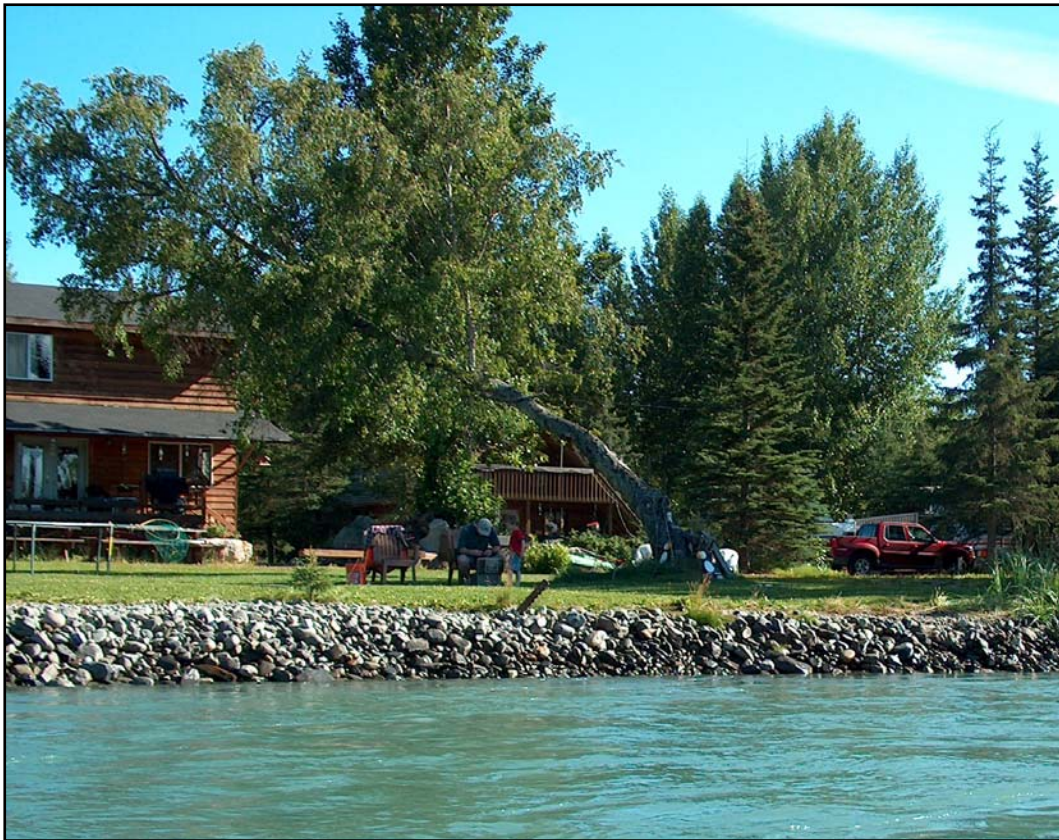
Figure 47. Type 1 bank stabilized with riprap.

manner. The assumption is that Type 1 reaches are stable against imposed river forces or will be maintained should local failures occur. Figures 47–51 show several typical Type 1 banks (stabilization techniques). All permits issued on the Kenai River in the past 15 years have been for the purpose of fish habitat restoration, and have been restricted to bio-engineering measures. Riprap stabilization has been limited to the protection of public structures.

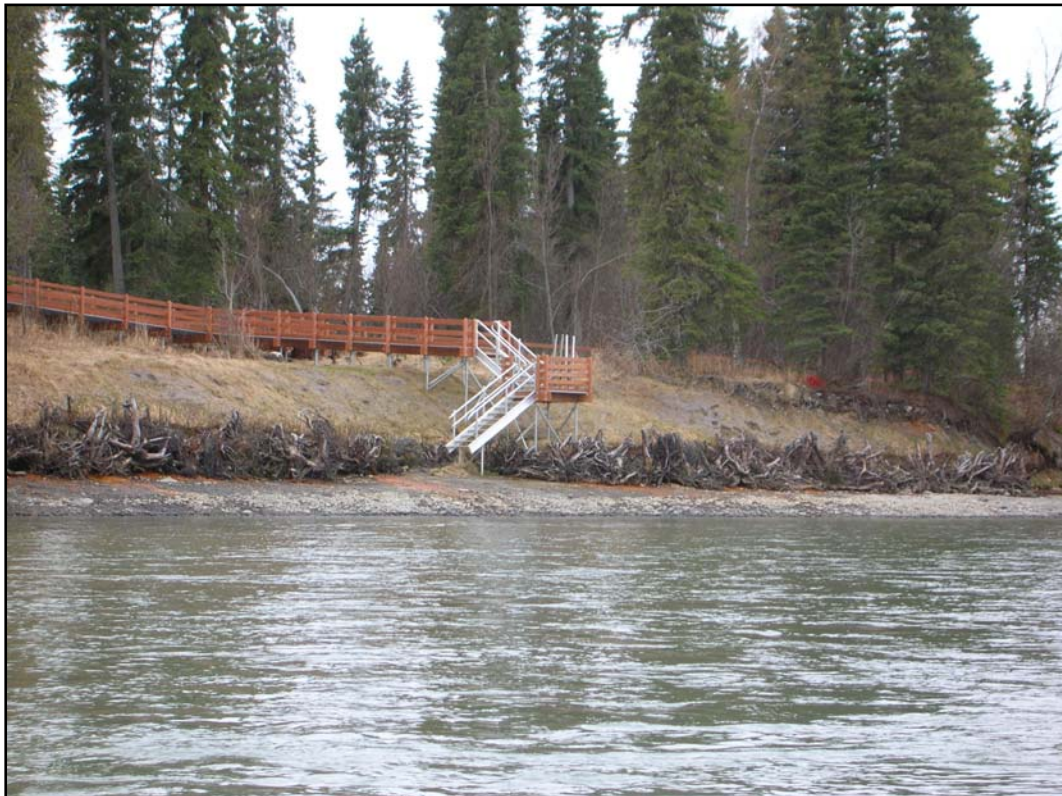
Figure 49. Type 1 bank with root wad habitat restoration.

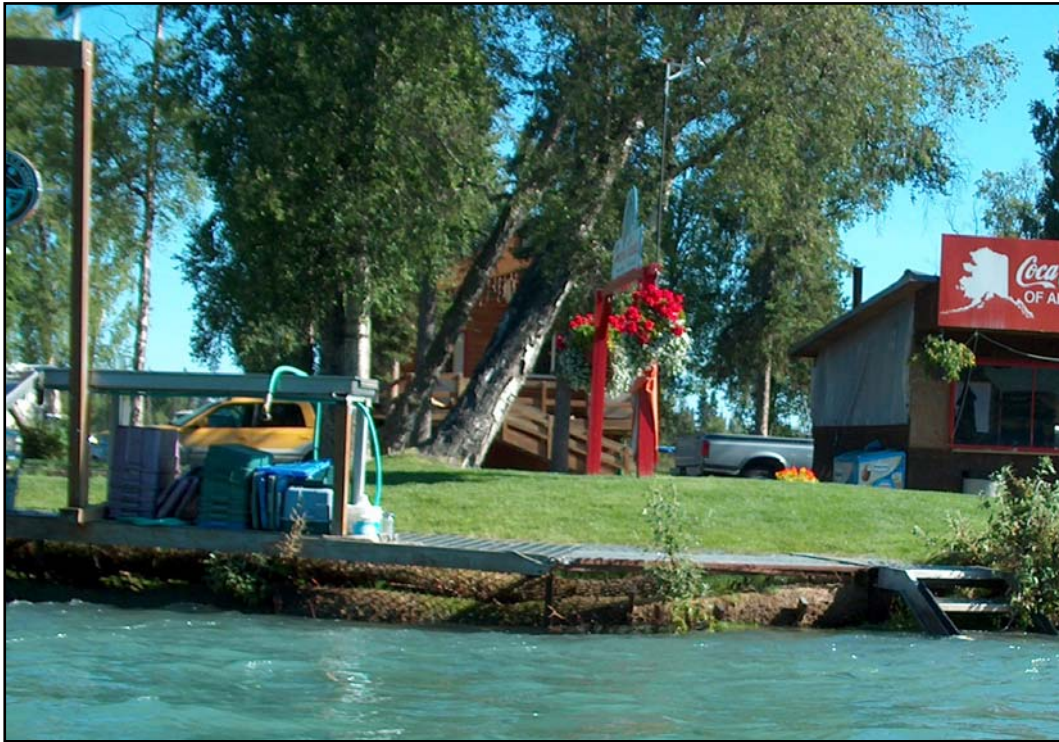
Figure 50. Type 1 bank with coir log habitat restoration.

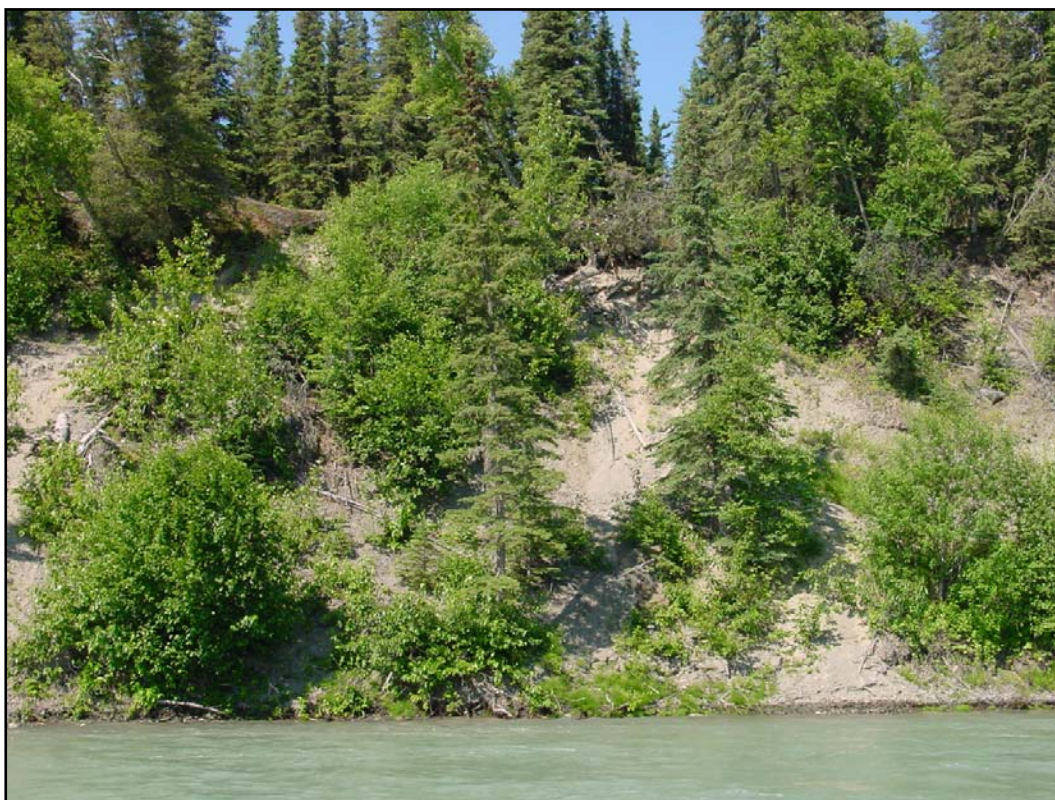
Figure 52. Type 2 bank, which is resistant to erosion at water line.

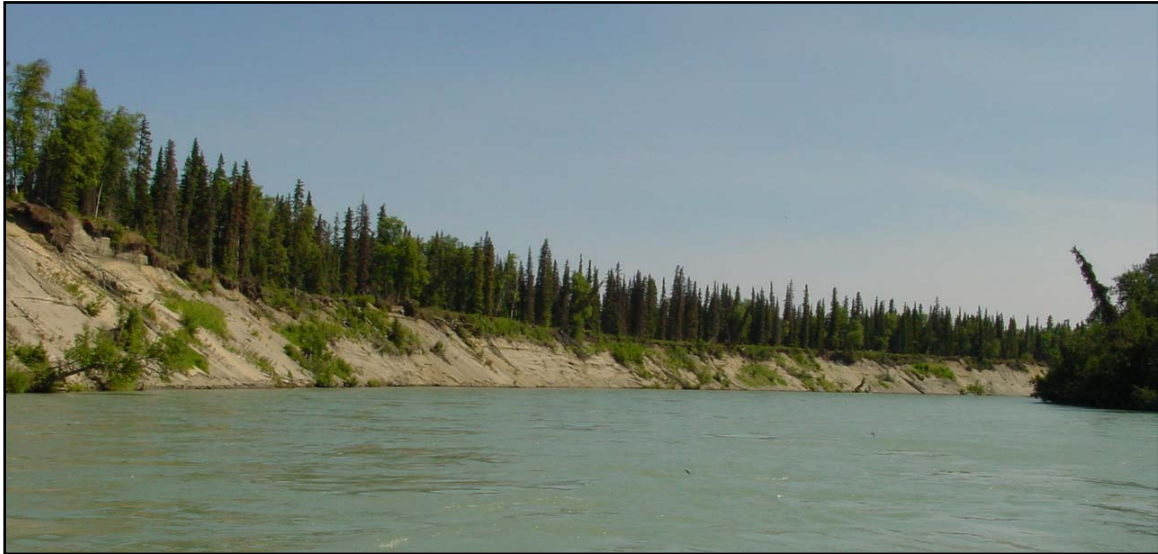
Figure 53. Typical Type 3 bank, predominantly void of vegetation.

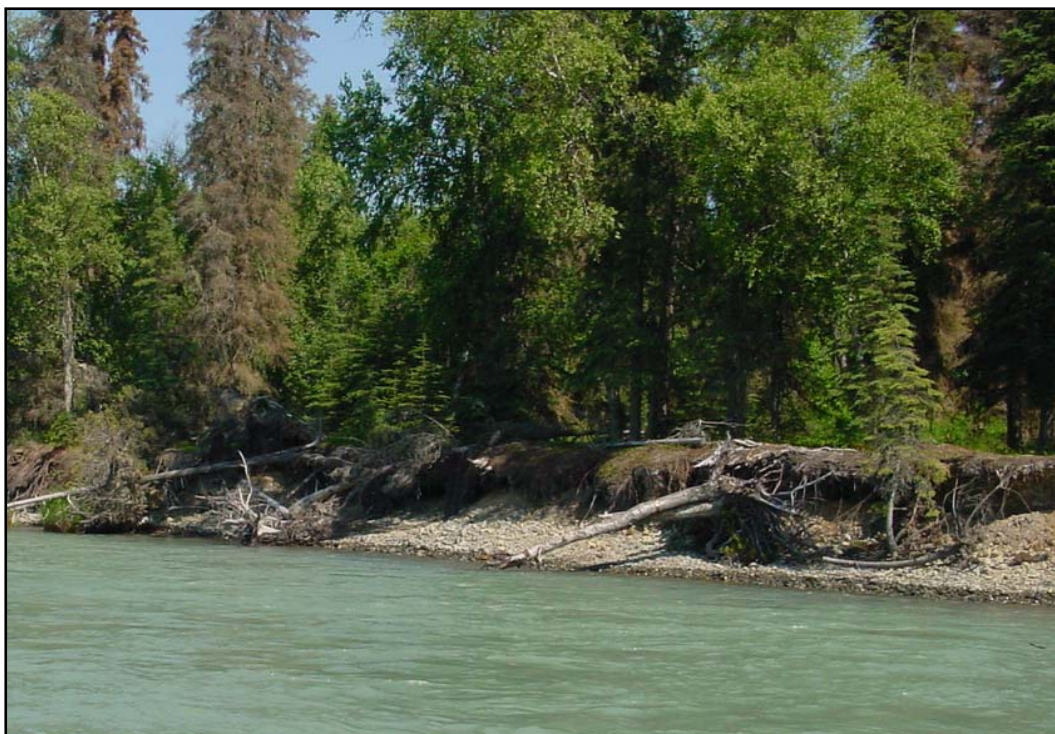
Figure 55. Typical Type 4 bank showing root/soil mantle draped over exposed bank face.

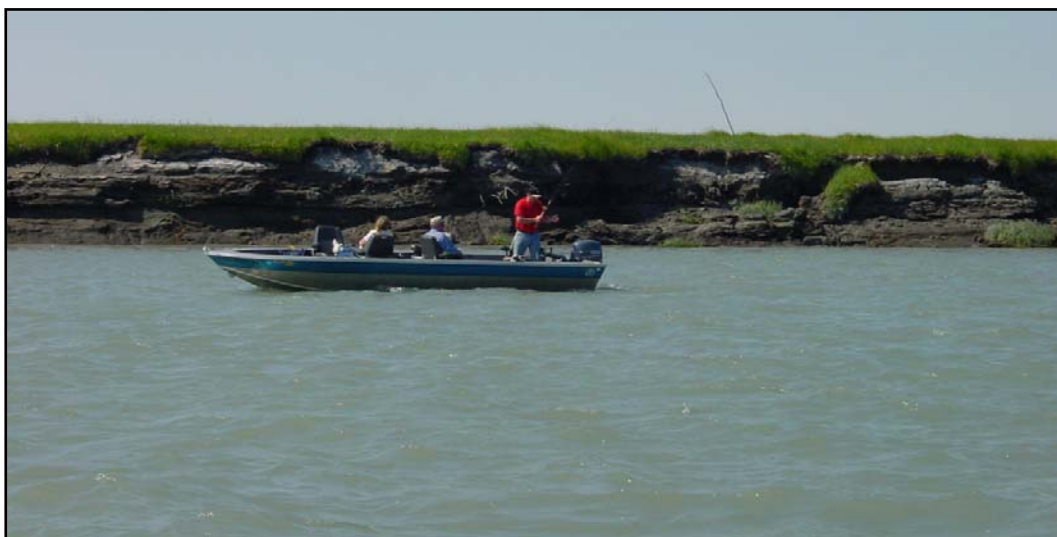
Figure 56. Typical Type 5 bank, which is highly susceptible to boat wakes.

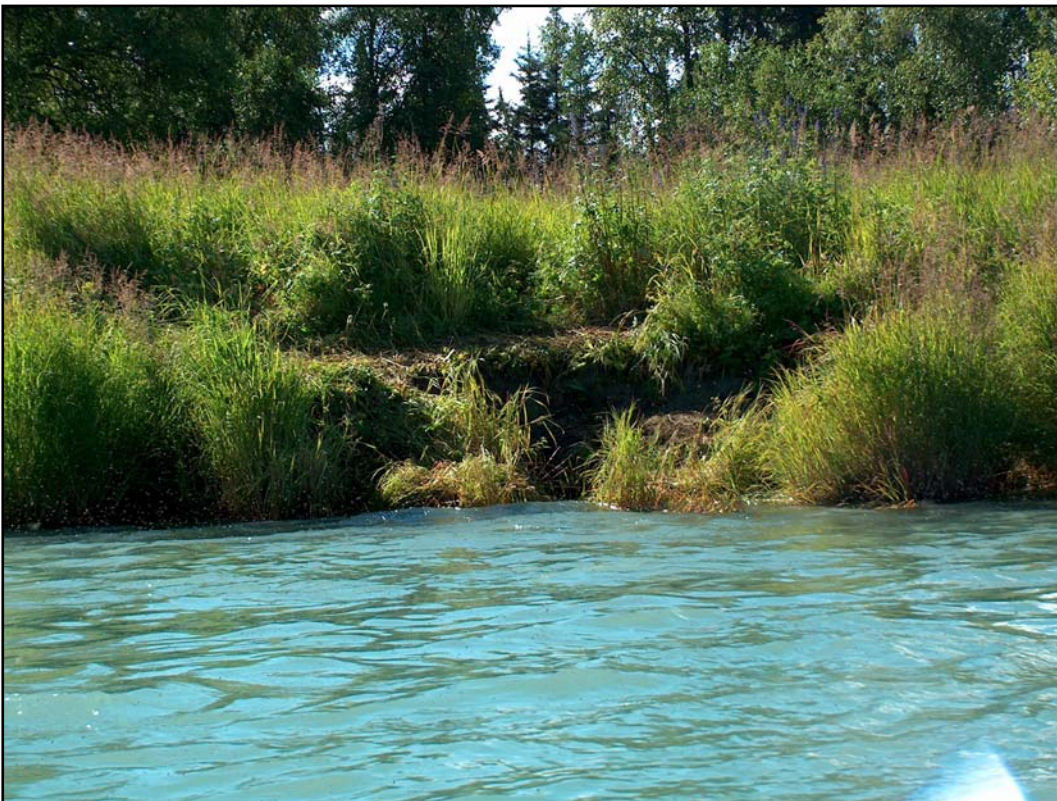
Figure 58. Trampling caused by bank anglers on Type 6 bank.

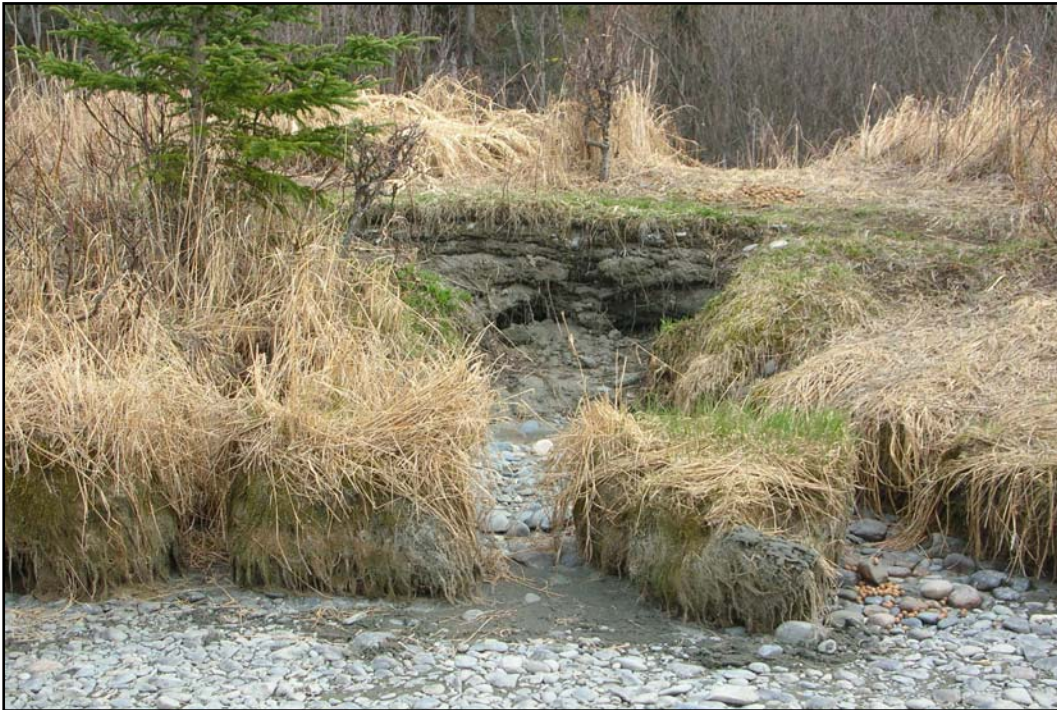
Figure 59. Type 6 bank failure mechanism.

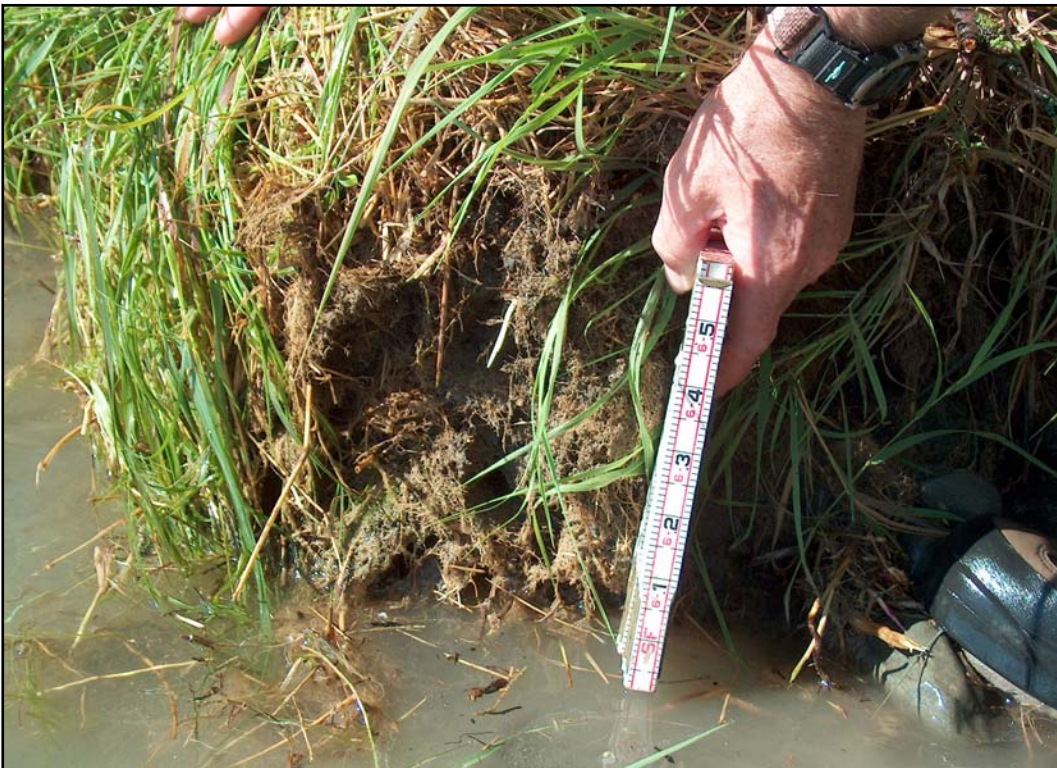
Figure 60. Root mass of herbaceous vegetation of Type 6 bank.

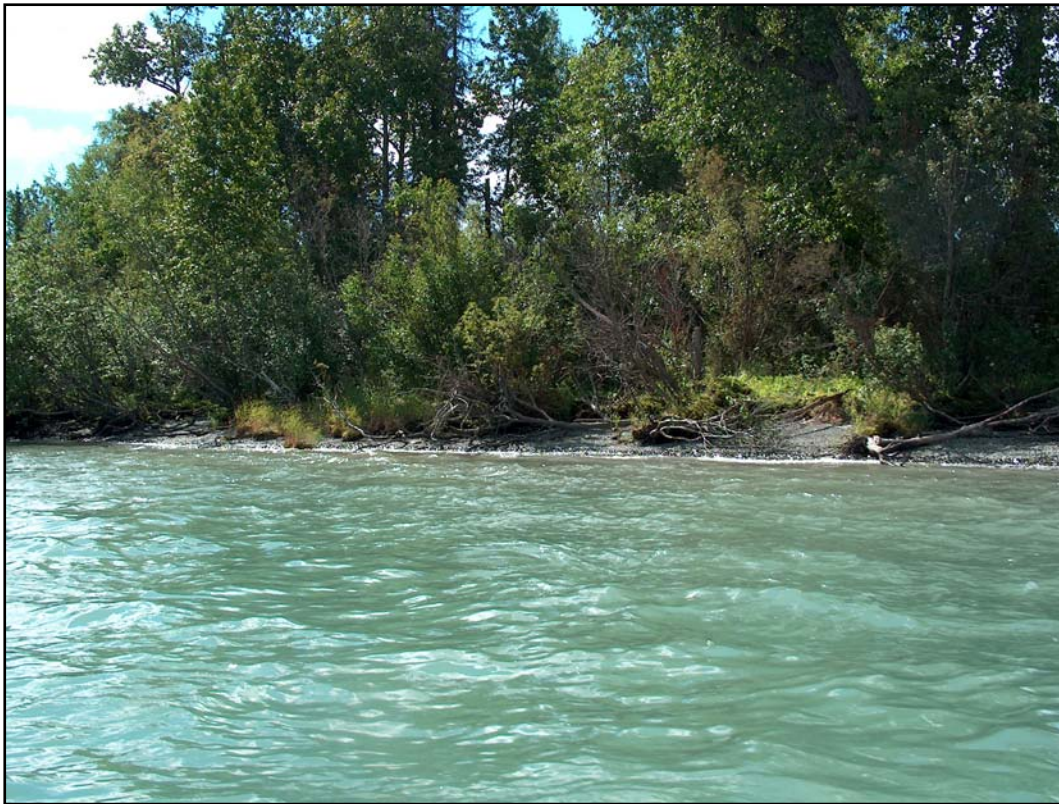
Figure 61. Typical Type 7 bank covered with woody vegetation.

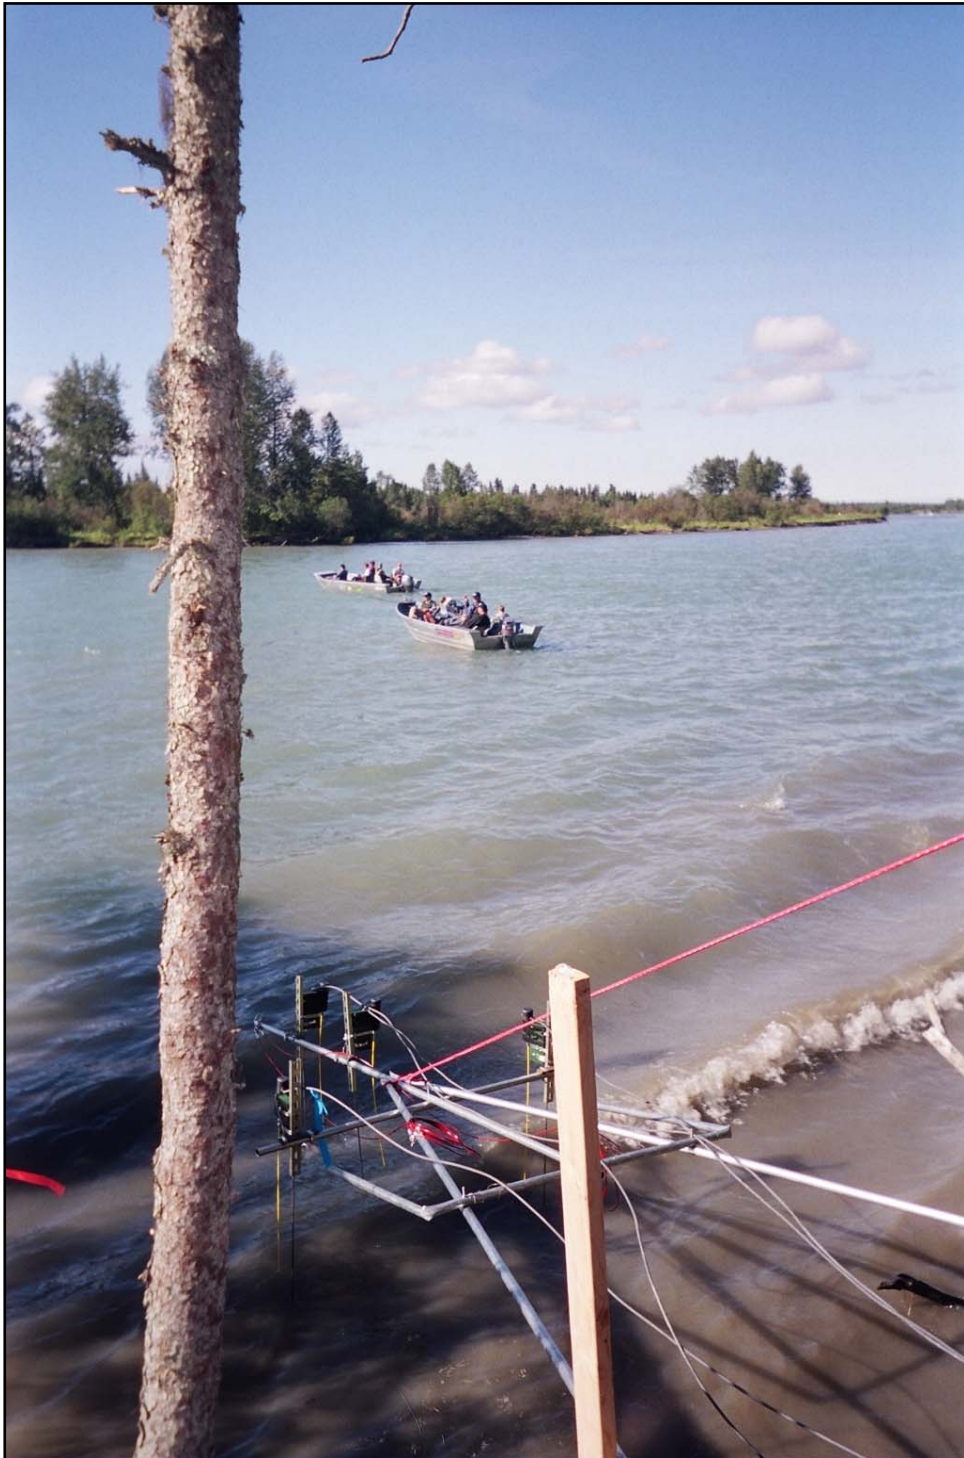
Figure 65. Near-bank turbidity at wave measurement site at RM 11.3.

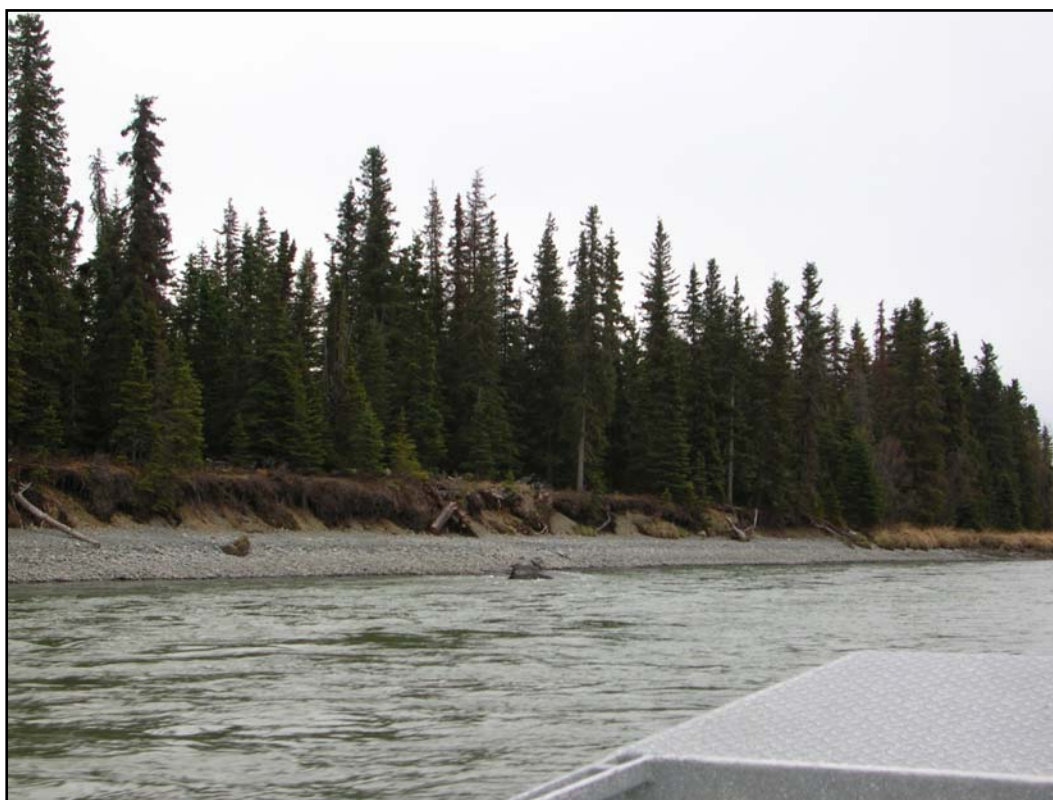
Figure 67. Cobble bench on Type 4 bank at low flow in May 2005.
