Aircraft Rotor Surface Coating Qualification Testing

Aircraft Rotor Surface Coating Technical Report Summary

Final Report

Revision 1 - October 25, 2006

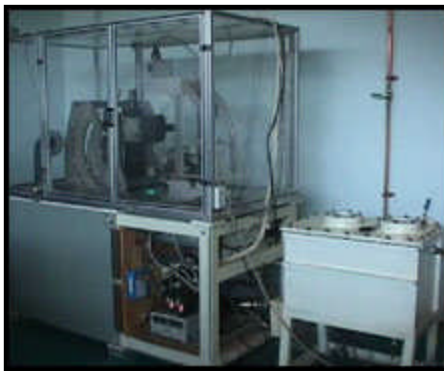
Figure #1
Particle Erosion Test Chamber

The Particle Erosion Test Apparatus was designed and built in the early 1980's for the Defense Nuclear Agency to simulate the effects of flight through a low concentration solid particle (dust) environment, see Figure #1. Specific simulation requirements included particle sizes ranging from 38 to 250 μm , particle mass fluxes as low as $1\text{mg}/\text{cm}^2/\text{min}$, particle velocities over a broad range of subsonic Mach numbers, and continuously adjustable impact angles from normal to 20 degrees (70 degrees angle of incidence). The following is a description of how the Particle Erosion Apparatus tests specimens:

- Dust particles are accelerated in a small diameter (approximately 0.25”) high-speed gas jet and directed onto the test specimen.
- Compressed air provides the transport gas stream with regulators and pressure transducers to measure and control the pressure at the nozzle inlet. Dust particles are metered into the transport gas stream from a pressurized screw feeder system.
- Dust velocity is determined as a function of the nozzle inlet pressure and the particle size by prior calibration.
- For a complete description of the Particle Erosion Test Apparatus, please see the UDRI web site at <http://www.udri.udayton.edu/>.

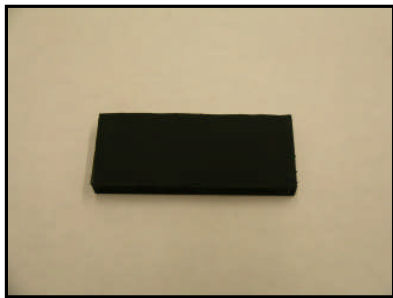
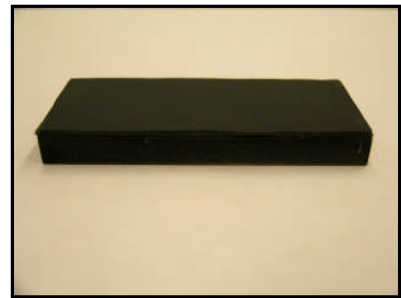
- Cut the Poly Tape 8663 to fit the test specimen.
- Apply a thin coat of Adhesive Promoter #86 in the area to be covered by the tape, using a brush. The control specimens' minimum drying time is five minutes. The poly tape must be applied prior to one hour after the promoter application.
- Apply the Poly Tape 8663 by peeling off the backing. Bubbles greater than 0.2in² are not allowed.
- Apply a second coat of Poly Tape 8663 by repeating the previous three steps.
- Allow the control specimen to dry for a minimum of 24 hours at room temperature.
- Measure and record the final thickness of the coated specimen. (See Figure #3 and #4 for an example of the control specimen.)

Figure #3
Control Specimen

Figure #4
Control Specimen

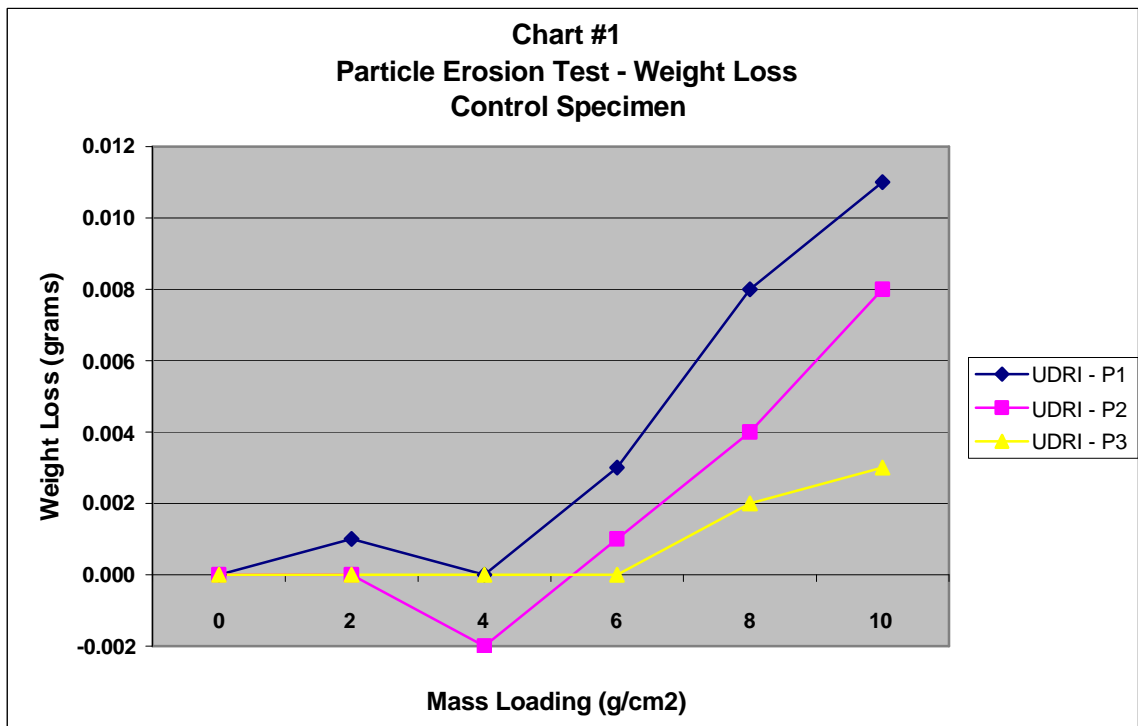
Table #2 Particle Erosion Test Control Specimens										
Specimen Number	Description	Velocity (MPH)	Angle of Impact (deg)	Particle Size (um)	Starting Weight (g)	Mass Loading				
						2 g/cm2 Weight (g)	4 g/cm2 Weight (g)	6 g/cm2 Weight (g)	8 g/cm2 Weight (g)	10 g/cm2 Weight (g)
UDRI-P1	Control Specimen	500	30	88 - 105	28.809	28.808	28.809	28.806	28.801	28.798
UDRI-P2	Control Specimen	500	30	88 - 105	28.754	28.754	28.756	28.753	28.750	28.746
UDRI-P3	Control Specimen	500	30	88 - 105	28.744	28.744	28.744	28.744	28.742	28.741

Chart #1 below shows a graphical representation of the weight loss for each control specimen tested after each mass loading cycle.

The control specimens performed very well in the particle erosion test. There was a maximum of 0.011 grams of weight loss from the UDRI-P1 control specimen. Visually, there were slight texture changes in the tape, however, the samples showed little signs of wear. The tape was not pitted, nor was it torn or separated from the base material; see Figures #5 and #6.

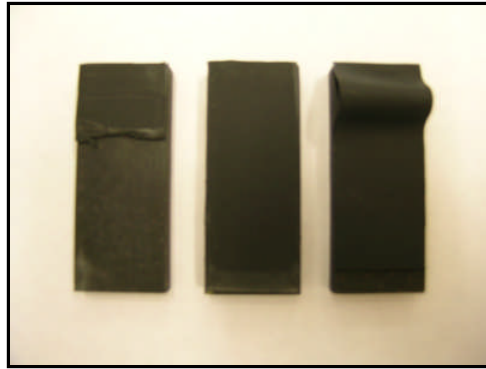
The control specimens did not perform well in the rain erosion test. Control specimens UDRI-R1 and UDRI-R3 had complete adhesion failure between the bottom tape layer and the primer. Control specimen UDRI-R2 did not have complete adhesion failure, however, at the end of the test, it was noticed that about 1/16” of creep (separation) occurred between the bottom tape layer and the primer; see Figures #7 and #8.

Figure #7
Control Specimens
UDRI-R1, R2, R3
Rain Erosion Test

Figure #8
Control Specimens
UDRI-R1, R2, R3
Rain Erosion Test

New control specimens were then tested in the rain erosion chamber. The time to failure was recorded for each control specimen; see Table #3 below. Two of the control specimens failed around 45 minutes into the test, while one specimen did last for the maximum test duration of 120 minutes.

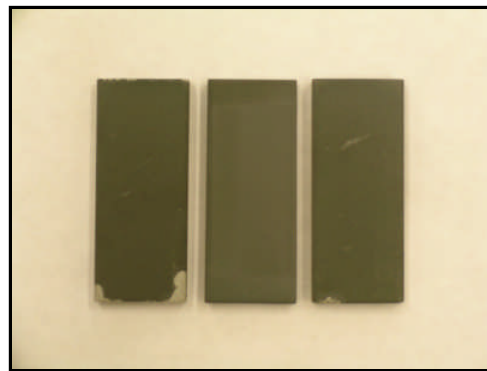
Figures #9 and #10 show the two test specimens that were chipped along with the middle specimen that was tested. There was some wear in the coating of the tested specimen, however, it did not break through to the base material, nor was there any visible pitting in the coating surface. This warranted possible further testing in the rain erosion chamber.

Figure #9
Saint-Gobain Coating Solutions
Rokide-C Chrome Oxide
STG-A-P1, P2, P3
Particle Erosion Test

Figure #10
Saint-Gobain Coating Solutions
Rokide-C Chrome Oxide
STG-A-P1, P2, P3
Particle Erosion Test

The Rokide-C Chrome Oxide test specimens from Saint-Gobain were first tested in the particle erosion chamber. Test specimens STG-A-P1 and STG-A-P3 did not fit within the test fixture. Action was taken to grind the sides of the specimens. However, in doing so, some of the coating chipped off the base material. Therefore, only test specimen STG-A-P2 was tested and the weight was measured and recorded after each mass loading cycle; see Table #4 below. Care was taken to make sure all the dry silica dust was removed from the test specimen prior to weighing.

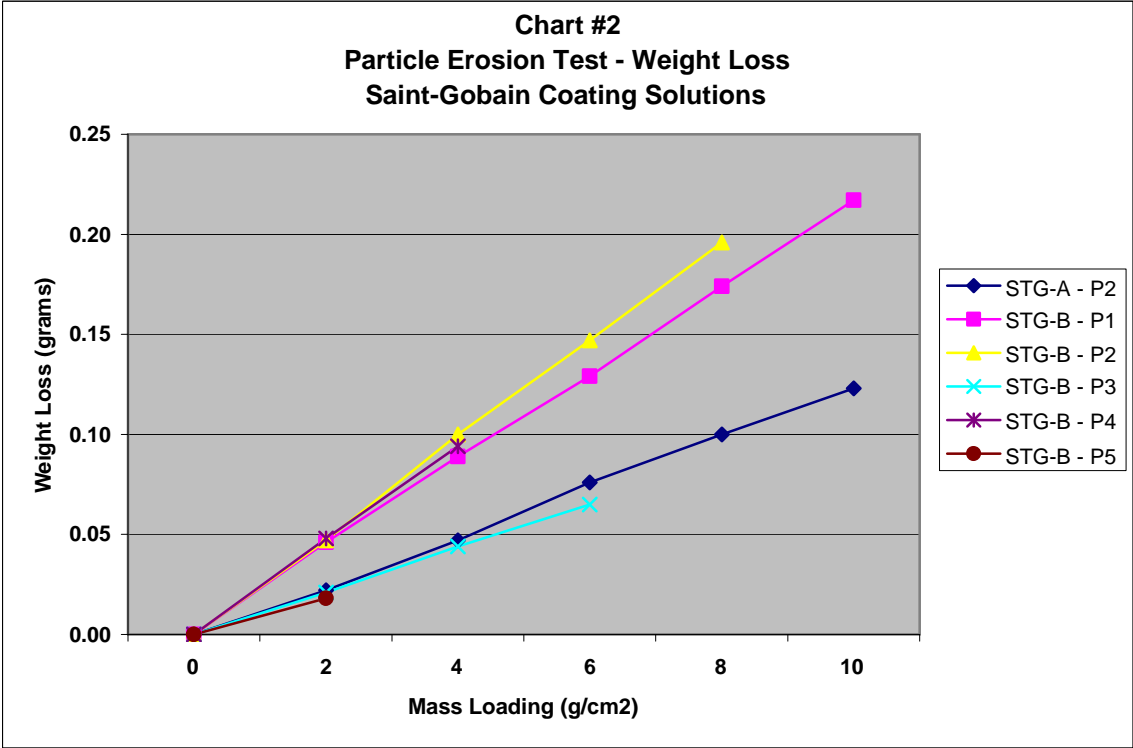
Chart #2 shows a graphical representation of the weight loss for each test specimen tested after each mass loading cycle.

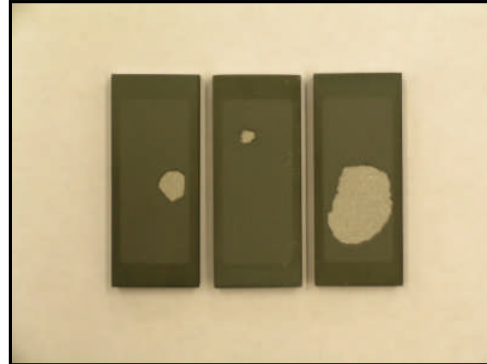
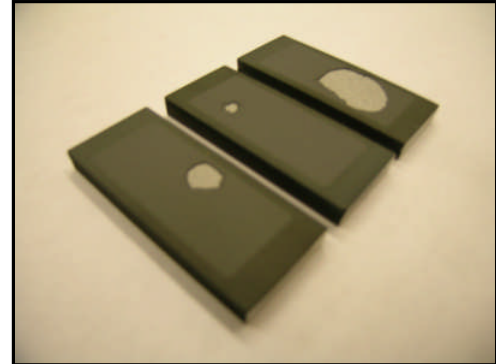
Each test specimen failed only minutes into the test. All the test specimens failed by cratering near the center of the test specimen and then exposing the base material; see Figures #13 and #14.

Figure #13
Saint-Gobain Coating Solutions
Rokide-C Chrome Oxide
STG-A-R1, R2, R3
Rain Erosion Test

Figure #14
Saint-Gobain Coating Solutions
Rokide-C Chrome Oxide
STG-A-R1, R2, R3
Rain Erosion Test

Compared to the control specimens, the Saint-Gobain Rokide-C Chrom Oxide coating performed comparable in the particle erosion test but failed to match the control specimens in the rain erosion test.

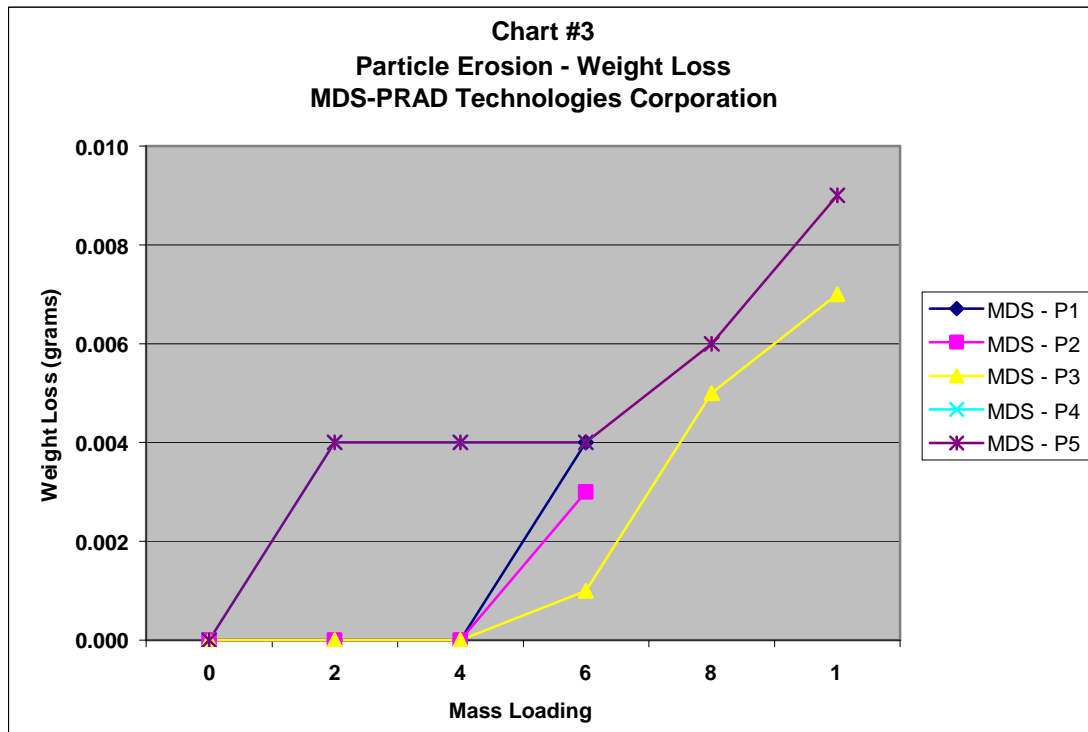
Chart #3 below shows a graphical representation of the weight loss for each test specimen after each mass loading cycle.

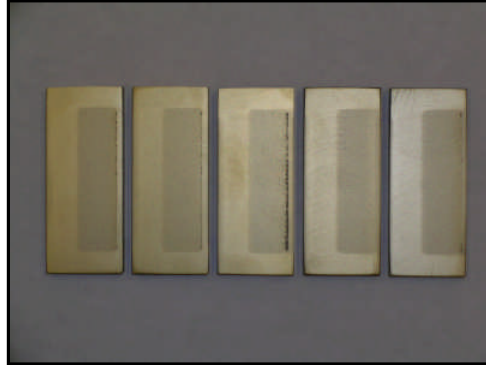
Figures #15 and #16 below show the Titanium ER-7 TiN test specimens after testing in the particle erosion chamber. The first three test specimens showed significant erosion and pitting into the Titanium base material. The last two specimens showed less wear and pitting.

Figure #15
MDS-PRAD Technologies Corporation
Titanium ER-7 TiN
MDS-P1, P2, P3, P4, P5
Particle Erosion Test

Figure #16
MDS-PRAD Technologies Corporation
Titanium ER-7 TiN
MDS-P1, P2, P3, P4, P5
Particle Erosion Test

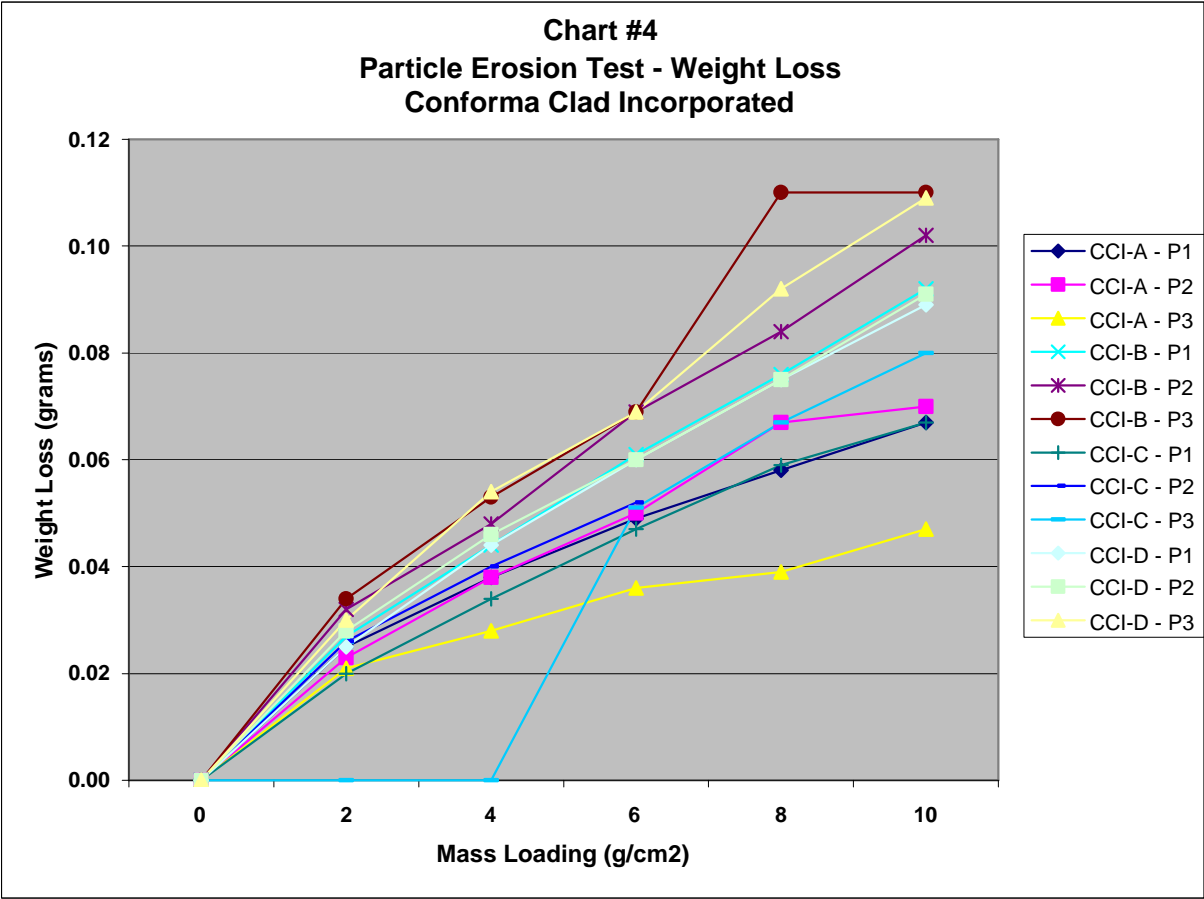
Chart #4 shows a graphical representation of the weight loss for each test specimen tested after each mass loading cycle.

Due to the limitation on the number of tests that can be run on the rain erosion apparatus, only one type of coating could be tested. All the coatings performed very similarly. Looking at the data from Chart #4 above, the Carbide Coating WC200 on the 410 SS base material had on average, less weight loss than the other test specimens during the particle erosion tests. Therefore, the Carbide Coating WC200 on the 410 SS base material was further tested.

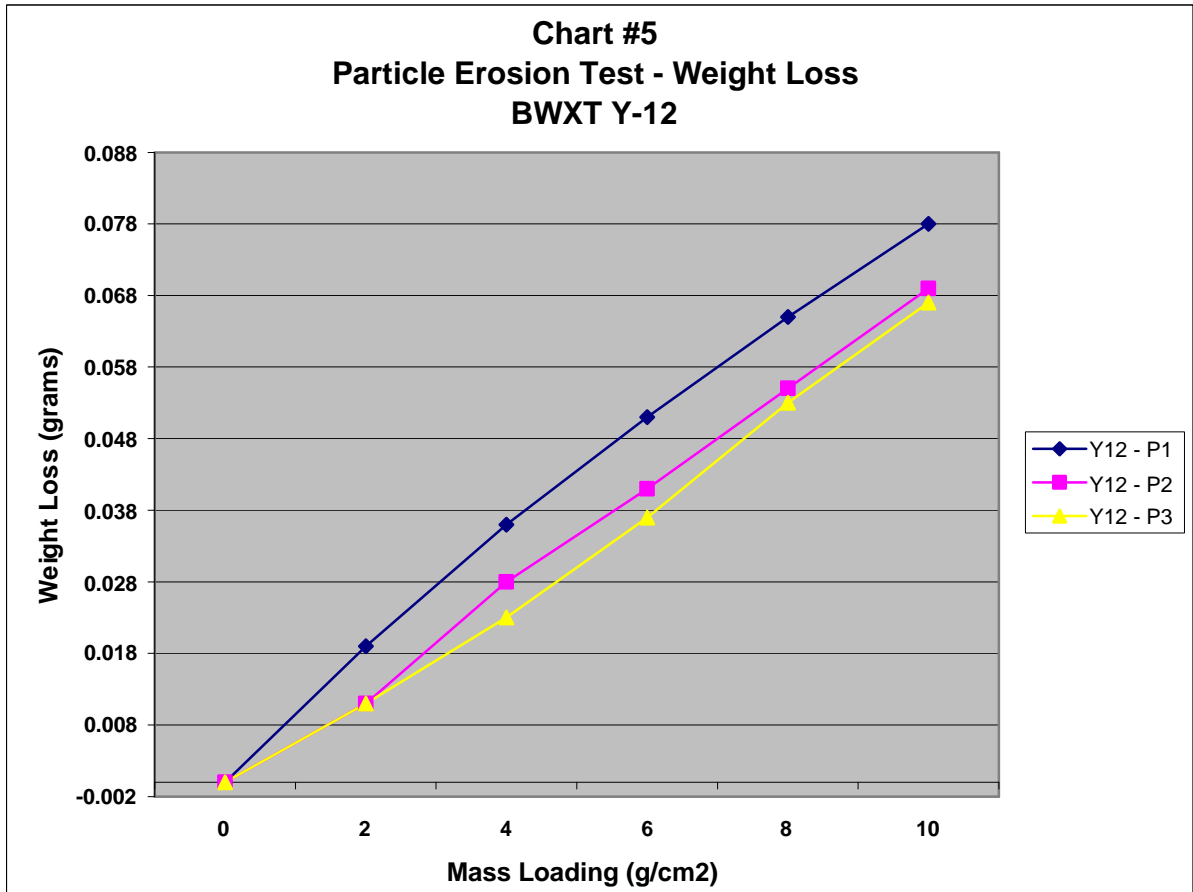
Chart #5 below shows a graphical representation of the weight loss for each test specimen after each mass loading cycle.

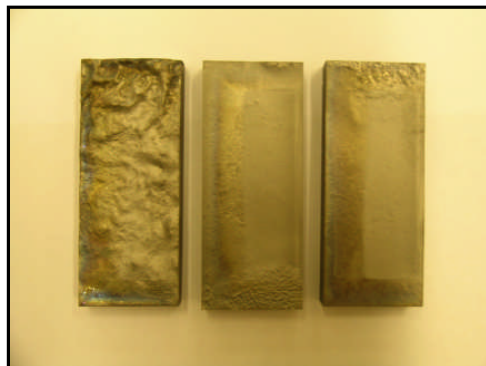
Figures #29 and #30 below show the Metal Deposition test specimens after testing in the particle erosion chamber. The first specimen showed little sign of surface erosion, but severe surface deformation was evident. The other two specimens also showed little sign of surface erosion with some surface deformation; however, the surface deformation was not as pronounced as the first specimen.

Figure #29
BWXT Y-12
Metal Deposition
Y12-P1, P2, P3
Particle Erosion Test

Figure #30
BWXT Y-12
Metal Deposition
Y12-P1, P2, P3
Particle Erosion Test
