## PERIODIC SHORELINE MORPHOLOGY, FIRE ISLAND, NEW YORK

**Abstract:** The presence of shoreline undulations along the Atlantic coast of Fire Island, NY requires careful consideration in developing erosion control and hurricane protection plans and design alternatives for the protection of the Fire Island barrier and the Long Island mainland. An analysis and geometric characterization of these morphologic shoreline features revealed that the magnitude of the shoreline undulations approximates typical protective berm design widths and exceeds typical advance nourishment beach widths. Because shoreline undulations are natural morphologic features of the Fire Island shoreline their presence after project construction must be anticipated. Conclusions drawn from the analysis of the Fire Island shoreline undulations indicate that the design berm width could be compromised well before scheduled renourishment if explicit consideration of shoreline undulations is not included in the development of the design cross-section.

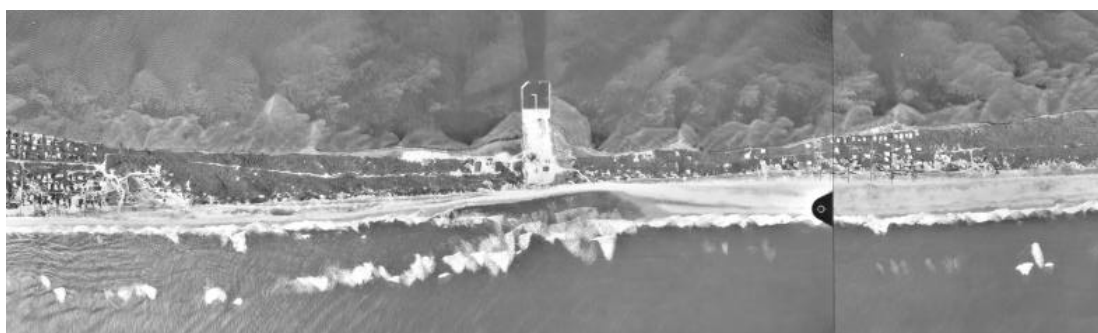
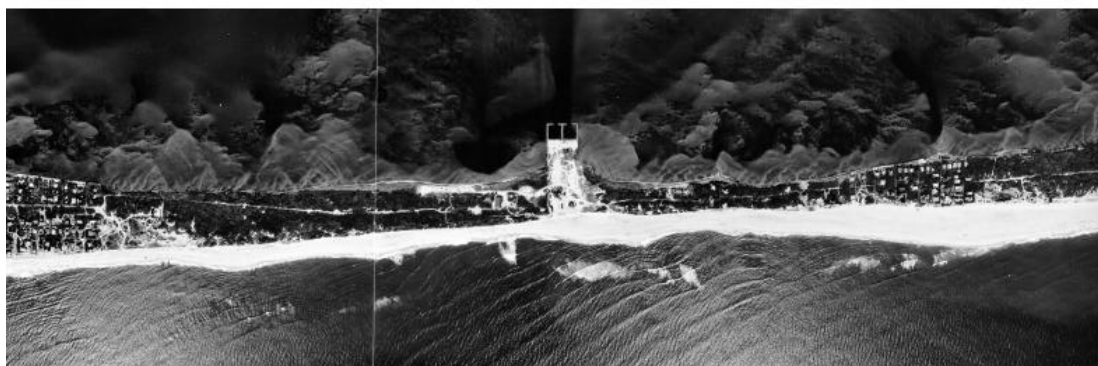
Fig. 3. Example of shoreline undulation (a) April 1983, (b) April 1995 (baseline stations 21.0 through 25.0 km).

The influence shoreline undulations have on typical engineering calculations at Fire Island is readily illustrated by examining the rate of shoreline change over various time intervals. For example, the rates of shoreline change over a representative 10-km reach in central Fire Island (approximately from Fire Island Pines to Watch Hill) for the intervals December 1979 to April 1983, April 1983 to March 1988, and March 1988 to April 1995 are plotted in Fig. 2. Fig. 2 shows that the local rate of shoreline change can be relatively large, ranging from about "10 m/year over an approximate 3-year interval to around "5 m/year over a 7-year interval. As can be seen in the figure, the rate of shoreline change is highly variable both spatially and temporally with high rates of accretion followed by high rates of erosion at the same location depending on the interval of time examined. Because of this high degree of variability, the historical rate of shoreline change may be relatively small (on the order of 1 m/year erosion) but have a large standard deviation (on the order of 5 m/year). Fig. 3 illustrates the wide fluctuations in shoreline position that result in the large rates of shoreline change and high degree of spatial variability in the rates plotted in Fig. 2. Note the comparatively wide berm width present on the right-hand side of both images and the very eroded condition (narrow berm width) in the central portion of the top image that subsequently

evolved to a substantially wider berm condition in the bottom image. Table 1 lists computed rates of shoreline change since 1979 over the entire Fire Island barrier together with the standard deviation associated with the listed shoreline change rate. From Table 1 it is seen that on average, the Fire Island shoreline is retreating landward at rates ranging from 0.04 m/year to 2.5 m/year depending on the time interval. However, the large standard deviation (equal to or exceeding 2.5 times the mean rate of shoreline change) indicates that notable shoreline accretion occurred at some locations during each of the time intervals. The approximate 15-year (December 1979 to April 1995) average rate of shoreline change was calculated at  $-0.66$  m/year. The rate of shoreline change plays a central role in the development of sediment budgets and estimating design quantities such as beach fill volumes and renourishment intervals. Because the large spatial and temporal variability in the shoreline rate of change is largely influenced by the presence of shoreline undulations, a detailed examination of these morphologic shoreline features was initiated. The goal of these analyses was to quantify the space and time scales associated with the shoreline undulations in order to develop design concepts compatible with the presence of shoreline undulations. Another goal was to develop a better understanding of the shoreline undulation scale of influence in the context of the larger-scale morphology and evolution of the Fire Island barrier.
