## CIRCULATION CHANGE AND EBB SHOAL DEVELOPMENT FOLLOWING RELOCATION OF MASON INLET, NORTH CAROLINA

Karyn M. Erickson<sup>1</sup>, Nicholas C. Kraus<sup>2</sup>, and Erica Eva Carr<sup>3</sup>

**ABSTRACT:** In March 2002, under the direction of the first author, a rapidly migrating inlet located in New Hanover County, North Carolina was relocated. The original entrance to Mason Inlet was closed, and the inlet was reopened approximately 850 m (2,800 ft) to the north. In addition, a 1,400-m (4,580 ft) long channel was dredged between the new inlet and the Atlantic Intracoastal Waterway (AIWW), and a sedimentation basin was constructed west of the new inlet entrance. Monitoring was initiated to determine if the downdrift beaches receive sediment from breakup of the abandoned ebb shoal and to assess development of the new ebb shoal, including natural sand bypassing. This paper examines ebb shoal development, inlet cross-section equilibration, beach response, and changes in the tidal prism and flow distribution through the primary two tidal channels connecting the new inlet with the AIWW following the inlet's relocation. Locational and cross-sectional stability of the entrance channel

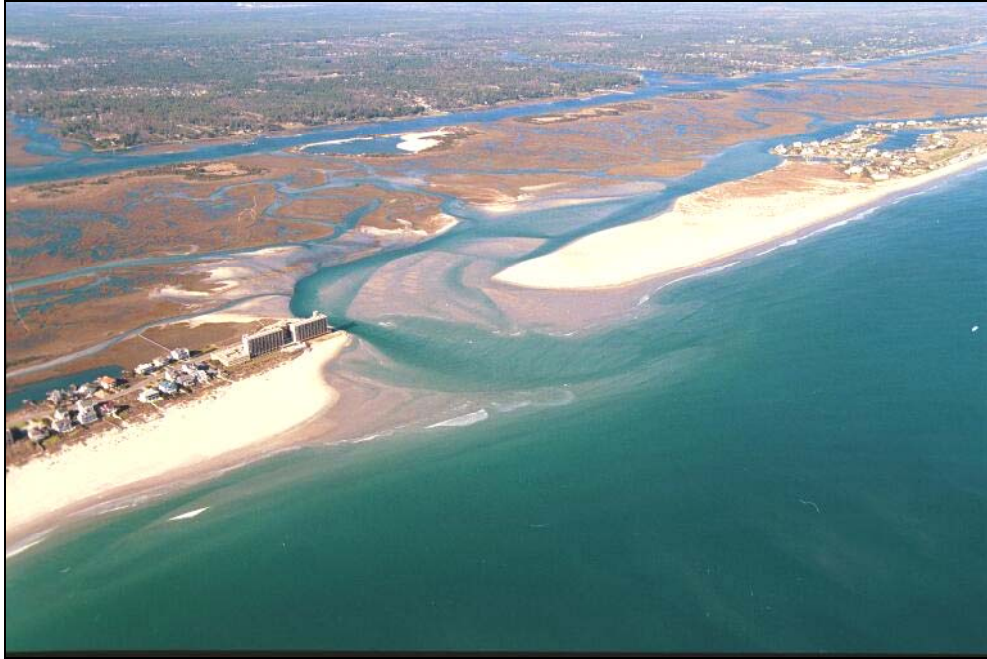
Fig. 2. Mason Inlet (Dec 2001) prior to construction of inlet relocation project.

The "imminent threat" to the Shell Island Hotel resulted in the State of North Carolina granting a variance for a permit to construct a temporary 6 m (20 ft) high, 130 m (425ft) long geotextile revetment along the hotel's foundation to prevent further movement of the inlet in 1997 (Fig. 2). The State of North Carolina's prohibition of hardened structures is an outcome of a 1985 general statute that strictly prohibits construction of hardened erosion-control structures on the ocean shoreline, except for protection of roads and national monuments. This statute prohibited placement of a terminal training groin or similar structure to control the inlet's position, thereby requiring the affected property owners to develop a long-term solution without stabilizing structures. With the impending December 2001 deadline to remove the temporary revetment approaching, and an agreement by the stakeholder group's property owners to repay the County for the costs of implementing a long-term solution to the inlet problem, New Hanover County contracted with a coastal engineering firm to begin work.

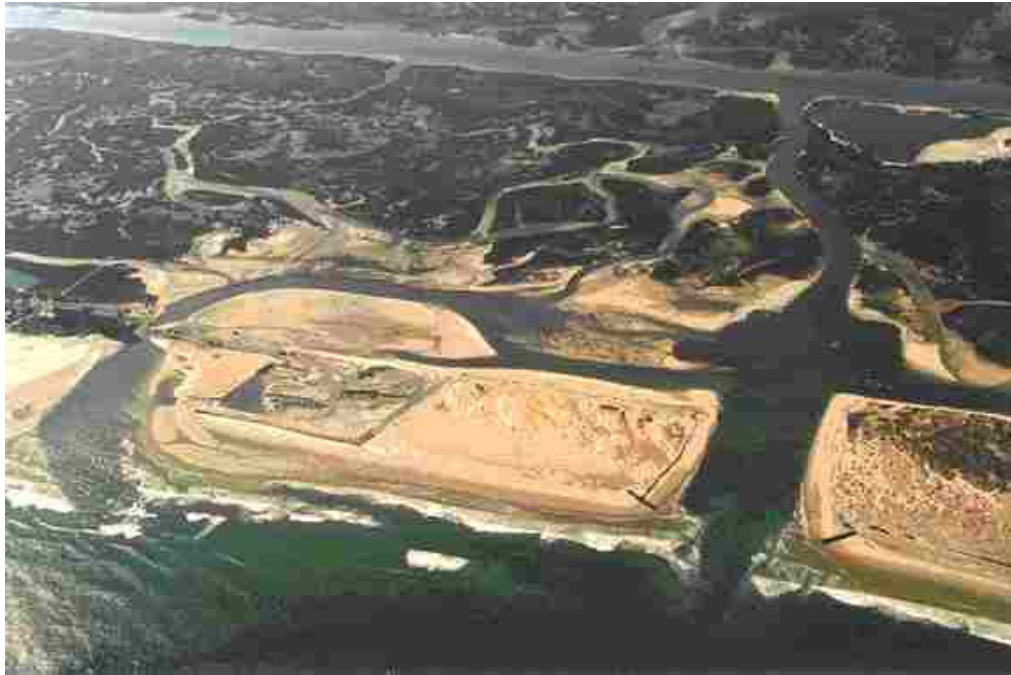
Fig. 5. Mason Inlet one week after inlet opening (photograph March 14, 2002).

The new Mason Inlet channel was opened on March 7, 2002 during a neap tide phase with the temporary sheet pile removed just prior to the beginning of an ebb tidal cycle. The following day, the Mason Creek channel, plugged by a 60 m (200 ft) unexcavated section, left in place to prevent extreme currents during the initial inlet opening, was dredged. Initial tidal flows between Mason Creek and the AIWW exceeded 1.6 m/sec (5 ft/sec) and boats were advised to remain away from the area until the inlet channel stabilized. Within a week of the new inlet's opening, the outer ocean channel scoured to a depth of 1.5 m (5 ft), providing boaters an opportunity to use the inlet. An aerial photograph of the site taken one week after the inlet's opening (Fig. 5) shows the old and the new inlet channels. The original inlet channel was subsequently closed on March 14, 2002 when a bridge of sand was pushed from the sand

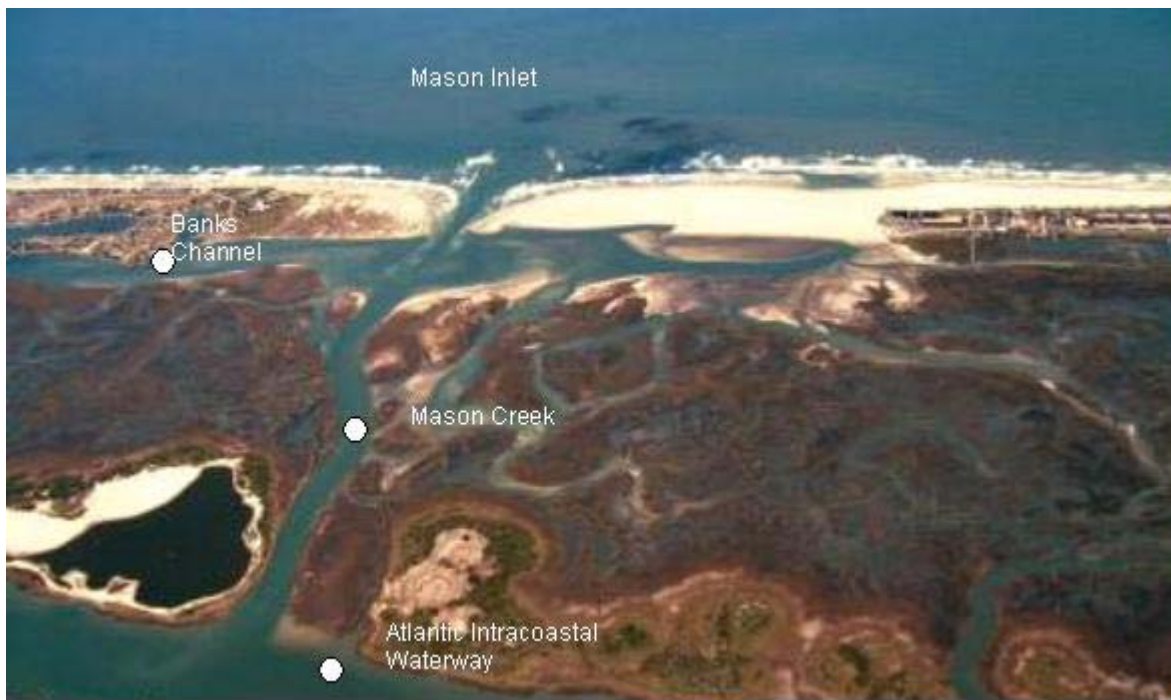
Fig. 6. Major morphologic features and three instrument locations.

To augment the County's studies, the U.S. Army Corps of Engineers' Coastal Inlets Research Program is supporting field studies to document development of the new ebb tidal shoal and to monitor circulation changes within the 3 affected tidal channels of the estuary (Fig. 6). These field investigations include periodic bathymetric surveys of the abandoned and new ebb-tidal shoals, and of the entrance and inlet channels; beach profile surveys; and measurement of current velocity and water surface elevation at three locations. Findings of these comprehensive monitoring studies will provide valuable data and information to guide future maintenance
