CRITICAL EVALUATION OF THE MOTOROLA M12+ GPS TIMING RECEIVER VS. THE MASTER CLOCK AT THE UNITED STATES NAVAL OBSERVATORY, WASHINGTON, DC

Abstract

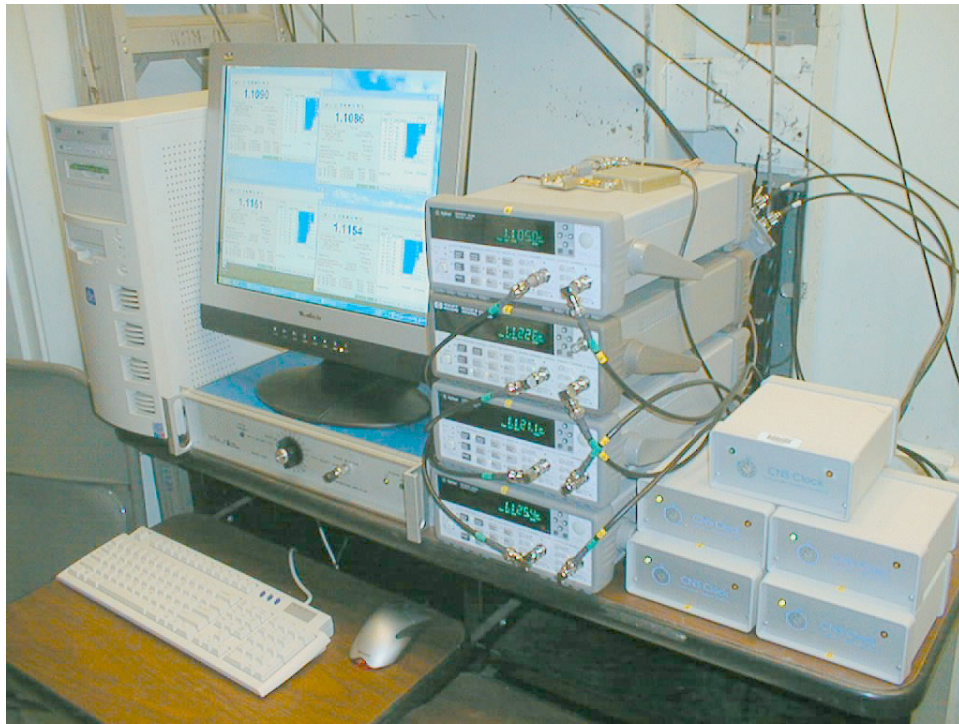
Figure 1. The CNS test bed.

bed is sized to simultaneously test four receivers. The architecture is an extension of the Master Clock monitoring facility developed for NASA's Very Long Baseline Interferometry (VLBI) geophysical observatory sites around the world. It is based on the use of a time interval counter (TIC) coupled with a computer that controls the GPS receiver module and performs data collection, reduction, statistical computations, and logging.

The Test Bed can be seen in Figure 1. Data collection was anticipated to be about 10 Mb per day. The computer also simultaneously collects data from four TICs and interfaces with four GPS receivers using eight serial ports. This requires a high-performance personal computer with plenty of disk storage, eight high performance serial ports, and fast enough to run four copies of the Tac32Plus software and respond quickly to many interrupts.

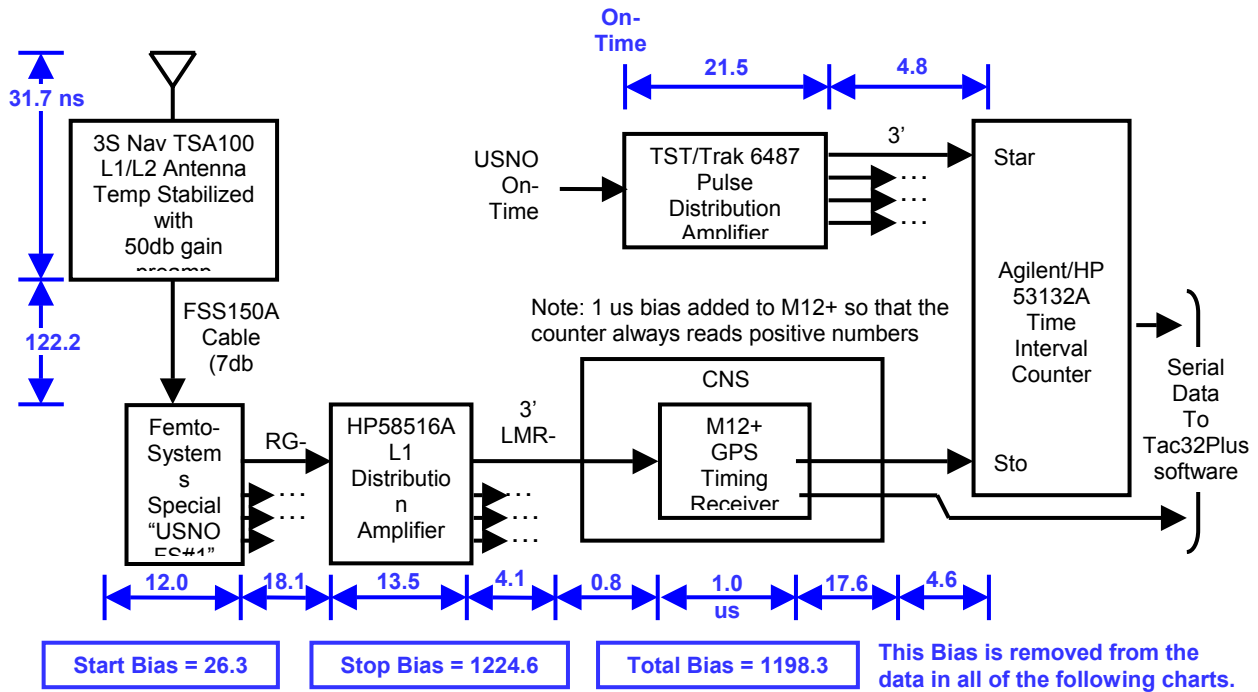
Figure 2. Test bed calibration.

Short cables with connectors were calibrated using an Agilent 8595E spectrum analyzer with tracking generator and an assortment of directional couplers by observing the unterminated cable's effect on a resonant circuit.

Longer cables and the 1PPS distribution amplifier were measured by feeding a 1PPS signal from a USNO hydrogen maser through the cable and observing the delay on an Agilent 53132A time interval counter, while maintaining correct termination impedance. Ed Powers of USNO assisted with these tests.

The GPS antenna, main cable, and USNO's distribution amplifier had previously been calibrated by USNO staff using an HP 8719D (13.6 GHz) network analyzer. Ed Powers of USNO calibrated the additional L1 signal splitter using this same network analyzer.

The final results were carefully reviewed with the assistance of Ed Powers and are shown in Figure 2.

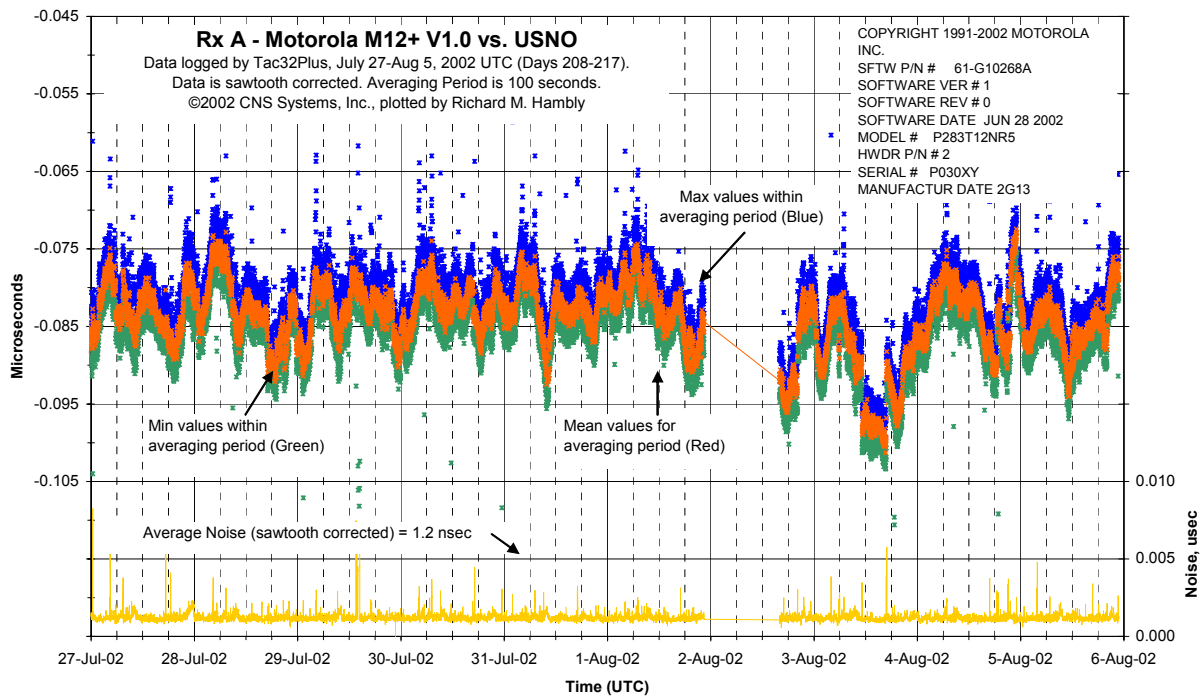
Figure 3. Pre-calibration results.

The four Motorola M12+ receivers were tested and evaluated against UTC, accounting for the calibration offsets in the Test Bed. A sample of the pre-calibration results is shown in Figure 3. The missing data from late on 1 August (UTC) through mid-day on 2 August was due to a power failure at USNO. After this happened two more times, we realized that this was the peak time of year for lightning, so we changed the power source to run off fully protected and backed up power. Fortunately, there was no damage to any of the equipment.

The receivers were all found to perform similarly with their 1PPS signals each about 84 nanoseconds early. Receiver-to-receiver tracking was very good, within a few nanoseconds. These results were sent to Motorola, the receiver firmware was updated and reloaded into the receivers, and testing resumed.

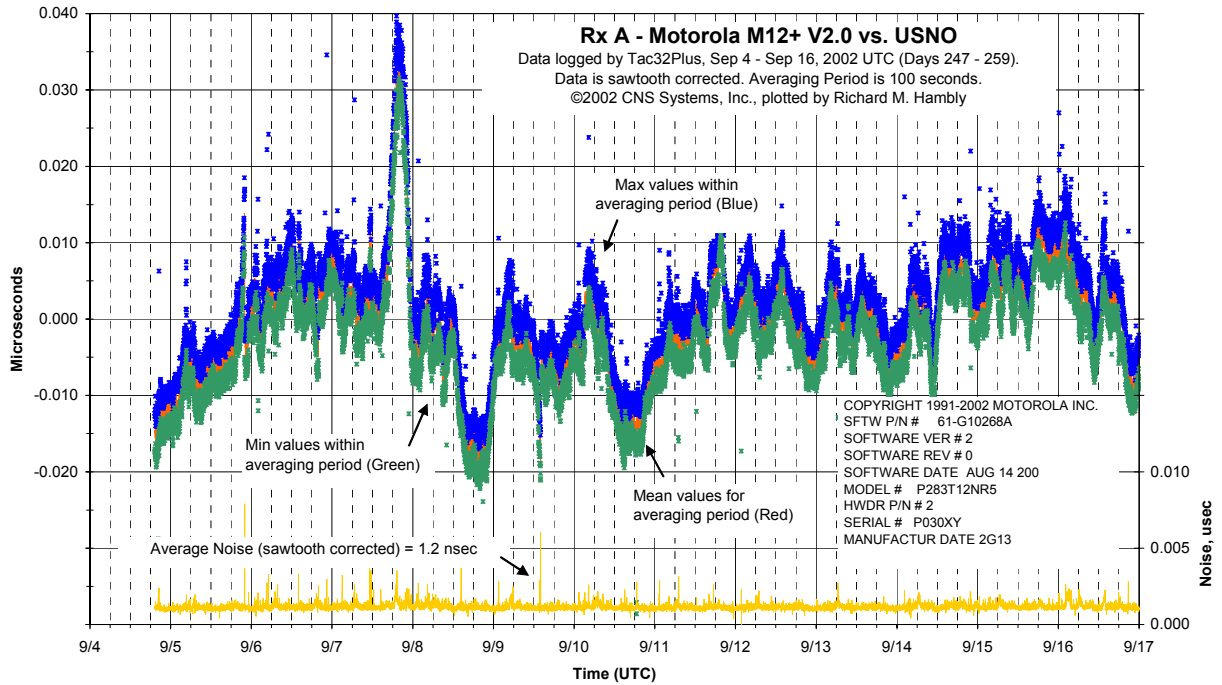
Figure 4. Post-calibration results.

Once the receivers had their revised firmware, the tests were repeated. This time the receivers were each very close to zero offset relative to UTC. The receiver shown in Figure 4 averaged 0.2 nanoseconds early over the more than 12-day period shown.

Notice the unusual excursion late on 7 September followed by two rebounds over the next 3 days. It turns out that during this period, Dr. Thomas A. Clark was photographing the night sky in Howard County Maryland (approximately N39° W79°) with his Cannon D60 digital camera. He captured a fairly rare and spectacular red and green aurora borealis display that commenced immediately after the peak shown on the chart. Additional data were collected and analyzed through mid-November with no repeats of either unusual data excursions or aurora displays

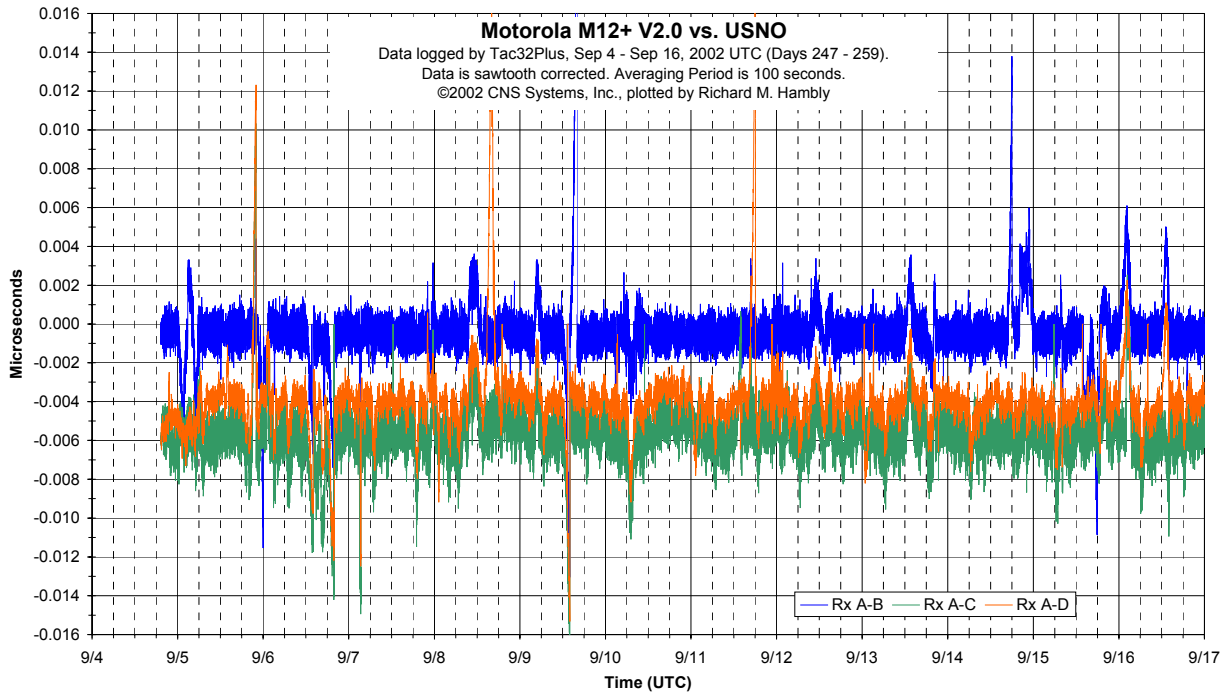
Figure 5. Result tracking - four receivers.

Figure 5 shows the tracking of the four receivers referenced to the “A” receiver. The “B” receiver tracks almost perfectly, while the “C” and “D” receivers are late by about 5 nanoseconds. This has been traced to a variation in group delay for the M12+ IF filters that came from two different production lots. It is hoped that the specifications will be tightened on these filters to minimize this offset in the future.

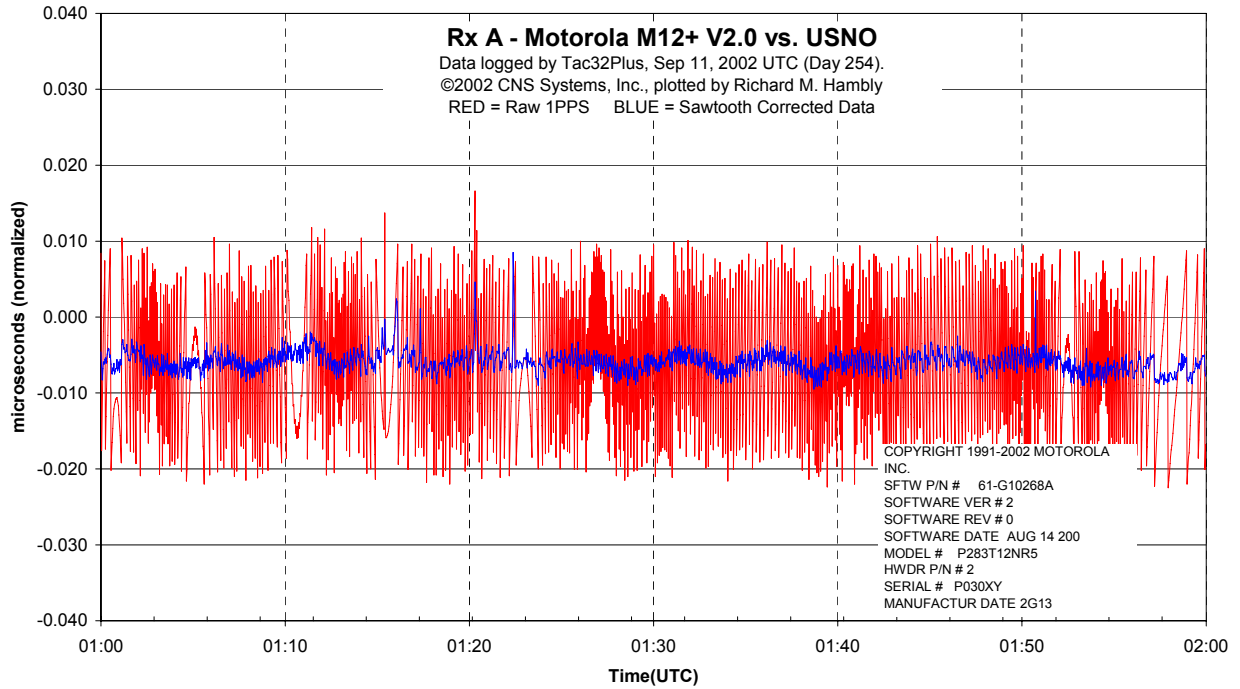
Figure 6. Short-term 1PPS noise.

The 1-hour short-term 1PPS noise for the post-calibrated M12+ Timing receiver is shown in Figure 6. The raw 1PPS shows the expected noise dominated by the quantization of the samples at twice the clock frequency of 16.367 MHz.

$$\frac{1}{2 \cdot 16.367 \cdot 10^6} = 30.55 \text{ ns } pk - pk$$

The line down the center of the short-term noise chart shows the effect of applying the sawtooth correction factor provided each second by the M12+ receiver to the raw data provided by the time interval counter. This allows for real-time correction of the quantization error and reduces the residual noise to about 5 nanoseconds peak to peak (pk-pk).

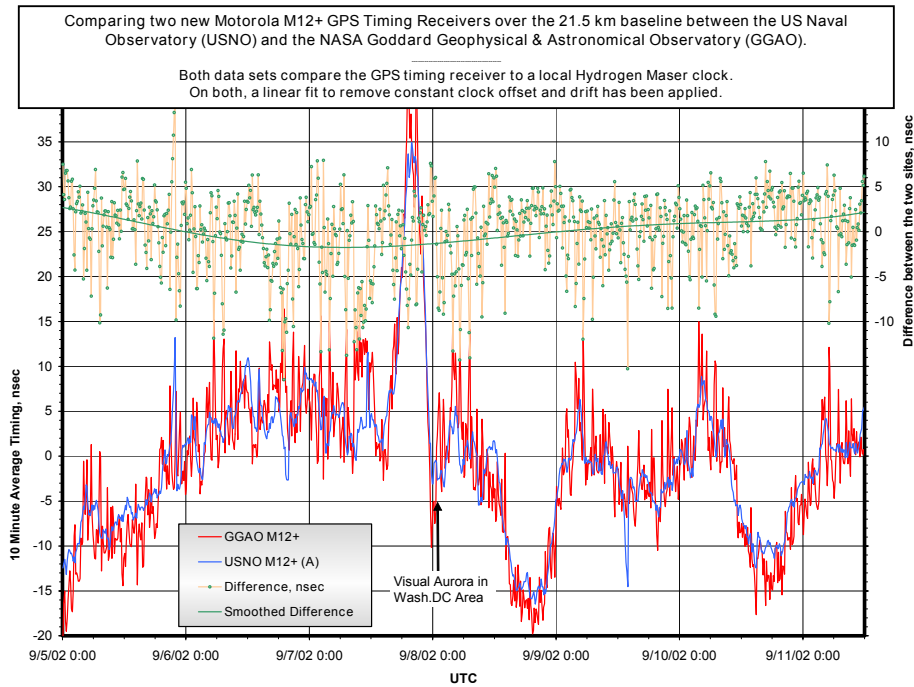
Figure 7. 21.5 km baseline test.

The results of this test are shown in Figure 7, comparing the performance of the “A” receiver at USNO (blue) with GGAO (red). The ~1.2 μs “DC” offset at USNO and a small (< 1:1014) linear drift have been removed from the USNO data. Similarly, a ~6.8 μs “DC” and ~1:1013 rate offset have been removed from the GGAO data. Because of differences in the data acquisition at the two sites (100-second samples at USNO, 60 seconds at GGAO), the raw data have been smoothed to yield common 5-minute samples. Clearly, the two data sets are in close agreement, even during the ~40 ns transient associated with the 8 September solar event.

Figure 7 also shows the point-by-point timing differences between the two sites. The rms difference between the two sites is 4.2 ns, while the absolute peak-to-peak range is 30 ns. A part of this is like due to small (< 1 ns/day/day) rate changes between the underlying hydrogen maser “flywheels.”
