**AFRL-RX-TY-TR-2008-4589**

# **EVALUATION OF TWO SKID-MOUNTED CORE DRILLS FOR AIRFIELD PAVEMENT EVALUATION**

**AUGUST 2008**

**Interim Report for 1 October 2007 – 31 July 2008**

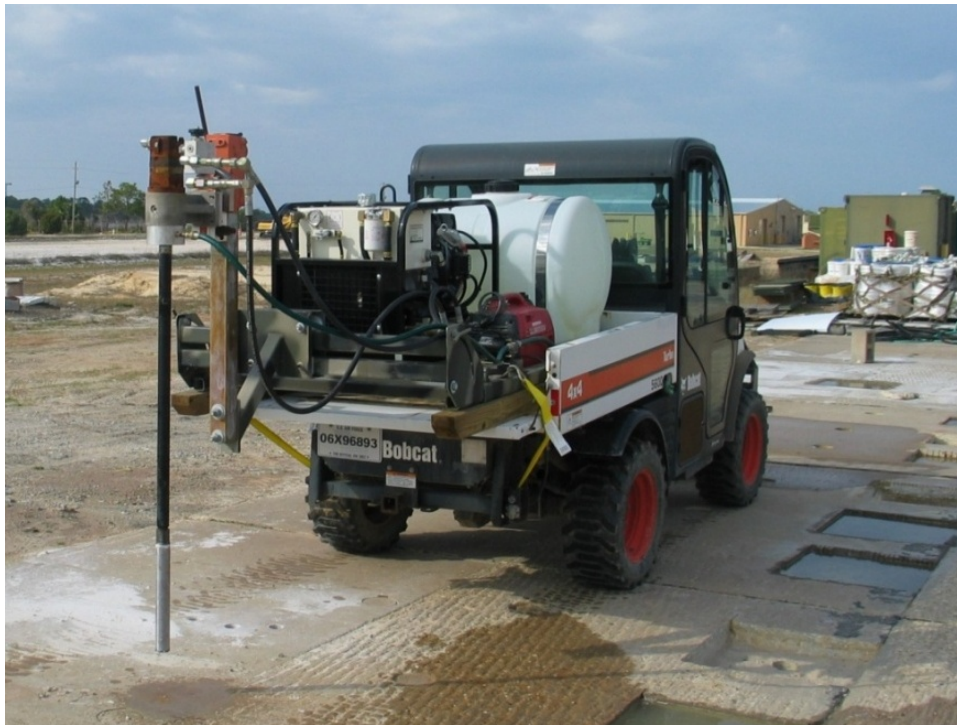
*Figure 1. Hydraulic Motor-Powered Core Drill*

The two drills tested included a hydraulic motor-powered drill (Figure 1) and an electric motor-powered drill (Figure 2), each of which are shown placed in the cargo bed of a small utility vehicle.

The hydraulic drill motor was powered by a Hydatech hydraulic pump model number HT20G. The hydraulic pump was driven by an electric motor powered by a Honda generator. However, there was no on-board source of power to operate the water pump, and auxiliary 110-volt electric power from a portable generator was required to operate the water pump.

Both drills were individually placed in a small utility vehicle as shown in Figures 1 and 2. From the outset of the project, AFRL planned to evaluate the drills using a small pickup truck as the platform. However, the units were too wide to fit between the pickup's wheel wells. AFRL chose the smallest vehicle available at the laboratory that contained sufficient cargo space to handle the footprint of the drills.

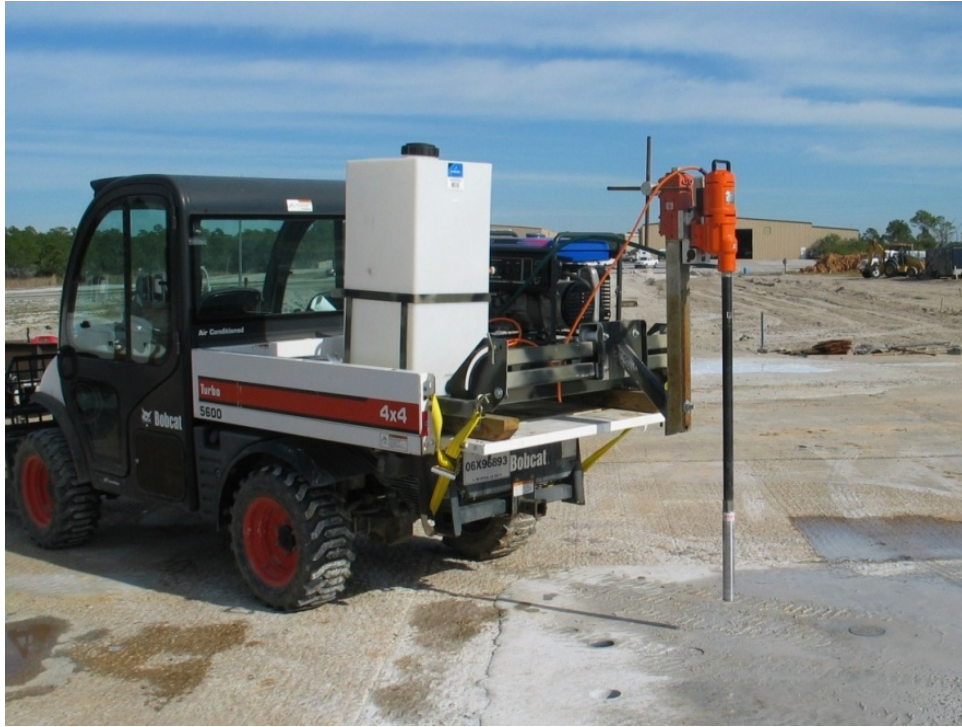
*Figure 2. Electric Motor-Powered Coring Drill*

The electric drill requires 110-volt alternating current (AC) power, and the unit contains its own gasoline-powered Yamaha generator. No external power source was required for the electric drill and its water pump.

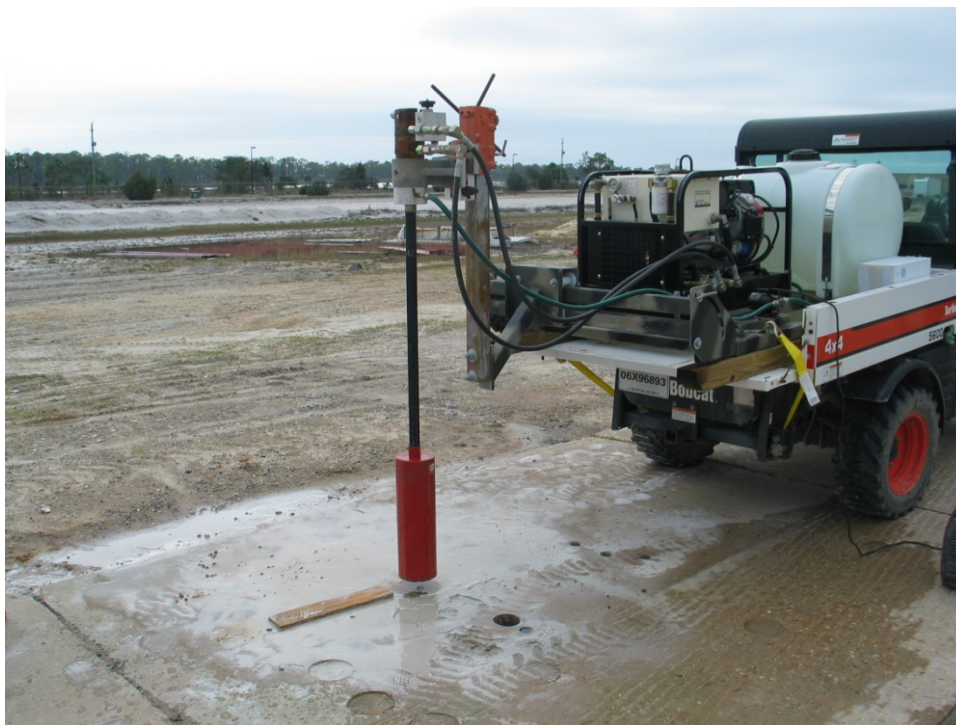
*Figure 3. Hydraulic Drill with 6-Inch-Diameter Core Barrel*

Evaluation consisted of using 2-, 4-, and 6-inch diameter core barrels on each drill. The time required to cut the cores was recorded along with the quantity of water used. Figure 3 shows an example photograph of the hydraulic drill with a 6-inch-diameter core barrel. Performance observations were made by AFRL technicians who are experienced operators familiar with the requirements of the APE Teams. Figure 4 shows a technician cutting a core with the electric drill.

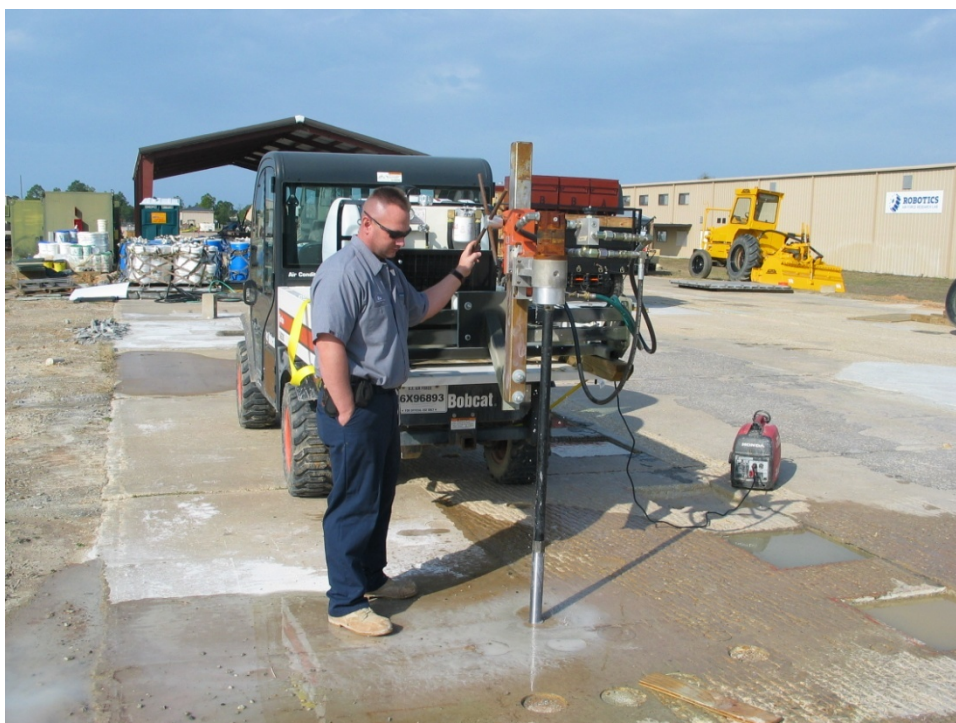
*Figure 4. Technician Cutting a 2-Inch-Diameter Core with Hydraulic Drill*

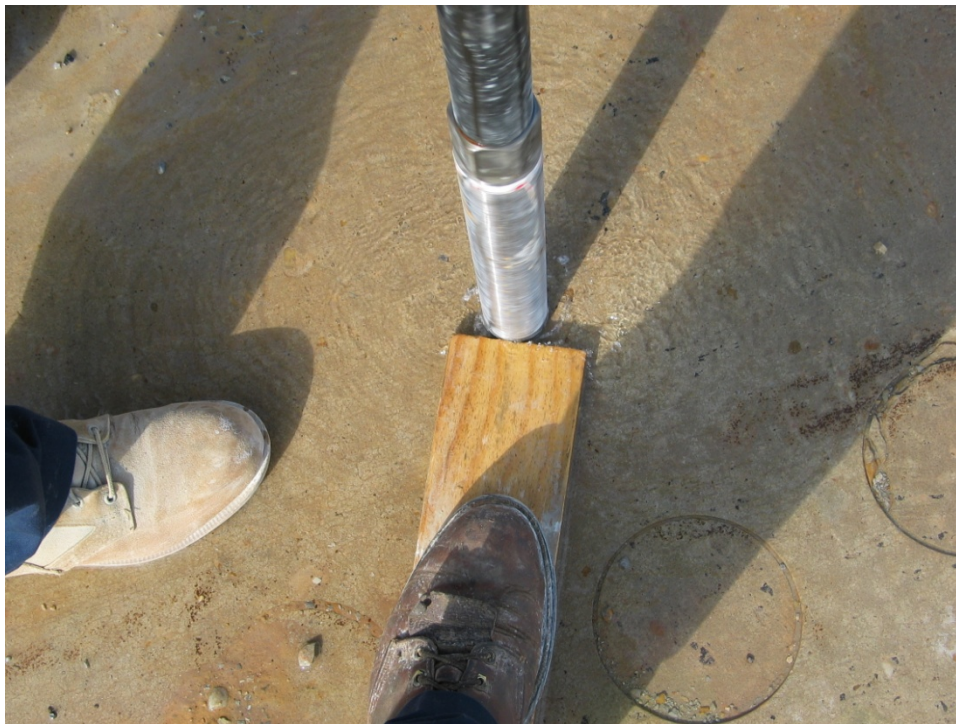
*Figure 7. Operators Using Lumber Plank to Keep Drill Plumb while Starting Core*

Both drills and adjoining shafts must be carefully plumbed prior to operation. ***This step is critical for safe operation of the units. If the drill shaft is not plumb, the barrel will not cut properly, and the potential for catastrophic failure of the shaft exists.*** AFRL technicians broke the shaft on the first series of testing resulting in life-threatening conditions and complete failure of the machine. The operator must check plumb at each core location. Two individuals are required to perform this--one to hold a one-foot-long level and the other to adjust the

alignment bolts. Figure 7 shows a photograph of operators improvising by using a wooden plank to keep the drill plumb while starting a core.
