## Noise and Reverberation Reduction in Post Chapel Activity Room

**U.S. Army  
Aeromedical Research  
Laboratory**

## Introduction

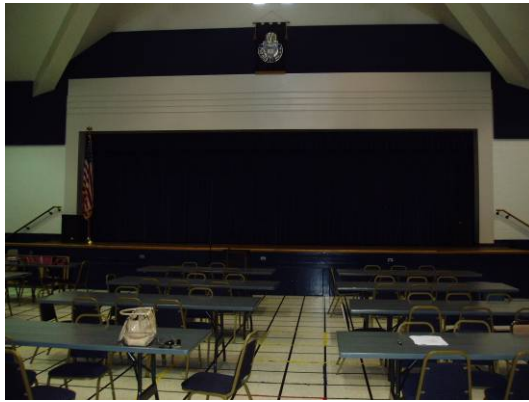
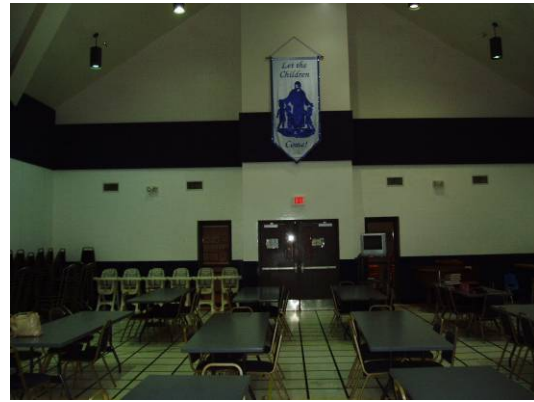
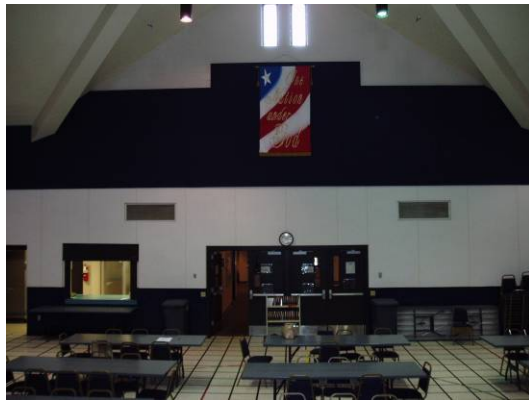
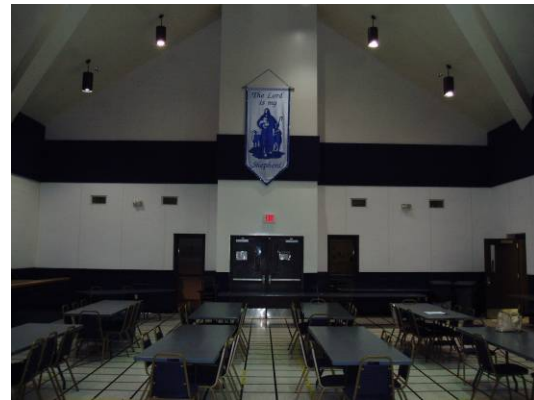
Figure 1a. Chapel Annex, north wall, with stage closed off by curtain.

Figure 1c. West (left side) wall.

Figure 1b. South (rear) wall.

Figure 1d. East (right side) wall.

The lower white-colored wall segments of rear and side walls show the original sound-absorbing paneling. The dark-blue covered wall segments are the newly added sound-absorbing wall panels. The white-colored areas above the blue panels are acoustically untreated brick wall segments.

The overhead ceiling baffle proposal was never executed but, instead, an additional amount (about 1000 ft<sup>2</sup>) of wall-mounted sound-absorbing panel material was added to the rear and side walls above the existing acoustic paneling. Figures 1a- through 1d provide an illustration of the four walls and their acoustical treatment; the dark-blue band represents the newly-installed added acoustic paneling. In June 2007, a second set of reverberation time measurements was made to quantitatively document the subjective acoustic improvement reported by the activity room users. This report details the equipment and methods used, the raw acoustic results, and the mathematics of extracting RT<sub>60</sub> reverberation times (i.e., the time required for a sound to decay by 60 decibels [db] in a space after the sound source is turned off). The report is also intended to demonstrate a relatively simple method to take such measurements using general-purpose equipment and dedicated signal processing software.
