**AFPTEF REPORT NO. 09-R-01  
AFPTEF PROJECT NO. 09-P-103**

**Performance Testing of the Hardigg M-9  
Weapons Case**

**AFMC 403 SCMS / GUEB  
AIR FORCE PACKAGING TECHNOLOGY & ENGINEERING FACILITY  
WRIGHT PATTERSON AFB, OH 45433-5540  
20 Feb 2009**

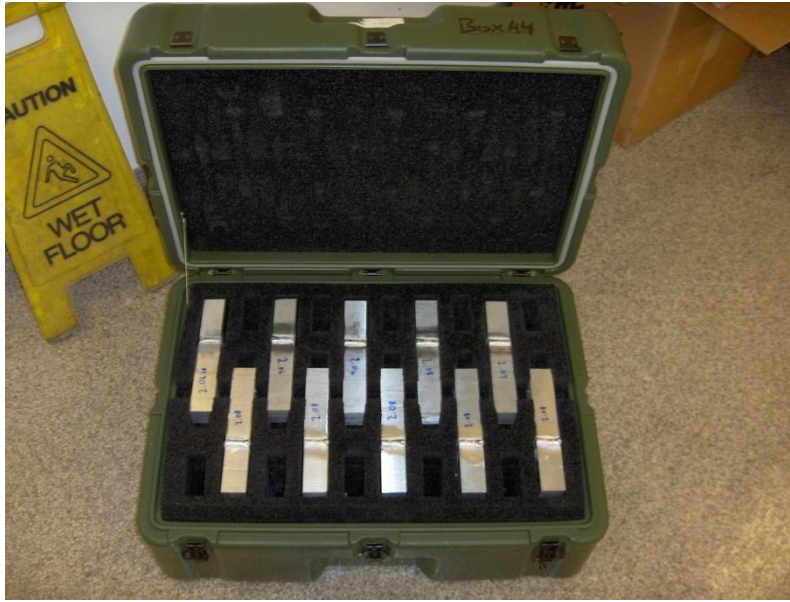
**Figure 1a.** Case with dummy loads inserted.

**DESIGN** – The Hardigg M9 case (Appendix 2, Figure 1a) consists of a rotational molded, gasketed polyethylene clamshell with custom-cut polyethylene foam on the inside. External hardware includes 3 stainless steel hinges, 5 half-turn latches, two plastic handles, a pressure relief valve, and a humidity indicator. Foam cutouts will accommodate 10 M9 pistols with 10 spare magazines.

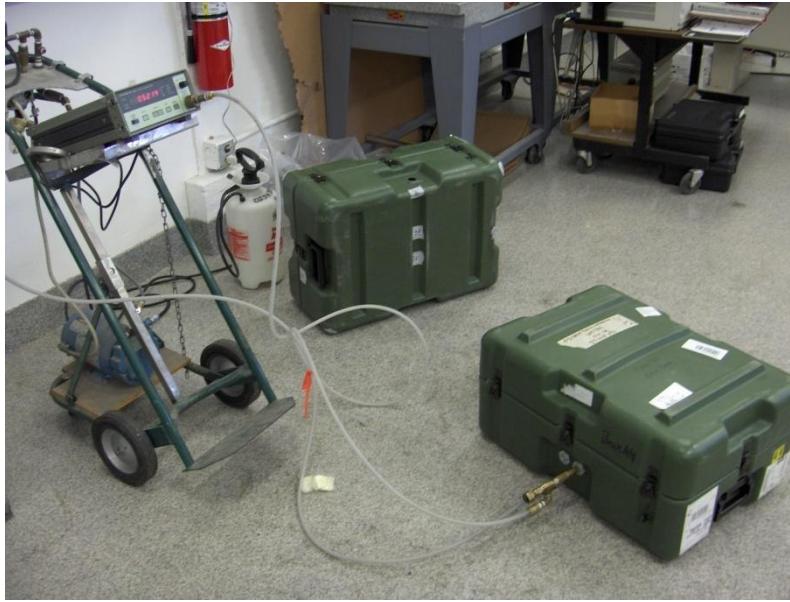
**Figure 2.** Leak test setup for case #2.

Procedure – The breather valve was removed and replaced with a flanged fitting modified for attachment of the digital manometer and vacuum/pressure pump lines. The container was closed and latches tightened. The pneumatic pressure leak technique was used to pressurize the container to a minimum test pressure of 0.5 psi (Appendix 2, Figure 2). Maximum allowable leak rate is 0.05 psi per hour. The leak test was conducted at ambient temperature and pressure.

Results – Fail: The first container failed the leak test with a leak rate in excess 0.05 psi *per minute*. The second container failed the leak test with a leak rate of approximately 0.10 psi per hour. Leaks were found *around the entire perimeter* of both cases. Note the indentations found on the gasket surface at room temperature (Appendix 2, Figure 3a and 3b). From a design standpoint, the gasket material and/or the number of latches is inadequate for this case.

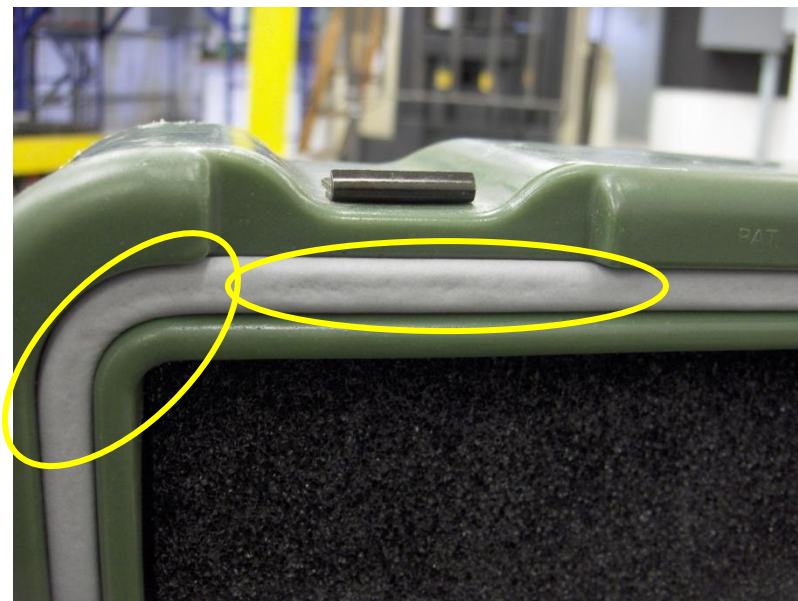
**Figure 3a.** Gasket surface indentation – corner of case.

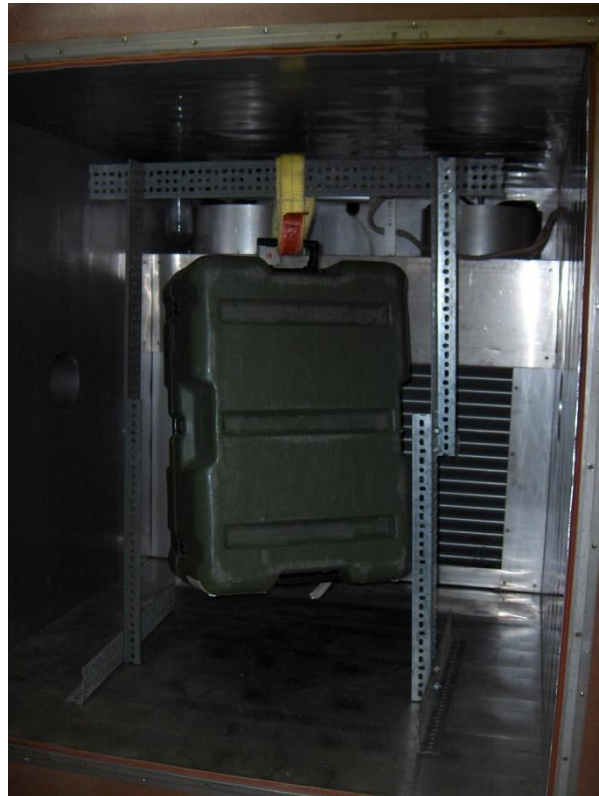
**Figure 4.** Handle strength test, hot.

Procedure: The case was suspended from one of the handles for 1 hour at a temperature of 160°F (Appendix 2, Figure 4).

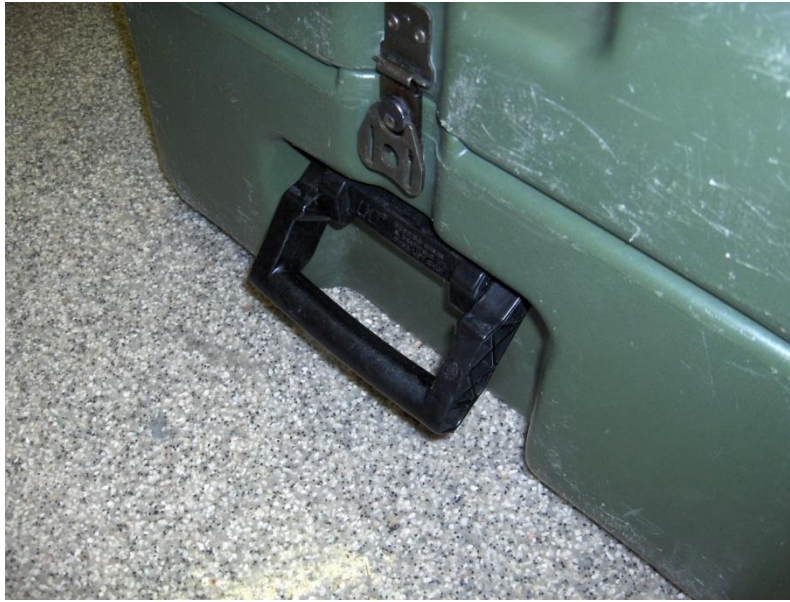
**Figure 7.** Sticking of tested handle.

of *permanent* deformation remained (Appendix 2, Figure 6), but the handle is still functional. When raised and lowered slowly, the handle sticks and does not drop freely to the side of the case (Appendix 2, Figure 7). If it is raised and released, there is enough spring force to return the handle to the side of the case.

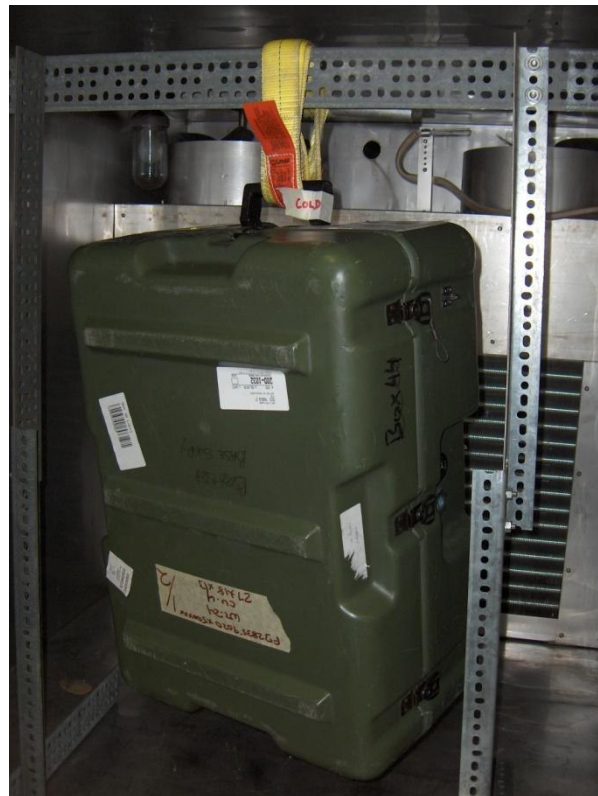
**Figure 8.** Handle strength test, cold.

Procedure – The case was suspended from the opposite handle for 1 hour at a temperature of -50°F (Appendix 2, Figure 8).

Results – Pass: The handle deformed *temporarily* to the point that, when released, it did not drop freely to the side of the case. Within 24 hours the handle returned to the original shape.

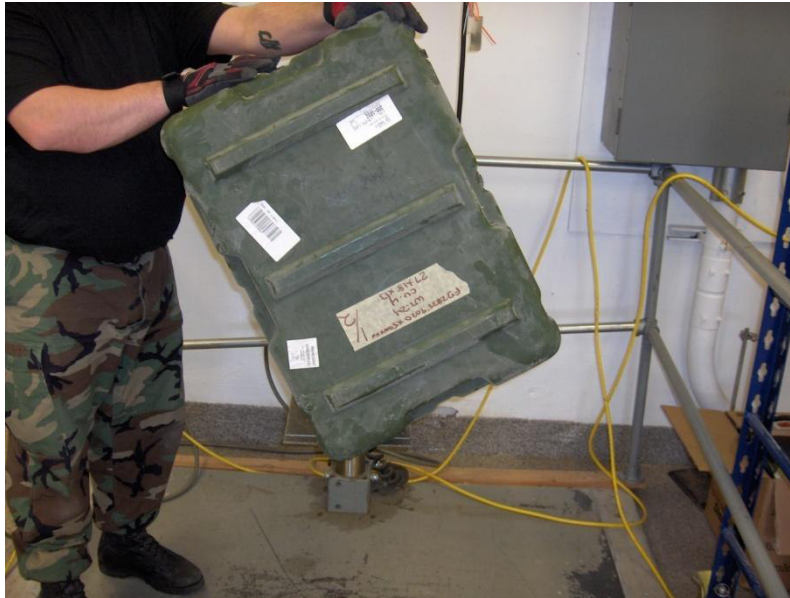
**Figure 9.** Freefall drop test, cold.

Procedure – The case was conditioned for 24 hours at a temperature of -40°F, and then dropped six times from a height of 24 inches (Appendix 2, Figure 9). Impact locations were as follows:

Results – Pass: The impacts caused no visible damage to either the container or the items. There were slight indentations to the case from resting on the edge of the drop testing platform.

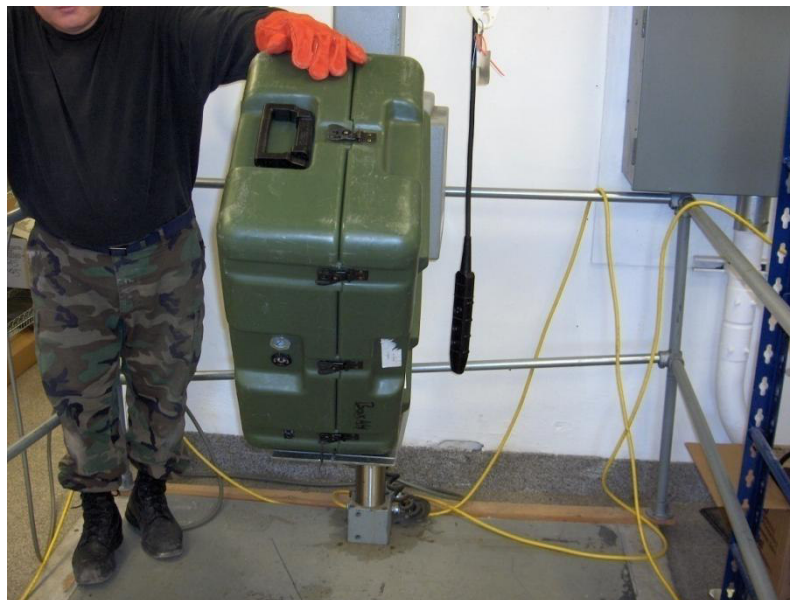
**Figure 10.** Freefall drop test, hot.

Procedure – The case was conditioned for 24 hours at a temperature of 140°F, and then dropped from a height of 24 inches (Appendix 2, Figure 10). Impact locations were as follows:

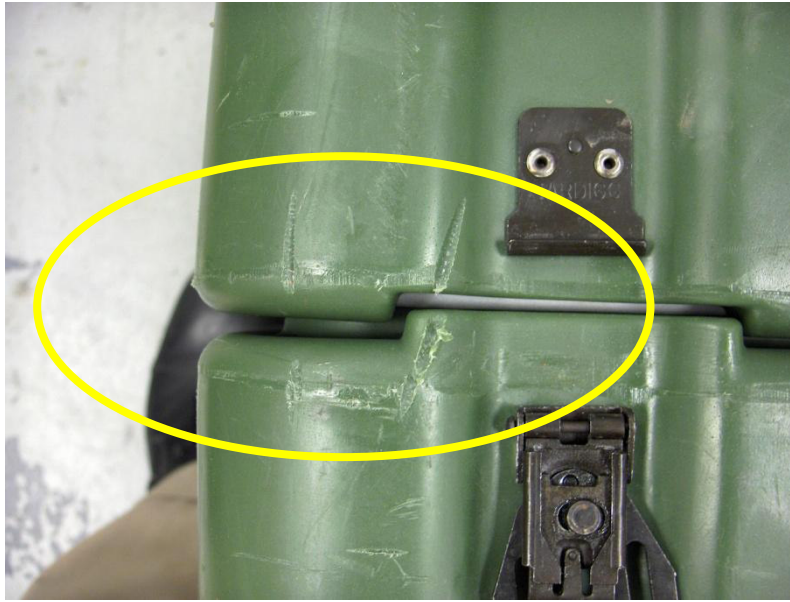
**Figure 11.** Scratches due to contact with edge of the drop tester.

Results – Pass: The impacts caused no visible damage to either the container or the items. There were slight indentations to the case from resting on the edge of the drop testing platform (Appendix 2, Figure 11). Items also shifted around in the case (Appendix 2, Figure 12), due to softness of the foam at high temperatures and the shape of the dummy items (Appendix 2, Figure 13). However, the trigger portion of a real M9 rests in the foam such that it prevents the item from sliding around in the case.

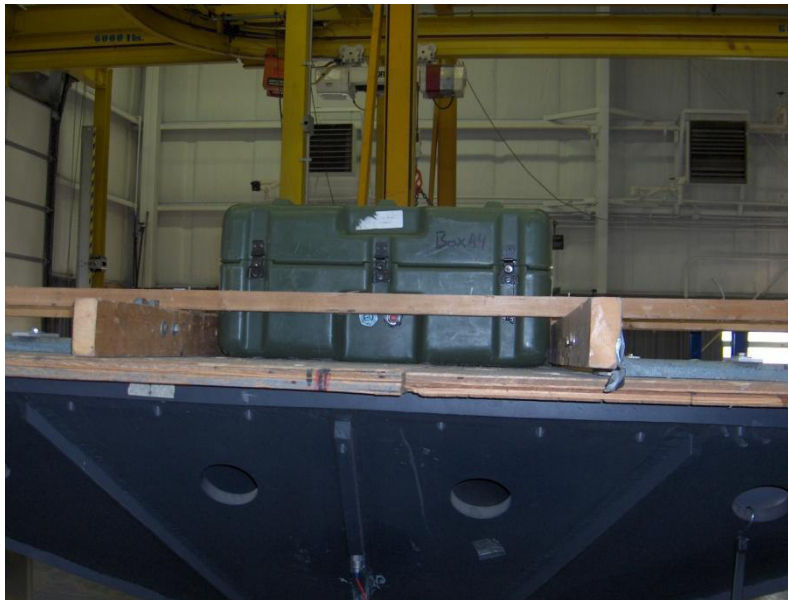
**Figure 14.** Loose load vibration test.

Procedure – A sheet of 3/4-inch plywood was bolted to the top of the vibration table, and the container was placed on the plywood. Restraints were used to prevent the container from sliding off the table. The container was allowed approximately 1/2-inch unrestricted movement in the horizontal direction from the centered position on the table (Appendix 2, Figure 14).

The table frequency was increased from 3.5 Hz until the container left the table surface (approximately 4.0 Hz). At one-inch double amplitude, a 1/16-inch-thick flat metal feeler could be slid freely between the table top and the container under all points of the container. Repetitive shock testing was conducted for 2 hours at ambient temperature.

Results – Pass: The loaded container was vibrated at 4.0 Hz for 2 hours. At the end of testing there was no visible damage to the either the container or the item.

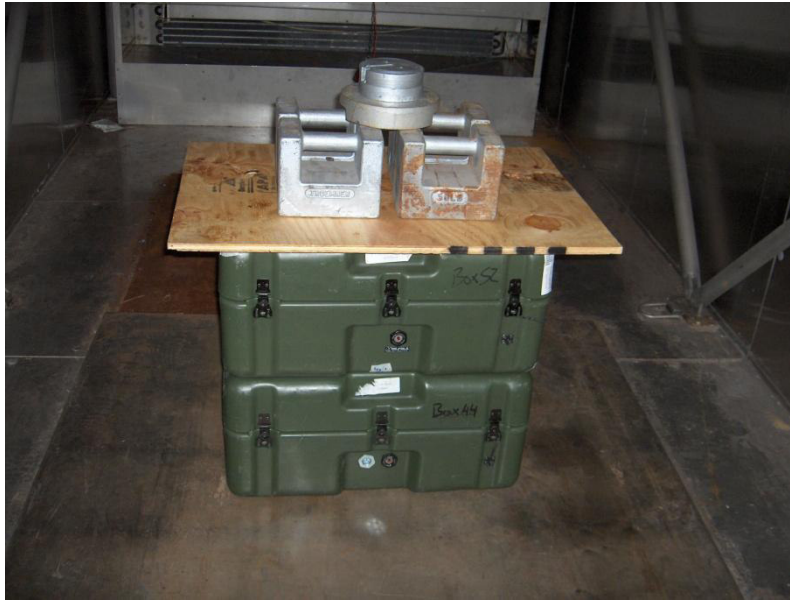
**Figure 15.** Warehouse stacking test.

Procedure – A 250-pound static load, consisting of the spare weapons case (#1 from leak test), a sheet of plywood, and iron weights, was set on top of the test case (Appendix 2, Figure 15). The stacked configuration was placed in an environment at 140°F and 90% relative humidity for 24 hours. The chamber was shut down, with the stacked configuration remaining in the closed chamber for 6 more days. Although test time was shortened from 168 hours as specified in the test plan, 24 hours at the test point (140°F and 90% RH) is sufficient to expose structural weakness of the container.

Results – Pass: There was no visible damage to the either the container or the item.

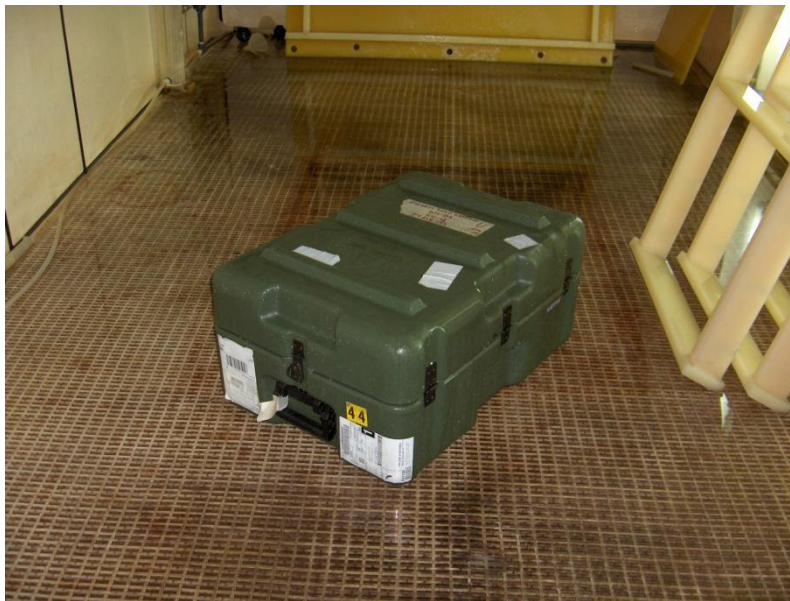
**Figure 16.** Rain chamber test.

Procedure – As a follow-on to the failed leak test, AFPTEF wanted to demonstrate that the case would protect items from rain. The weapons case was placed in a rain chamber and subjected to 5 in/hour rainfall with 40-mph wind for a total of 90 minutes (Appendix 2, Figure 16). The case sat in two different orientations, with edges 5 and 6 facing into the wind for 45 minutes each.

Results – Pass: There were no signs of water intrusion into the case.

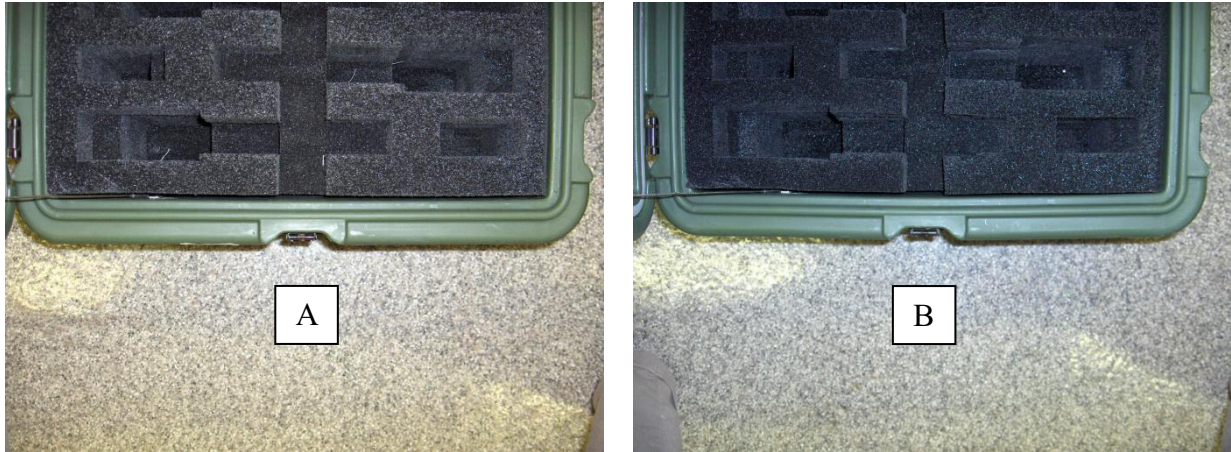
**Figure 17.** Comparison of untested case (A) with tested case (B). Note slight bowing-out of the left end of case B, caused by the hot handle strength test.

There was also a slight bowing-out of the left end of the case (Appendix 2, Figure 17) due to this test. This will not affect the ability of the case to protect the items. However, if the case had passed the initial leak check, this deformation may have diminished the sealing properties of the case.

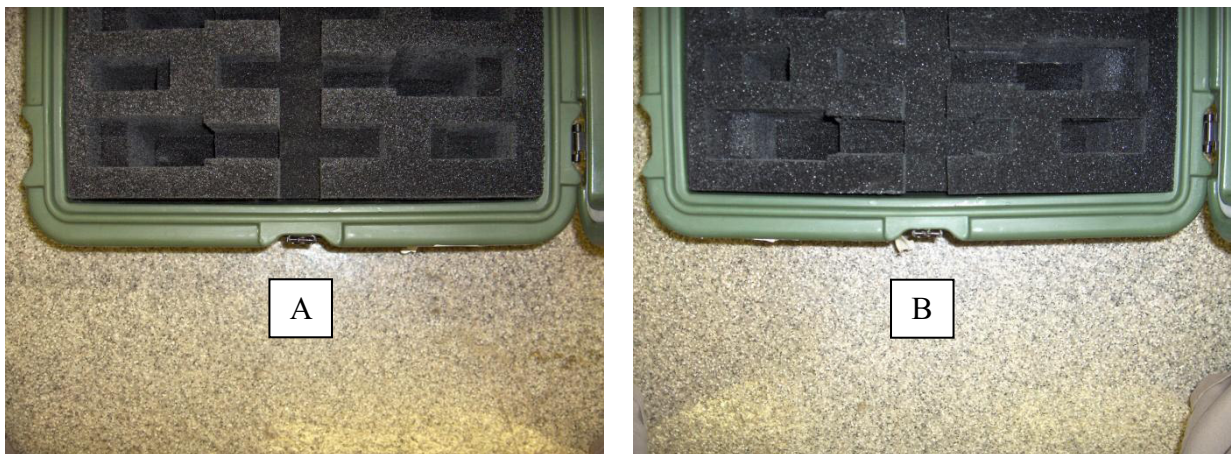
**Figure 18.** Comparison of untested case (A) with tested case (B). Note slight bowing-out of the right end case B, caused by the cold handle strength test.

There was also a slight bowing-out of the right end of the case (Appendix 2, Figure 18) due to this test. This will not affect the ability of the case to protect the items. As with Test Sequence 2, if the case had passed the initial leak check, this deformation may have diminished the sealing properties of the case.
