## **HIGH PERFORMANCE MAGAZINE CERTIFICATION TEST NO. 3: PLANNING AND RESULTS**

Robert N. Murtha  
Naval Facilities Engineering Service Center, Port Hueneme, CA

28<sup>th</sup> DDESB Seminar  
Omni Rosen Hotel  
Orlando, FL  
18-20 August 1998

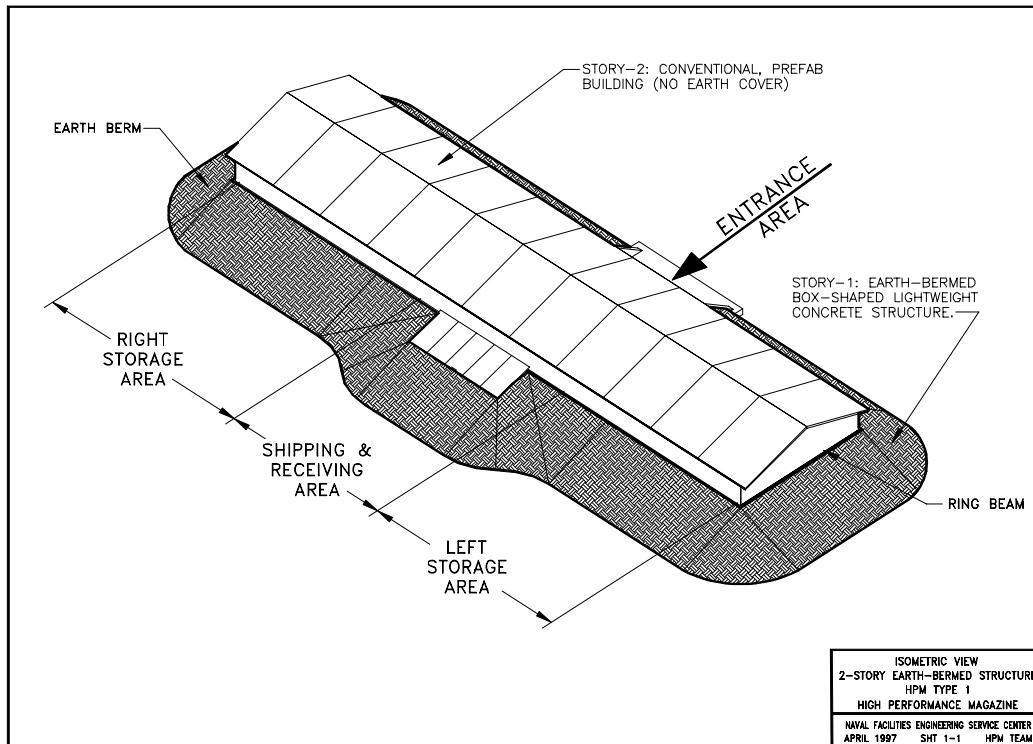
Figure 1. High Performance Magazine: Isometric view of magazine.

The conceptual design of the current (April 1997) HPM prototype is shown in Figures 1, 2, and 3. The HPM is a partially buried, earth-bermed, 2-story, box-shaped structure. Story-1 is partially buried and earth-bermed along all four sides of the concrete structure, to an elevation slightly above the maximum possible elevation of stored ordnance. Story-2 is a conventional, prefabricated building with no earth cover. The second story protects personnel and ordnance handling equipment inside the magazine for local weather conditions. The earth berm serves as a barricade designed to prevent sympathetic detonation between adjacent magazines from fragments and debris. The earth berm also serves to direct blast overpressures and debris upward. The Entrance Area provides the path for vehicle access to the SRA. The vehicle entrance will accommodate a fully loaded truck. The SRA is used to load and unload conveyance vehicles. The vehicle is parked in the vehicle pit, which will accommodate a flatbed truck. A side-loading dock and rear-loading dock allow storage and retrieval of ordnance in side-loaded and rear-loaded covered conveyance vehicles, using a forklift truck located on the loading dock. Also, the side- and rear-loading docks plus the staging dock allow prestaging of ordnance before arrival of the transport vehicle. The weapons storage areas are located at both ends of the box structure. Each storage area consists of two storage pits, each 82'-0" x 20'-0" x 15'-6" (LxWxH). The storage pits provide protected space to store containerized and palletized ordnance. The storage pits are separated by a 9'-0" wide storage transfer aisle, for unobstructed transport of ordnance between storage pits and the SRA. A relocatable, modular, nonpropagation cell wall (5'-8" total thickness) may be added to a storage pit to subdivide a storage pit into two storage cells. Each storage pit has a cover, consisting of ten pit covers.

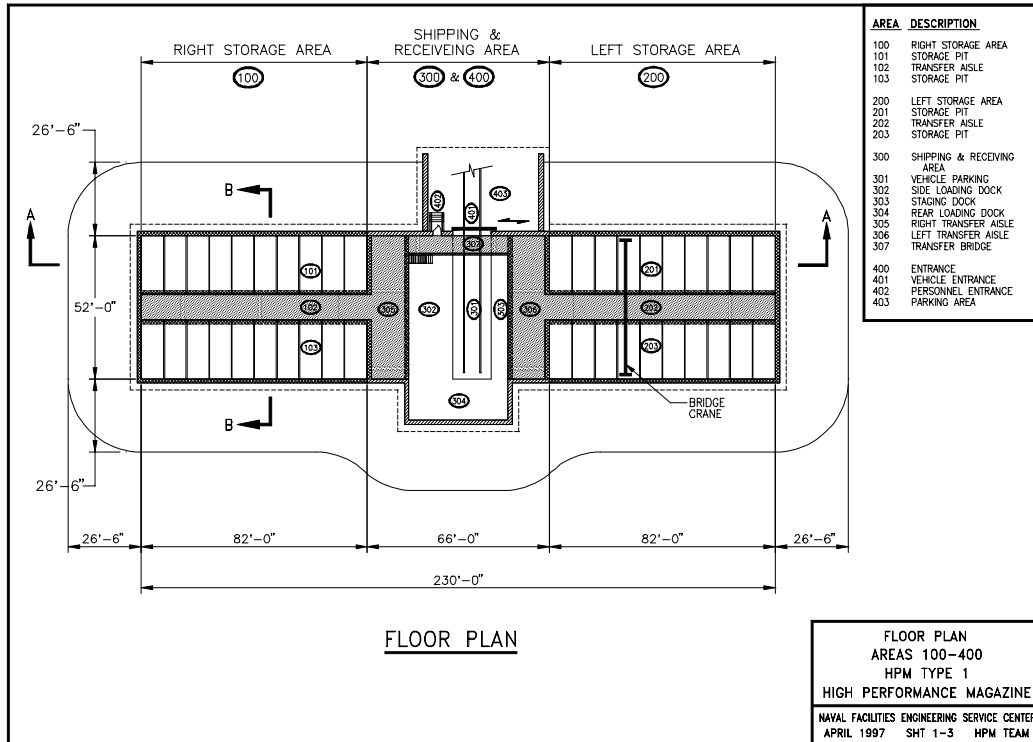
Figure 3. High Performance Magazine: Floor plan.

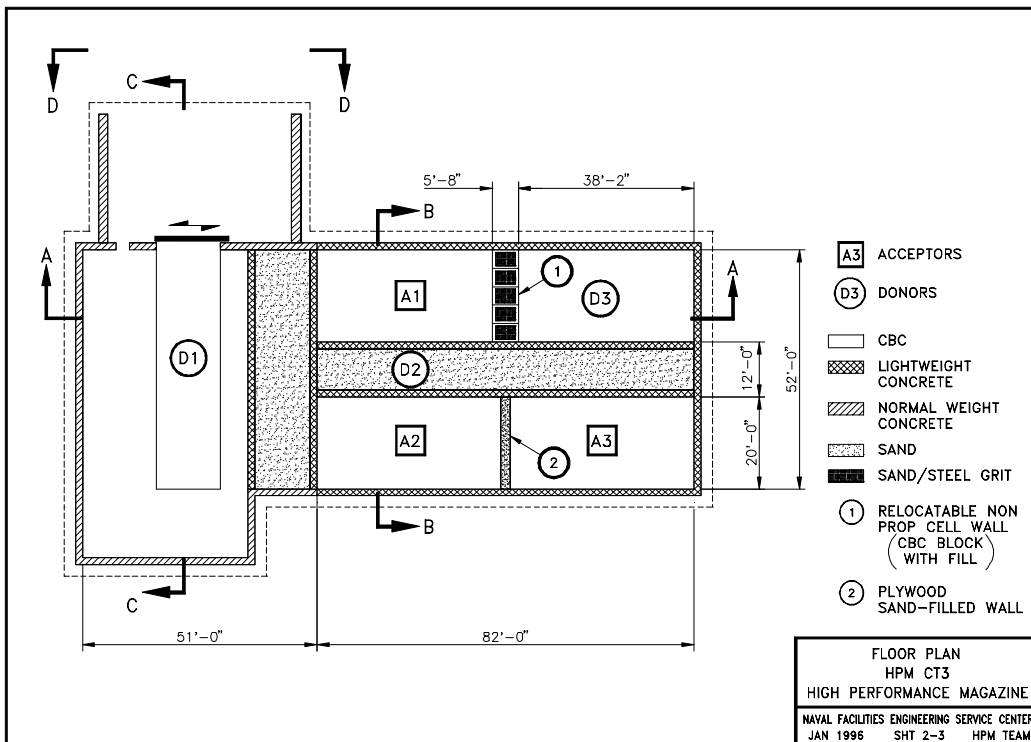
Figure 6. CT3 structure: Floor plan.

The floor plan of Story-1 is shown in Figure 6. The exterior walls of the Entrance Area and SRA, plus the structure floor and foundation are normal weight reinforced concrete. The exterior walls around the storage area and the transport aisle walls are lightweight structural concrete. The gross internal volume of the structure is 133'-0" x 52'-0" x 28'-3" (LxWxH). The top of the earth berm is 3'-0" above the storage area height. An exterior photograph of the completed structure is shown in Figure 9.

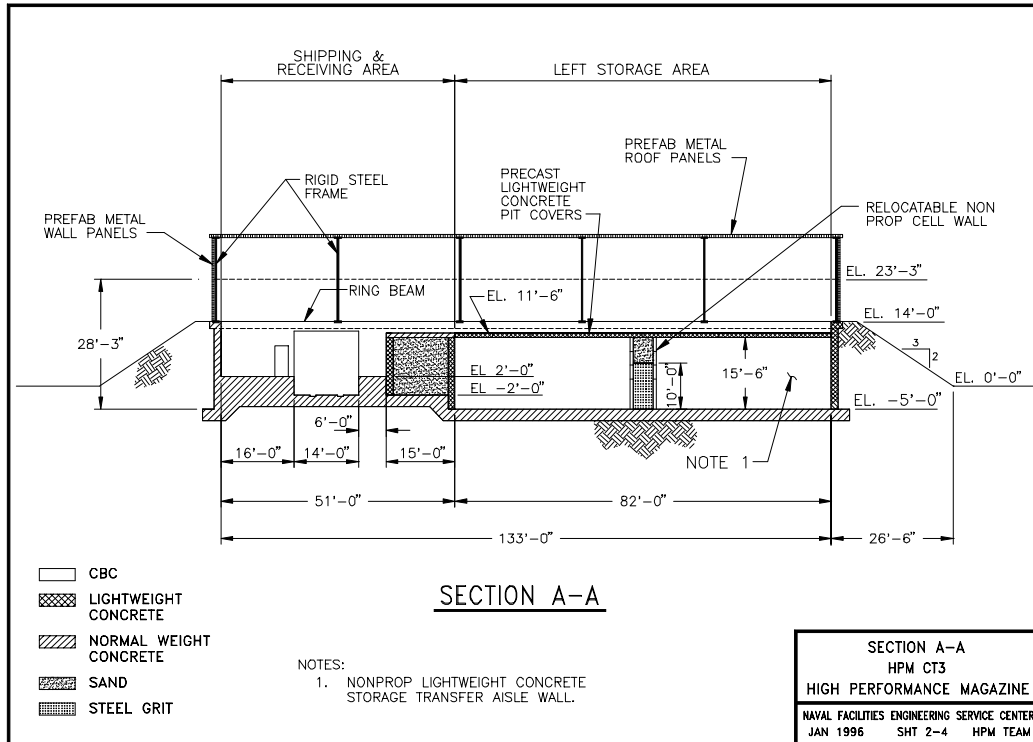
Figure 7. CT3 structure: Section A-A.

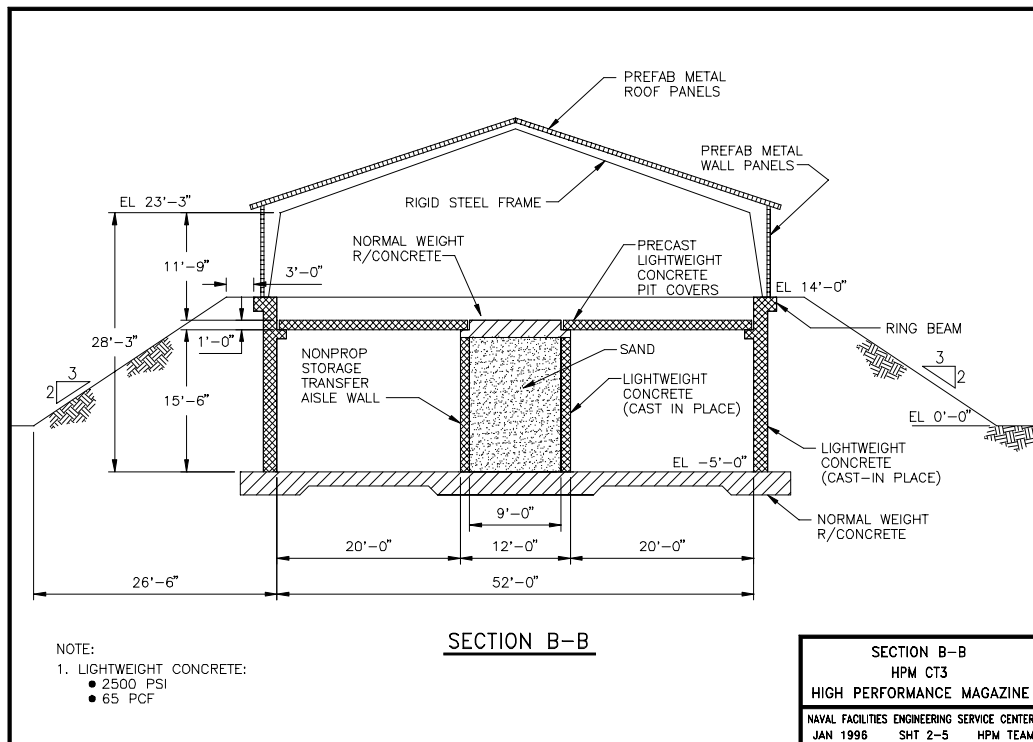
Figure 8. CT3 structure: Section B-B.

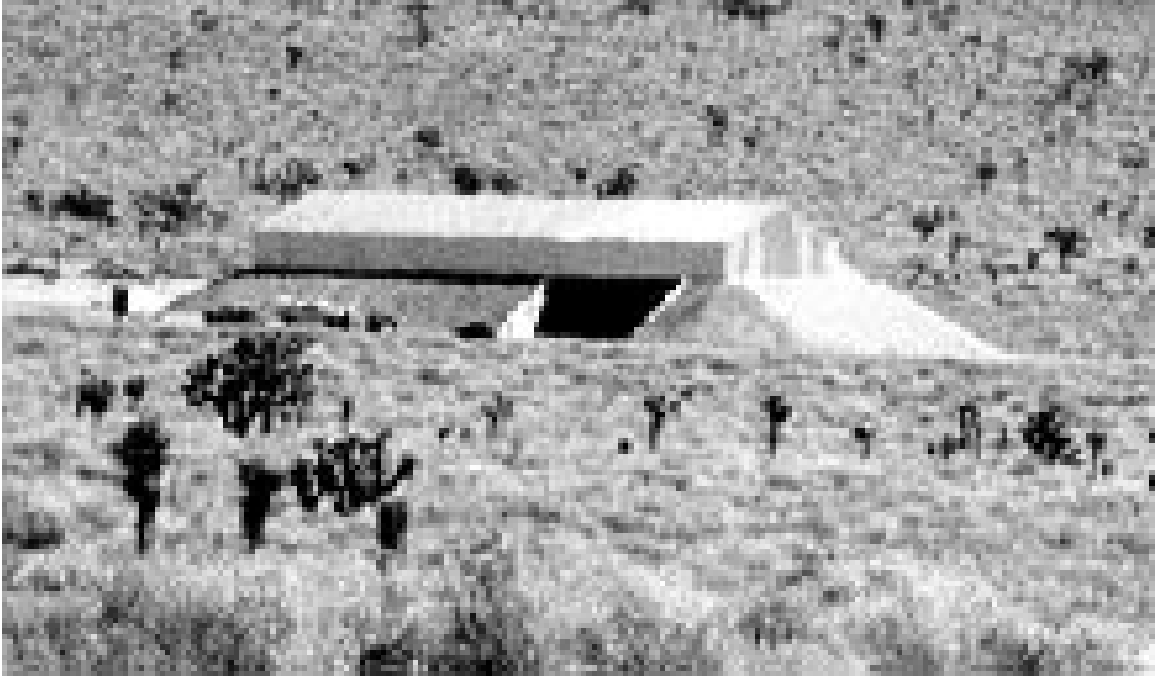
Figure 9. Exterior view of CT3 structure.

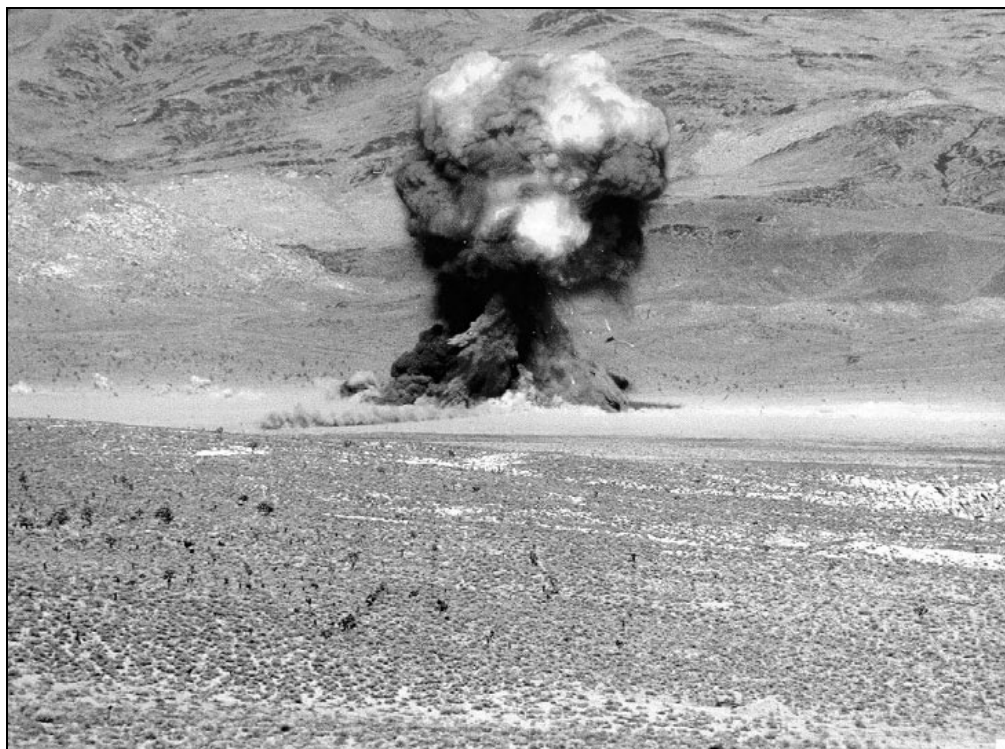
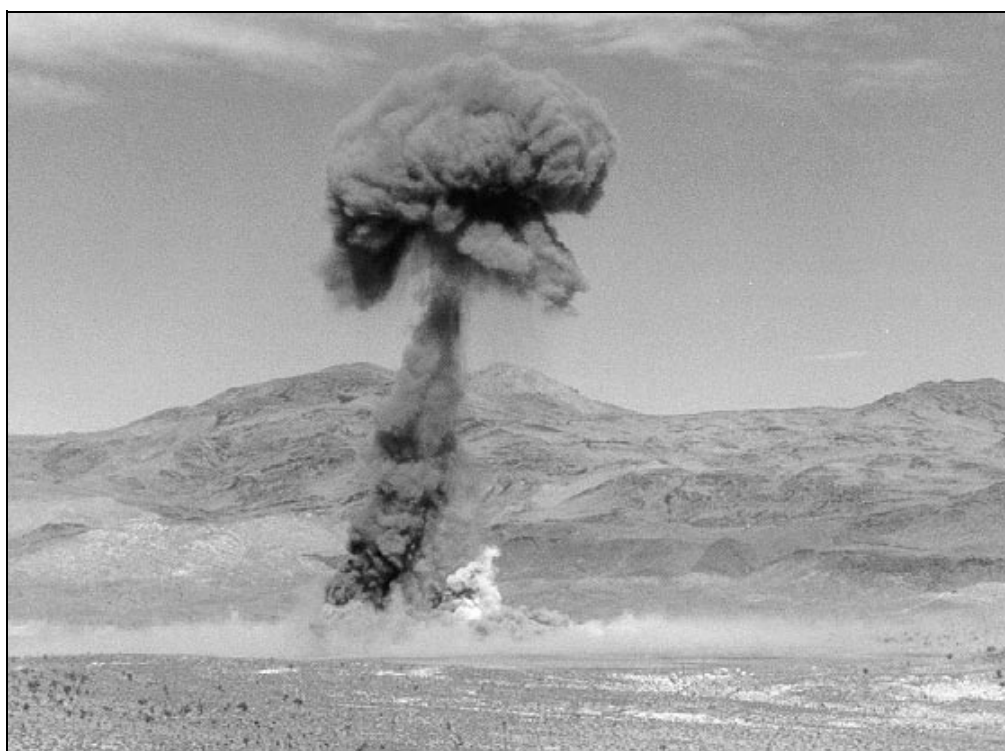
Figure 16a. CT3 site: Detonation sequence photographs.

Figure 16b. CT3 site: Detonation sequence photographs.

HPM CT3 was conducted on 24 October 1996. All 288 Mk82 and 4 Mk84 donor bombs were successfully detonated and the CT3 structure was destroyed. A 4-shot sequence of far-range photographs of the detonation is shown in Figure 16.

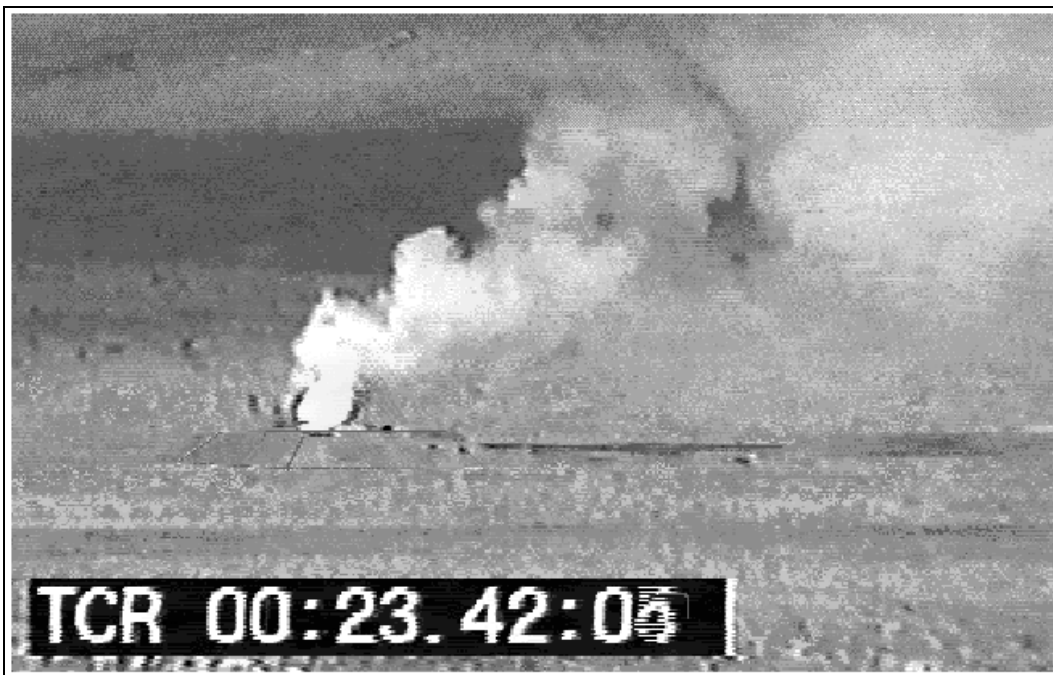
Figure 18. CT3 site: Video image at  $T_D + 16$  min 57 sec.

The list is based on analyses of the video tapes and direct on-site observations by NFESC, NAWC, and ISA personnel. Low resolution images captured from these tapes are shown in Figures 17 and 18. Figure 17 shows the white smoke from the early-time ( $T_D + 20 \text{ sec}$ ) burning explosives which eventually burned out when the explosives were consumed. Figure 18 shows the 3<sup>rd</sup> late-time

reaction in Cell A1 at  $T_D + 16 \text{ min } 57 \text{ sec}$ .

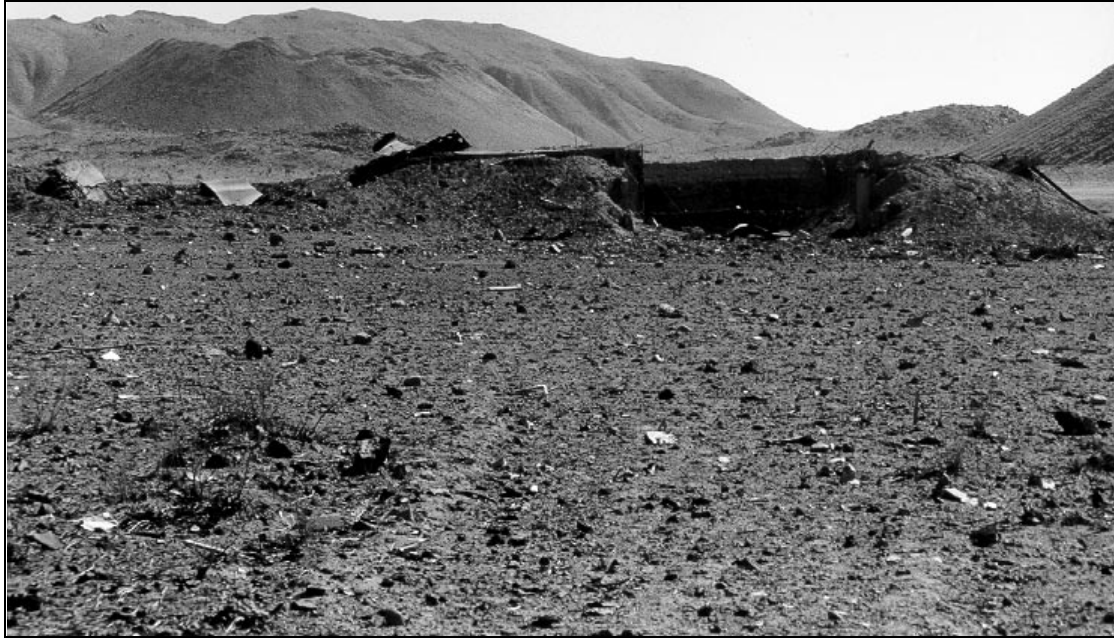
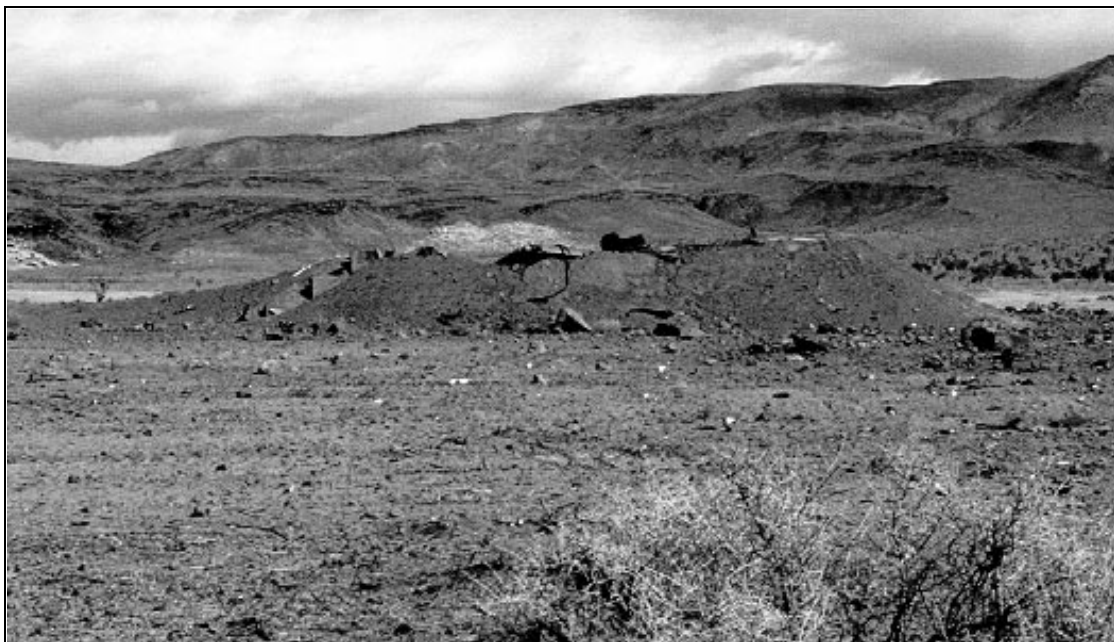
Figure 19a. Post-test views of CT3 structure.

Figure 19b. Post-test views of CT3 structure.

Photographs taken the next day of the exterior CT3 site are shown in Figure 19. None of the 2<sup>nd</sup> story structure remained. Closer views of the interior damage to the CT3 structure are shown in Figures 20, 21, and 22. The exterior concrete walls of Cell D3 were destroyed and small pieces of concrete were thrown outside the structure. The exterior walls of the SRA and the three acceptor cells were rotated outward against the soil berm. The following internal nonpropagation walls were destroyed and completely missing:
