**AL KAZIM WATER SUPPLY  
NASSRIYA, IRAQ**

**SIGIR PA-08-125  
JULY 23, 2008**

SUBJECT: Report on Construction of the Al Kazim Water Supply, Nassriya, Iraq (Report  
Number SIGIR PA-08-125)

## Al Kazim Water Supply, Nassriya, Iraq

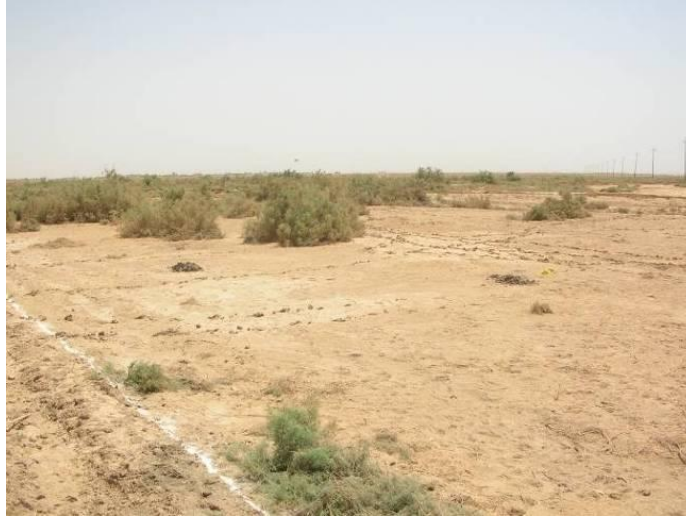
**Site Photo 1. Location of the compact unit site (Courtesy of the USACE)**

The land in general is low-lying at approximately 1-2 meters above sea level and can be well irrigated through a system of pump engines, locks, and channels (Site Photos 1 and 2).

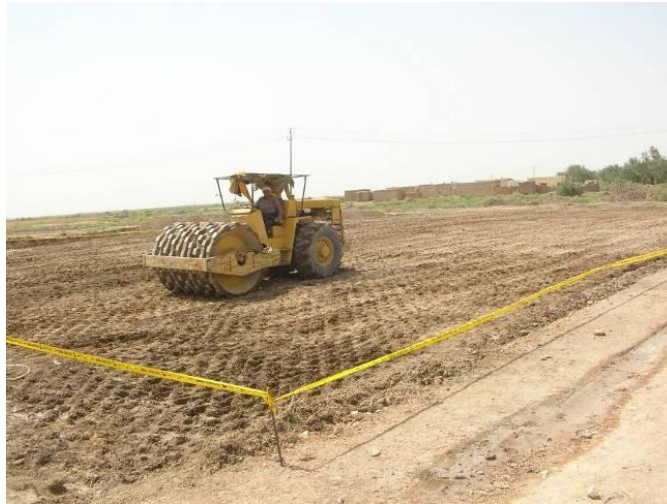
Prior to construction, the contractor excavated and leveled the site. Site Photo 3 shows the contractor's compaction of the first layer of backfill, and Site Photo 4 shows the contractor testing the compaction of the first layer of backfill.

**Site Photo 3. Compaction of first layer of backfill (Courtesy of the USACE)**

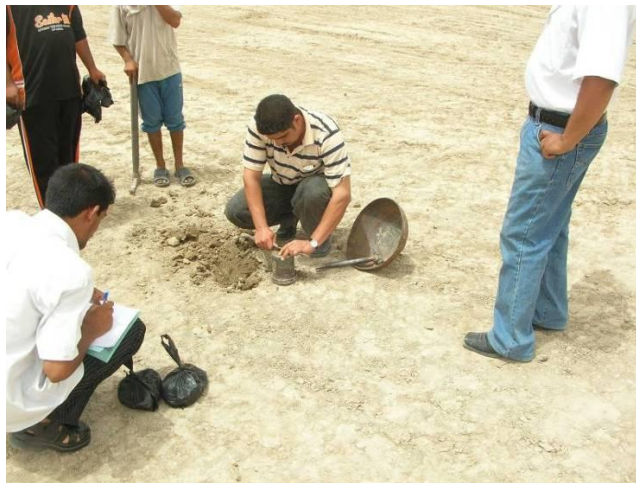
**Site Photo 4. Compaction test of first layer of backfill (Courtesy of the USACE)**

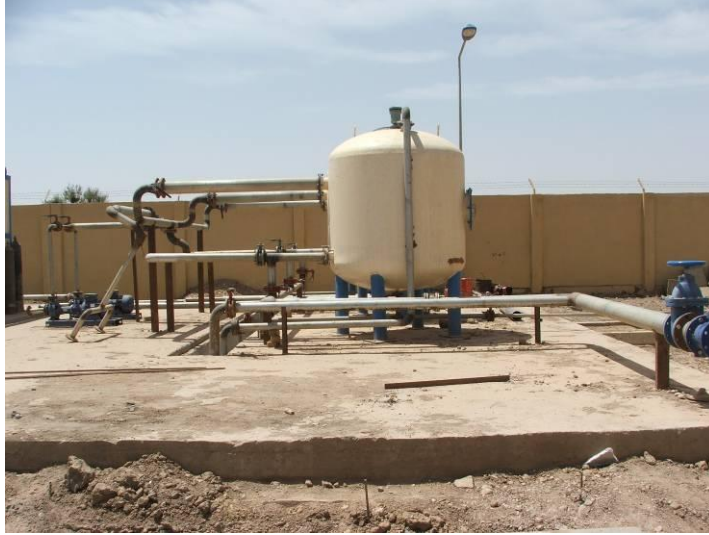
The contractor constructed a new reinforced concrete pad for the 50-m<sup>3</sup>/hr compact unit water treatment plant (Site Photo 5). The structural concrete SIGIR observed did not have any noticeable cracking, segregation, or honeycombing areas.

**Site Photo 5. Reinforced concrete pad for 50-m<sup>3</sup>/hr compact unit water treatment plant**

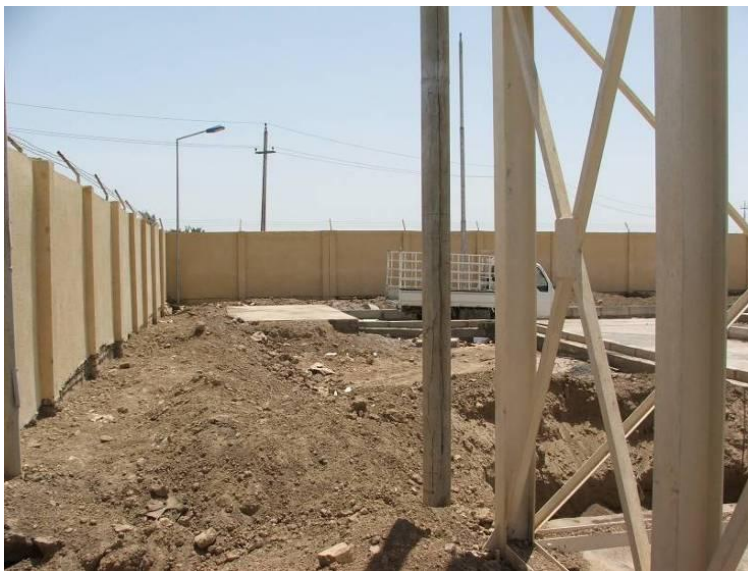
SIGIR observed significant work underway in the Al Kazim Water Supply construction area. For example, for the security of the plant and its operators, the description of work required exterior site fencing consisting of brick and topped with three strands of barbed wire. At the time of our second site visit, SIGIR observed that the exterior site fencing was nearly completed, including the three strands of barbed wire and perimeter lighting (Site Photo 6).

**Site Photo 6. Site fencing with barbed wire and perimeter lighting**

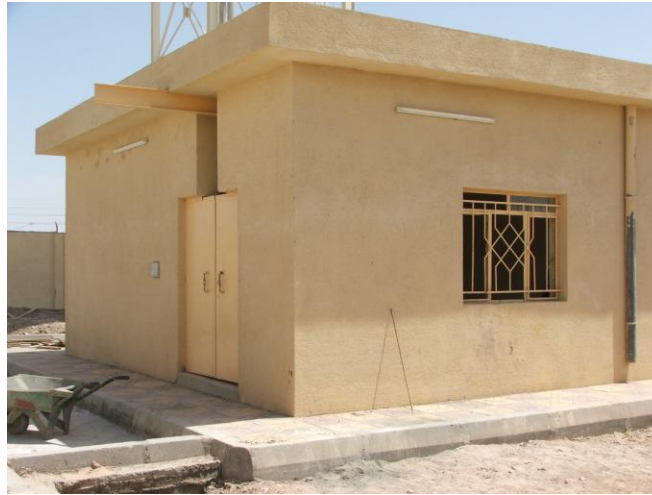
The contract included the construction of a chemical building (Site Photo 7), a water compact unit (Site Photo 8), an operator building (Site Photo 9), and a generator and fuel tank concrete foundation (Site Photo 10).

**Site Photo 7. Chemical building**

At the time of our second site visit, the contractor had not completed the chemical building, operator building, and water compact unit. For example, electrical work was still required in both the chemical and operator buildings (Site Photo 11). In addition, the contractor had not installed the crane for the chemical building (Site Photo 12). Further, the water compact unit sunshade and the generator and fuel tank sunshade were not constructed.

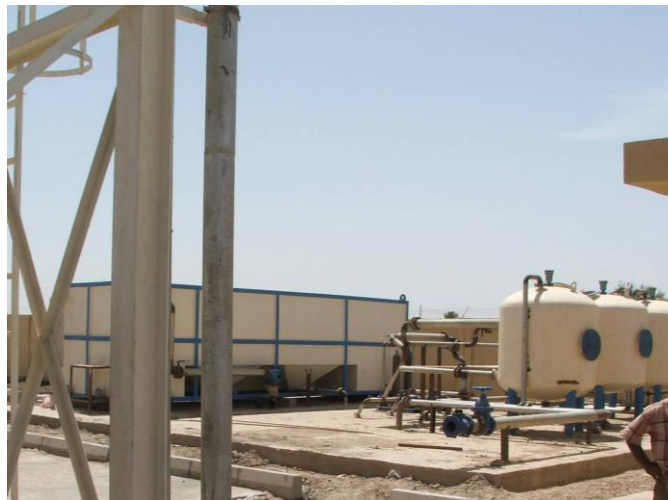
**Site Photo 8. Water compact unit**

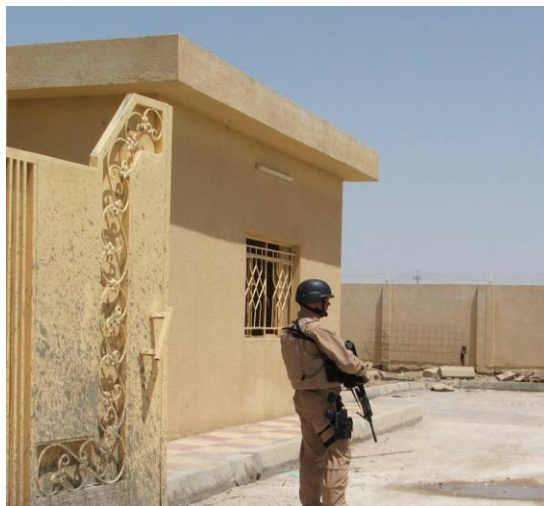
**Site Photo 9. Operator building**

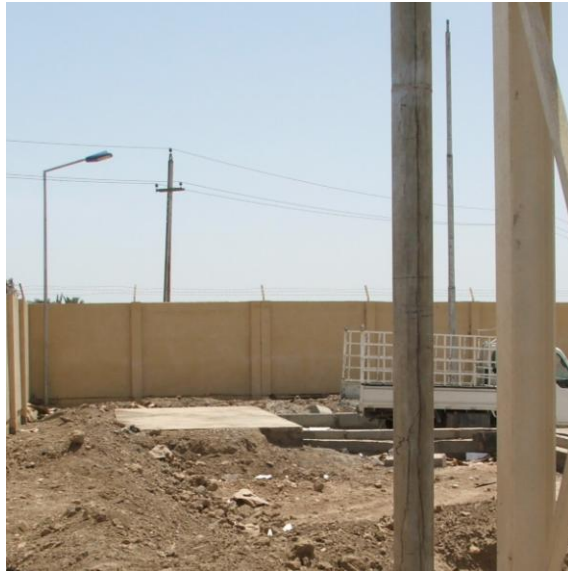
**Site Photo 10. Generator and fuel tank concrete foundation**

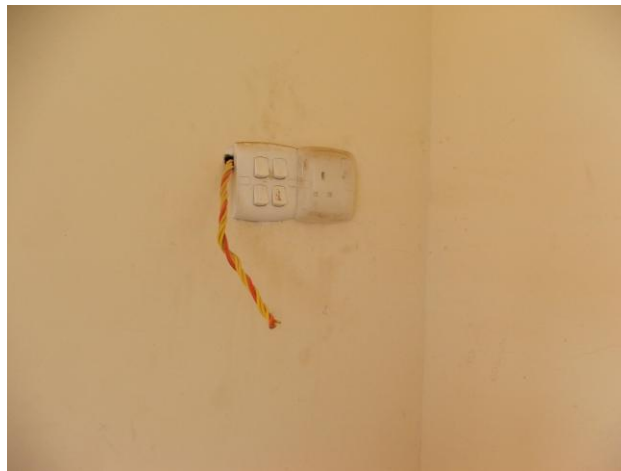
**Site Photo 11. Electrical work left unfinished**

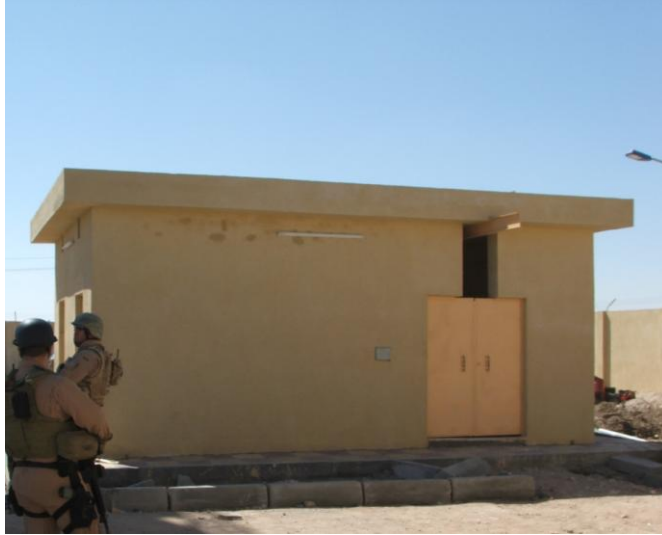
**Site Photo 12. Chemical building's crane in progress**

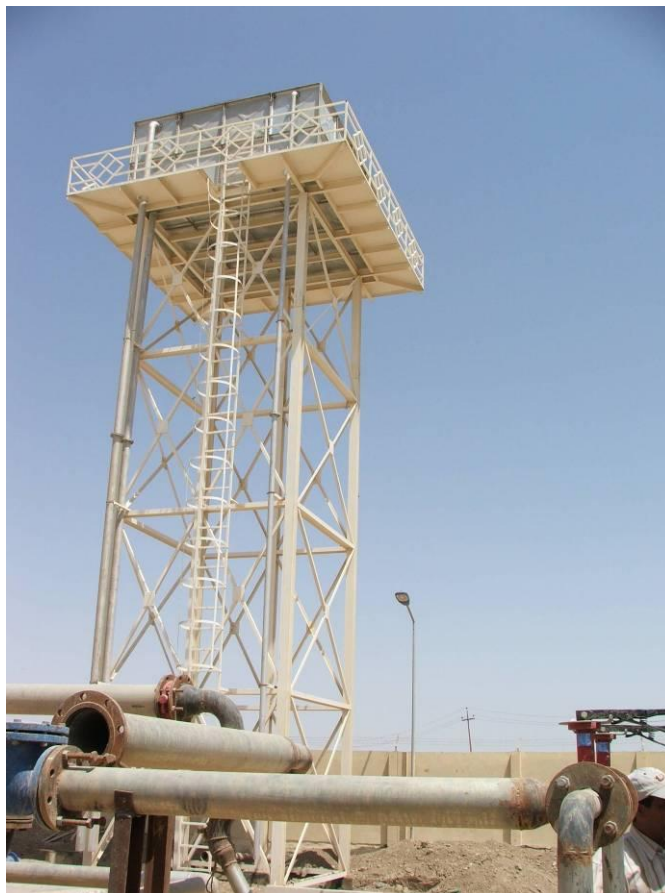
The contractor did finish construction of a new elevated storage reservoir (Site Photo 13).

**Site Photo 13. Elevated storage tank**

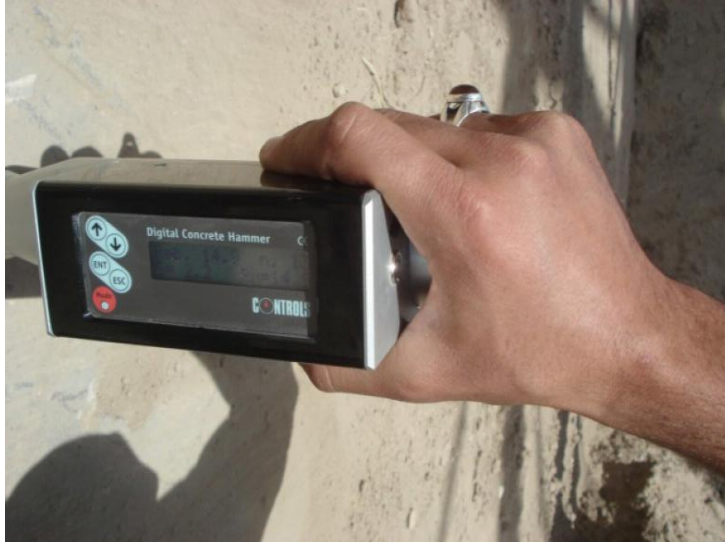
During the site visit, the GRS representative stated that the elevated storage tank's concrete foundation had not passed the Hammer (Site Photo 14) and Ultrasonic (Site Photo 15) tests. The elevated storage tank's concrete foundation would not support

**Site Photo 14. Hammer test for elevated storage tank (Courtesy of the USACE)**

the full load of the elevated storage tank when filled completely with water. The contractor provided the GRS a corrective action proposal plan for the concrete foundation. The corrective action plan for the elevated storage tank states that if the concrete foundation fails the core test and the second ultrasonic test, then the steel structure will be taken down, and a new concrete foundation will be constructed. In a follow-up email, the GRS stated that the concrete foundation failed the core test. The contractor would remove the elevated storage tank, and the contractor would use the old foundation as a blind, and the new foundation will be poured on top.

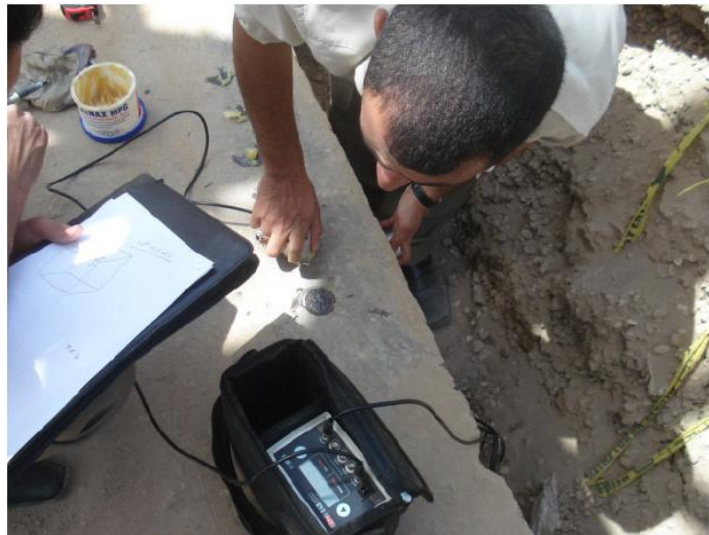
**Site Photo 15. Ultrasonic test for elevated storage tank (Courtesy of the USACE)**

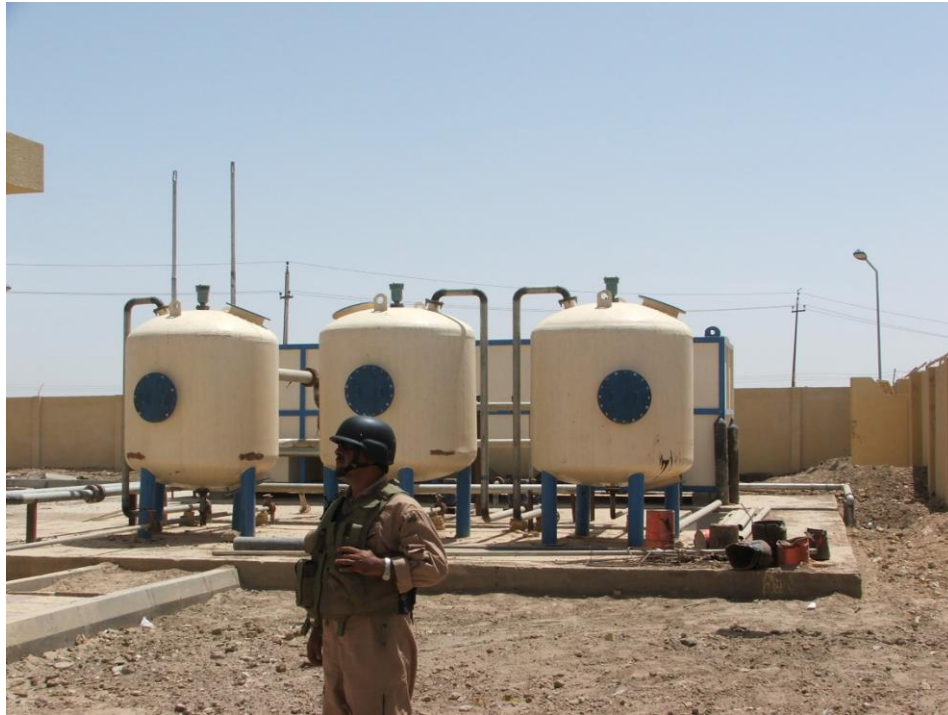
Since the Al Kazim Water Supply project was reported as 55% complete at the time of SIGIR's second site visit, there was significant interior and exterior work remaining on the water compact unit. The other required pending work included civil and site works, an internal road network and perimeter security roads, potable water treatment and distribution systems, a power generation system, sunshades (Site

Photo 16), wastewater collection and treatment systems, electrical systems, and all finishing work.

**Site Photo 16. Water compact unit without sunshade.**
