A Review of Australian and New Zealand Investigations on Aeronautical Fatigue During the Period April 2007 to March 2009

DSTO-TN-0885

This document has been prepared for presentation to the 31st Conference of the International Committee on Aeronautical Fatigue scheduled to be held in Rotterdam, the Netherlands, 25th and 26 May 2009. Brief summaries and references are provided on the aircraft fatigue research and associated activities of research laboratories, universities, and aerospace companies in Australia and New Zealand during the period April 2007 to March 2009. The review covers fatigue-related research programs as well as fatigue investigations on specific military and civil aircraft.

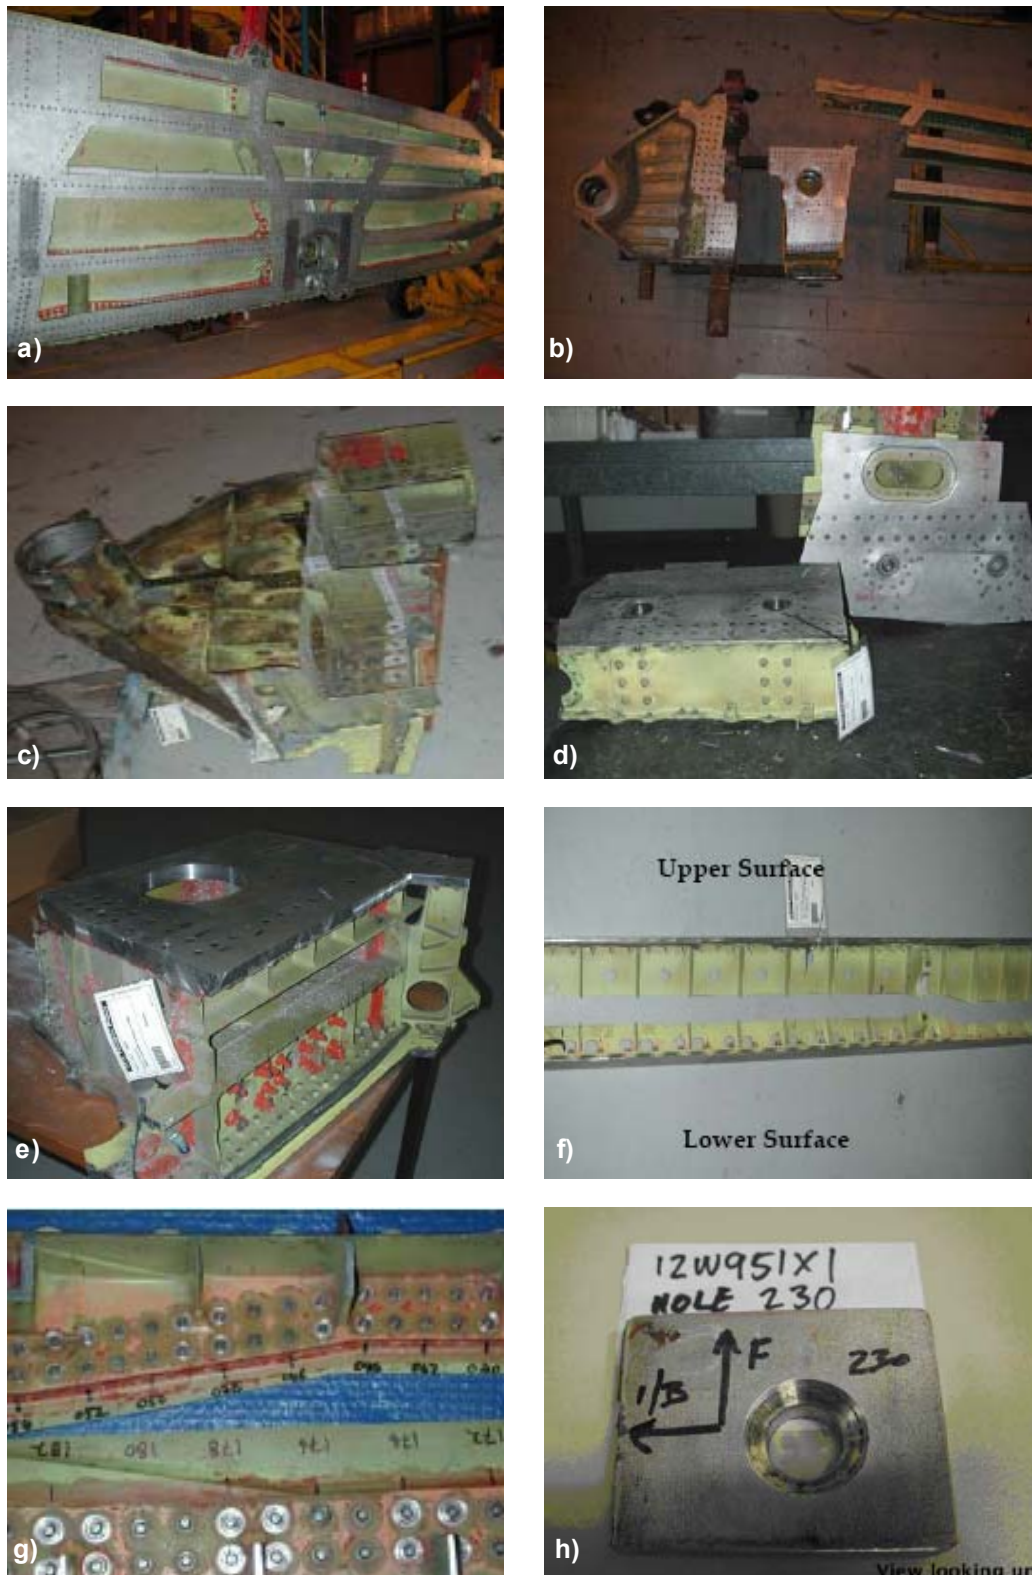
Figure 4 a) Upper Wing Skin removal; b) Separation of the Wing Pivot Fitting (WPF) and Inboard Pivot Pylon (IPP); c) WPF Lower Plate; d) Lower Wing Skin (LWS) Hardpoints; e) IPP Housing; f) Spar fragment; g) Example of water picked fragments; h) Fragment prior to being broken open for fractographic analysis.

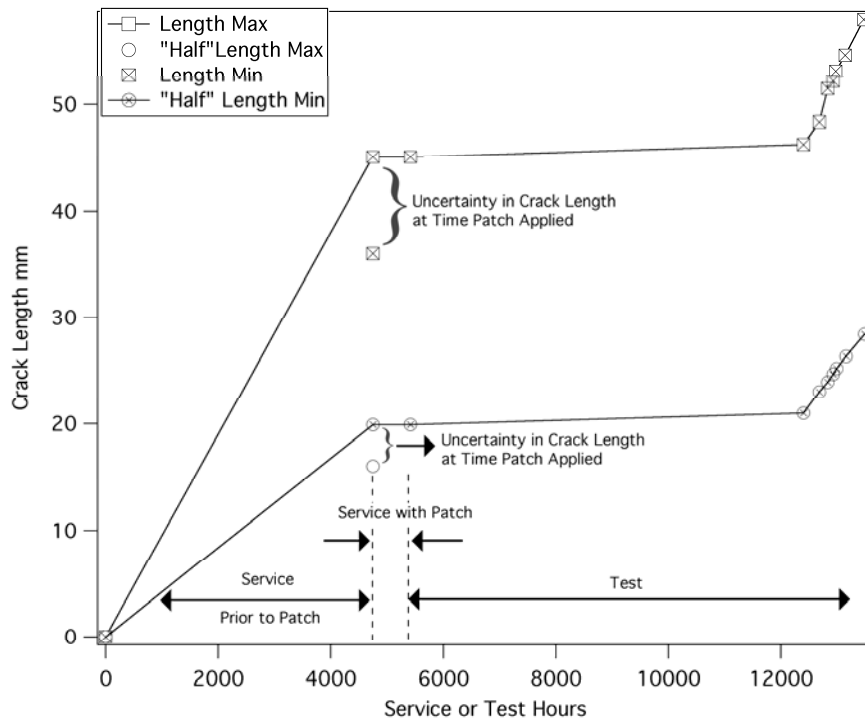
Figure 9 Plot of crack size over the life of the wing measured from fractographic analysis of the patched crack region

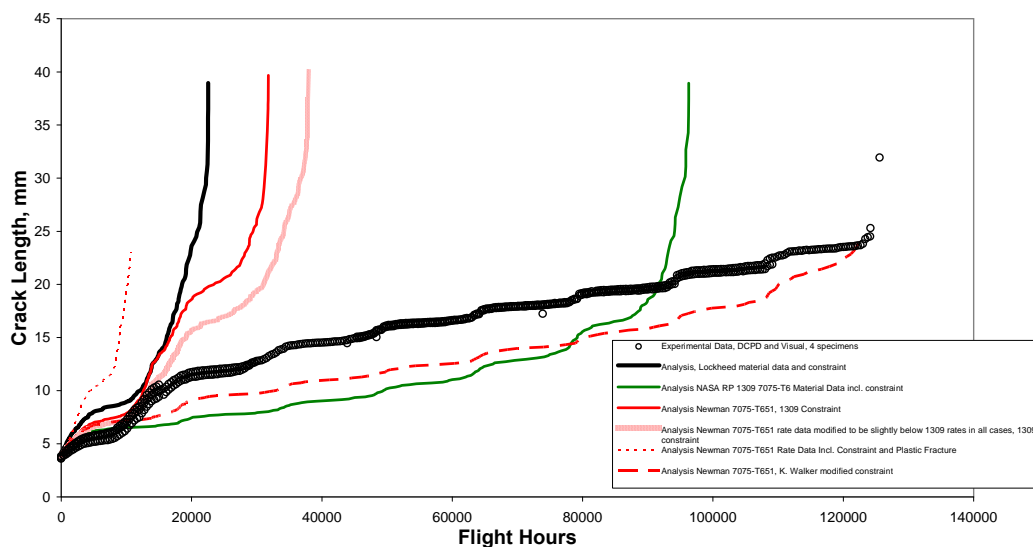
FCA 301 FSFT Crack Growth Comparison

Figure 13 Comparison of experimental crack growth against FASTRAN analyses using various material data and constraint factors for FCA 301 FSFT. The red long dash curve indicates the improvement which may be possible.

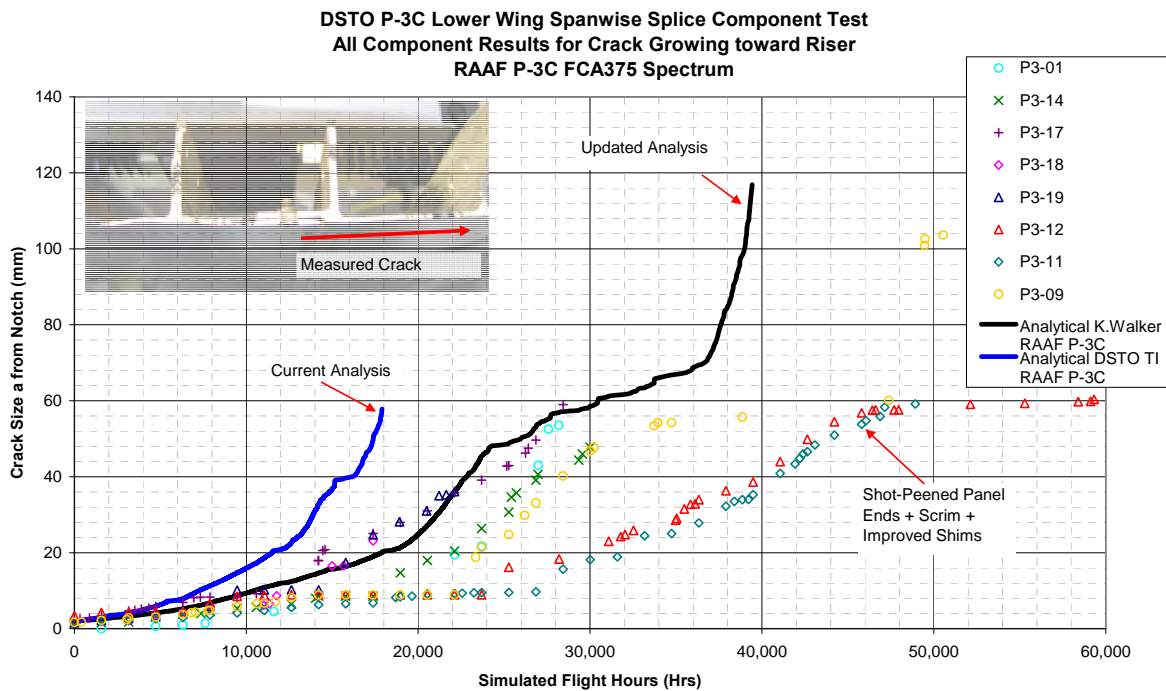
Figure 15 Crack growth results so far for span-wise splice component panels compared with current and updated FASTRAN analyses

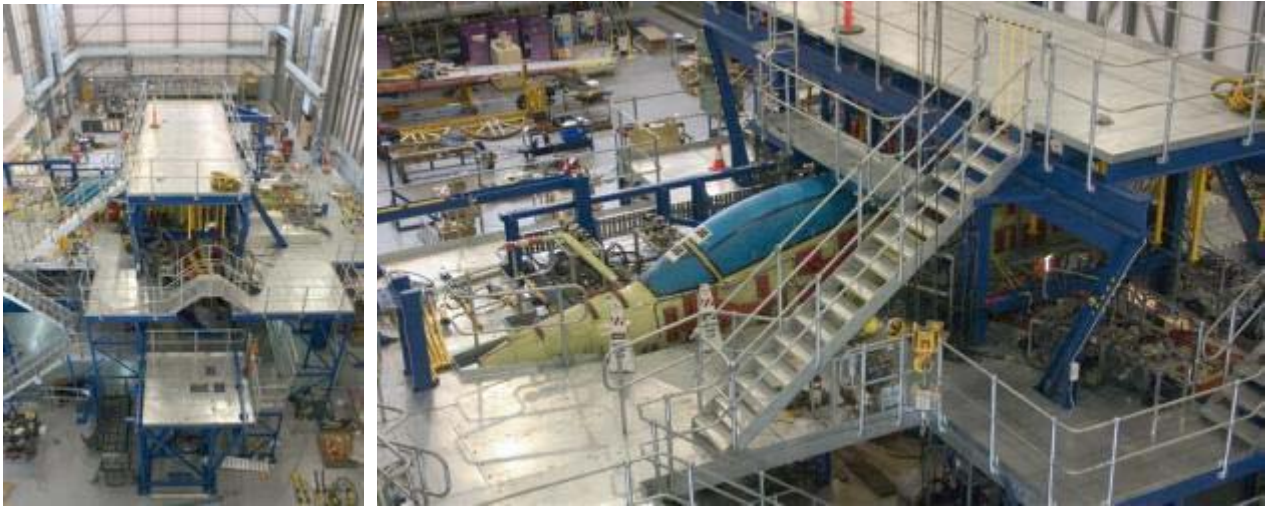
Figure 18 LIF Test Rig (left) under construction, and (right) with aircraft installed.

Design, construction and commissioning of the test rig was completed in December of 2005. The fatigue test commenced in December 2005 with the application of a simulated Production Flight Acceptance Test (PFAT) load block. Continuous testing commenced in February of 2006 and is expected to continue until 2012, eight years before the fleet's proposed withdrawal date. The fatigue test will be followed by DSTO carrying out a residual strength test and a full teardown inspection. Overall the project will be completed by 2014.

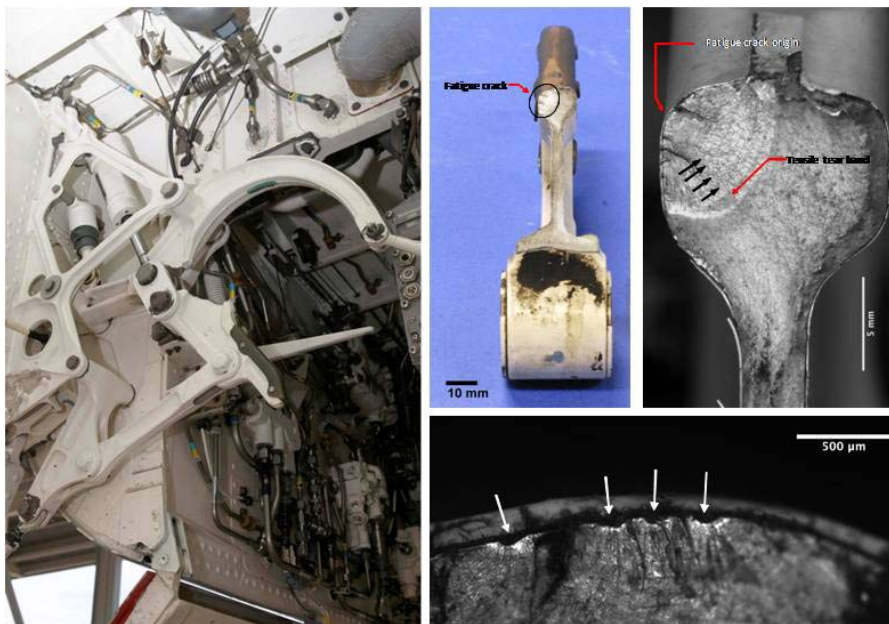
Figure 21 RAAF F/A-18 nose landing gear up-lock mechanism failure

The fatigue cracks propagated to approximately 10 percent of the total fracture surface indicating that the component was subjected to very high nominal applied stresses.

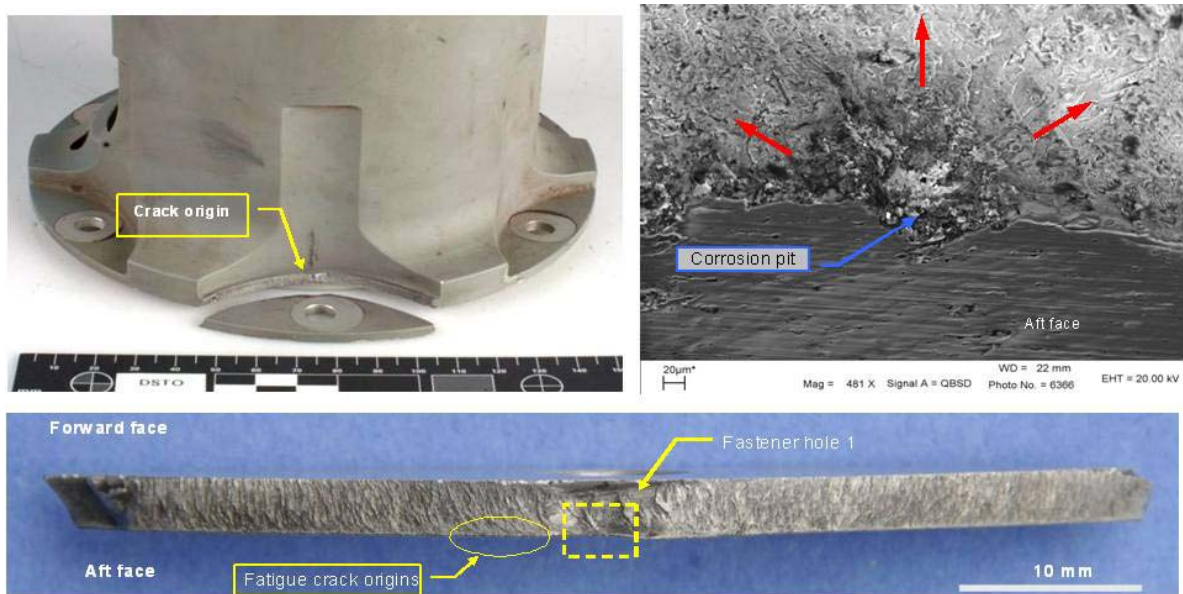
Figure 22 Black hawk high speed shaft tube cracking.

It was likely that the combined effects of the service stresses, the point loading (and flexing) and the presence of surface damage and corrosion pits caused the fatigue crack initiation, Figure 22.

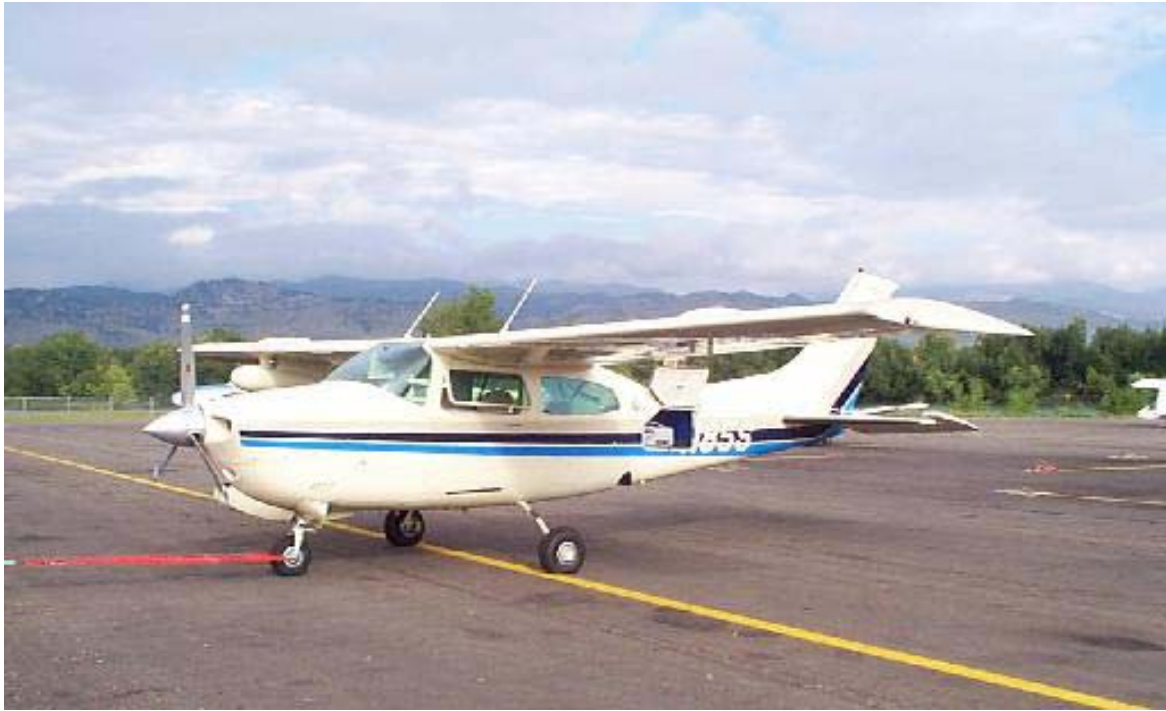
Figure 25 The Cessna 210 has a wing carry-through forging that is prone to corrosion as well as fatigue

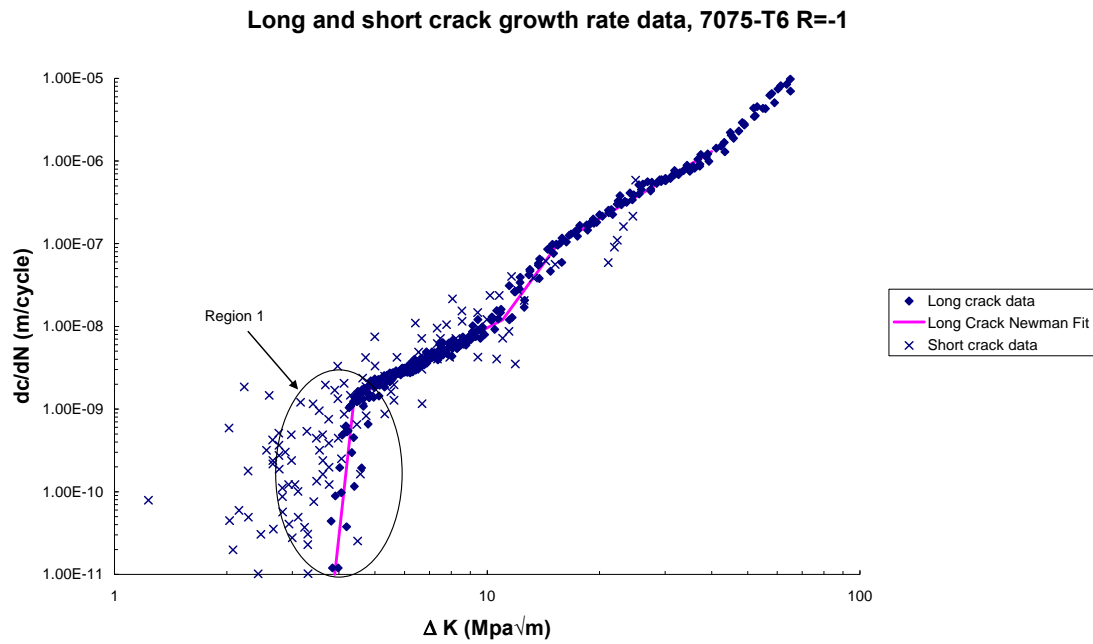
Figure 29 Long crack growth rate data for 7075-T6 material

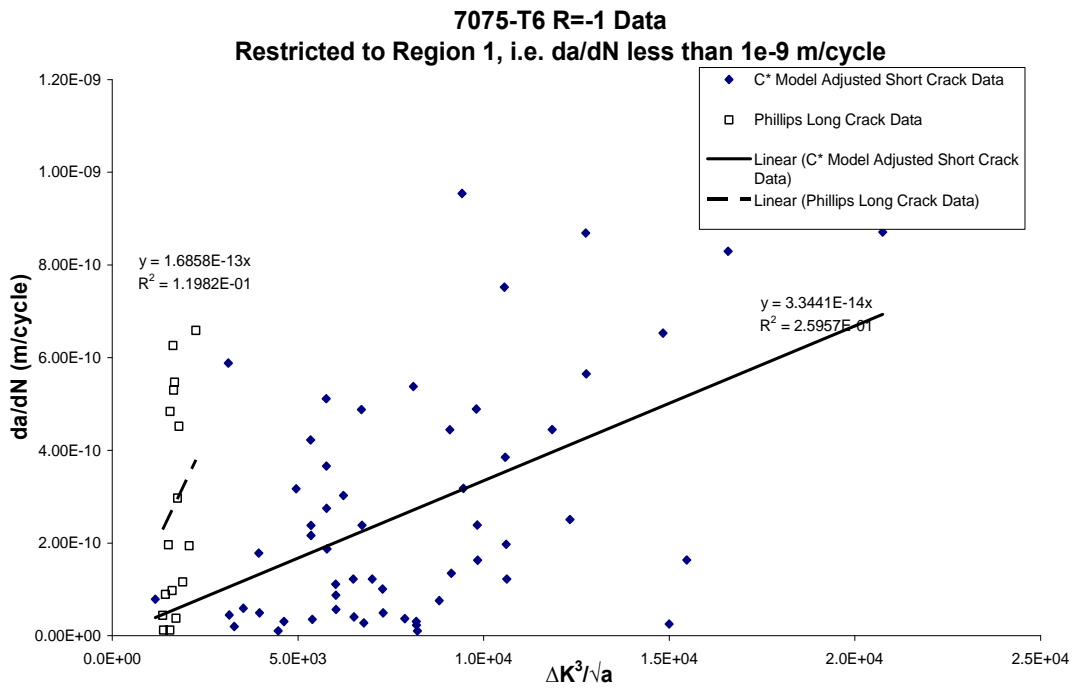
Figure 30 Crack growth rate plotted against the C^* parameter. Note the difference between the long and the short crack data points.

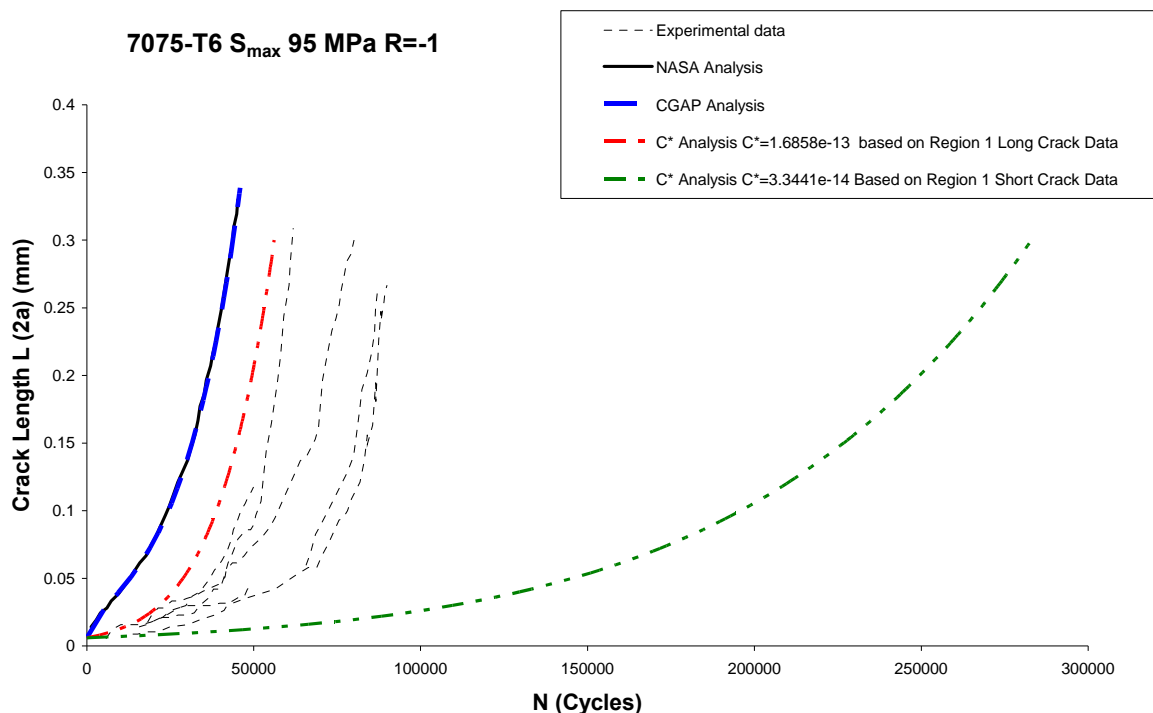
Figure 31 C^* based crack growth analysis results using long and short crack data restricted to Region I compared with the experimental crack growth data.

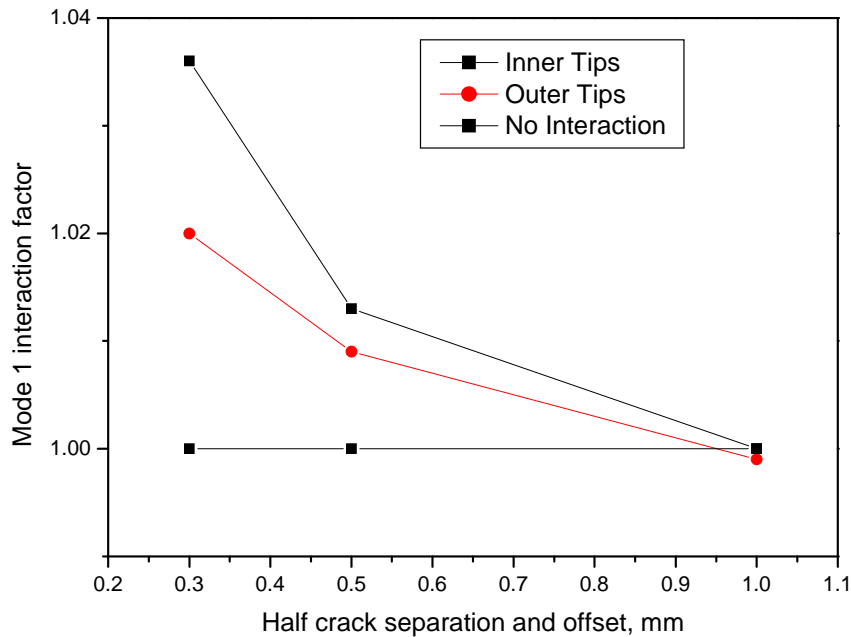
Figure 33 Numerical results showing interaction between parallel surface cracks with an offset. The interaction factor is defined as the ratio of the stress intensity factor for the multiple cracks to that of the single crack.

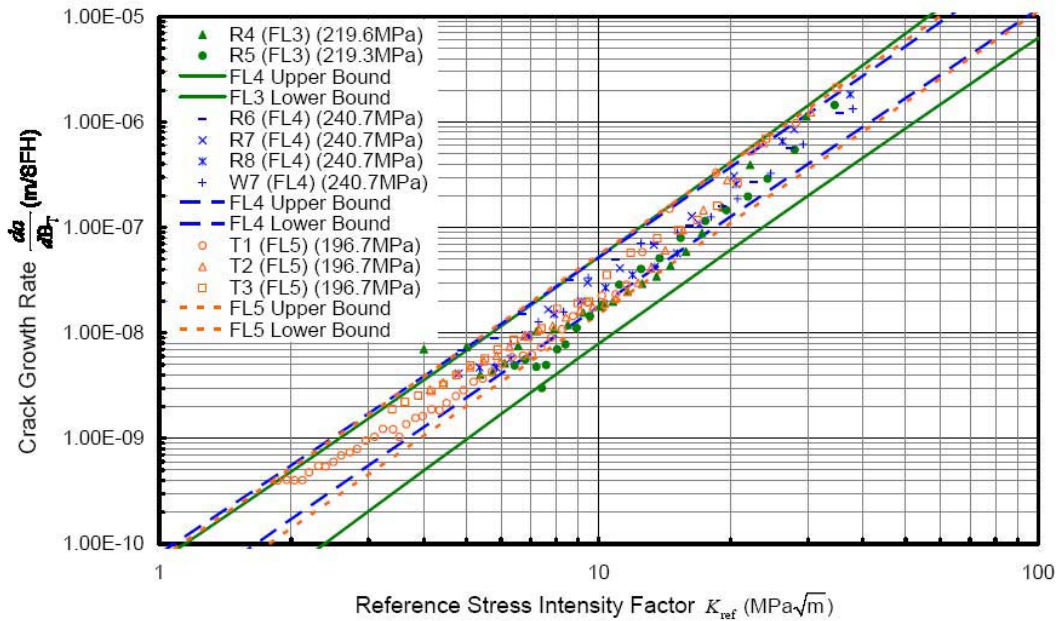
Figure 34 Prediction intervals (upper and lower limits) for FL3, FL4 and FL5 crack growth rate data sets.

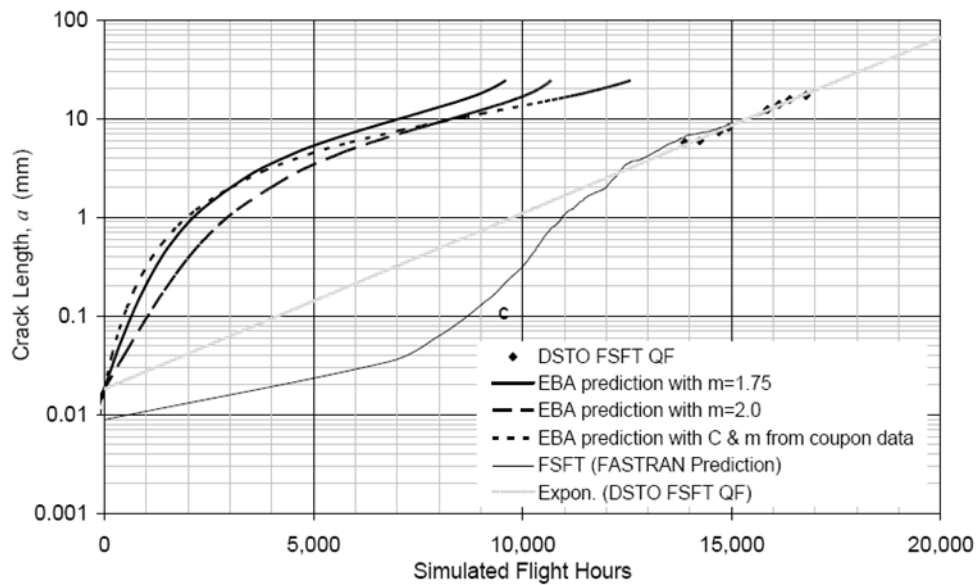
Figure 35 EBA predictions of a crack with an initial flaw size of 0.018 mm located at WS 220

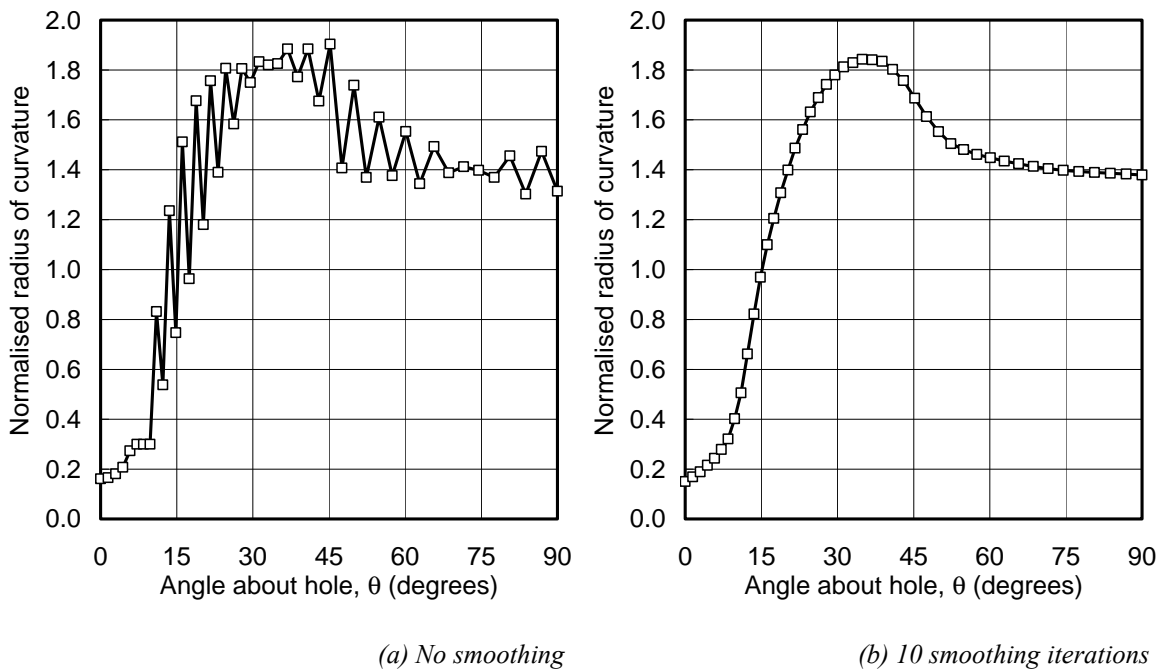
Figure 38 Normalised radius of curvature of an optimal shape - no smoothing and 10 smoothing iterations.

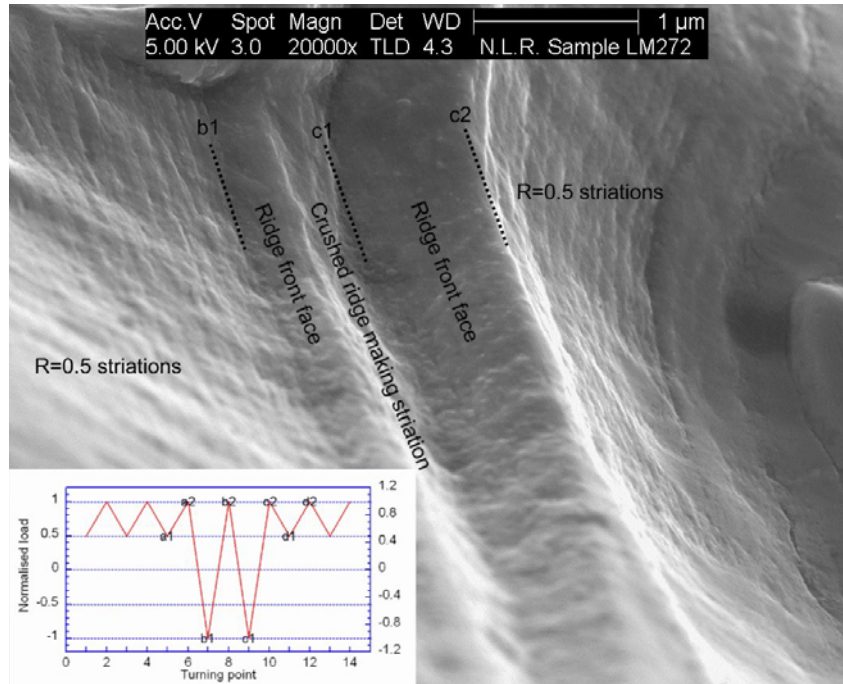
Figure 42 Striation and ridge formed by the application of two underloads in a sequence of $R=0.5$ loads. The striation appears to be a ridge (produced by the load segment from $b1$ to $b2$) that has been partially crushed by the load segment from $b2$ to $c1$ in the schematic. [3]

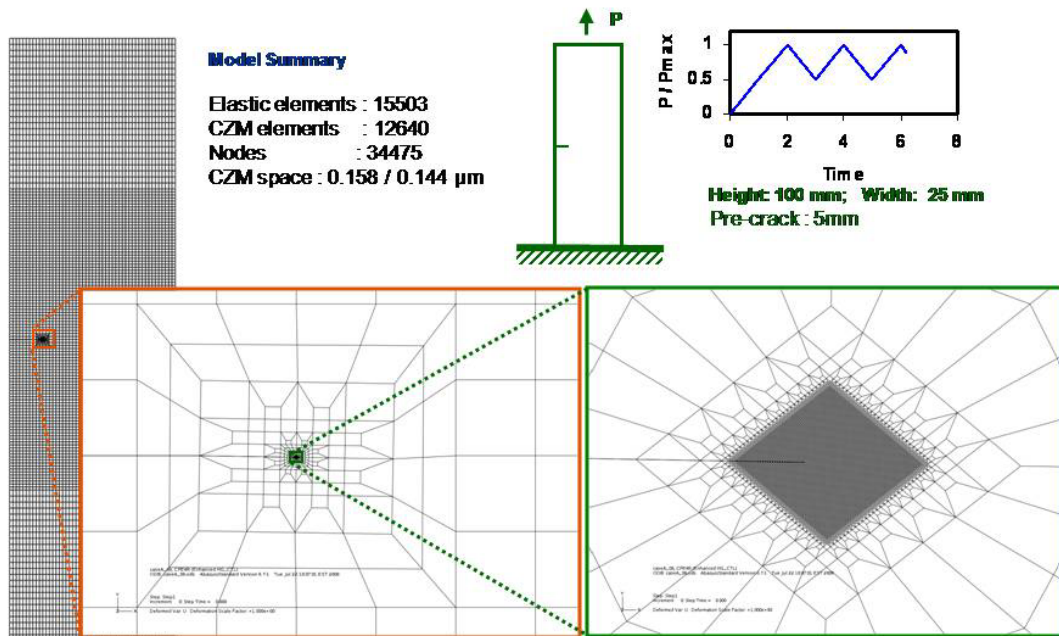
Figure 44 Finite element model for case study.
