Report No. CG-D-10-09

# Inland Rivers Floating Aids Final Technical Report

October 2009

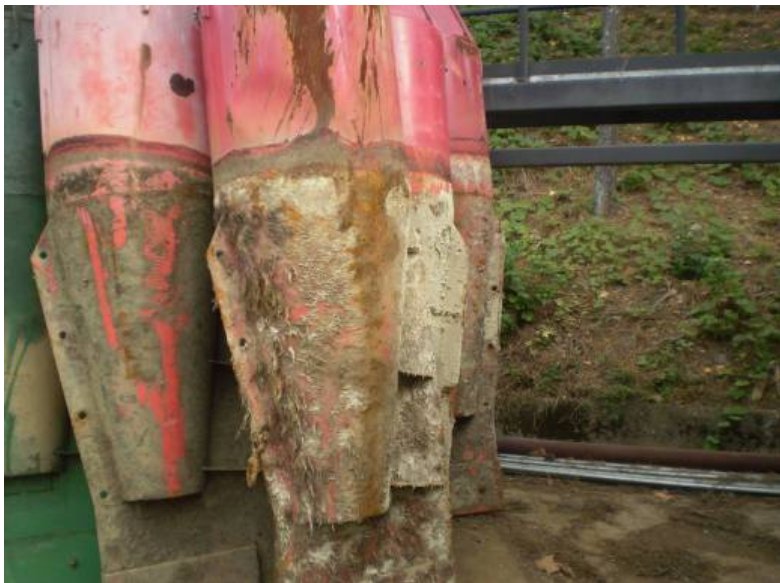
Figure 2. Corroded buoys requiring maintenance.

The Western Rivers system requires buoys that can withstand varying environmental and man-made conditions. Some of these conditions were listed in Section 1.1 and will be summarized and elaborated on within this section. These conditions affect daytime visibility, radar reflectivity, and service life. Daytime visibility is hindered by the fading color of the daymark, bird droppings covering the paint, natural debris increasing buoy drag, and excessive currents causing the buoys to submerge or dive. Submergence and inclination of the buoy in currents also reduce radar reflectivity. Based on water conditions, the currents for the pooled waters range from 1 to 7 knots with an average of 1-2 knots and varying water levels, while the fast-water current range from 3 to 8 knots with an average of 5 knots, as shown in Reference 6, carrying significant amounts of debris. These conditions require frequent maintenance, observation, and replacement of the river buoys. The service life of the buoy is reduced by corrosion of the steel shell leading to filling with water, causing the buoy to have reduced freeboard or be lost due to diving (Figure 2). Corrosion and chafing can also cause the mooring links to part, resulting in the buoys moving off station. The environment is not the only contributing factor to the reduction in service; man-made conditions of debris and damage from collision also contribute to the buoys being lost due to diving (Figure 3). The varying currents also contribute to the buoy visibility by causing the buoy to incline depending on the mooring point used when the buoy was set. As seen in Figure 4, the buoys can either incline towards or away from the river current and hinder the buoys performance. One buoy was off station because of a chafed chain which had parted and allowed the buoy to drift. See Figure 5.

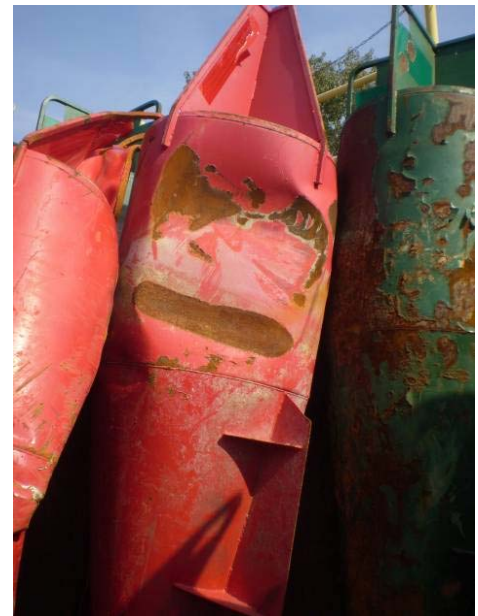
Figure 3. Buoys damaged from collision.

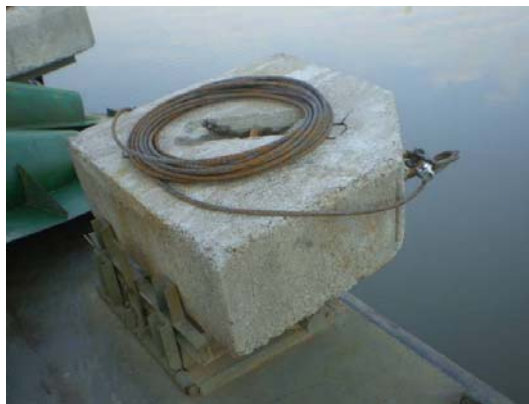
For the stretch of the Mississippi River that is the KANKAKEE's AOR, it deploys and retrieves 4<sup>th</sup> Class buoys exclusively, using 90 ft of ½-in. wire rope attached to a 1,500 lb concrete sinker. At the start of the visit, the crew demonstrated the setting and recovery of a buoy while the cutter was still at the dock. To deploy a buoy, the sinker is set on a kickboard launching mechanism at the barge side by the barge crane; see Figure B-2. The buoy is placed at the barge side, with the coiled wire rope connecting the buoy and the sinker. When the kickboard is released, the sinker tips into the river and the wire pays out. The buoy is then pushed over the side by two crew members.

Figure B-2. Sinker and mooring on kickboard.

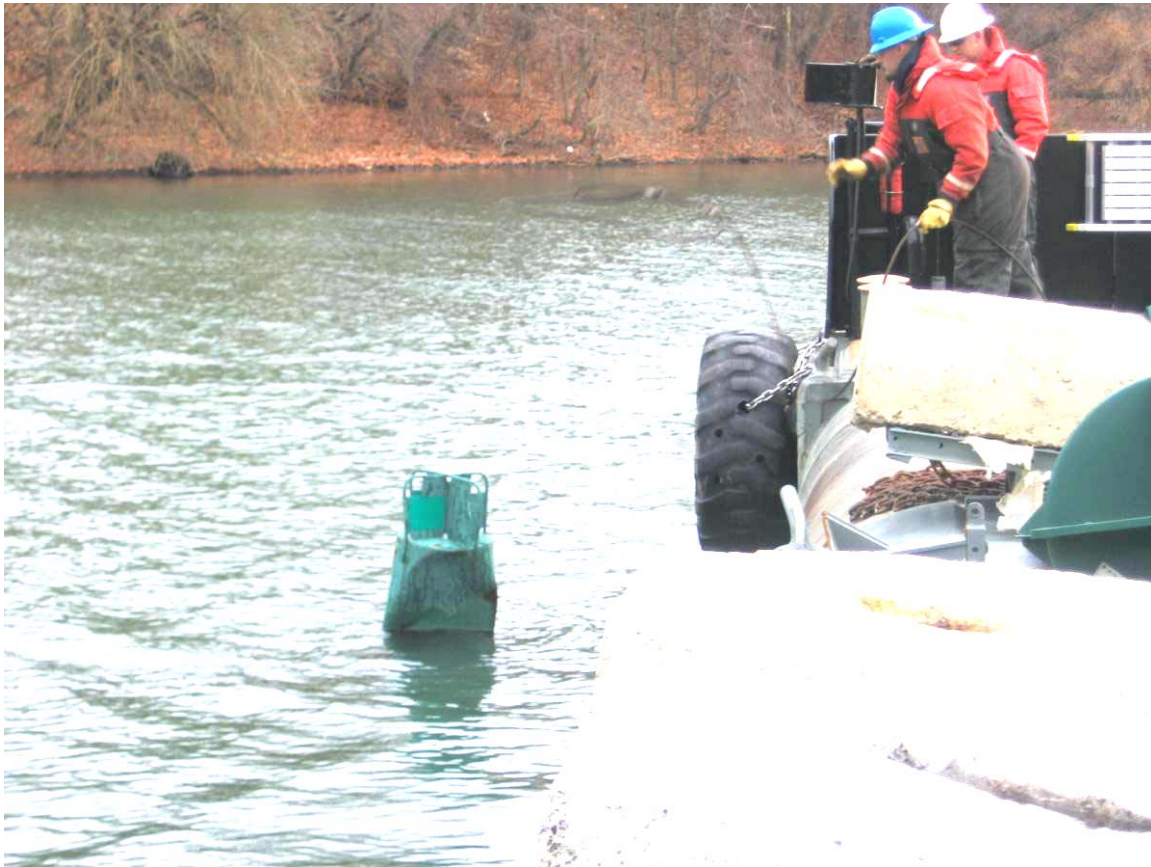
The OSAGE sets and retrieves 4<sup>th</sup> Class and 6<sup>th</sup> Class buoys, using 90 ft (one shot) of ½-in. chain attached to a 1,500 lb concrete sinker. To recover a buoy, the crew lassoes the buoy using procedure similar to that used on the KANKAKEE. Once the buoy is brought alongside, a wire rope is attached to a lifting eye which is used to pull the buoy aboard using the barge's centerline capstan. When the buoy is pulled up on the deck, the mooring chain is detached from the buoy and may be pulled up using the capstan if the buoy is to be reset. The buoy is then removed to the storage pen (corral) and a new buoy is placed ready for launching. The chain and sinker will typically be reused and not inspected if the buoy is not moved. See Figure B-9.

Figure B-9. Buoy recovery using lasso.
