HAMMAM AL ALIL REGIONAL
TRAINING CENTER
MOSUL, IRAQ

SIGIR PA-09-183
JANUARY 12, 2010

Summary of Report: PA-09-183

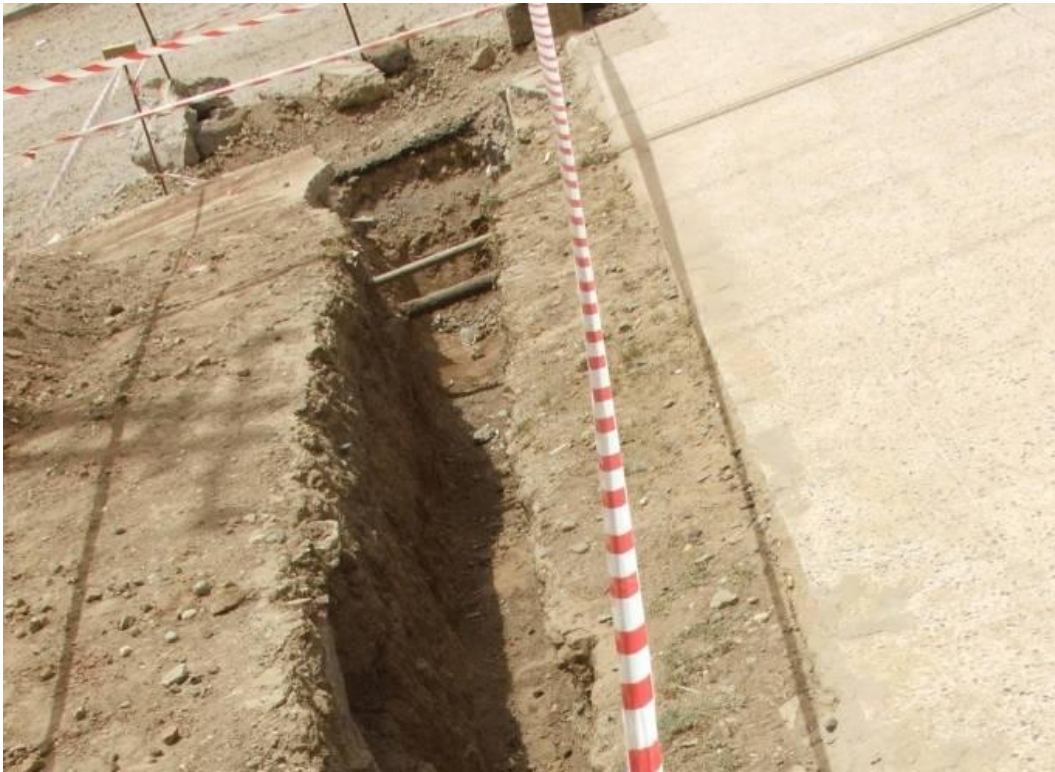
At the time of the SIGIR site assessment, the contractor was performing general site work. Excavation for the underground utilities was performed and caution tape had been placed around the excavation (Site Photo 1).

Site Photo 1. Excavation for underground utilities

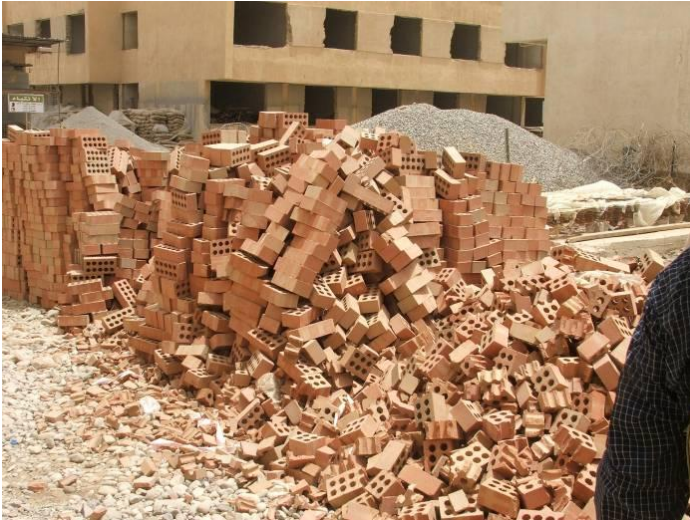
The contractor was stockpiling construction materials on site. Some of the construction materials were bricks (Site Photo 2) and rebar (Site Photo 3). The stockpiles were disorganized.

Site Photo 2. Construction bricks

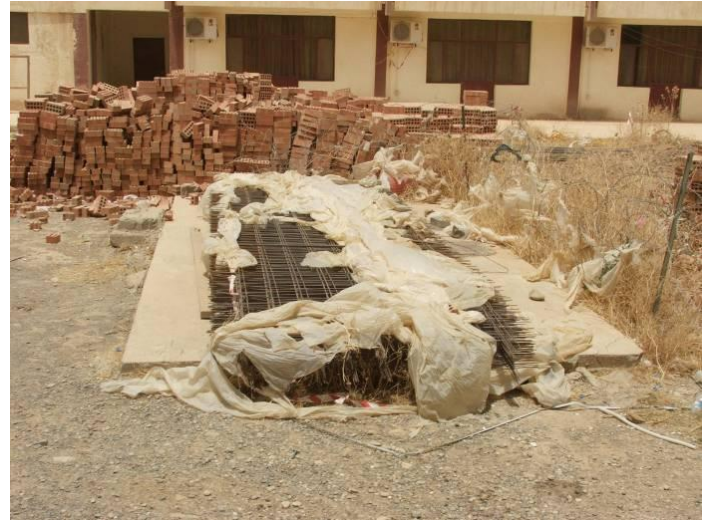
Site Photo 3. Construction rebar

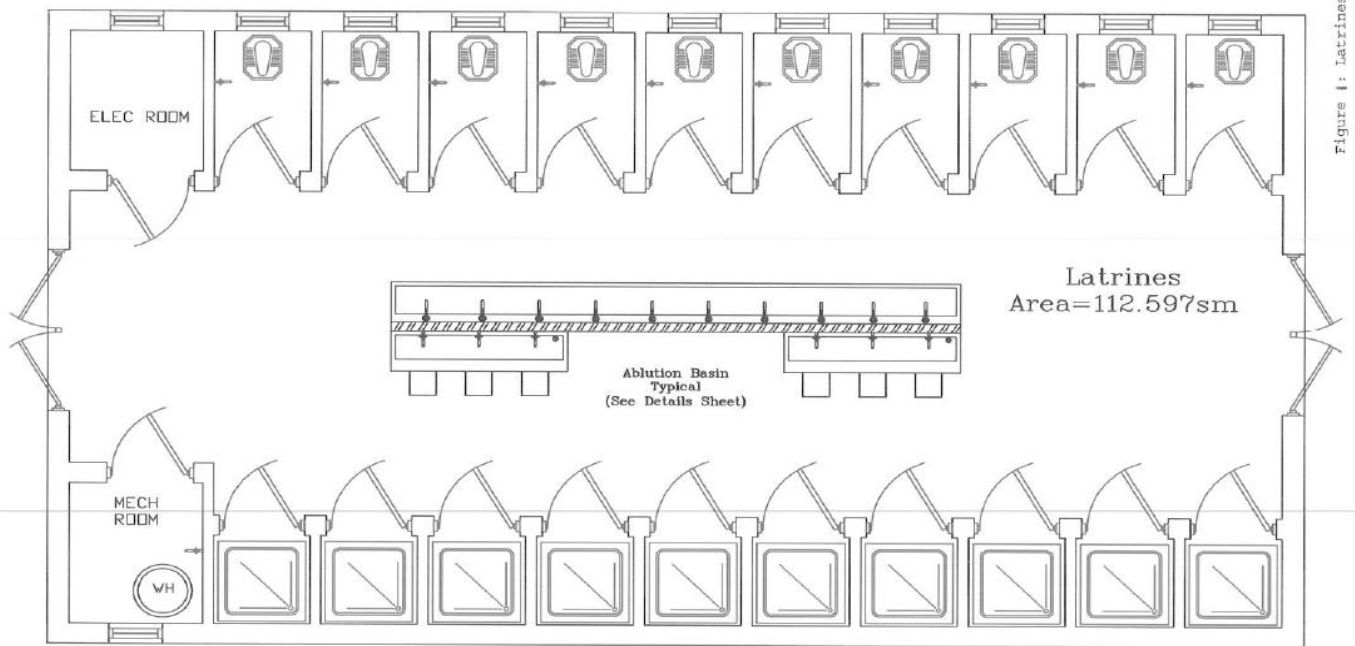
The SOW included general information for the contractor to use as the design for the latrine building (Figure 2).

Figure 2. Latrine layout (Courtesy of the USACE)

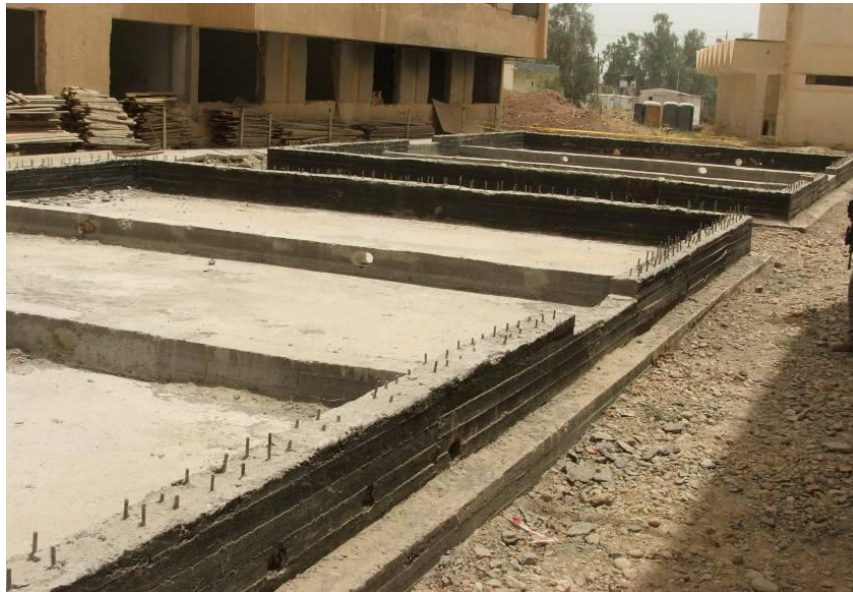
At the time of the SIGIR site assessment, the contractor had constructed the foundation and the floor slab for the latrines (Site Photo 4).

Site Photo 4. Latrine foundation and floor slab

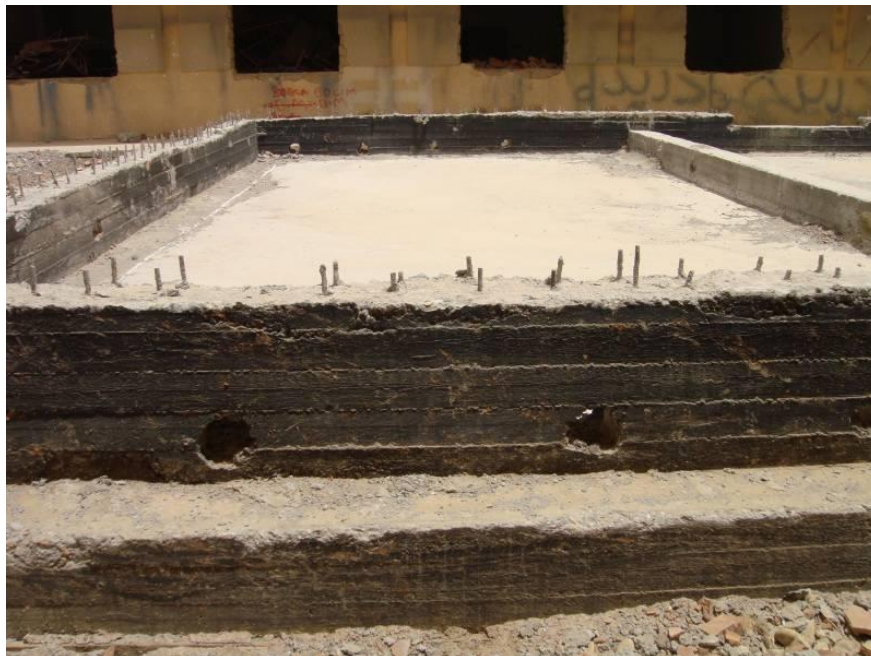
The perimeter stub walls were constructed on top of the footers, and the penetrations for the latrine plumbing were installed through the walls. Reinforcing steel was present through the top of the wall. However, the length of the exposed bars was minimal (Site Photo 5). The length of the reinforcing, shown in Site Photo 5, was less than that required for embedment or splicing into adjacent pours. The defect was noted in the Mosul Area Office quality assurance (QA) documentation, and the Mosul Area Office was addressing the issue.

Site Photo 5. Latrine foundation with penetrations for sanitary sewer piping

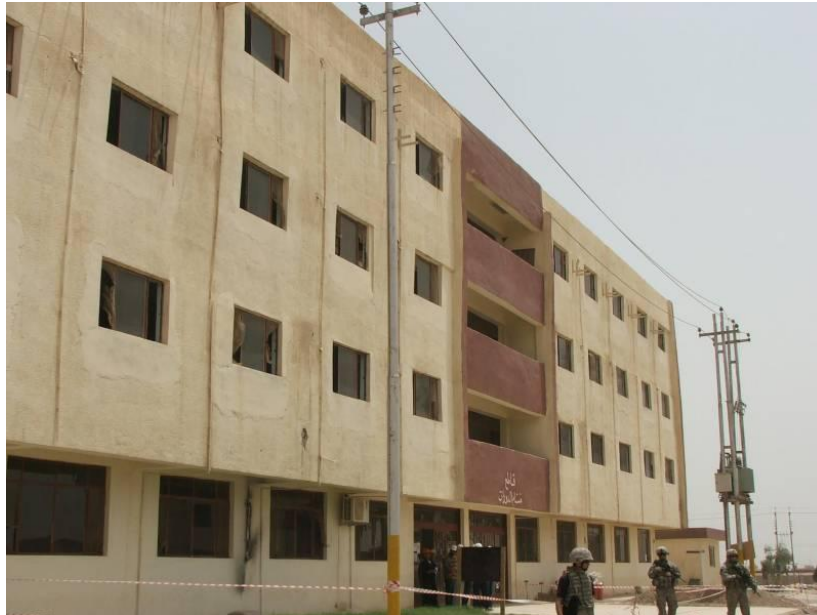
During the site assessment, contractor personnel were on site and performing renovation work to the existing building (Site Photo 6). Based on discussions with the GRN Mosul Area Office representative, the contractor was performing work on all floors of the building. The clinic and common area would be located on the first floor, and the living areas would be on the remaining floors.

Site Photo 6. Building 6 exterior

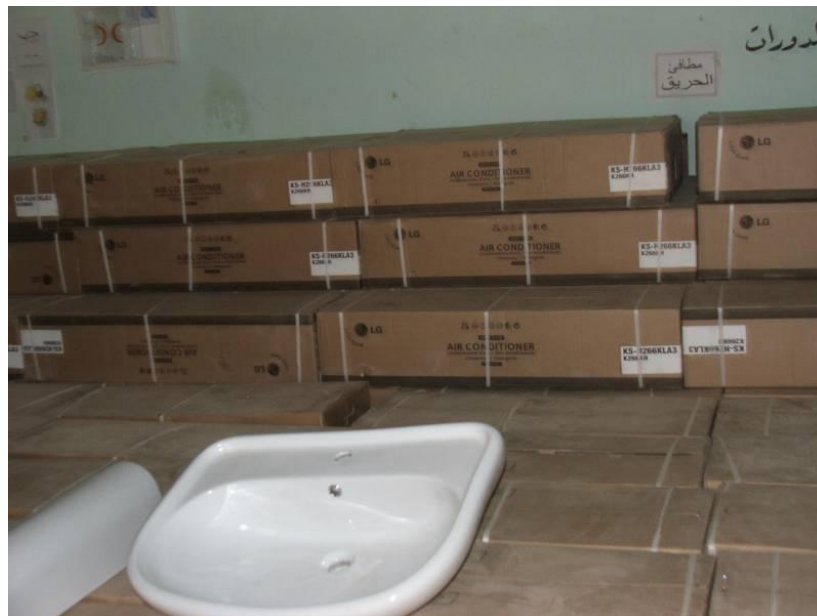
SIGIR noted that the contractor stored materials for the project on the first floor. The stored materials consisted of plumbing fixtures and a significant number of air-conditioning units (Site Photo 7).

Site Photo 7. Stored materials in building 6

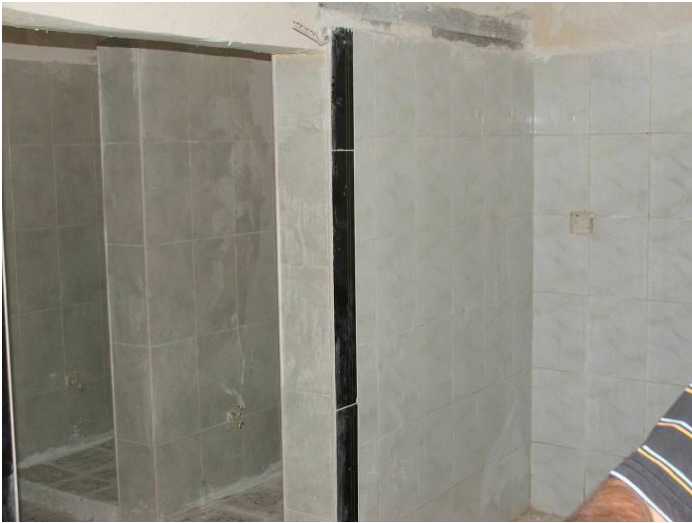
At the time of the site assessment, the contractor had started renovation of the restrooms in building 6. The renovation consisted of replacement of the floor and wall tiles (Site Photo 8), re-plumbing the restrooms (Site Photo 9), and installation of new fixtures.

Site Photo 8. Tile replacement

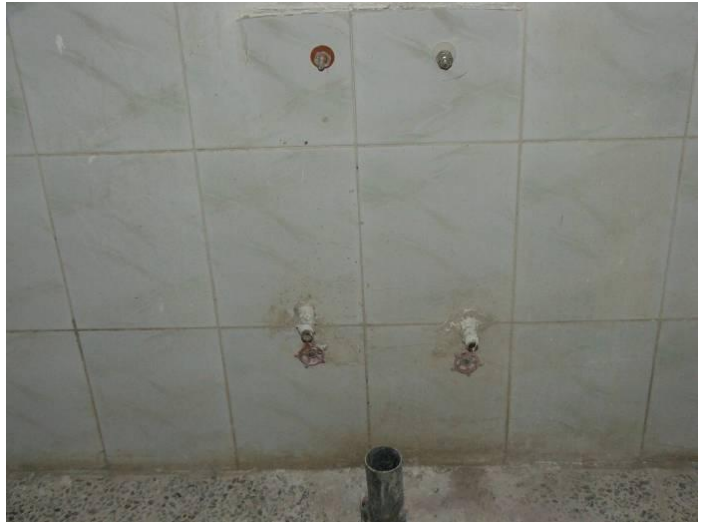
Site Photo 9. Re-plumbing restroom

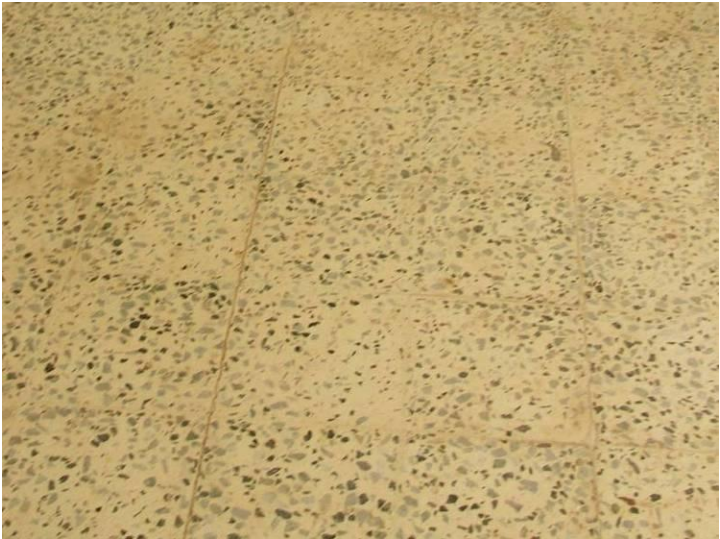
As part of the renovation, the contractor replaced the tile floor. The floor was level with no apparent cracking or displacement (Site Photo 10). The contractor was in the process of installing new electrical wiring and conduit in the building. In accordance with the SOW, the contractor was surface mounting the conduit (Site Photo 11). The contractor was using junction boxes to join intersecting runs of conduit.

Site Photo 10. Tile flooring

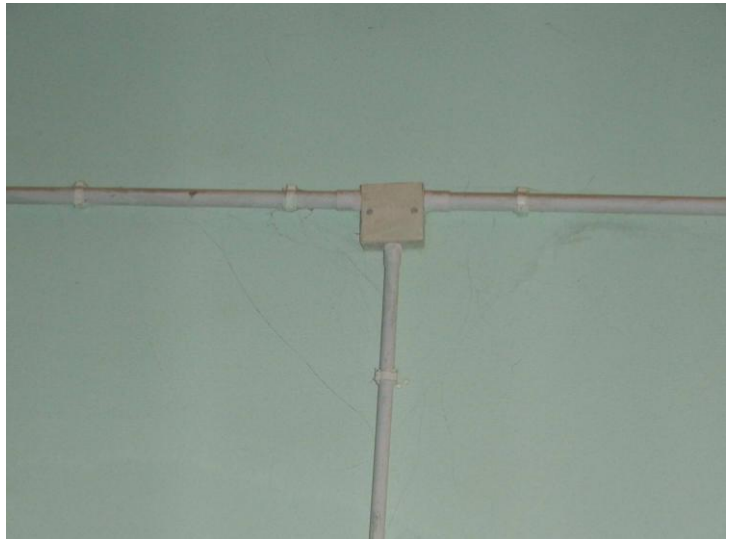
Site Photo 11. Building 6 interior wiring
