REAL TIME FAULT DETECTION AND DIAGNOSTICS

USING FPGA-BASED ARCHITECTURES

THESIS

AFIT/GCE/ENG/10-04

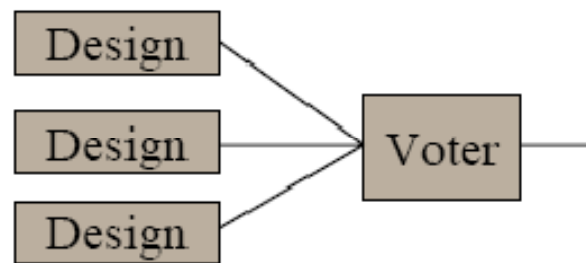
TMR has been widely used as a form of design hardening to greatly improve the reliability of FPGA designs to mitigate an upset as it occurs in the device configuration. TMR has been shown to greatly improve the reliability of FPGA designs subject to SEUs [2]. This mitigation technique traditionally uses three identical copies of a circuit which would run in parallel. The outputs would then go through a majority voter circuit. If there would be an error on one of the bits in one circuit, the TMR votes out the error. To improve the basic concept of TMR, a few design enhancement steps were made on the simple three circuit and voter layout (Figure 1).

**Figure 1 – Basic TMR**

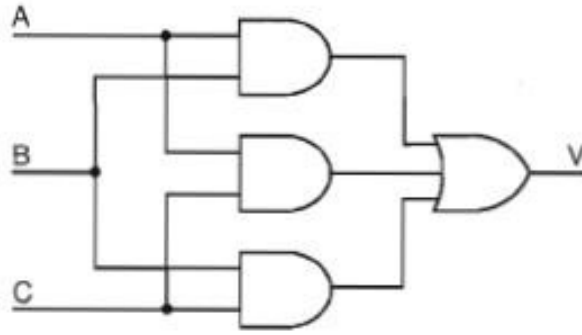
The first addition was to expand the one bit voter layout shown in Figure 2 and triplicate the voter unit so there would no longer be a single point of failure (Figure 3). This application significantly reduces the configuration sensitivity of the design [2].

**Figure 2 – TMR Circuit Diagram**

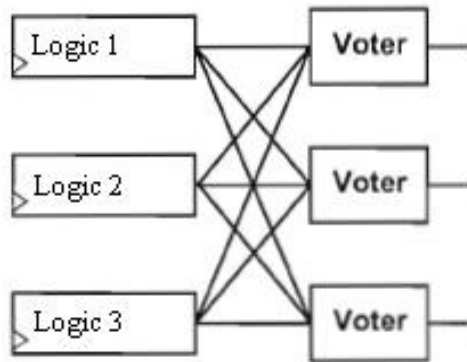
**Figure 3 – TMR with Triplicated Voter**

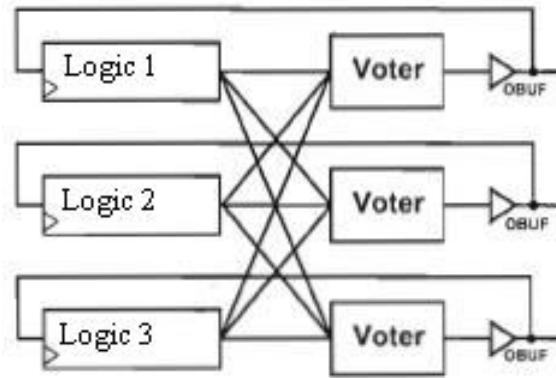
**Figure 4 – TMR Design with Feedback**

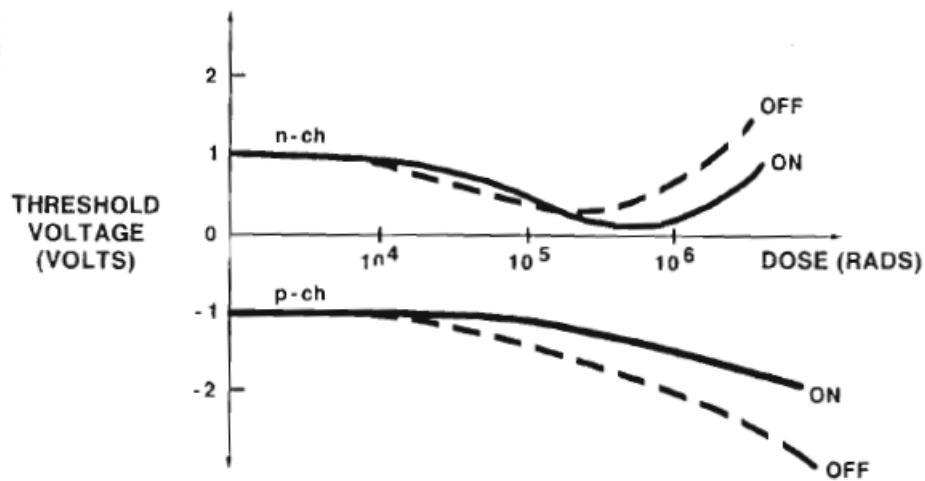
Figure 5 – Threshold Voltage of 'n' and 'p' Transistors during Irradiation [15]

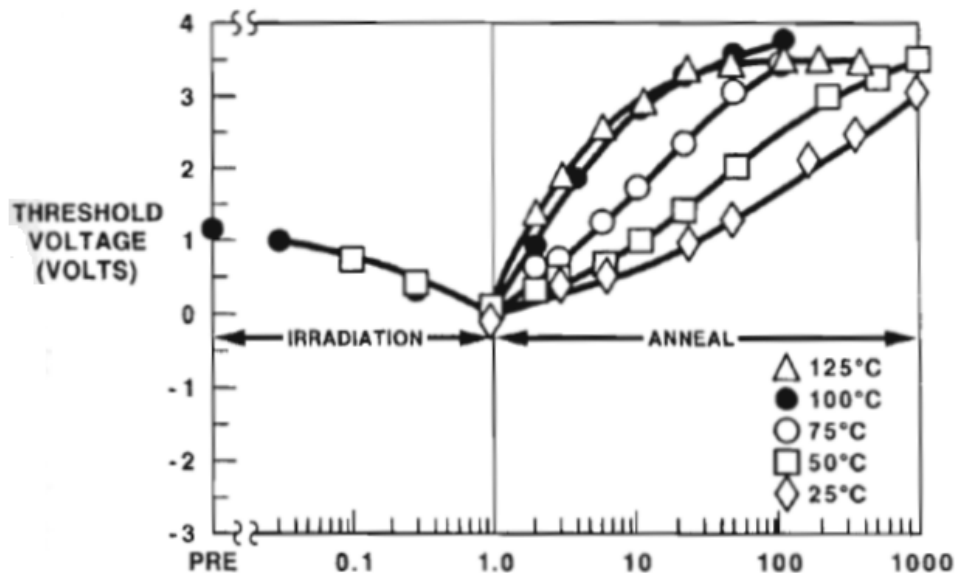
overall effect depends on bias conditions and device technology. With devices becoming smaller, the gate oxides in these shrinking transistors are growing thinner. Being thinner, the gate oxide traps less positive charge overall [14]. Therefore, transistors with smaller technologies are becoming inherently more radiation resistant. Figure 5 shows how the total dose effects the threshold voltage and causes a shift in both 'n' and 'p' transistors. The threshold voltage does change during the annealing process after it has been irradiated shown in Figure 6.

Figure 6 – Irradiation and Annealing Effects [15]

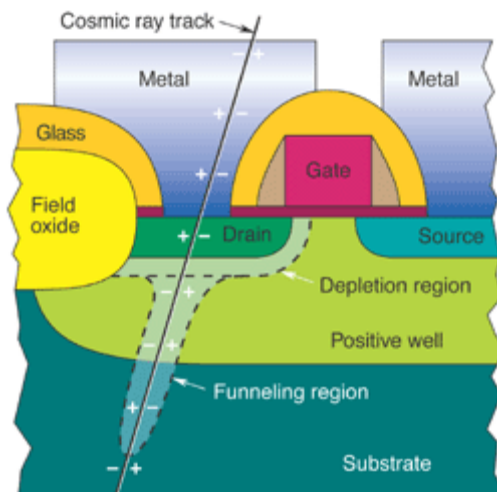
Another important category of radiation effects that an integrated circuit is vulnerable to are Single Event Effects (SEE). A SEE occurs when a single high-energy particle strikes a device, leaving behind an ionized track and can lead to sudden device or system failure (Figure 7). These failures result from the charge deposited by a single particle crossing a sensitive region in the device and are a function of the amount of charge collected at the sensitive node and the node state [13]. The ionization along the path of the impinging particle collects at a circuit node. The ionized track contains equal numbers of electrons and holes and is therefore electrically neutral.

**Figure 7 – Cosmic Ray Through the Strain of a NMOS Transistor**

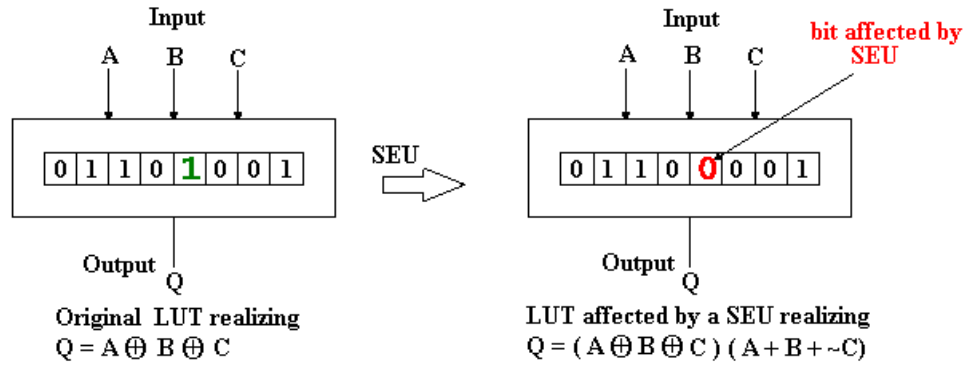
A cosmic ray, or a secondary ion released via a high-energy proton-induced nuclear reaction, can deposit enough energy within a sensitive node that an integrated circuit can be upset. These single event upsets (SEUs) are analogous to soft errors in electronics or avionics due to energetic alpha particles or atmospheric neutrons. SEU is defined by NASA as "radiation-induced errors in microelectronic circuits caused when charged particles (usually from the radiation belts or from cosmic rays) lose energy by ionizing the medium through which they pass, leaving behind a wake of electron-hole pairs." A SEU usually manifests itself as a state change or "bit-flip" of a single data bit or memory cell that causes a momentary glitch in the device output (Figure 8).

**Figure 8 – Example of SEU**

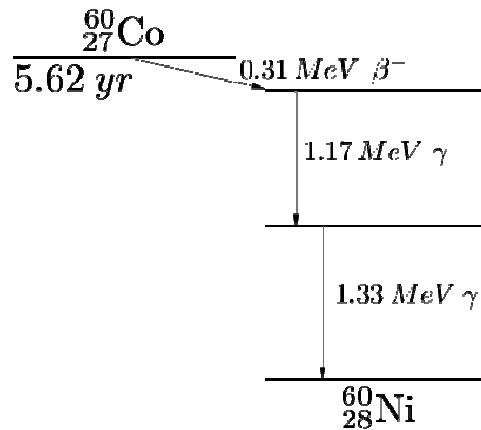
The cobalt-60 isotope (Co-60) was used as the source of ionizing radiation for this experiment. Co-60 undergoes beta decay with a half-life of 5.24 years releasing two gamma particles and one electron, demonstrated in Figure 9.

Figure 9 – Decay scheme of  $^{60}\text{Co}$  [20]

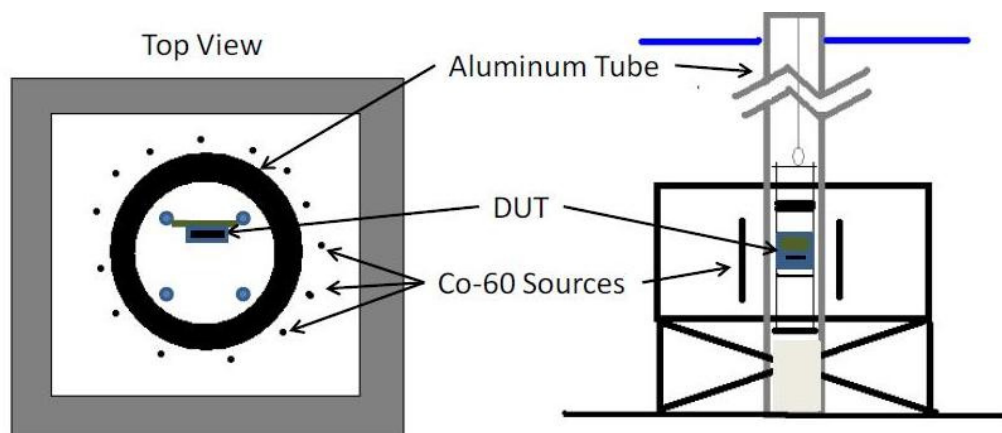
Ohio State University (OSU) Nuclear Reactor Lab (NRL) in Columbus, Ohio provided a Co-60 source. A simplified diagram showing the gamma irradiator can be found in Figure 10. It contains a six inch wide aluminum tube containing a movable platform that can be raised and lowered out of the irradiator. The gamma irradiator cell itself sits on the bottom of a pool of water and consists of 14 Co-60 sources evenly spread around the aluminum tube.

Figure 10 – Co-60 Gamma Irradiator Layout [17]

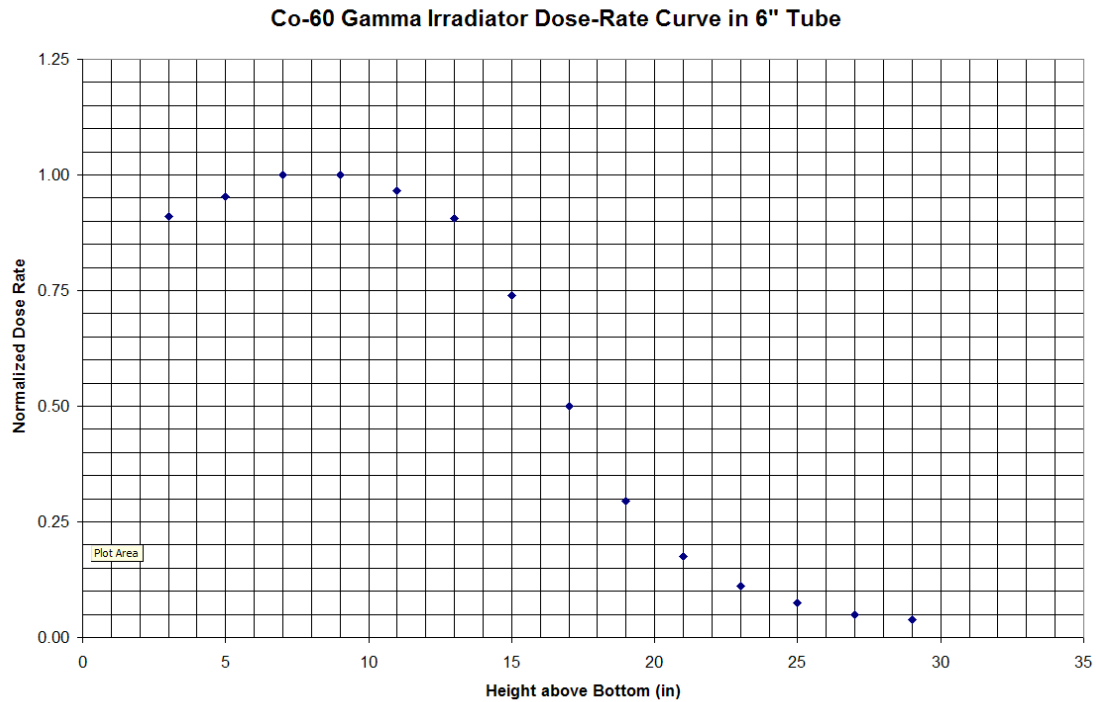
When the device under test (DUT) is lowered into the tube, the radiation dose rate is based on the location of the device relative to the center of the Co-60 source rods. However, the dose rate curve is based on the distance of the DUT above the bottom of the moveable platform when the platform is resting on the bottom of the aluminum tube [17]. The radiation dose curve provided by OSUNRL is depicted in Figure 11.

**Figure 11 – Dose Rate of Co-60 Irradiator [21]**

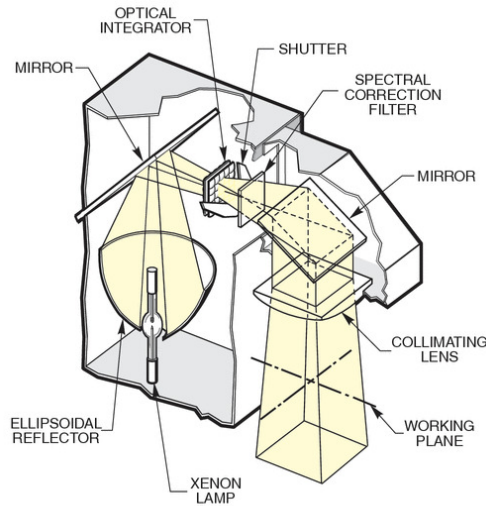
A 1600W Xe lamp thermal simulator was used for the irradiation of the DUT in this thesis. The schematic shown below (Figure 12) is accurate with the exception that the thermal simulator used in these experiments had an output direction rotated 90 degrees so that the output was perpendicular to the major axis of the thermal simulator producing a horizontal beam [18].

**Figure 12 – Schematic of 1600 W Solar Simulator**

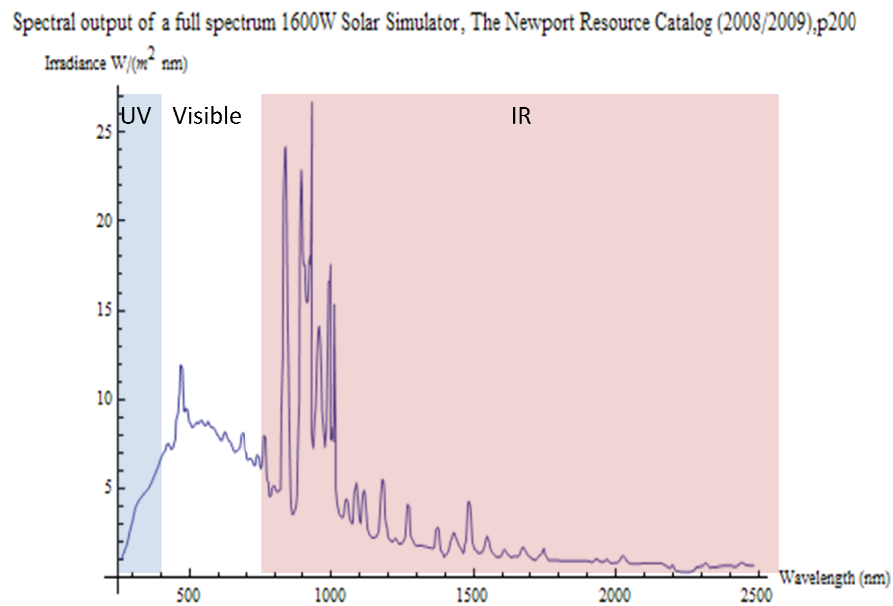
The thermal simulator was assembled by Koehl [19] and the manufacturer recorded a spectral output seen in Figure 13 below.

**Figure 13 – Spectral Output from 1600W Thermal Simulator**

The spectrum is largely a smooth Plankian distribution, reflecting the source plasma temperature with superimposed lines from the xenon emission spectrum. The smooth Plankian portion of the distribution is similar to the measured intensities for a 1 kT nuclear explosion [19].

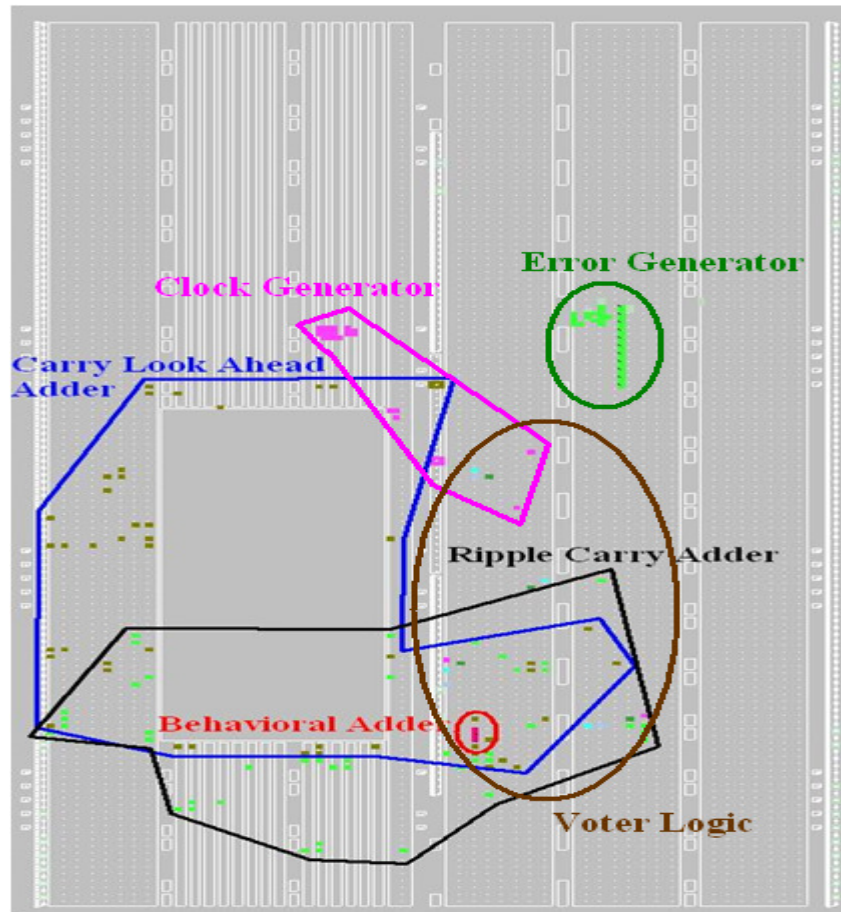
**Figure 14 – Layout of the 3 Adders on the FX12 Board**

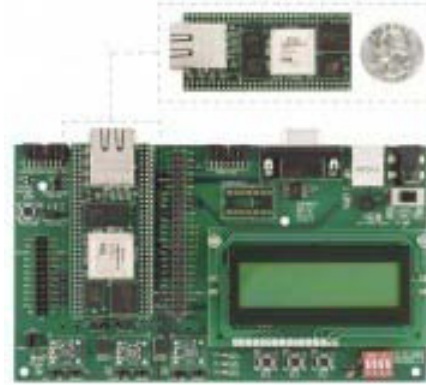
The FPGA device under test (DUT) for these radiation experiments was the Xilinx Virtex 4 FX12 Series Mini-module mounted on an Avnet Mini-Module Baseboard, pictured in Figure 16. The FPGA contained 90nm transistor technology with 10 layers of metal interconnects and triple oxide technology running internally at 1.2 Volts (V) [22]. A more complete description of the Virtex 4 Mini Module can be found in Appendix A.

**Figure 16 – DUT Virtex 4 Mini-Module**

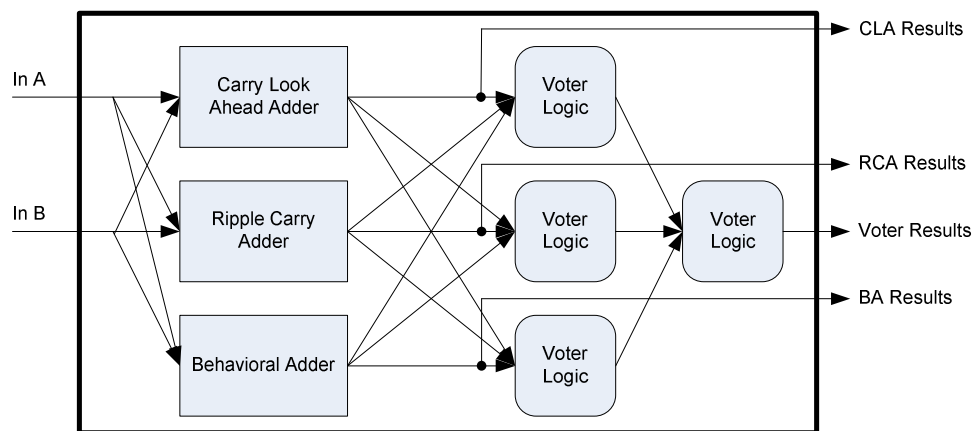
The DUT component consisted of the new Triple Design TMR. The design also utilized the triplicated voter enhancement [2]. The DUT contains three copies of different forms of adder logic. The Carry Look Ahead Adder and Ripple Carry Adder designs were implemented structurally using base level gates. The two adder diagrams can be found in Appendix B and C. The third adder was implemented in a behavior method, meaning it was left to the Xilinx software to layout how the adder would be designed. The three adder's results entered the triplicated voter logic in an effort to perform fault redundancy. The outputs of each adder were also sent to the controller board along with the results of the triplicated voter logic. Figure 17 shows the design of the entire TDTMR Unit.

**Figure 17 – Diagram of TDTMR**

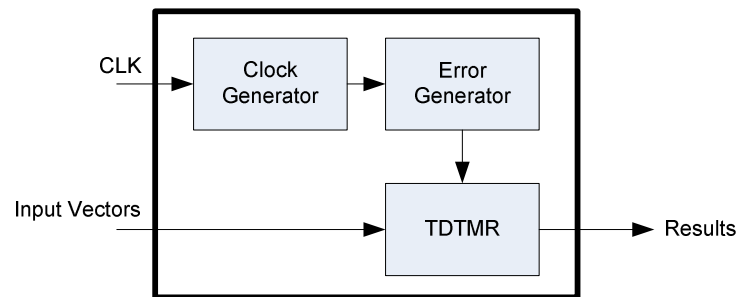
Other components were also added to the DUT as well, for testing purposes. A clock generator and an error generator were also added in the DUT (Figure 18). These units were used to simulate fault injections into the design. A fault injection is an error purposefully implanted into the integrated circuit that can be controlled by a user or automated through a computer program with specific guidelines.

**Figure 18 – Diagram of DUT**

The error unit generated errors at different timing intervals to simulate single errors into the TDTMR. These generated errors would lie dormant unless activated by a switch from the base board. Upon activation it would generate four errors at four different timing intervals, one microsecond, one millisecond, two seconds, and eight seconds.

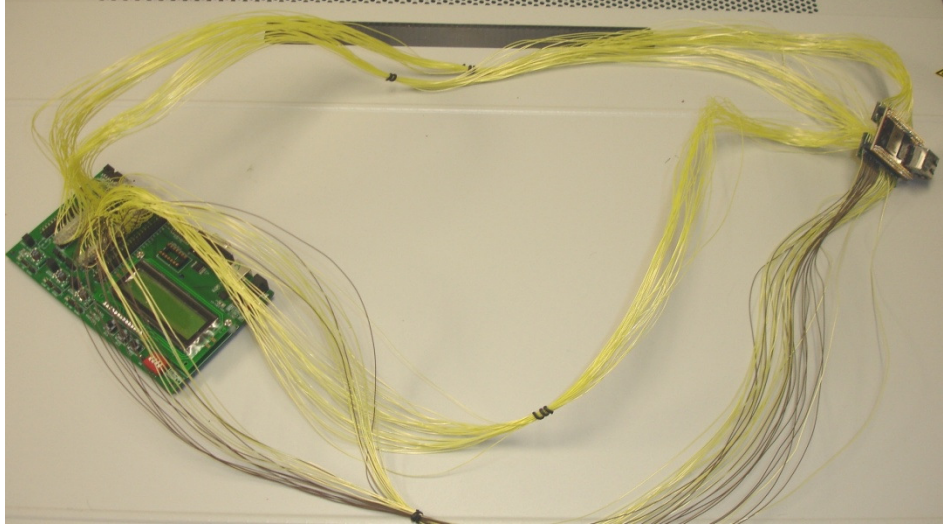
The overall goal of this research was to radiate just the Virtex 4 chip without the baseboard. To help eliminate other possible errors and isolate the chip itself, specialized connector cables (Figure 19) were constructed to allow just the chip to be placed under radiation and keep the base board protected from any possible radiation damage. No buffers were needed to have the chip be fully functional. With the current cables, the chip itself can be two feet away from the base board without any problems with timing and synchronization.

**Figure 19 – Connector Cables between Chip and Baseboard**

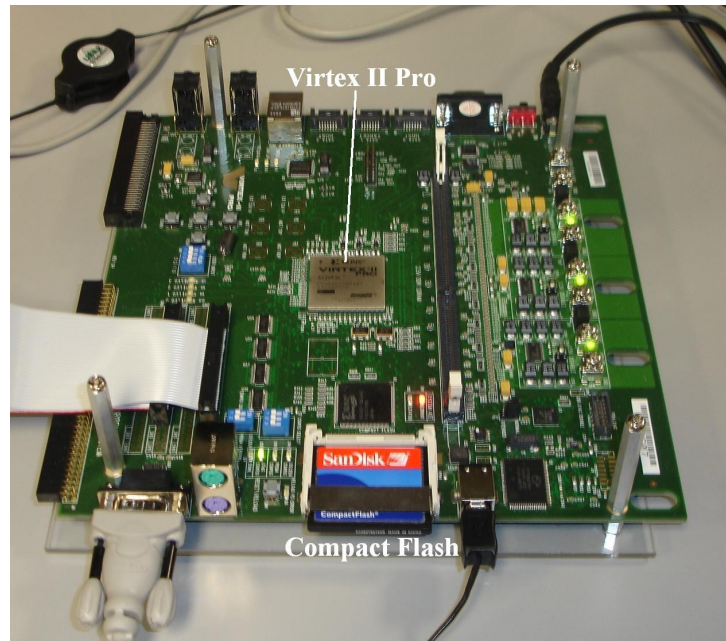
The Virtex-II Pro development system was the FPGA chosen to implement the controller board logic. It contains a PowerPC Processor which was used in the compilation of the diagnostic algorithm. 130 nm technology was also used with this board along with nine layers of metal. Output pins were soldered onto the board to provide the ability to utilize ribbon cables. Figure 20 shows the Virtex-II Pro board. Further description of the Virtex-II Pro can be found in Appendix D.

**Figure 20 – Virtex-II Pro Controller Board**

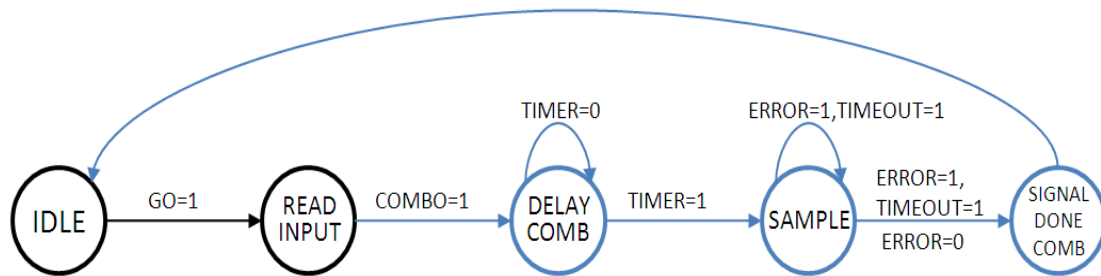
VHSIC Hardware Description Language (VHDL) controlled the basic flow of how the hardware operated. A state machine was developed in VHDL on the controller board to run the basic operations. Figure 21 shows the state diagram used for the controller board.

**Figure 21 – State Diagram of Controller Board**

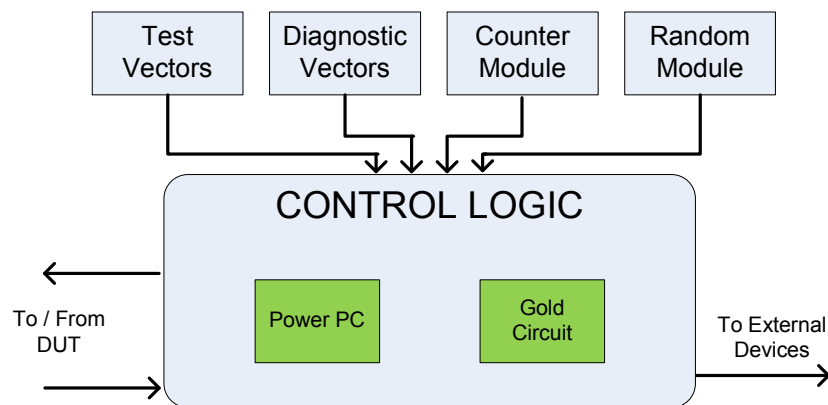
The remaining parts of the controller logic was written in C and utilized by the PowerPC. The controller board cycles through vectors of nine bits for the input that come from a counter or random module. These two modules can be interchanged during runtime by the user. A copy of the DUT circuit is also placed in the controller board and acts as the ‘golden circuit’ for comparison purposes. All the values from the DUT were compared to the ‘golden circuit’

results. Figure 22 illustrates the block diagram of the controller logic. Upon detecting an error, the controller board automatically switches to ‘Diagnostic Mode’ which has all the test and diagnostic vectors chosen as inputs. The PowerPC also runs the algorithm that calculates the location of the error. This will be discussed further in this chapter.

**Figure 22 – Controller Board Block Diagram**

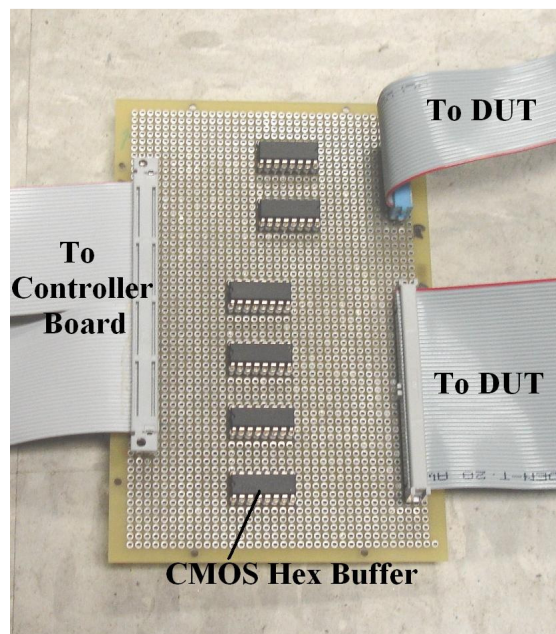
The Virtex 4 Mini-Module was originally chosen for its size to fit down a pipe under radiation. To communicate between the two boards, ribbon cable was used. Due to the incompatibility of the two boards to match the same pin layout, a bridge board needed to be constructed (Figure 25).

**Figure 25 – Bridge Board**

The bridge board also serves as a buffer to clean up the signal degradation between the two boards. Since there would be fifteen feet of cable between the controller board and the DUT, high speed CMOS buffers were used to aid in cleaning up the signal. Full details and specifications of the high speed CMOS buffers can be found in Appendix E. Figure 26 displays the comparisons of the signals with and without the CMOS buffers after fifteen feet. Another

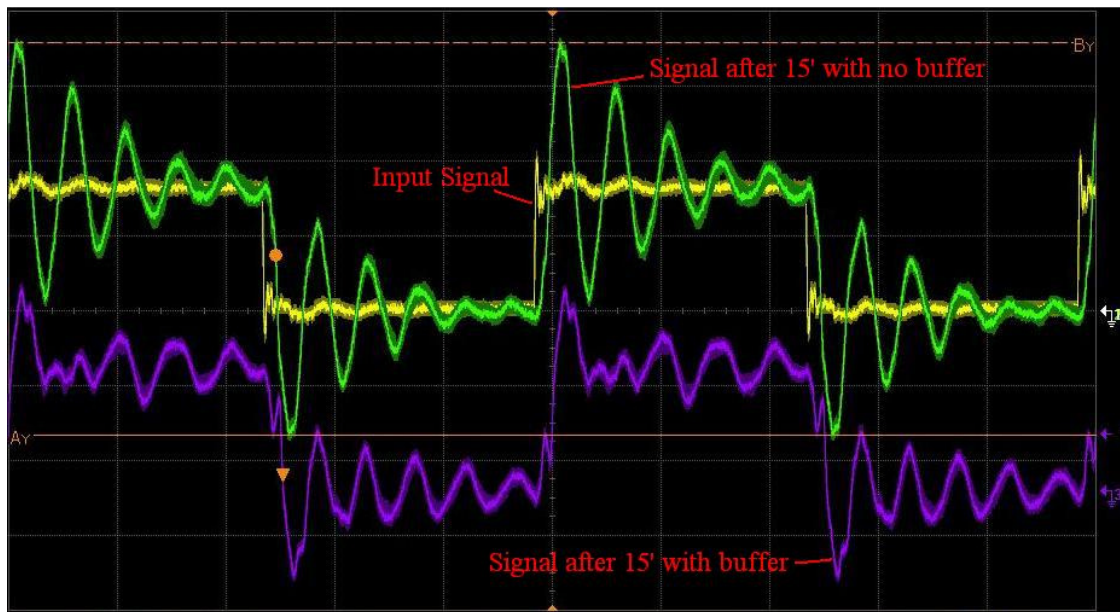
Figure 26 – Signal Comparisons

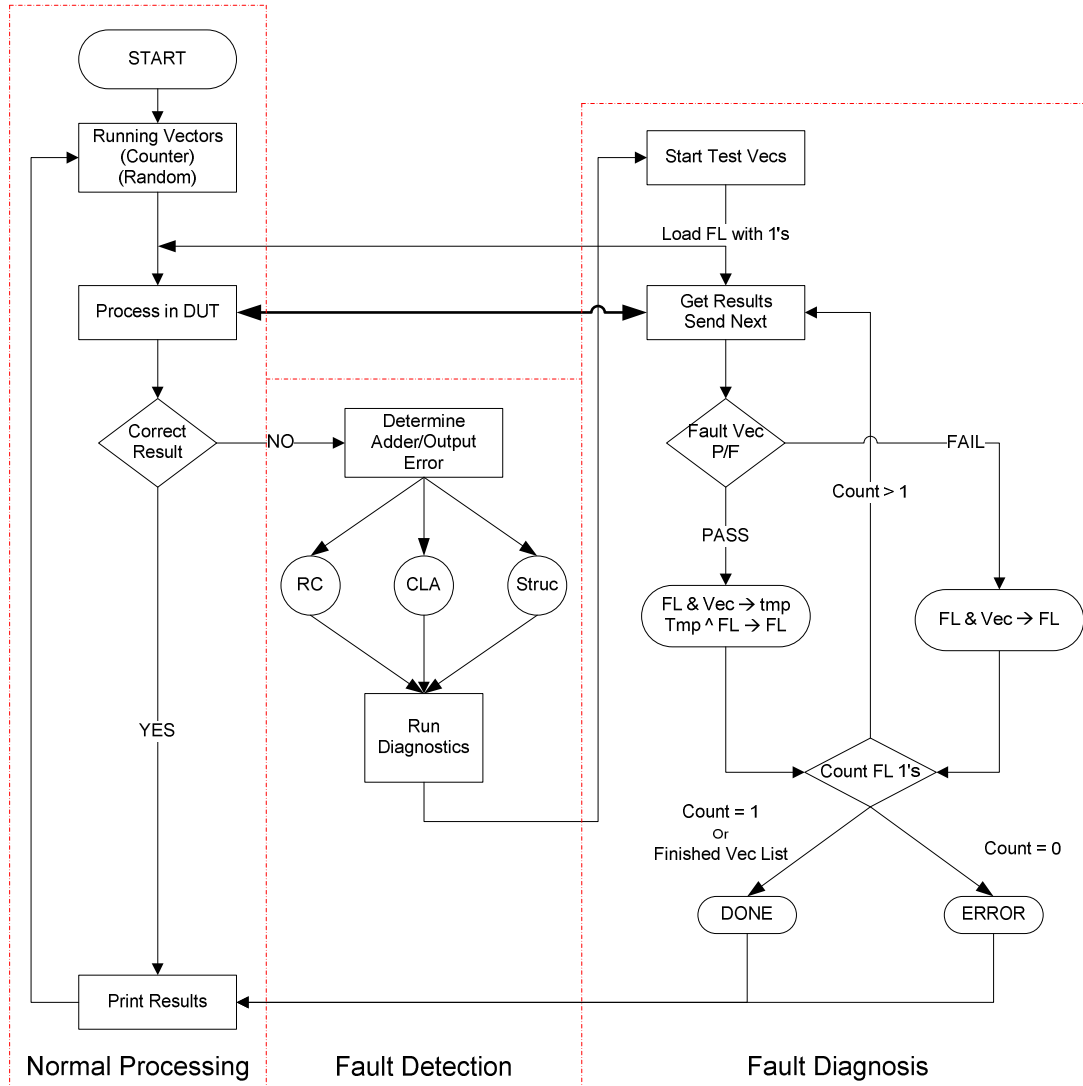
This section describes the process and methodology used to come up with the fault detection and diagnosis algorithm. The method used to detect faults was similar to previous work done in this field [17] with a few differences. The diagnosis algorithm was developed by utilizing the TESTCAD test generation and fault simulation tool sets. The full algorithm flow chart is displayed in Figure 27.

**Figure 27 – Fault Detection and Diagnosis Algorithm**

The goal of this algorithm was to diagnose a single fault in the entire system. Upon determining which adder and which bit caused the error, the algorithm would choose the appropriate test vector list and fault list to start inverse deductive fault detection. A possible fault list array was created and populated with values of ‘1’ which represent the possible location of faults. Each of the test and diagnostic vectors would process through the system and the

results would be evaluated. Pending on passing or failing, would determine how the elimination process of the fault list array would be conducted. The algorithm would continue in a loop until only one error remained or the end of the list has been reached. If more than one fault remained at the end of the list, it was determined that there was no possible way to distinguish the single fault amongst them all. The remaining faults would be the best possible resolution for fault diagnosis.

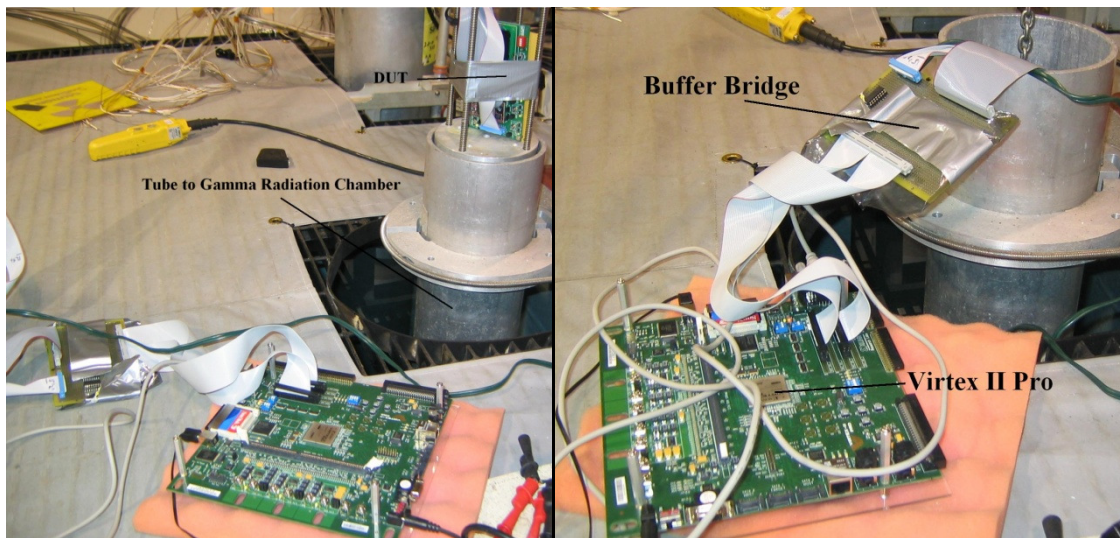
The test platform was originally constructed to be tested under gamma radiation at the OSUNRL. The DUT was separated from the base board and placed eight inches from the bottom based on Figure 10 to achieve the highest dose rate per hour (see Chapter 2). The base board was strapped above the DUT separated by a thick piece of lead to be protected from the radiation. The bridge board, controller board, and the remaining devices stayed fifteen feet above the reactor. Figure 29 depicts the entire set up used for the gamma radiation test.

**Figure 29 – Gamma Radiation Test Setup**

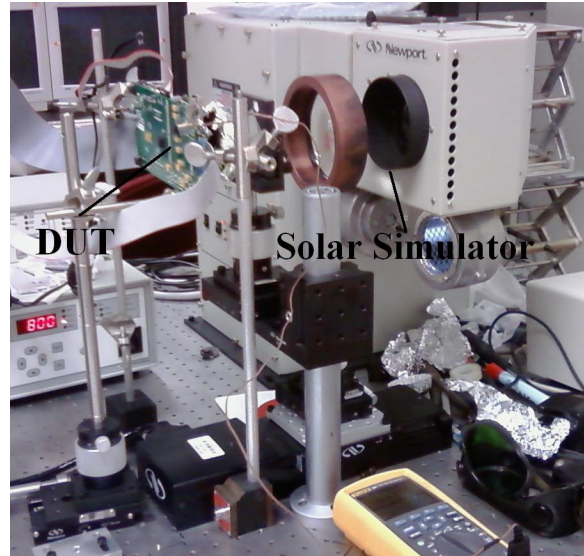
Thermal Radiation was chosen as another form to generate errors on the DUT. In a previous thesis [19], a Newport Xe Solar Simulator was assembled with the ability to provide 3.3 cal/cm<sup>2</sup>s irradiance. Figure 30 depicts the set up used for this irradiation test.

**Figure 30 – Thermal Radiation Test Setup**

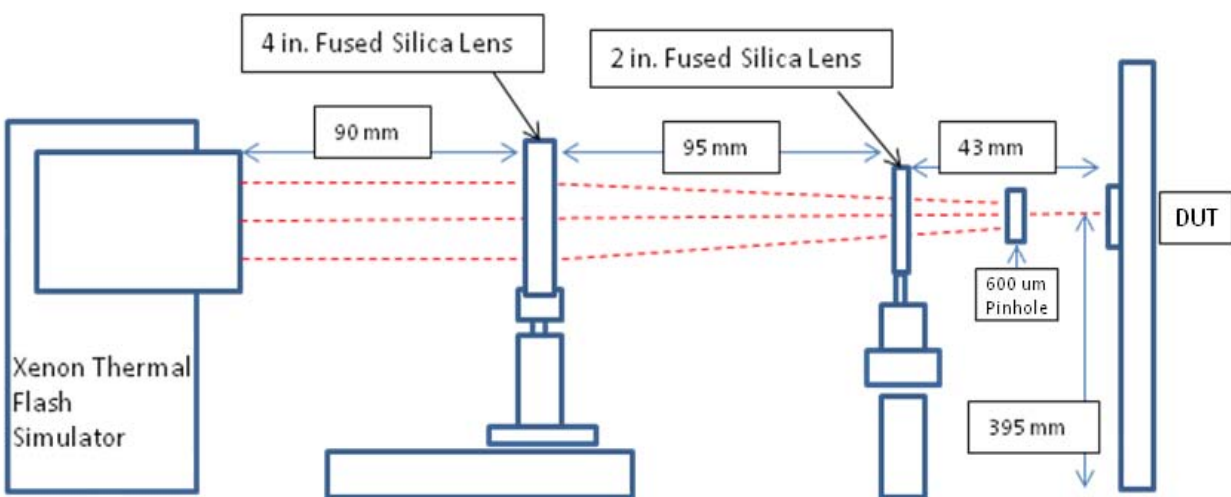
A two inch diameter fused silica Plano convex lens was inserted 95 mm after the focusing optic of the setup. The focal length of the second external optic is 150 mm. However, to increase the homogeneity of the beam, the target was placed closer to the second external optic than the focal length [18]. A pinhole was constructed that was placed in between the two inch Silica Lens and the FPGA to ensure the focus of the thermal radiation onto the FPGA alone. Figure 31 provides a diagram with detailed specification of the entire set up.

**Figure 31 – Thermal Radiation Specification Setup**

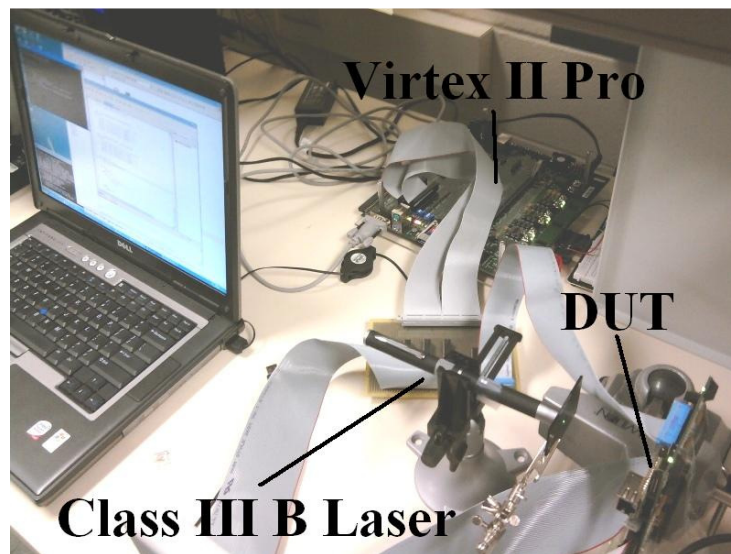
Using a COTS laser pen to cause errors was another test. The test setup consisted of a laser pointer, a pinhole plate, and the DUT. All the lasers were green in color with a wavelength of 532 nm. Three different wattage laser pens were used in an attempt to create errors. The three lasers had wattages of 10 mW, 20 mW, and 50 mW. The cover of the FPGA on the DUT was removed for this test. The pinhole plate was 600 micrometers in diameter.

The laser pointer was setup with the pinhole over the laser to get a more focused target onto the uncovered FPGA. The distance to the FPGA was 73 mm. Each laser was focused on one corner of the FPGA. Figure 32 depicts the entire set up used for the optical laser test.

Figure 32 – Optical Laser Test Setup

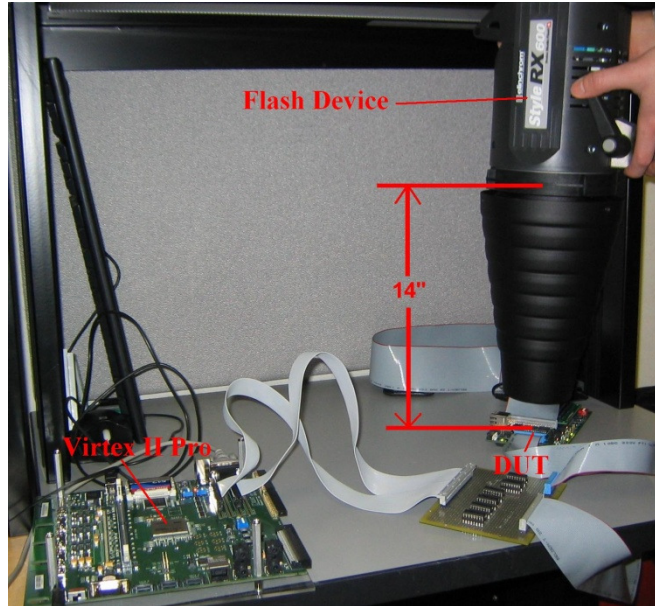
The last test setup used for this research that was available was the optical flash test. The goal of this test was to see if the Electrical Magnetic Interference (EMI) of a professional, camera flash device would cause errors on the DUT. Figure 33 depicts how the test setup was arranged.

**Figure 33 – Optical Flash Test Setup**

The flash device was controlled digitally through the concept in photography known as F-stop. F-stops are powers of  $\sqrt{2}$ . The first  $f$  stop is  $\sqrt{2}^0$ , or  $f/1$ . Next is  $\sqrt{2}^1$ , or  $f/1.4$ , then  $\sqrt{2}^2$  for  $f/2$ , etc [24]. For each increment of  $f$ -stop number the output wattage doubles.  $f/1$  starts with output wattage of 18.75,  $f/2$ 's output wattage is 37.5,  $f/3$ 's output wattage is 75, and so forth.

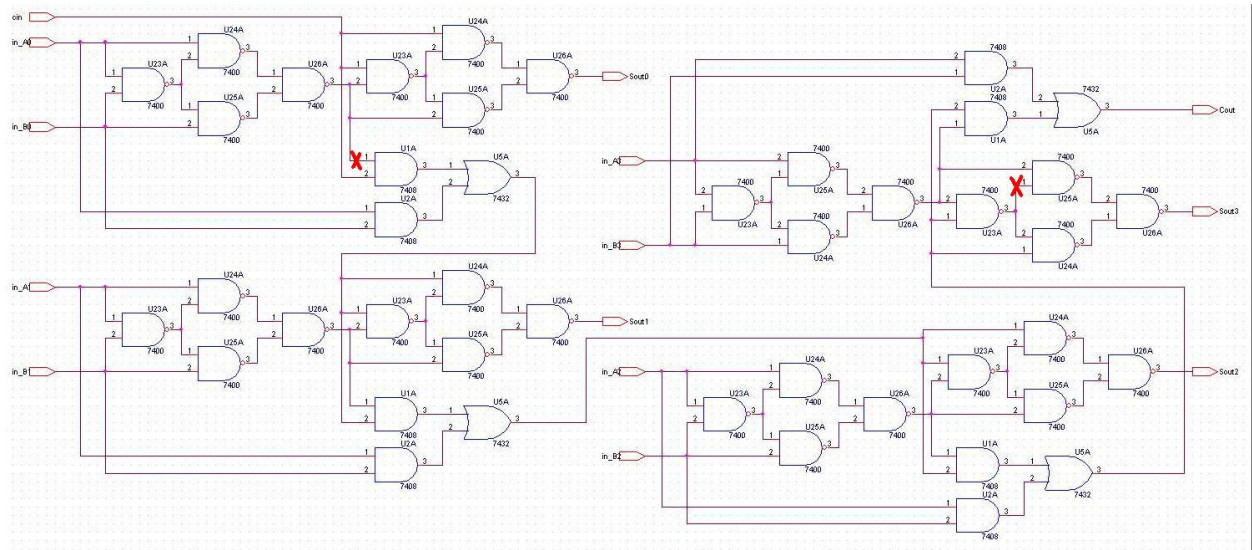
The results for this hardware simulation test setup were completed. The objective of locating the fault within the circuit and be able to diagnose the location of that particular fault in real time were achieved. The four hardware injected faults were located with the best resolution through the algorithm described in Chapter 3. The algorithm was able to pinpoint the exact location of the fault that was randomly placed in the structural design of either the Ripple Carry Adder (Figure 34) or the Carry Look Ahead Adder (Figure 35). Three of the four faults were

**Figure 34 – Injected Fault Locations for Ripple Carry Adder**

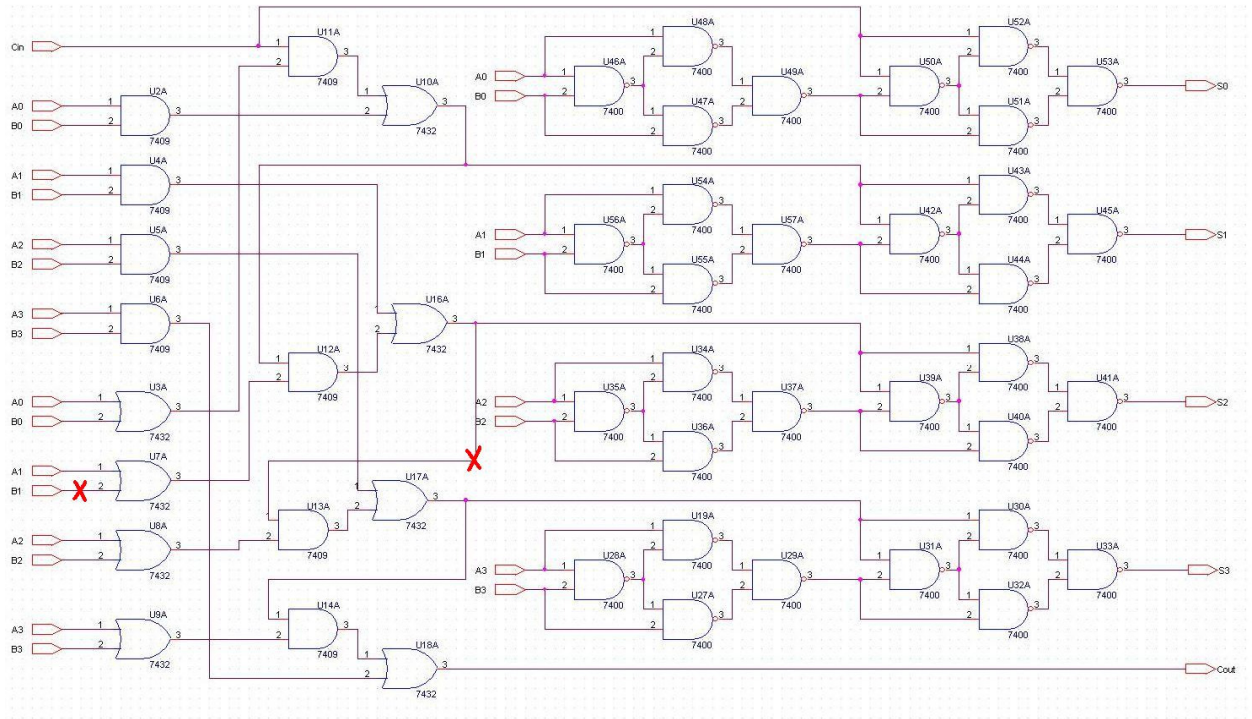
**Figure 35 – Injected Fault Locations for Carry Look Ahead Adder**

detected and the diagnostic algorithm pinpointed them exactly on the circuit diagram. One of the faults was not able to be located exactly; however, the algorithm reduced the number of possible locations to three. This result cannot uniquely distinguish amongst the three faults without fully

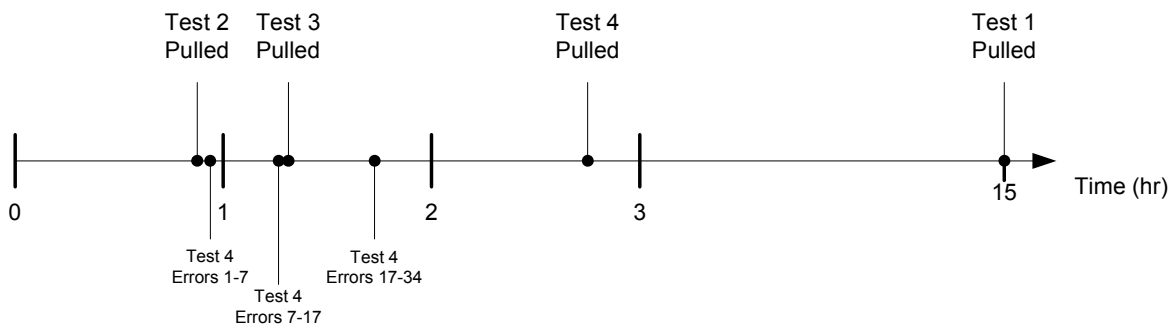
The final test for gamma radiation was met with differing results. The device was raised to seventeen inches from the bottom of the radiation chamber. By raising the distance, the dose rate is effectively reduced to 35 krad(Si)/hr based on Figure 11 found in Chapter 2. After two and three quarter hours, the baseboard and the DUT were still operational after being pulled from the radiation event. There were a total of thirty-four errors that were traceable coming in three groups of time. Figure 38 shows the timeline for all four tests for gamma radiation along with the group of errors detected in Test 4.

**Figure 38 – Gamma Radiation Timeline**

The three groups of errors, based on the logs, were consistent and traceable. It appeared that the voting logic produced errors at bit zero. The results showed that bit zero of the voting logic was a stuck-at-zero fault meaning a value in the output remained zero for a period of time. Table 3 presents an example of how the results represent a bit stuck at zero. Finally, Table 4 shows a summary of all four test results taken during the gamma radiation test.
