A Portable Hybrid Ultrasound-Eddy Current NDI System for Metal Matrix Composite Track Shoes

Xiaoliang Zhao, Bao Mi, Tao Qian

Intelligent Automation, Inc., 15400 Calhoun Dr., Suite 400, Rockville, MD 20855

U. S. Army RDECOM/TARDEC, 6501 E. 11 Mile Road, MS 255, Warren, MI 48397

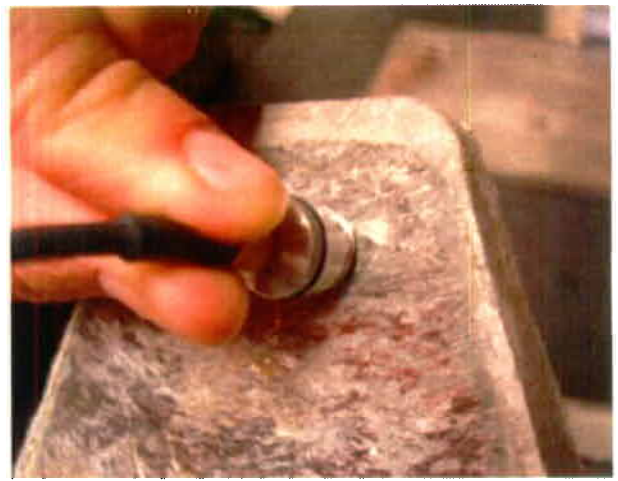
Fig. 2: Illustration of pulse-echo method for disbond detection. (a) Conventional contact transducer on the tank shoe; (b) Illustration of the ultrasound paths; (c) Signal at location with no disbond; (d) Signal at location with disbond.

Fig. 2 illustrates how a disbond at the boundary between the MMC insert and the aluminum substrate is detected by the pulse-echo method with a contact ultrasonic transducer. Fig. 2a shows the center spline section with a contact transducer placed on its surface. The possible ultrasonic propagation paths are illustrated in Fig. 2b. When no disbond is present, ultrasonic energy propagates through the MMC-substrate boundary and is reflected from the back wall, with the corresponding signals as shown in Fig. 2c. At the area of the disbonded region, the ultrasonic energy is bounced back and forth between the surface and the MMC-substrate interface, with the corresponding signals as shown in Fig. 2d. Multiple reflections are present since the thin layer of MMC is less attenuative than the entire thickness of the center spline.

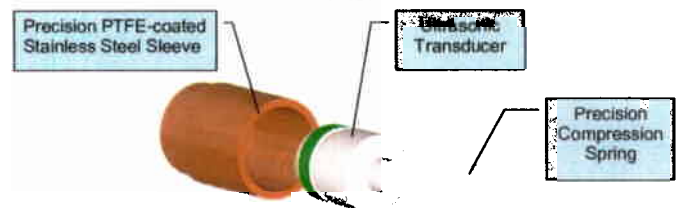
Fig. 4: Prototype fixture design. (a) Fixture assembly; (b) sensor housing plate assembly; view of sensor contact surface with backing plate removed; (c) ultrasonic transducer assembly.

To prove the concept of a clamped-on fixture, a prototype that hosts four ultrasonic transducers has been designed and fabricated to detect disbond in the center spline. Fig. 4 shows the fixture assembly and how pressure can be applied on each individual transducer by springs in detail. The designed fixture has the following features:

Fixed-angle separation: Transducer housing plate and the backing plate for clamping on to a spline are designed at 12 degree angle to parallel, which matches the angle between left and right faces of spline. Angled counter bores are designed to provide increased surface area for clamping pressure between housing and clamping plate.

Spring-loaded transducer assemblies (Fig. 4c): Individually loaded transducers allows for compliance

with surface irregularities (depressions, angular deviations). The design makes it possible to adjust contact pressure by installing spacers (washers). While the spring-loaded transducer introduces a contact pressure variance range when the surface is not level, this range can be reduced by using a stiffer spring (higher K).

Precision PTFE-coated stainless steel transducer sleeve: The low-friction PTFE surface reduces binding between the transducer subassembly and the housing so that the pressure applied on the transducer is not affected by the friction force. Another advantage is that it is corrosion resistant.

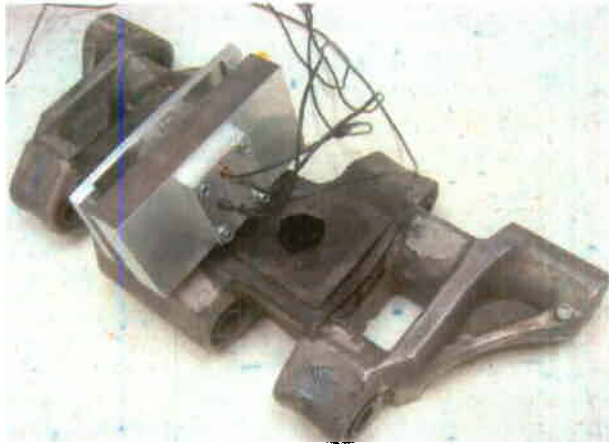
Fig. 5: Tank shoes with prototype fixture attached.

The prototype fixture has been attached to various shoes with four 10-MHz transducers for disbond detection test, as shown in Fig. 5. Note that a special dry

couplant of 2.3 mm thick is placed between the transducers and the spline surface. All the shoes have been C-scanned and the images are available on the spline section for ground truth confirmation. To help understand the ultrasonic signals obtained by the contact transducers, a typical signal is shown in Fig. 6 with the echoes marked. The 2.3 mm thick Elastomer dry couplant produces a large reflection first and the reflections from the disbonded area (if present) follow.

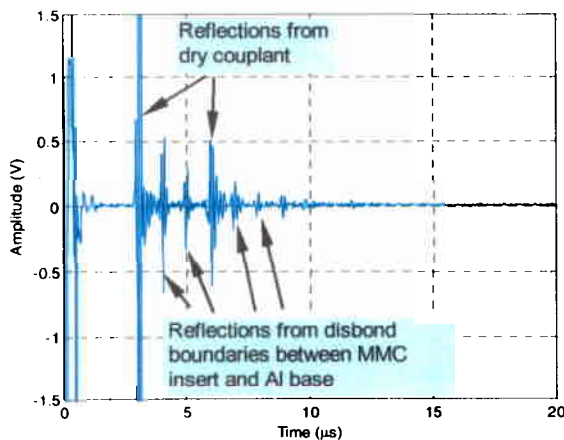
Fig. 6: Typical ultrasonic signal received by contact transducer with echoes marked.

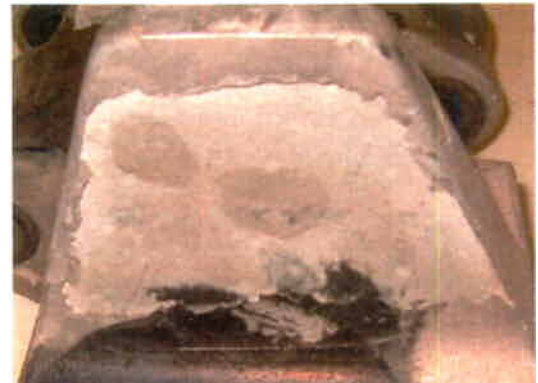
Fig. 7: Test results compared to the ultrasonic C-scan image for shoe #4. Signals at Locations 2 and 4 show low level of disbond. The signal

received at Location 1 shows no echoes from dry couplant. The uneven surface at that area may have caused the weak coupling.

The testing results for two typical shoes are shown in figures Fig. 7 and Fig. 8. The first shoe #4 is a new shoe that has never been used. The second shoe #6 is a used shoe and has quite a bit of surface wear at the spline section. This is also confirmed by the time-of-flight of the disbond boundary reflection signal that reveals the Shoe #4 (new shoe) has a thicker MMC insert than Shoe #6 (used shoe).

As can be observed from Fig. 7 and Fig. 8, the fixture with contact transducers works well for detecting the disbond defects. For used shoes, the results are very reliable when comparing to the C-scan images due to

the flat surface caused by the surface wear. For brand-new shoes, the surface is uneven around the edge of the MMC insert. The uneven surface may cause coupling problem and produce unreliable results. This problem can be solved by the surface preparation before inspection.

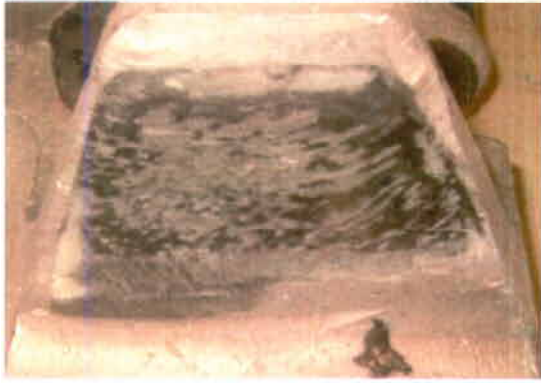
Fig. 8: Testing results compared to C-scan image for shoe #6. All four signals agree with the C-scan images well.

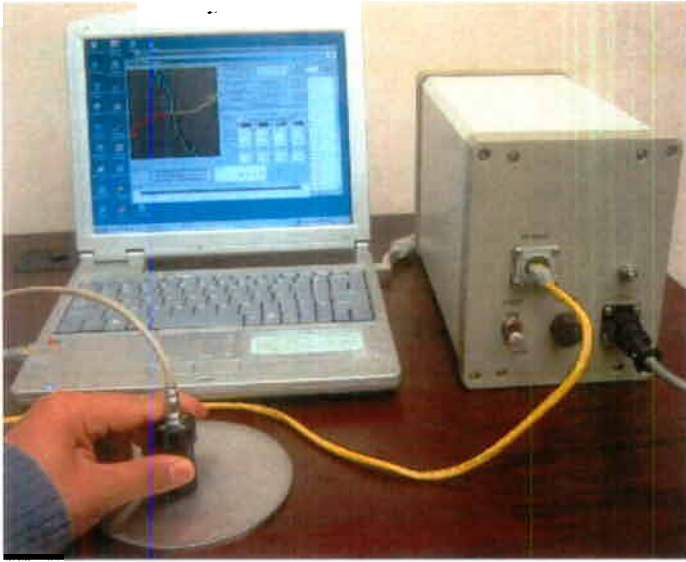
Fig. 10: Eddy current system

An eddy current inspection system manufactured by a German company IZFP is used for detecting the porosity and surface cracks. The eddy current system is mainly composed of an instrumentation board, which is designed for PC-aided eddy current testing. The connection between the eddy current board and the PC

is realized by network cable. This board is preferred by IAI because once the raw eddy current data is transferred to the PC computer, powerful signal processing algorithms can be developed to enhance the capability of defect detection and quantification. The system is shown in Fig. 10. The eddy current board is packaged in the box shown on the right in the picture.

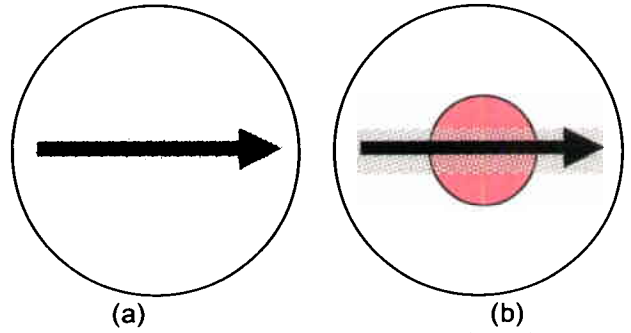
Fig. 11: Eddy current probe scanning across the MMC specimen. (a) Specimen #1: porosity free; (b) Specimen #2: porosity at the center (shaded by pink color).

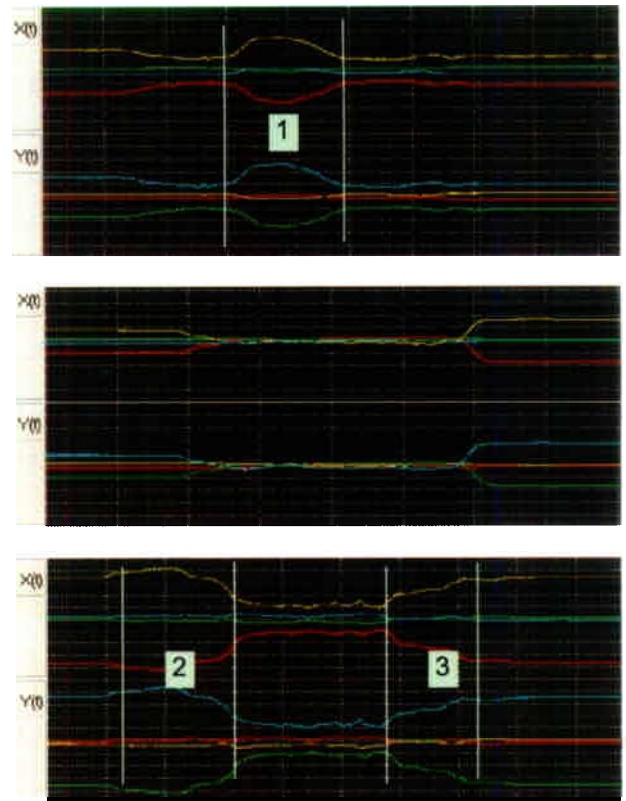
Fig. 16: Eddy current scanning results for the used tank shoe spline with surface defects as shown in Fig. 15.

The corresponding eddy current time based signals are shown in Fig. 16. Each of the three pictures represents one of the three scans illustrated in Fig. 14. The four colors in the eddy current results represent four different eddy current frequencies. The corresponding eddy current signals to marked areas with numbers in Fig. 15 are marked with same numbers in Fig. 16. It can be concluded that the eddy current signals respond well to the surface conditions. Some of the deviations in the eddy current signals at the start and the end of the time based displays are caused by resting the probe on the edge of the inspected shoe spline.

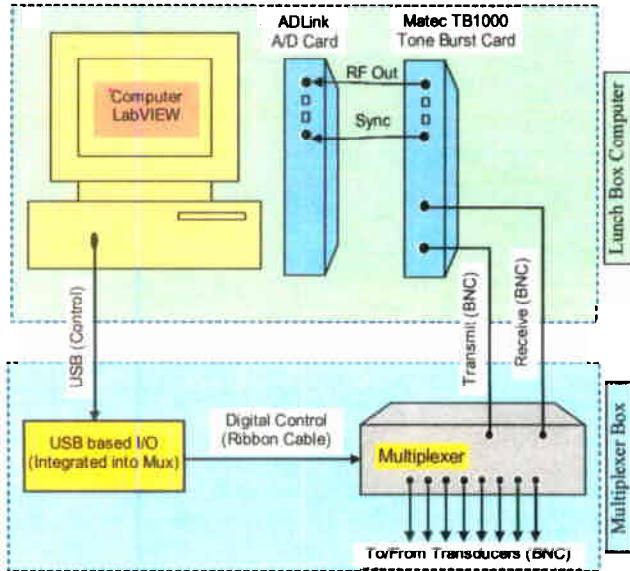
Fig. 17: Hardware schematic.

Fig. 17 illustrates the hardware configuration for the ultrasonic signal acquisition system. While this configuration is designed directly for the transducer array used for disbond detection, it is extendable/scalable to the crack and porosity detection. Currently the lunch box computer is equipped with an ADLink high speed A/D card and Matec TB1000 tone burst card. It is ready for collecting ultrasonic signals from a single transducer in pulse-echo mode or signals from a pair of transducers in through-transmission mode. To automate the signal acquisition from an array of transducers in a pulse-echo mode, a multiplexer is required.

A 16-channel multiplexing board has been designed and fabricated. Up to 16 transducers can be connected to the pulser/receiver through this multiplexer card. Each of the 16 transducers can be selected to be either the transmitter or the receiver. The computer selects channels through a USB based I/O board. Four I/O pins are used to select one of the 16 input channels as transmitter and another 4 I/O pins are used to select one of the 16 output channels as receiver. Reed mechanical relay was used to open or shut the channels. Compared to solid-state relays, the mechanical relays have lower contact resistance, higher switching voltage, lower across open contact capacity. The drawback of the

mechanical relay is that it has longer operation time, which is not critical in our application because switching frequency is not high. The mechanical relay also dramatically reduces the cross talk between channels. To prevent the input signal from shorting to output, a hardware logic system was added to the design, which automatically shut down all output channels when the same channel is selected for both input and output.

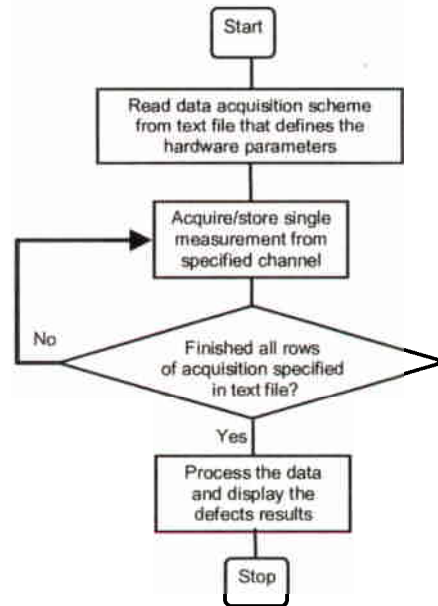
Fig. 18: Operational flow chart.

The software has been developed in LabVIEW. The primary objective of the LabVIEW program is to automate the acquisition process of the multiple-channel ultrasonic data and the eddy current data with a high speed ADLink A/D card, a Matec TB1000 Tone Burst Pulser Receiver Card, and the USB-controlled multiplexer. The design of the software is modular, as shown by the block diagram in Fig. 18. The basic modules of the software include the following:

Control of multiplexer card through a USB port. Sending control signals to multiplexer card to select the specified transducer(s) through USB based I/O port.

Configuration of Matec TB-1000 tone burst pulser/receiver card. This includes the setting of the parameters, such as gain, mode (pulse-echo or through-transmission), pulse width, repetition rate, filter setting, etc.

Data acquisition via ADLink high speed A/D card. This includes the setting of the acquisition parameters, such as sampling rate, averaging number, record length, etc. The acquired data will be saved into a text file with specified file name and appropriate index number.

Data processing. This includes processing the raw ultrasonic data to extract the defect information
