**AL QAIM 33/11KV ELECTRICAL  
MOBILE SUBSTATION  
AL QAIM, IRAQ**

**SUSTAINMENT ASSESSMENT**

**SIGIR PA-09-191  
APRIL 12, 2010**

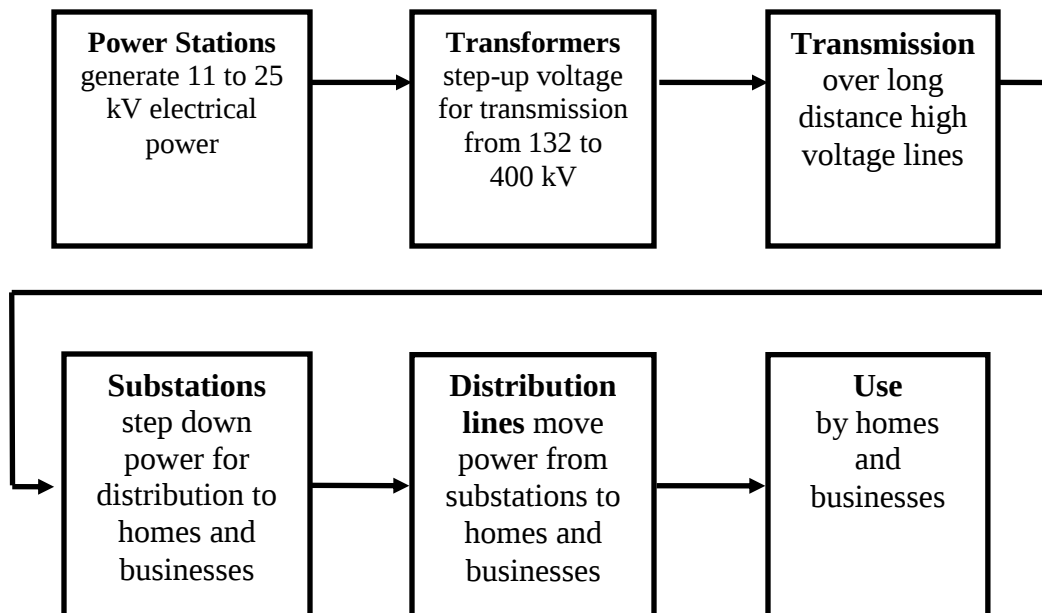
Electrical power is normally generated in power stations at voltages from 11 to 25 kilovolts (kV). In order to most efficiently transmit this power over long distances, it is stepped-up from 132 to 400kV. Power is then carried over long distances by the high voltage 132 to 400kV transmission lines. Substations step-down electrical power for eventual distribution to homes and business as shown below (Figure 1).

Figure 1. Diagram of the electrical generation, transmission and distribution process.

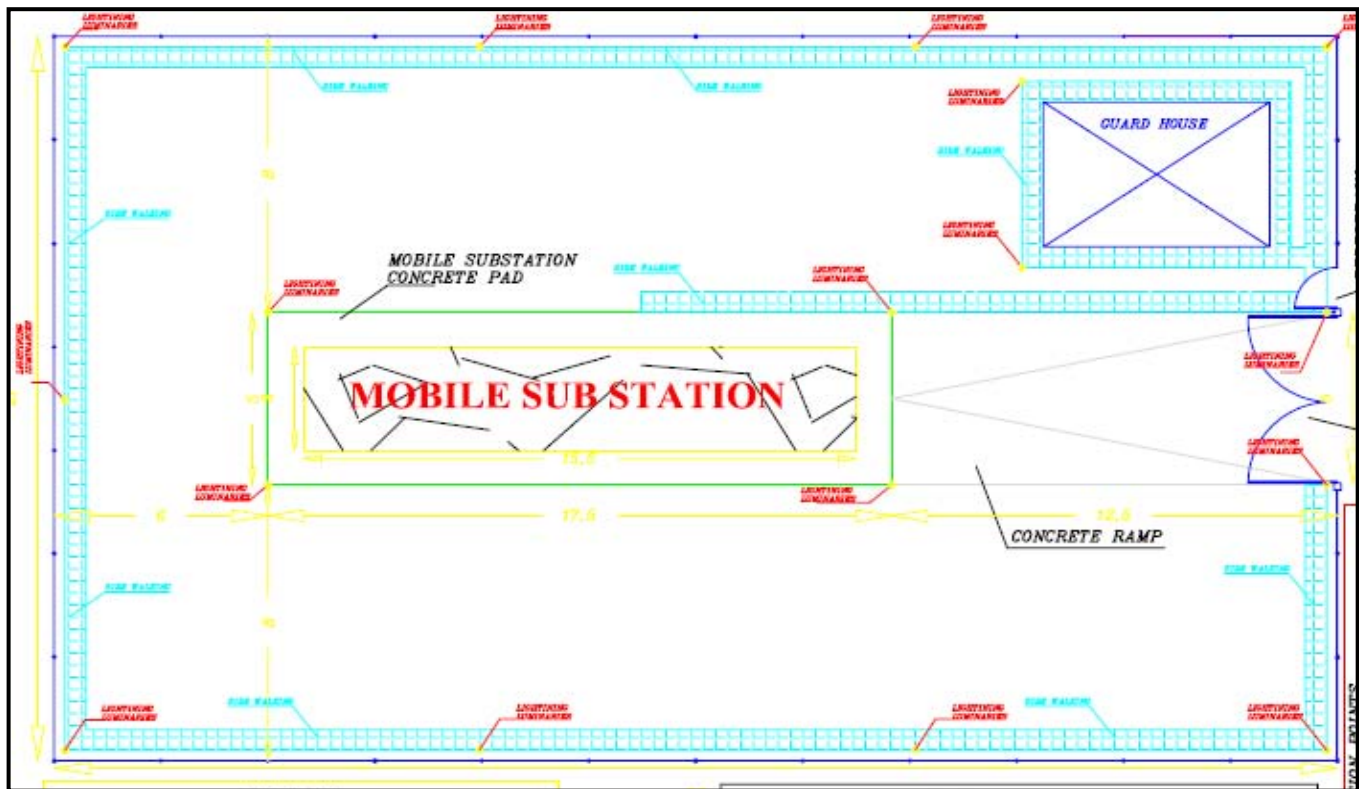
Further, the SOW required the construction of a concrete pad, service buildings, and perimeter wall and gates for each substation (Figure 3).

Figure 3. SOW requirement for concrete foundation pad, fence, and guard house (Courtesy of GRC)

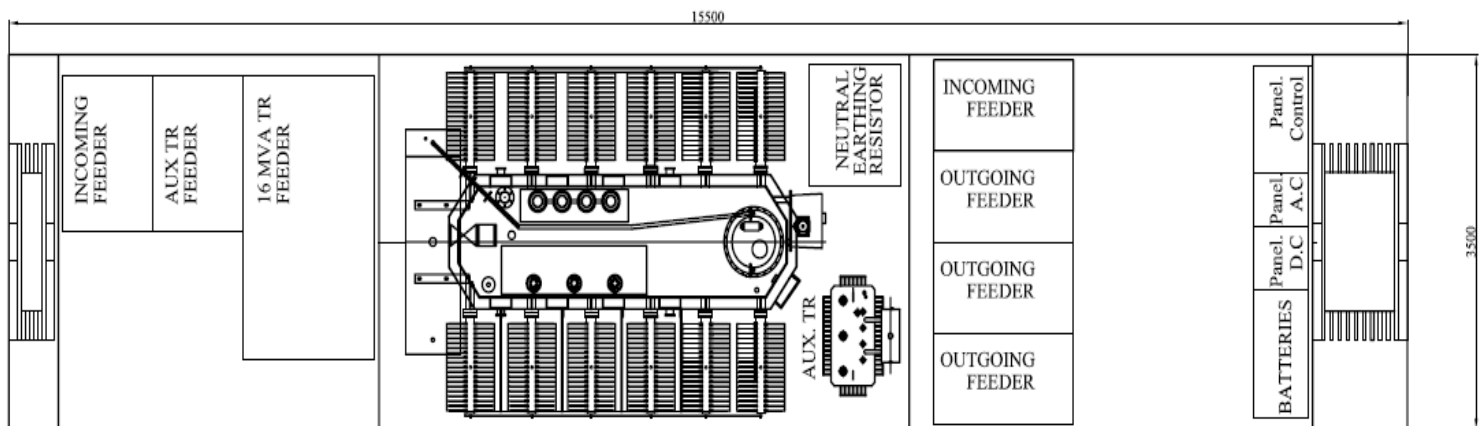
**Figure 4. Top view of mobile substation on trailer (Courtesy of GRC)**

SIGIR reviewed the contractor's specifications and design drawings and found them to be in accordance with the requirements of the contract. The mobile substations, as designed, will provide the necessary mechanism to transfer and distribute electrical power from the national grid to local communities within Anbar province.

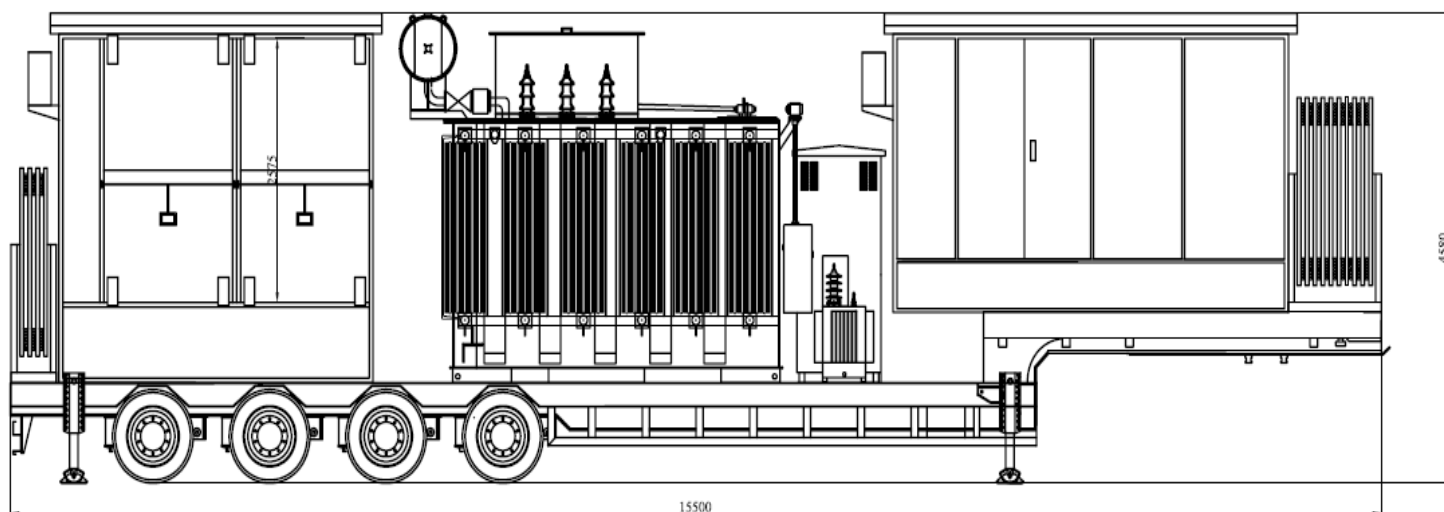
**Figure 5. Front view of mobile substation on trailer (Courtesy of GRC)**

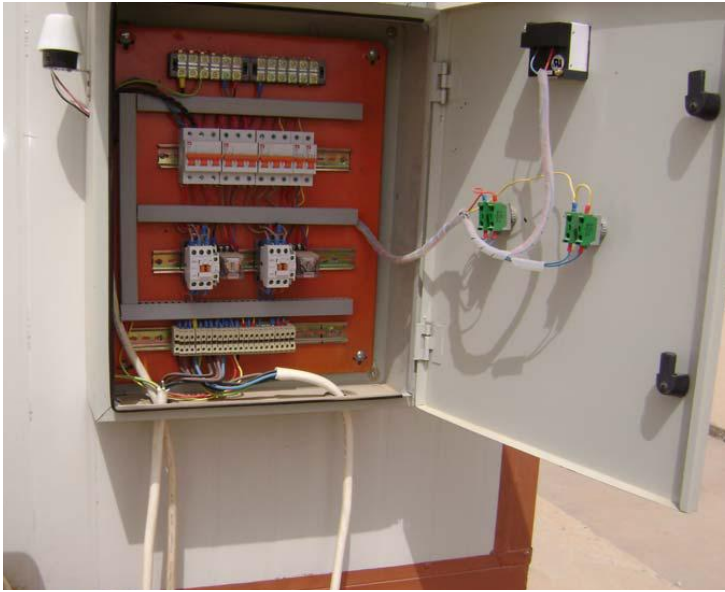
Site Photos 1-3 document various construction deficiencies the daily QA reports identified. After reviewing the daily QA reports and photographs, SIGIR agreed with GRC's concerns regarding the construction practices, which led directly to the deficiencies identified.

**Site Photo 1. Cables unsecure and not in conduit  
(Courtesy of GRC)**

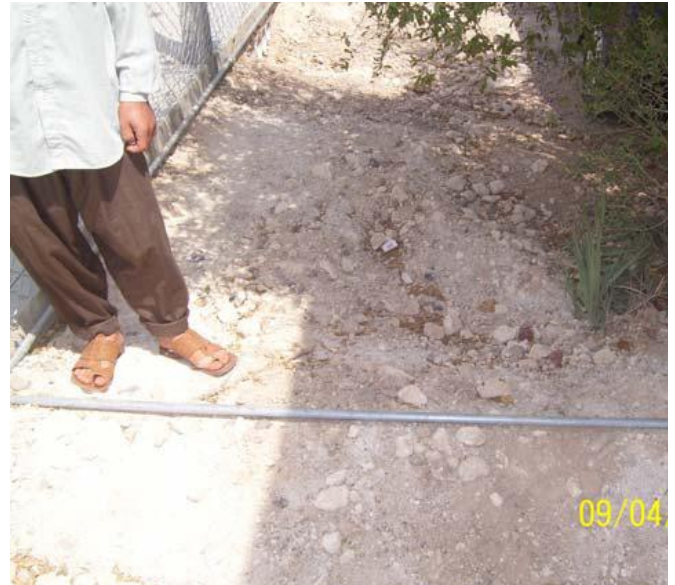
**Site Photo 2. Water supply to guard house not buried  
(Courtesy of GRC)**

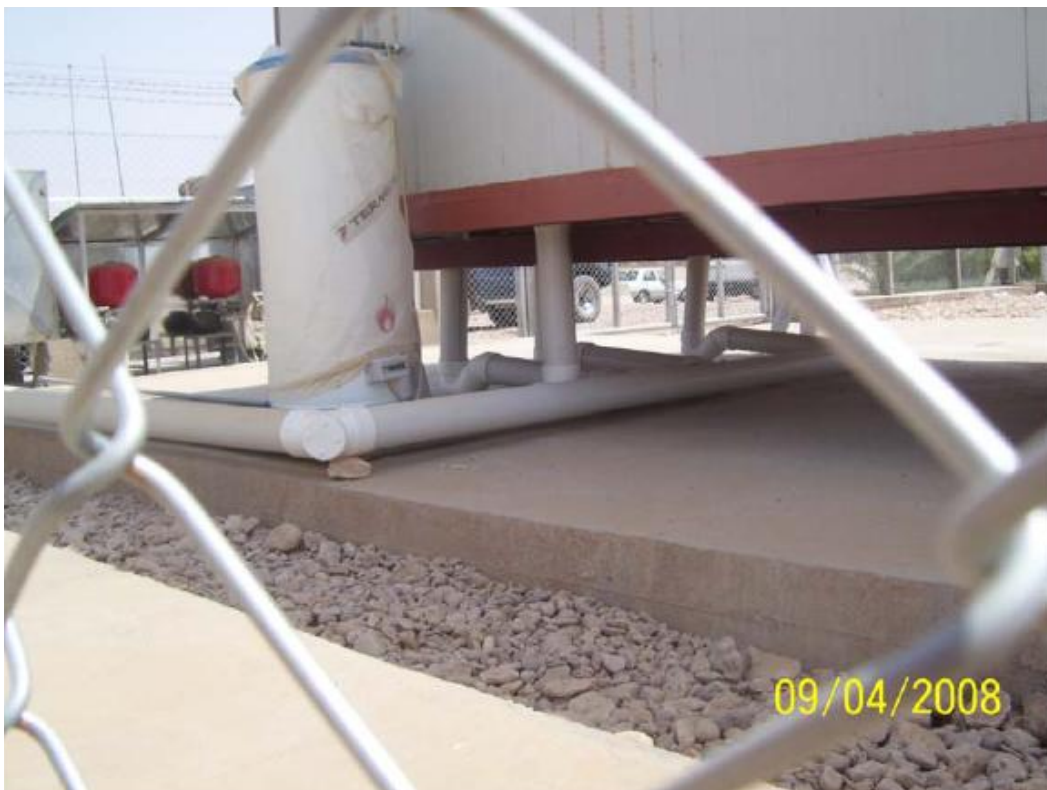
**Site Photo 3. A rock used to improperly pitch the sanitary line  
(Courtesy of GRC)**

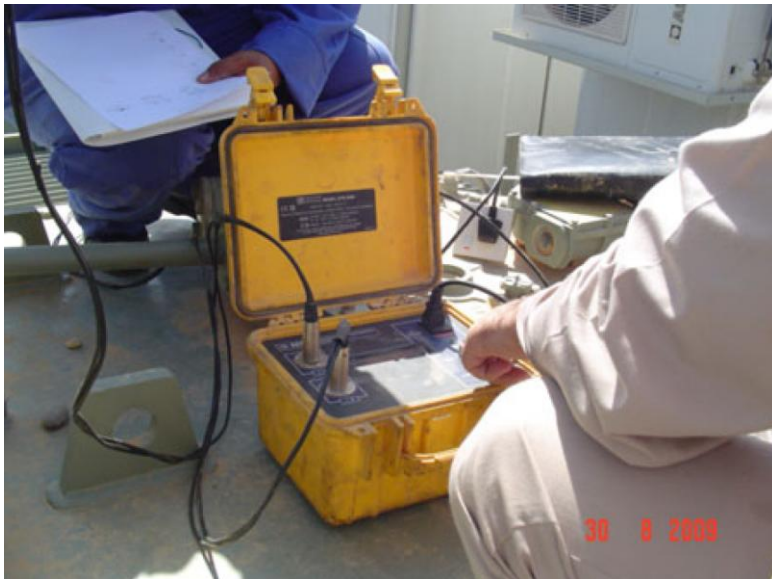
SIGIR reviewed project file documentation to determine the condition/status of the equipment at the time of the contractor's termination. The Iraqi Director of Anbar Electrical Distribution organized a committee of four engineers to receive and inspect the contractor-provided mobile substations. The project file included the receipt of all four mobile substations and inspection reports documenting that each mobile substation was tested and successfully passed. Site Photo 4 shows testing performed on the mobile substations.

Site Photo 4. Testing of mobile substations after delivery  
(Courtesy of GRC)

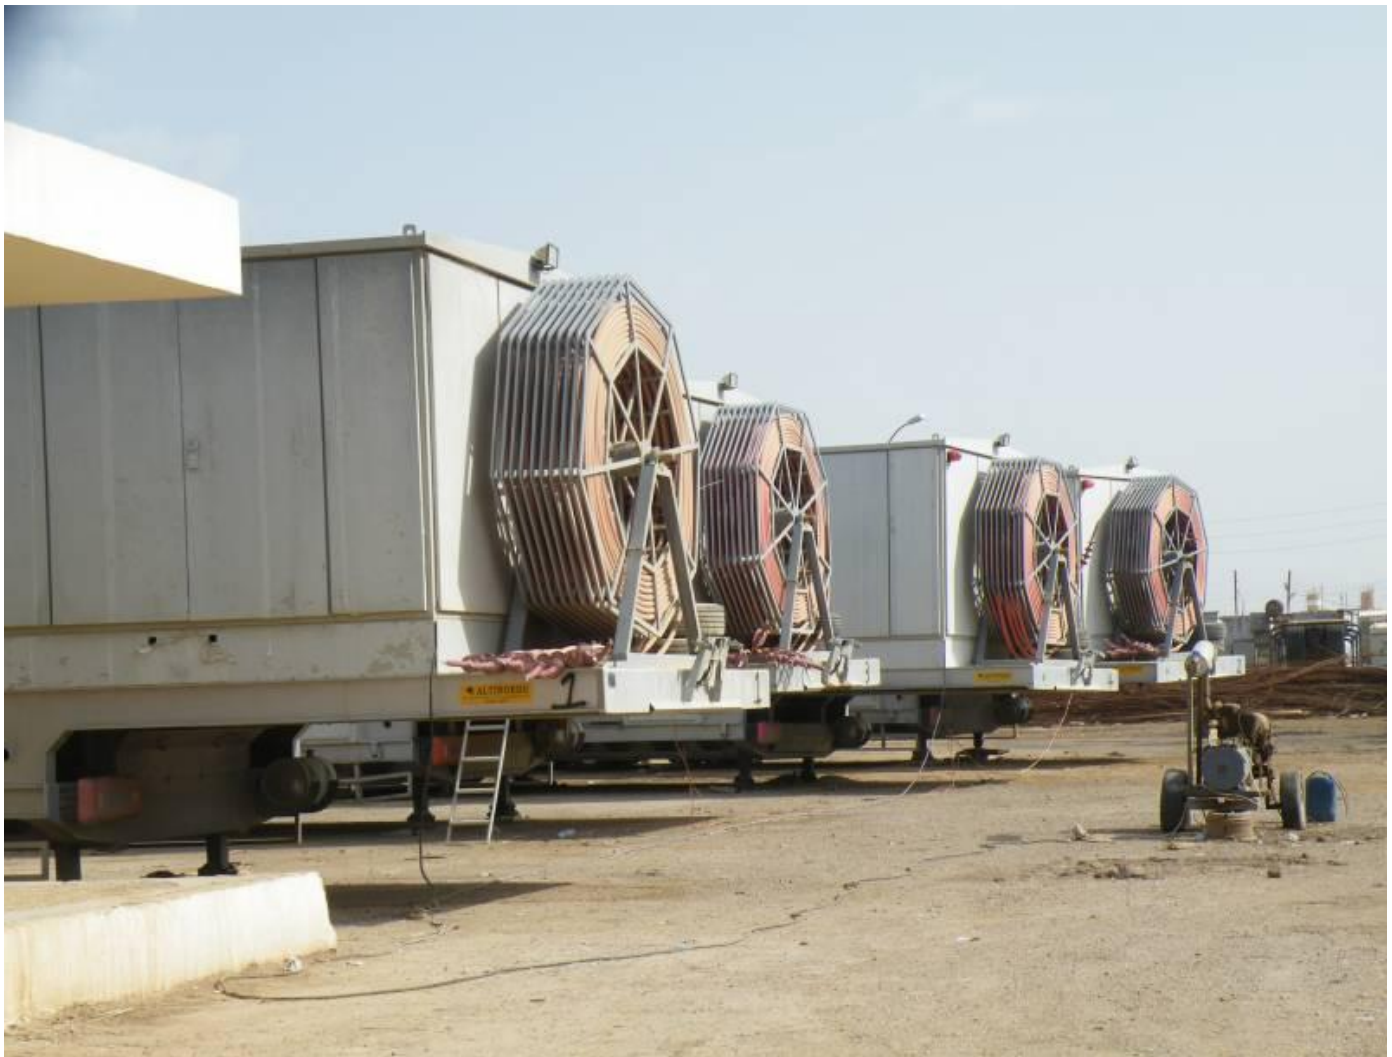
SIGIR identified four mobile substations within the MOE's outdoor warehouse facility (Site Photo 6). Each 33/11kV 16 MVA mobile substation was factory-equipped/installed/assembled and mounted on trailers approximately 50 feet long by 11 feet wide. It appeared that the mobile substations were complete and adequately assembled with the required cables, transformer, power management units, and circuit components (Site Photo 7).

However, since the contractor did not connect any of the substations to the national grid, SIGIR could not determine the current operational status of the substations.

**Site Photo 6. Four mobile electrical substations at the MOE's Ramadi outdoor warehouse facility**

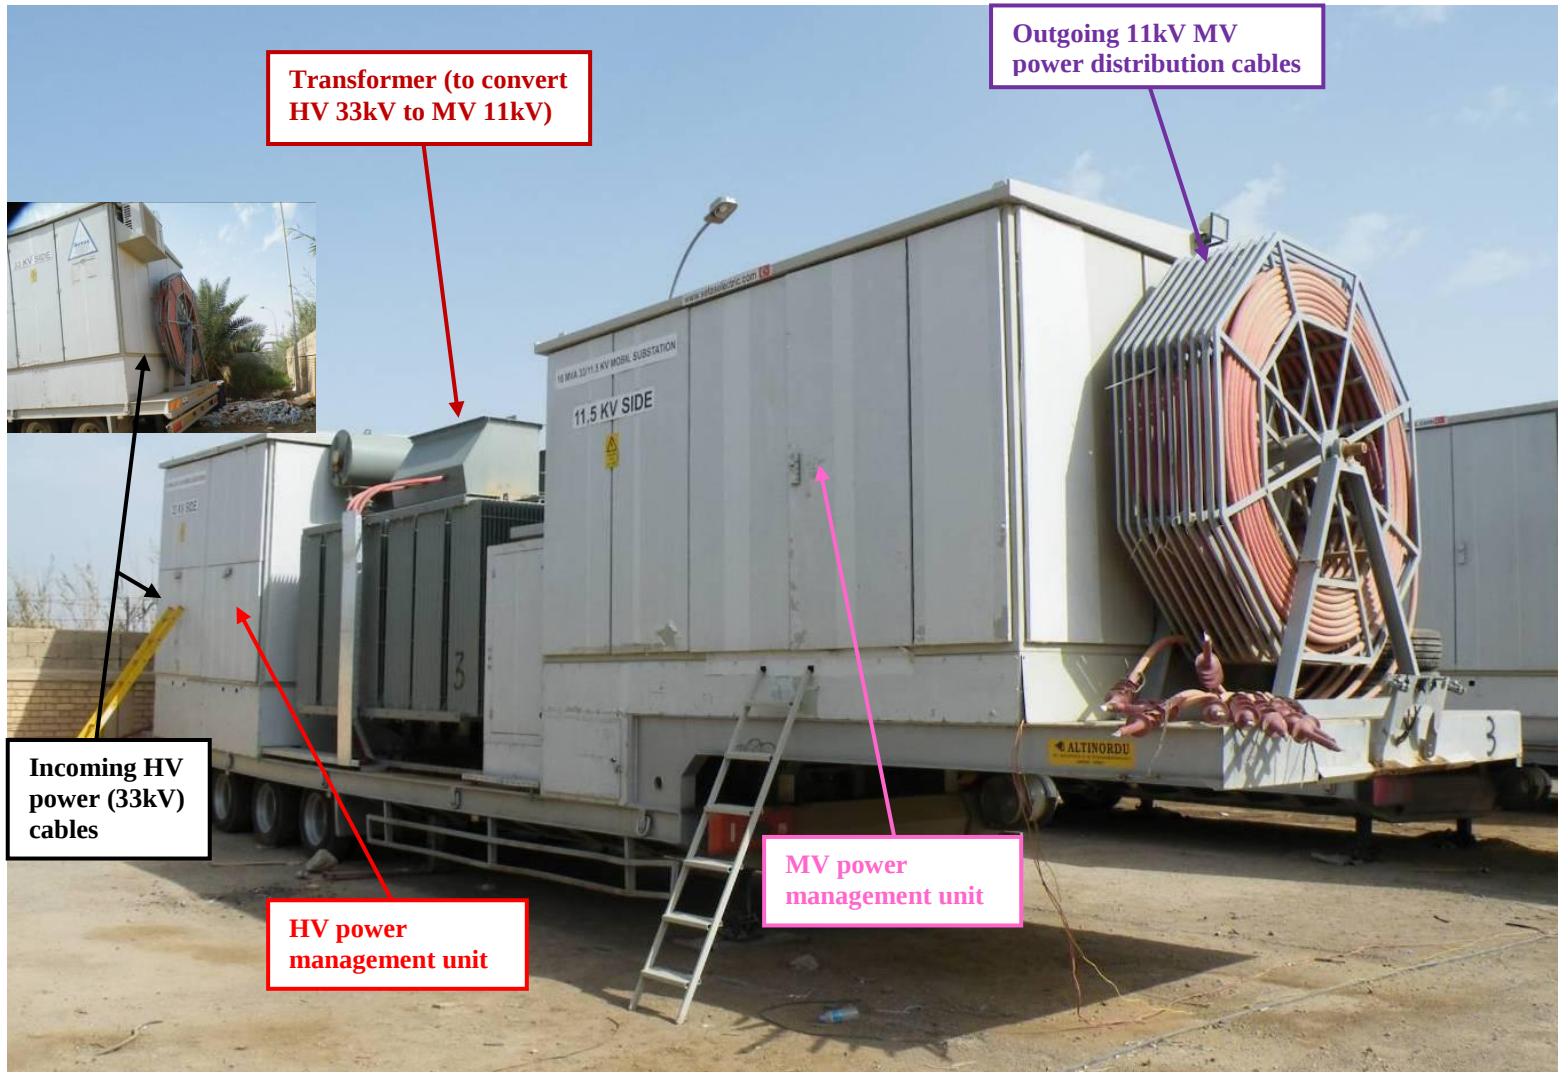
**Site Photo 7. Fully assembled mobile electrical substation**

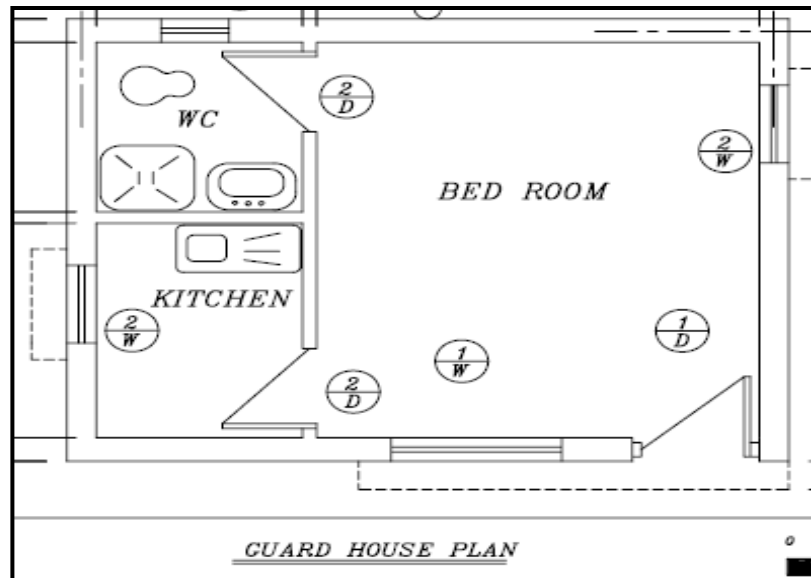
The SOW required the contractor to provide “service buildings” for each mobile substation. The intent of the service buildings is to provide living accommodations for guards protecting the mobile substations from vandalism and/or theft. The contractor’s service building design consisted of a bedroom, bathroom (water closet), and kitchen, including an air-conditioning unit and lights (Figure 6).

**Figure 6. Design of the service buildings/trailers (Courtesy of GRC)**

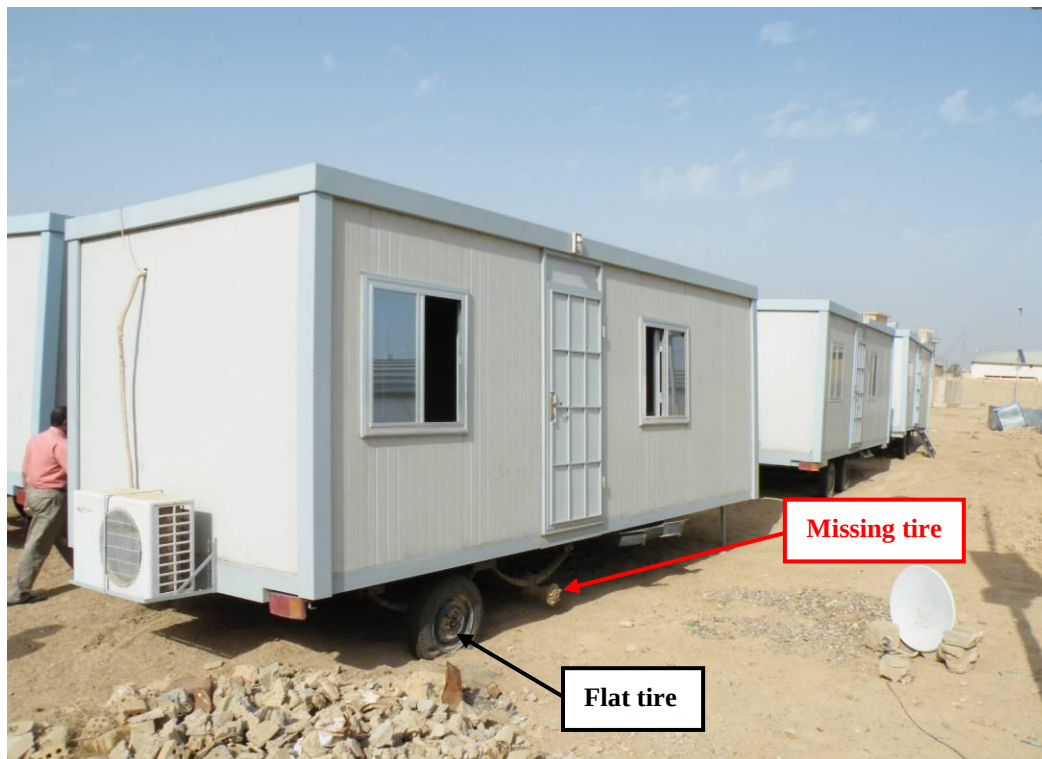
SIGIR identified five trailers within the MOE's outdoor warehouse facility, which were to serve as the service buildings for the substations (Site Photo 8). SIGIR found each trailer in poor condition. Specifically, trailer wheels either missing or having flat tires, interior lights broken, circuit panels not connected, and debris scattered throughout (Site Photos 9 and 10). It appeared the trailers had been vandalized; however, the project file documentation lacked photographs of the condition of each trailer upon arrival at the MOE's warehouse facility. Consequently, SIGIR could not conclude whether the contractor delivered poorly constructed trailers or that they were damaged/ vandalized since their delivery.

**Site Photo 8. Exterior condition of trailers at the MOE's Ramadi outdoor warehouse facility**

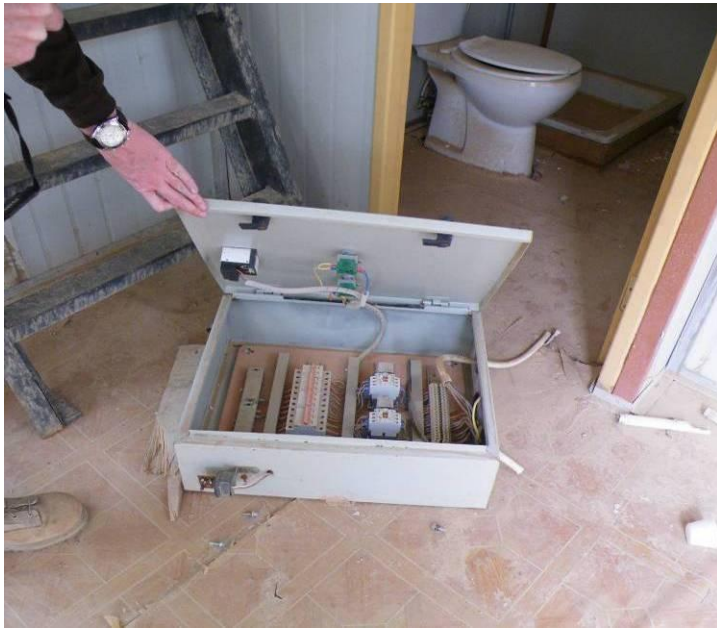
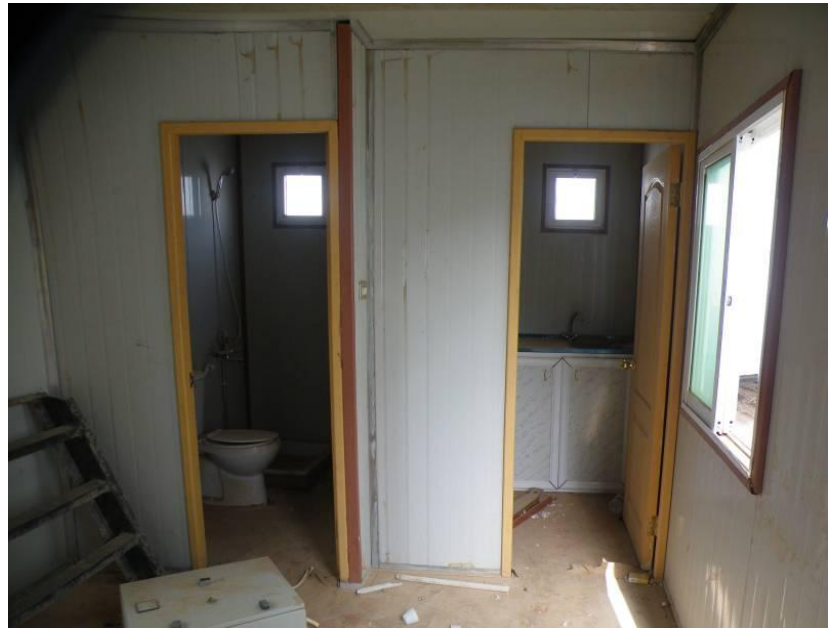
Site Photos 9 and 10. Examples of interior condition of trailers, including disconnected circuit boards, debris, and broken lights
