**AL HADI PERMANENT POLICE  
STATION  
BASRAH, IRAQ**

**SIGIR PA-09-190  
APRIL 21, 2010**

SUBJECT: Report on the Al Hadi Permanent Police Station, Basrah, Iraq  
(SIGIR Report Number PA-09-190)

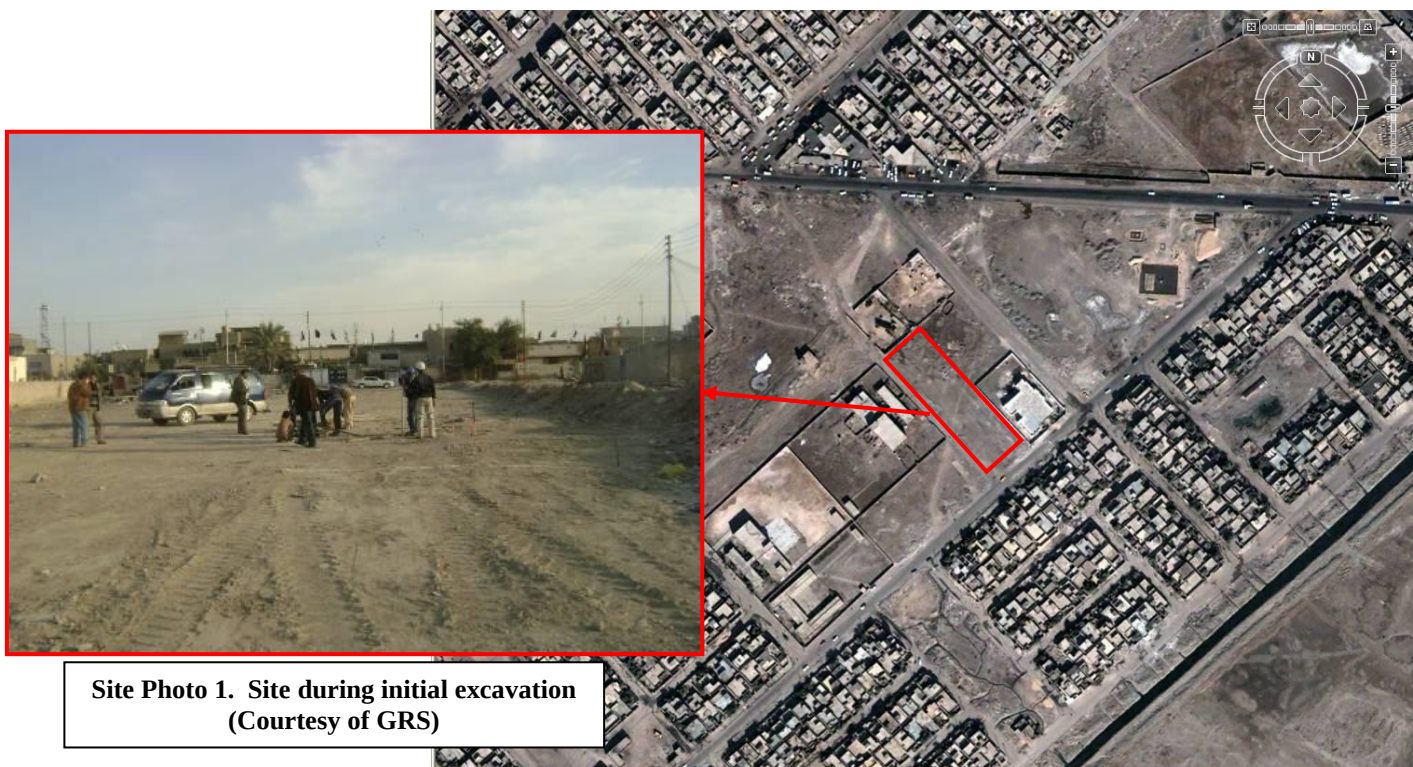
**Site Photo 1. Site during initial excavation (Courtesy of GRS)**

Amendment 00001, dated 4 January 2009, changed the location of the project site, (Figure 2) and removed the squatter's residences and all temporary utilities above and below ground from the project site to prepare for the actual construction of the project (Site Photo 1).

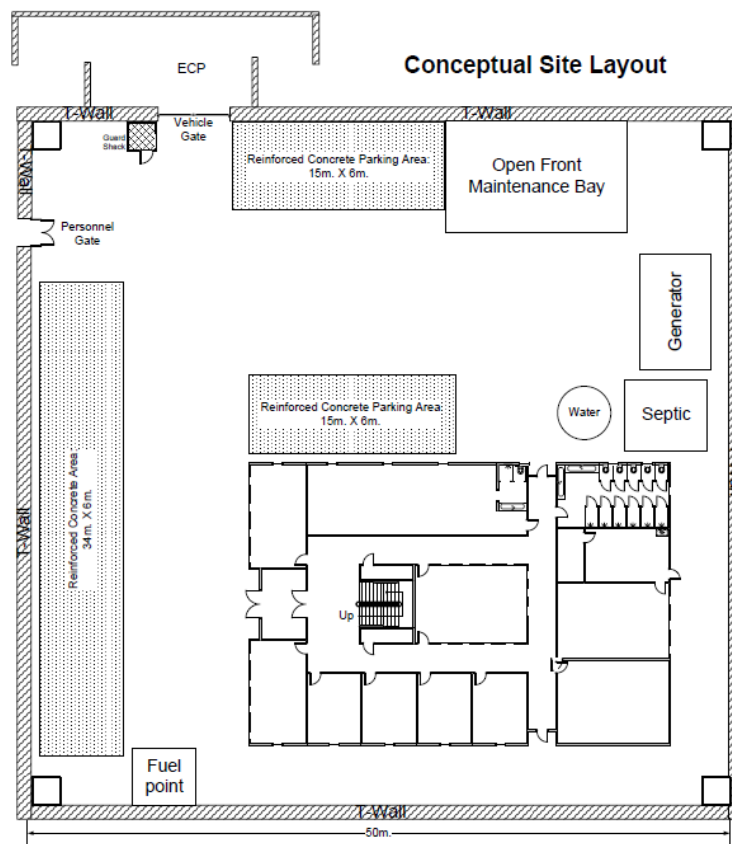
**Figure 3. Conceptual site layout (Courtesy of GRS)**

A conceptual site layout was provided with the SOW (Figure 3). The conceptual site layout included all the major items stated in the SOW, and functioned as a guide for the contractor.

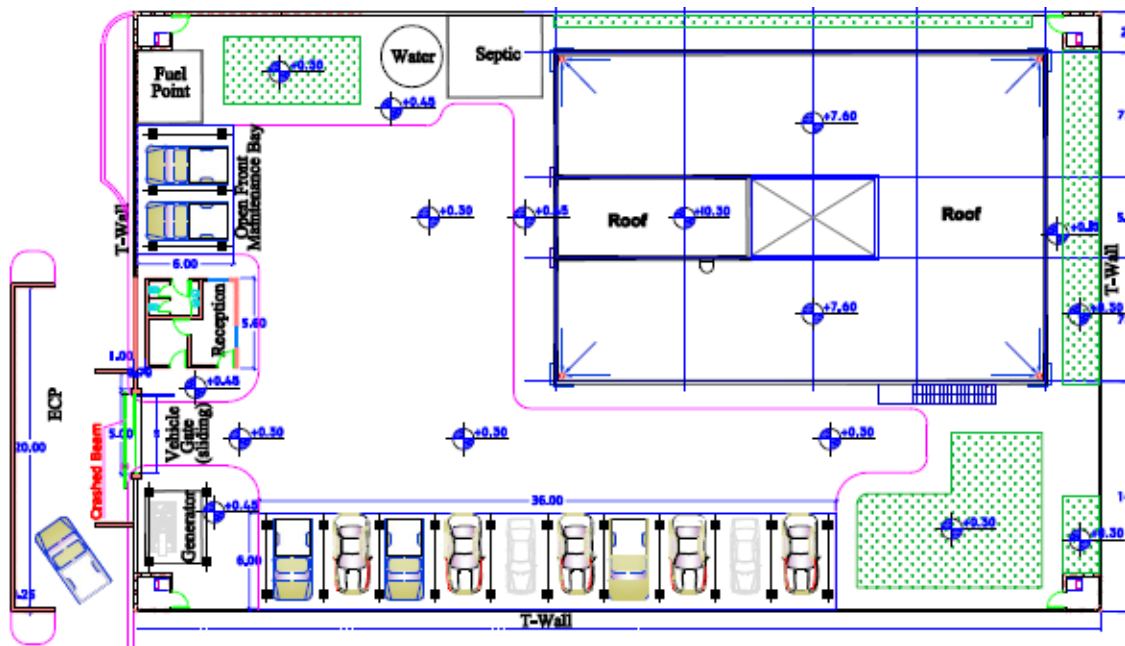
Figure 4. Contractor's site design (Courtesy of GRS)

The contractor submitted an actual site plan for the project (Figure 4). The contractor's site plan included all of the items stated in the SOW and accommodated the actual conditions of the project site.

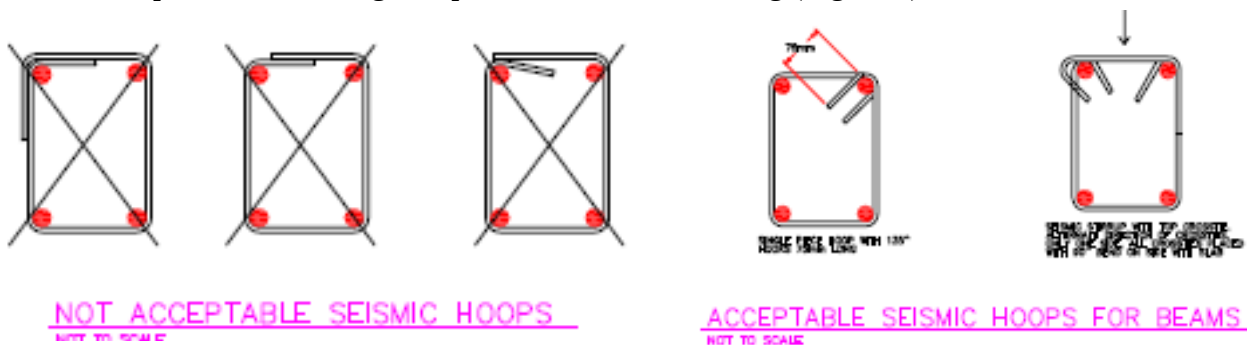
Figure 5. Non-acceptable and acceptable seismic reinforcing details (Courtesy of GRS)

The design drawings included details for the reinforced concrete beams and columns. These details include the typical beam cross section, required primary moment<sup>7</sup> reinforcing, and the shear reinforcing for the reinforced concrete beams. Details are also provided detailing acceptable seismic reinforcing (Figure 5).

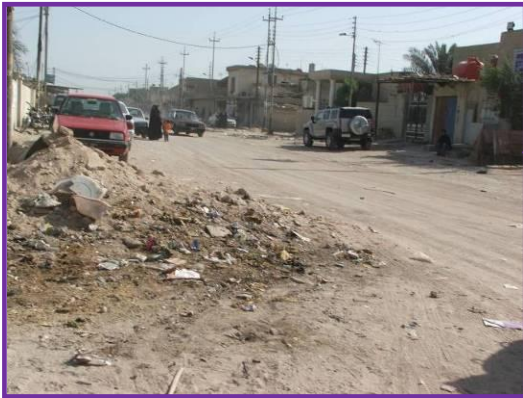
Site Photo 2. Residential street

The SIGIR inspection team noted that the general topography of the area was flat, and that the adjoining properties are public use (Figure 6). The Al Hadi Permanent Police Station project is fronted by an existing residential street (Site Photo 2).

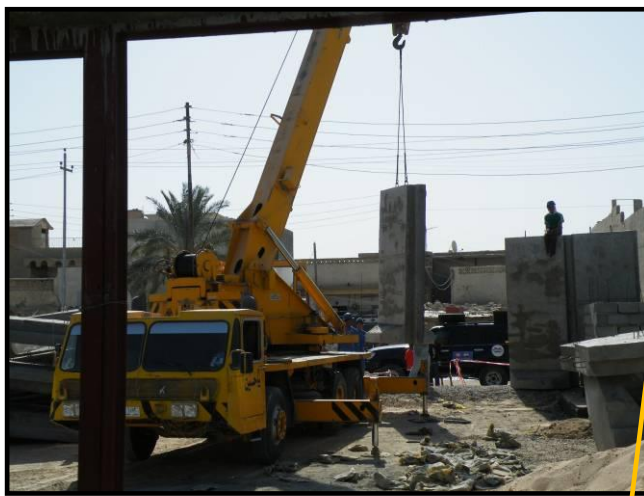
Site Photo 3. T-wall installation

At the time of the site assessment, the contractor was erecting T-walls around the perimeter of the project site (Site Photo 3). The T-walls were in good condition with minor cracks and spalls<sup>8</sup>. The contractor appeared to install the T-walls plumb and level and set on a straight alignment.

The contractor was erecting T-walls around the building perimeter. The T-walls were in good condition with minor cracks and spalls. SIGIR observed that the contractor appeared to install the T-walls plumb and level and set on a straight alignment. Also, the contractor was constructing the guard towers in the four corners of the facility perimeter. The guard towers are reinforced concrete masonry structures with one steel entry door at the base. The reinforced concrete masonry walls were partially constructed and the steel door frame was installed.

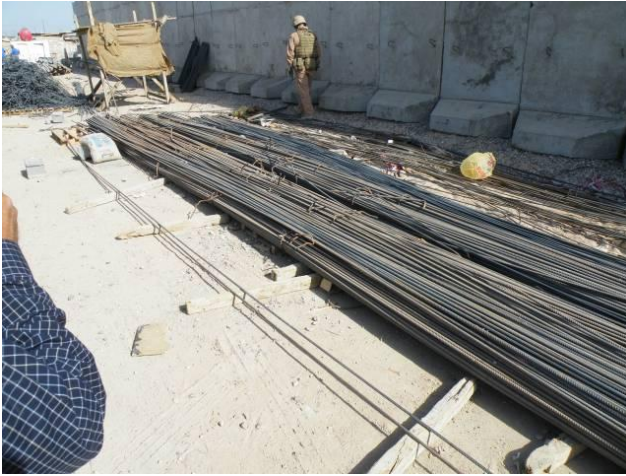
**Site Photo 5. Stockpiled reinforcing steel**

The contractor was stockpiling materials on site for the project. At the time of the inspection, the contractor had a significant amount of reinforcing steel, cement, and sand on site. The contractor organized the stockpiles into one of steel (Site Photo 5), and a haphazard pile of fabricated reinforcing steel (Site Photo 6).

SIGIR observed that the contractor was stockpiling materials on site for the project. At the time of the inspection, the contractor had a significant amount of reinforcing steel, cement, and sand present on the site. SIGIR inspected the

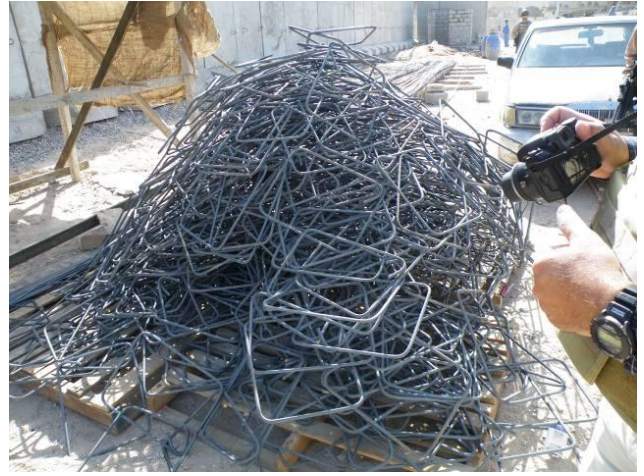
**Site Photo 6. Fabricated reinforcing steel**

SIGIR inspected the fabricated reinforcing steel and verified that the steel is shear reinforcing for the reinforced concrete beams. The reinforcing steel is fabricated according to the design drawings.

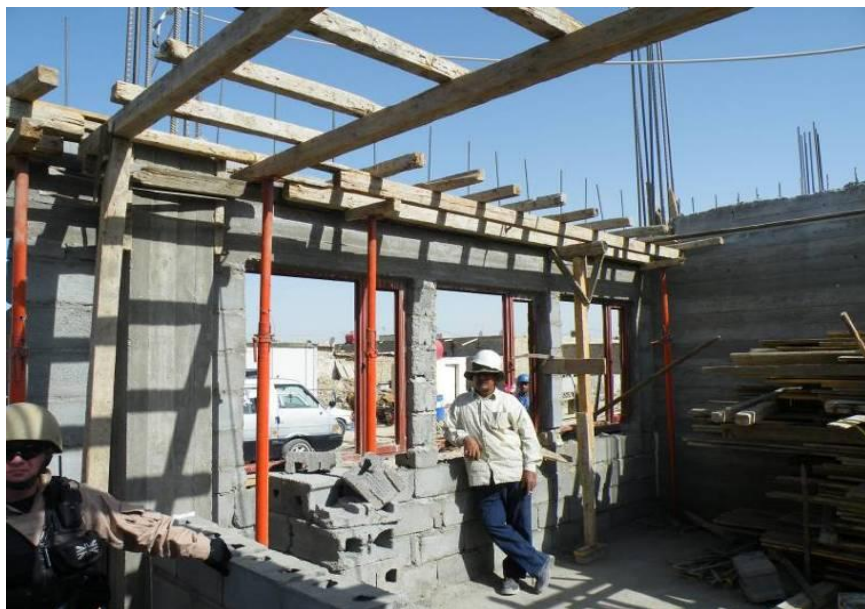
**Site Photo 7. Reinforced concrete beam formwork**

During the site inspection, the contractor was constructing the police station structure. The structure for the police station consists of a two-story reinforced concrete frame with reinforced concrete masonry infill. At the time of the site assessment, the contractor completed construction of the concrete columns for the first floor and had partially constructed the reinforced concrete masonry infill. While the masonry work was progressing with the walls, the contractor was constructing formwork to place the reinforced concrete beams for the second story (Site Photo 7).

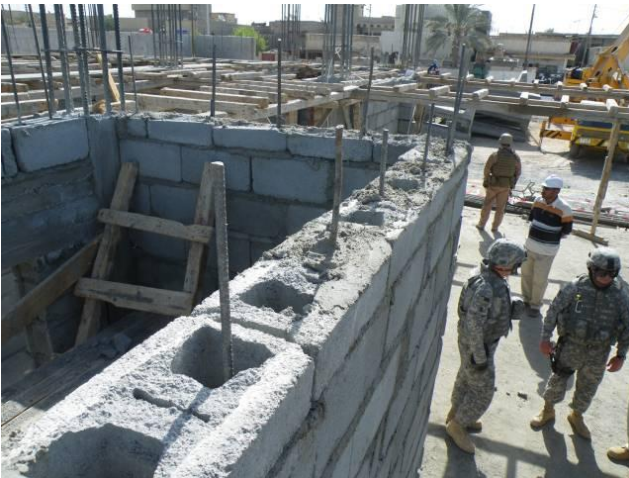
**Site Photo 8. CMU vertical reinforcing**

The contractor installed reinforcing steel in the concrete masonry wall. SIGIR was able to verify that the contractor installed both the horizontal and vertical reinforcing bars in the wall. The vertical bars were placed in alternating cores of the block with sufficient length available for splicing to the next wall section (Site Photo 8). At the time of the site assessment, the horizontal reinforcing was placed along several of the unfinished levels of the walls (Site Photo 9).

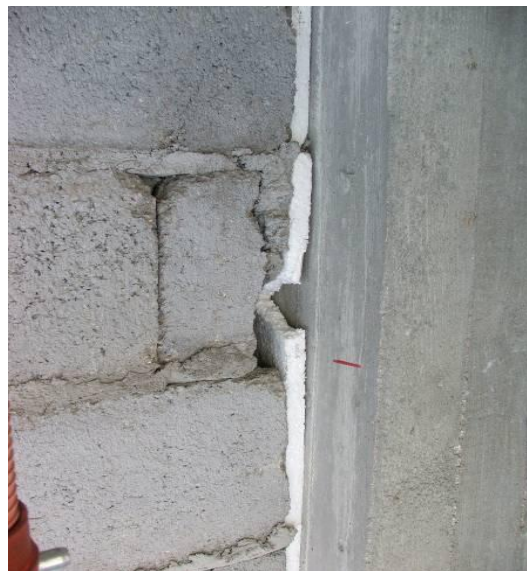
**Site Photo 10. Expansion joint between infill and frame**

The contractor installed expansion joints between the reinforced concrete frame and the concrete masonry infill. The expansion joints consisted of approximately three centimeters (cm) of polystyrene (plastic) foam placed against the reinforced concrete column (Site Photo 10). This joint will effectively isolate the concrete masonry unit (CMU)<sup>9</sup> from the reinforced concrete frame and allow for differential movement between the two elements.

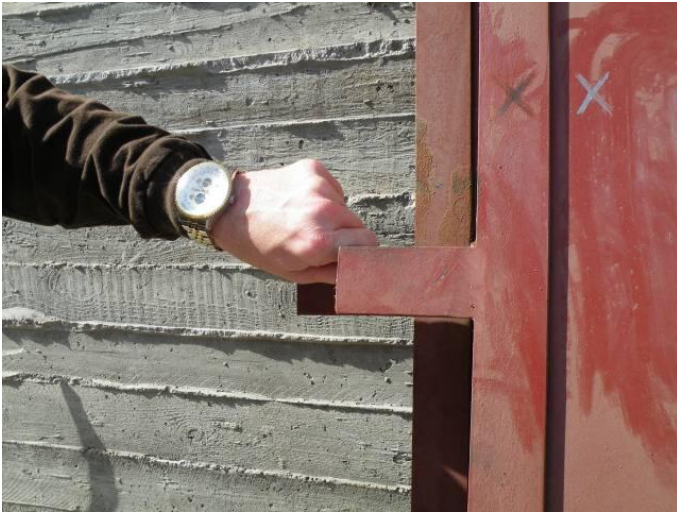
**Site Photo 11. Embedment tab**

During the construction of the reinforced CMU exterior walls, the contractor installed the steel window and door frames. The steel frames consist of welded steel sections and steel embedment tabs (Site Photo 11) securing the windows and doors to the walls. The embedment tabs are steel angle sections approximately 10 cm in length. The tabs are placed in the mortar joints of the CMU and held in place with the mortar. To plumb the windows, the opening in the CMU was constructed larger than required leaving a gap which can be used for leveling (Site Photo 12). Due to this gap, the actual length of embedment in some cases can be as little as 5 cm, so the strength of the window attachment is less than the strength of the surrounding concrete masonry wall.

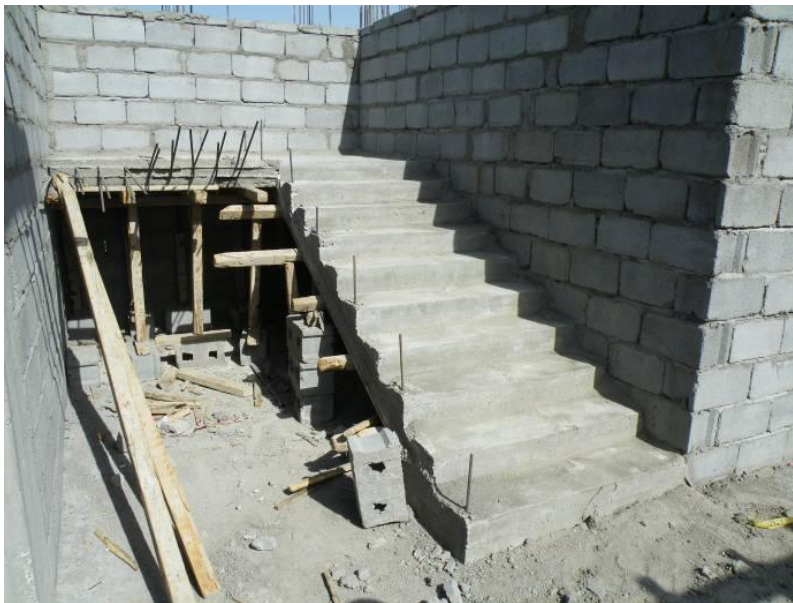
**Site Photo 13. Reinforced concrete stairs**

At the time of the site assessment, the contractor constructed the first half-flight of stairs (Site Photo 13). The stairs are constructed of reinforced concrete. Dowels were present at the landing to tie the reinforcing material for the next flight. The construction appeared adequate. The risers were a uniform height and the treads were level and even.
