AFRL-RZ-WP-TP-2010-2084

**CRITICAL CURRENT IN YBCO COATED CONDUCTORS
IN THE PRESENCE OF A MACROSCOPIC DEFECT
(POSTPRINT)**

13. SUPPLEMENTARY NOTES Journal article published in the <i>IEEE Transactions on Applied Superconductivity</i> , Vol. 19, No. 3, June 2009. PA Case Number: 88ABW-2009-2981; Clearance Date: 01 Jul 2009. Paper contains color. © 2009 IEEE. The U.S. Government is joint author of the work and has the right to use, modify, reproduce, release, perform, display, or disclose the work.
--

Critical Current in YBCO Coated Conductors in the Presence of a Macroscopic Defect

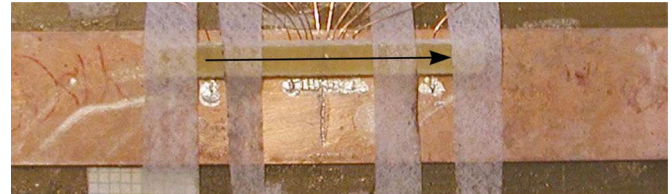
Fig. 1. Microphotograph of Sample 1 with the transverse defect 7 mm long and the 6 pairs of the potential taps (taps 1–6 on the left side, 7–12 on the right side of the defect). The table shows the distances between the taps.

To study the influence of defects we used YBCO coated conductors manufactured by SuperPower, Inc. Sample 1 was made from a $12 \times 90 \text{ mm}^2$ tape stabilized by a $20 \mu\text{m}$ thick electroplated copper layer. Transverse defects of various lengths (1.9 mm, 3.5 mm, 5 mm and 7 mm) were successively made in the tape center using a micro-drill. Several potential taps were attached to the tape at various distances from the defect. Fig. 1 shows Sample 1 with a 7 mm long defect and the 12 potential taps. As a note, the location of potential taps changed for the

For Sample 1, we measured the I-V curves between the reference tap 1 and tap 2, 1 and 3, 1 and 4, etc., up to 1 and 12 for each of the defect lengths. As an example, in Fig. 3 we show the I-V curves measured for Sample 1 with the 3.5 mm long defect. From these measurements we obtained the profiles of the potential drop $V_{1,n}$ as a function of distance from the reference tap 1, $L_{1,n}$. In Figs. 4(a)–4(c) the profiles $V_{1,n}$ are shown for different lengths of defects and at several values of current. As depicted, the voltage rapidly changes only in close proximity to the defect. This indicates that the electric field is strongly localized around the defect. The difference in the voltages measured, for the 7 mm defect of Fig. 1, between taps 6 & 7 (0.65 mm apart) and taps 1 & 12 (20 mm apart) is very small.

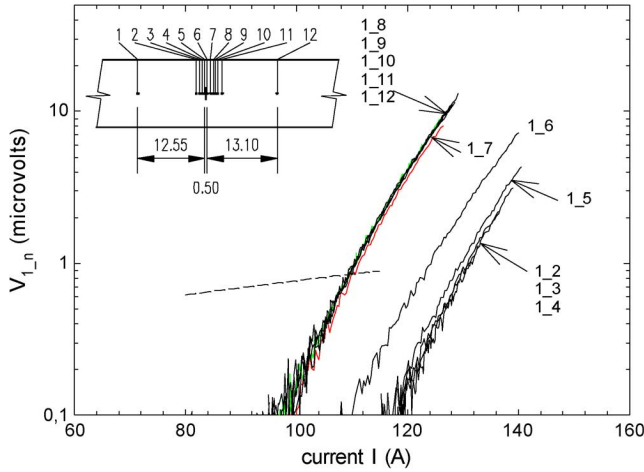
Fig. 3. I-V curves measured between the reference tap 1 and other taps (see inset) in Sample 1 with defect 3.5 mm long in external magnetic field of 74 mT. The dashed line corresponds to the relationship (5), $V = r_0 I$. The intersection point determines the critical current of the damaged section.

For example, let us assume that the critical current in the undamaged section of a conductor, determined by the conventional criterion (1), is 108 A/cm . This corresponds to the critical sheet resistance, (3), $r_0 = E_0/J_c^0 = 0.93 \times 10^{-8} \Omega$. In the damaged section of the same conductor we measure the potential drop across the defect, as shown in Fig. 3, and define the critical current by the condition that

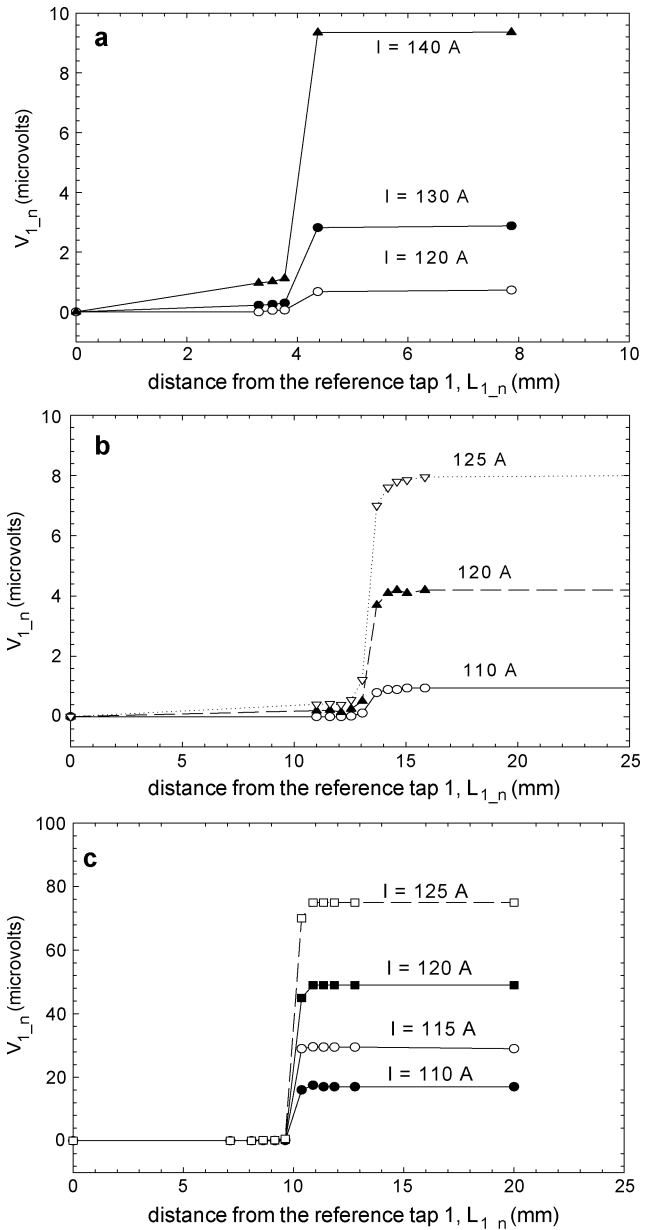
Fig. 4. The voltages measured for Sample 1 between Reference Tap 1 and other taps vs. the distance from Tap 1, $L_{1,n}$, measured at the different currents indicated in the figures where Sample 1 has a defect length of: (a) 1.9 mm long (only 6 potential taps were used in this measurement), (b) 3.5 mm long, and (c) 5 mm long.

determined by a localized defect. Another empirical criterion needs to be chosen. As the data in Figs. 4 indicate, the potential drop across the defect, or its derivations such as resistance $r(I) = V/I$, can be an objective criterion defining I_c , because it is independent of the distance between the voltage taps. The critical current I_c defined by the new criterion in the area around a defect has to be related to the critical current I_c^0 in the undamaged sections of the same conductor. The latter is determined by the commonly accepted criterion of the electric field $E_0 = 1 \mu\text{V}/\text{cm}$, according to the relationship:

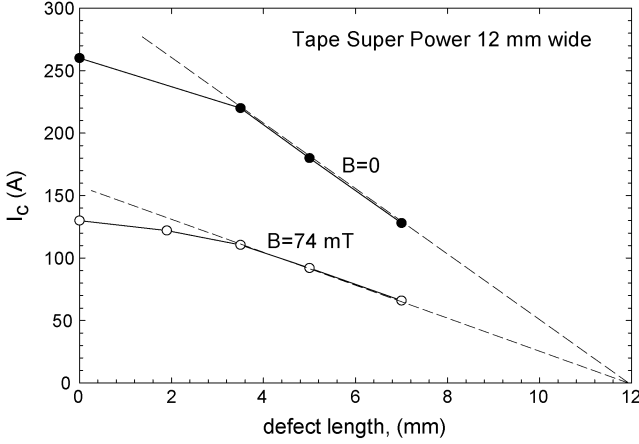
Fig. 5. Critical current I_c defined by $1 \mu\text{V}/\text{cm}$ at zero applied field and $B = 74 \text{ mT}$ as a function of the defect length.

In Fig. 5 the degradation of the critical current in Sample 1 caused by the defects of different lengths is shown. The voltage was measured across the defects between the most separated taps (1 and 12). Without the defects, the critical current is 130 A

in a field of $B = 74 \text{ mT}$ and 260 A in self-field. This corresponds to the critical current density $J_c^0 = 108 \text{ A/cm}$ and $J_c^0 = 217 \text{ A/cm}$, respectively, with corresponding critical resistances, (3), $r_0 = 0.93 \times 10^{-8} \Omega$ and $r_0 = 0.46 \times 10^{-8} \Omega$. Preliminary results shown in Fig. 5 indicate that the critical current I_c decreases almost linearly with increasing defect length. More detailed results will be presented elsewhere.
