AFRL-RX-TY-TR-2010-0033

## **FIELD DEMONSTRATION OF A CENTRIFUGAL ULTRA HIGH PRESSURE (UHP) P-19**

**AIR FORCE RESEARCH LABORATORY  
MATERIALS AND MANUFACTURING DIRECTORATE**

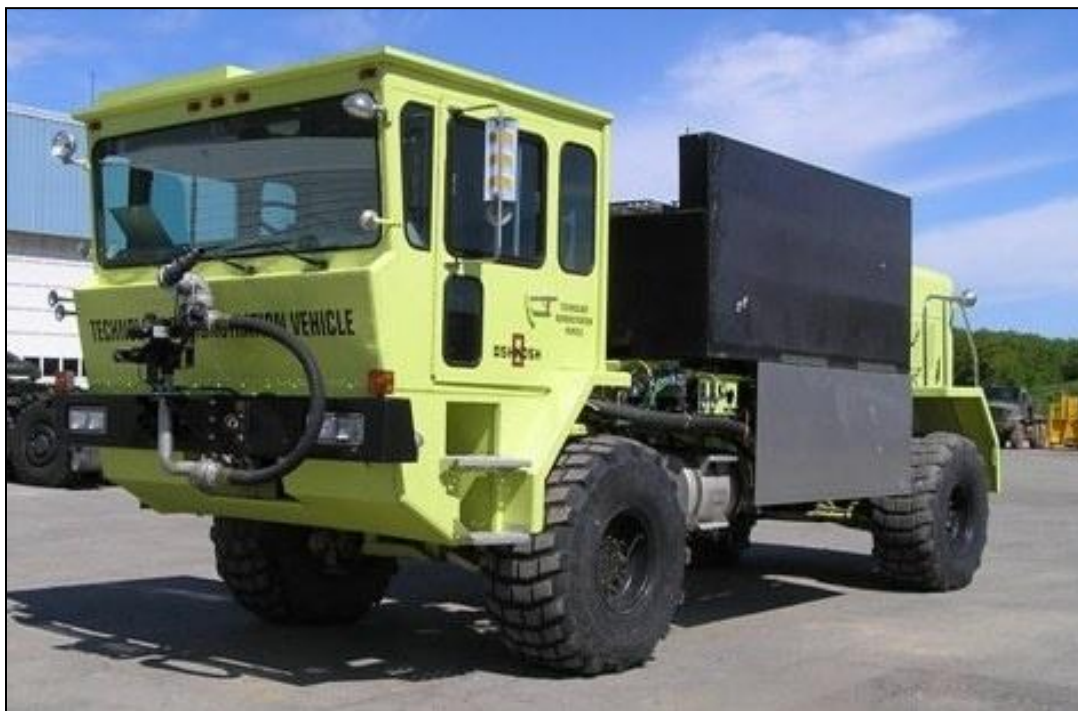
The platform chosen for the CRADA program was an Oshkosh T-1500 fire truck (Figure 1) with a 540 horsepower Detroit Diesel engine, power divider with two power take-offs (PTO), with pump and roll capability referred to as the Technology Demonstrator (TD). Modifications made by Oshkosh to the TD included installation of the UHP system, the CAF system, a combined UHP/CAF bumper turret, UHP and CAF handlines, and associated instrumentation and controls.

**Figure 1. The Technology Demonstrator**

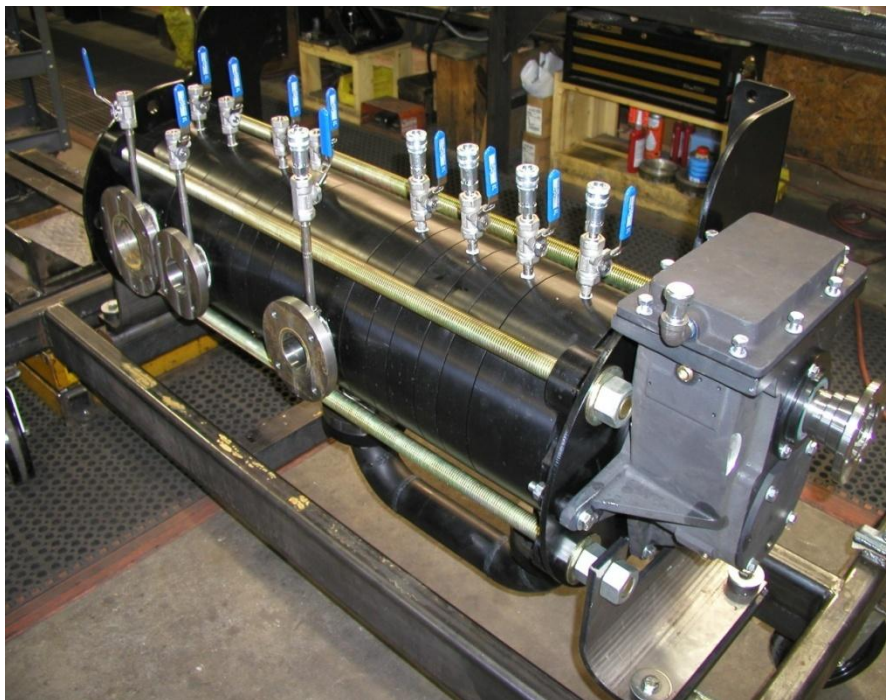
W.S. Darley & Co designed, engineered, fabricated and tested a new six stage centrifugal pump capable of producing low and ultra high pressure with a single pump (Figure 4). The pump specifications for both low and ultra high pressure are shown in Table 1. The first stage provides low pressure while the other five stages build the pressure to UHP. Development started in 2006, and in 2007 Darley finalized a prototype for testing. The first unit was used for testing in the Oshkosh TD. Unfortunately, a problem with a snap ring caused the pump to fail but identified an issue that could easily be addressed in future units. Darley conducted additional testing on the next pump including hydrostatic pressure, high/low pressure performance points, endurance testing, dry run testing, wear component and calculated time to failure to assure reliability and durability. The notes from those tests are provided in Appendix A. Darley has finalized the commercial production of the pump and provided the first five units for retrofit for the field prototype testing.

**Figure 4. The Darley Six Stage Centrifugal Pump**

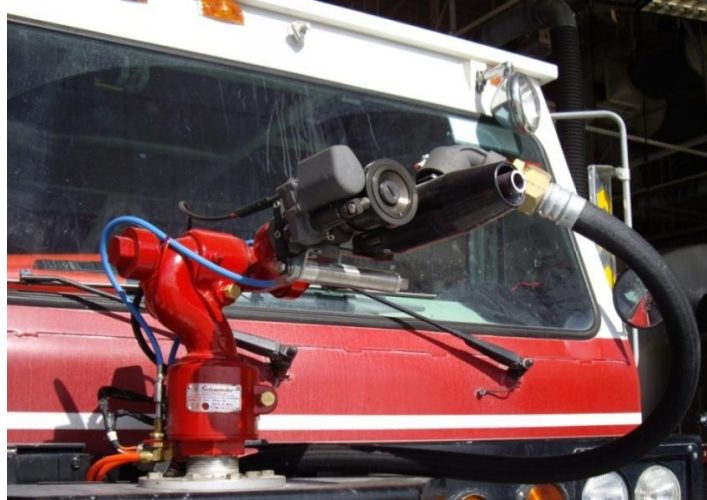
Elkhart Brass has engineered several UHP turret designs that have been tested on the UHP P-19p, Oshkosh TD and UHP P-19c. The most recent design incorporated a single waterway for both UHP and CAF foam Figure 5. The Elkhart Brass Combination UHP and Hydro-Chem™ Turret using a sliding plate that positions the selected nozzle in line with the turret waterway. This unique design allowed the turret to sit lower on the bumper, improving the field of view for the vehicle operator while simplifying the plumping and associated hardware. This system was installed on the Tyndall, MH and DM vehicles then later retrofitted on the Dyess and Ellsworth vehicles.

**Figure 5. The Elkhart Brass Combination UHP and Hydro-Chem™ Turret**

During testing at MH, an engineering defect was found with the UHP nozzle. The pattern selector sleeve broke away from the nozzle while cycling the nozzle from fog to straight stream. Elkhart Brass redesigned the part and performed cycle testing to assure performance. In total, four design modifications were required before the problem was completely resolved. Appendix B contains schematics and correspondence on the resolution to the failure. All five bases have new UHP nozzles with the current design changes incorporated and are functioning properly without any issues.

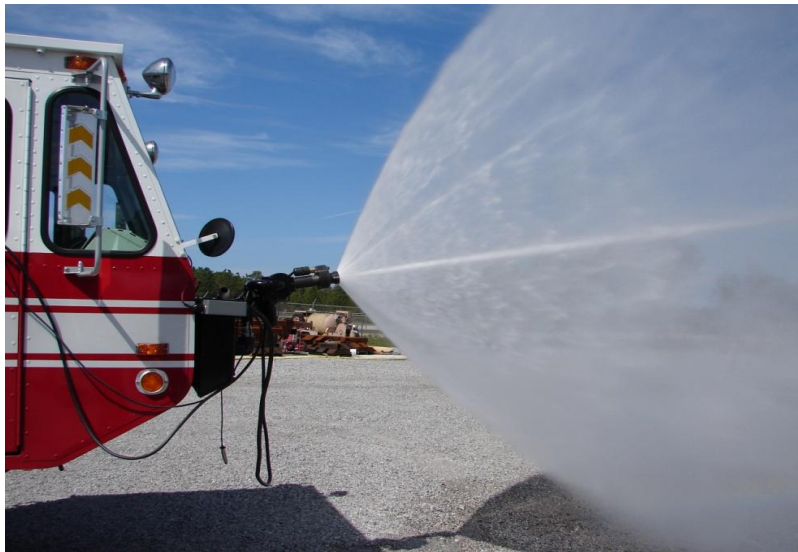
Akron Brass has designed and fabricated several versions of a UHP bumper turret and nozzle system. Originally, Akron Brass focused on the UHP nozzle and did not incorporate the Hydro-Chem™ nozzle. The first Akron Brass UHP turret and nozzle, tested on the UHP P-19p in 2006, was very effective and equaled performance to the Elkhart Brass UHP system in foam expansion ratio, drain time and discharge distance. The Akron Brass UHP nozzle had a different fog pattern than the Elkhart Brass nozzle and followed the traditional conical stream pattern (Figure 6). Also, due to the design of the nozzle, a small straight stream of water was discharged simultaneously from the center of the nozzle providing some level of longer range protection. The stream pattern was altered for the system used on the UHP P-19c.

**Figure 6. Akron Brass UHP Nozzle in Fog Pattern**

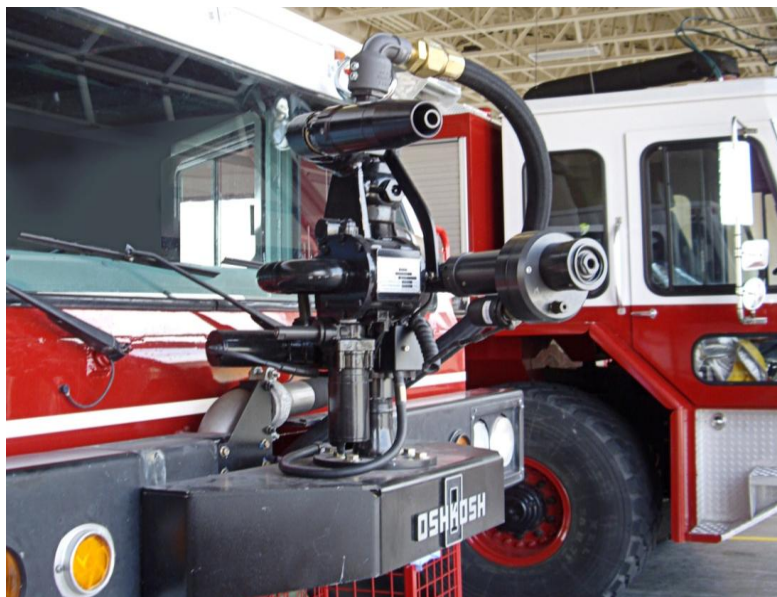
Fig. 7 shows the combination Akron Brass turret that was designed for the UHP P-19c. This system was originally installed on the Tyndall, Dyess and Ellsworth vehicles. Oshkosh was responsible for the design to marry the Hydro-Chem™ nozzle to the UHP nozzle so that both nozzles could be controlled with a single motor. Four issues were identified with this design and ultimately led to the replacement of the Akron Brass system with the Elkhart Brass system.

**Figure 7. The Combination Akron Brass UHP and Hydro-Chem™ Turret**

- The mounting of the Hydro-Chem™ nozzle obscured the field of view of the driver/operator, hindering extinguishment performance.
- Another design consideration of the bumper turret is the shape of the water stream in fog pattern. Akron Brass designed the pattern so that it formed a horizontal fan rather than the traditional conical pattern. This was done to minimize overspray onto the windshield while improving the field of view of the driver/operator and still providing protection. Careful consideration needs to be made when reattaching or tightening the nozzle to assure the nozzle is in the right orientation otherwise the stream will not be horizontal, which reduces the effectiveness of the fog pattern.

Per the performance specifications in the contract, Oshkosh was notified of these problems and given the opportunity to either correct the Akron Brass system or replace the bumper turret with the Elkhart Brass system. Due to time and cost constraints, Oshkosh chose to replace the Akron Brass system with the Elkhart Brass system.

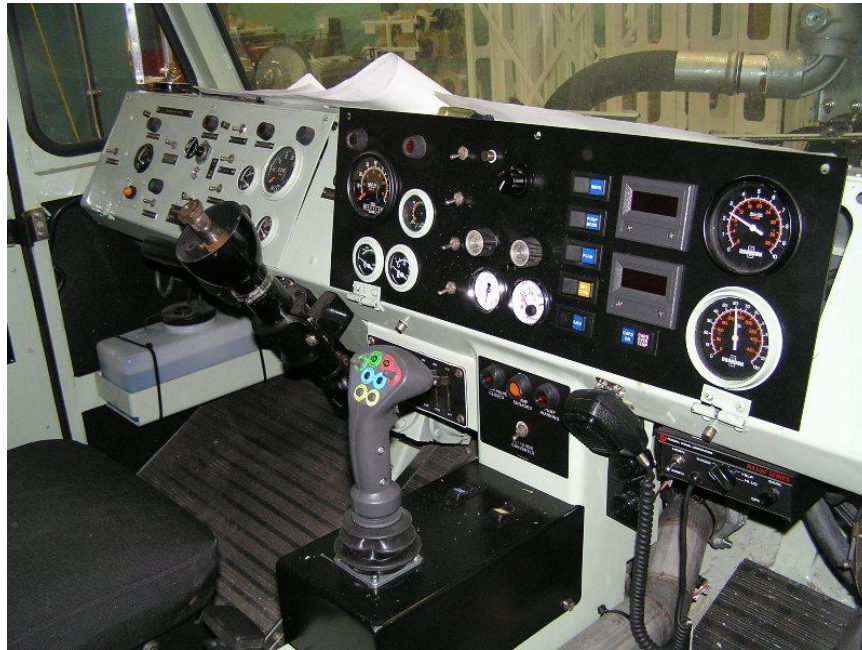
Oshkosh was responsible for the engineering design and modifications of the vehicle once the performance specifications were finalized by the Air Force. One of the main objectives of the modification was to minimize the complexity so that the firefighters could focus on fire fighting versus trying to learn new controls. While a few new switches were installed for added functions, such as CAF, the overall dashboard panel remained unchanged (Figure 8). Accomplishing the retrofit of the centrifugal pump system required Oshkosh to convert the original P-19 two dimensional line drawings into three dimensional solid models. The P-19 computer model allowed Oshkosh to design the vehicle in model space before the vehicle was physically modified. Creative engineering allowed for all the components to be fitted within the original envelope of the P-19 while maintaining the original 1000 gallon water capacity (previously the UHP P-19p water tank was cut to 750 gallons to accommodate the three plunger pumps and associated hardware). Oshkosh performed extensive testing to calibrate agent flow and pressure at each nozzle as well as testing each vehicle for stability (using tilt table testing) and weight distribution across each wheel (Appendix C).

**Figure 8. UHP P-19c Cab Control Panel**

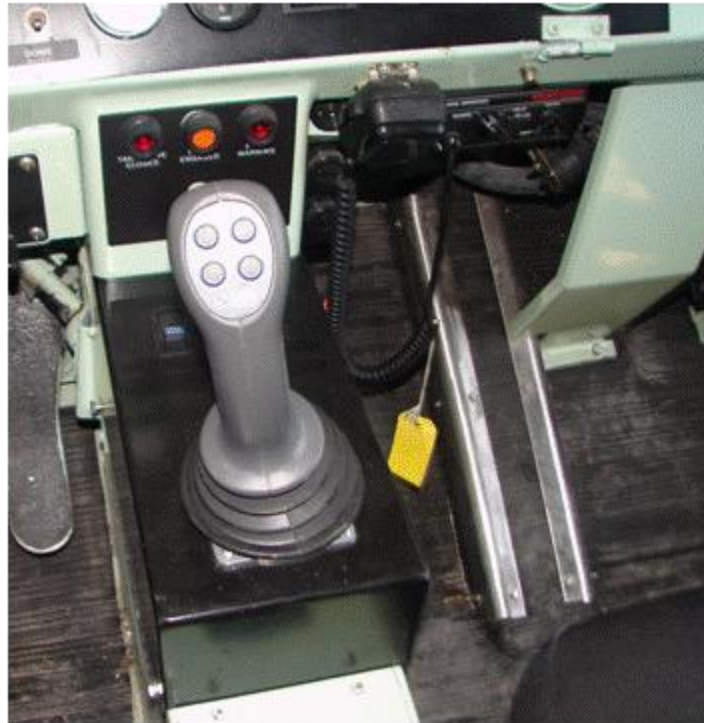
HMA Fire Apparatus and AFRL have been working together on a variable speed joystick controller for the UHP and CAF turret (Figure 9). Current systems only allow the buyer to choose motors with a speed of either fast or slow. Fast motors can quickly overshoot the target while slow motors delay the reaction time of repositioning the turret. The solution was to design a variable speed controlled joystick. The farther the joystick is moved from the spring returned center, the faster the turret moves in the given direction, essentially creating a variable speed turret. The HMA joystick worked with both the Akron Brass and Elkhart Brass bumper turret systems.

**Figure 9. HMA Force Feedback Joystick**

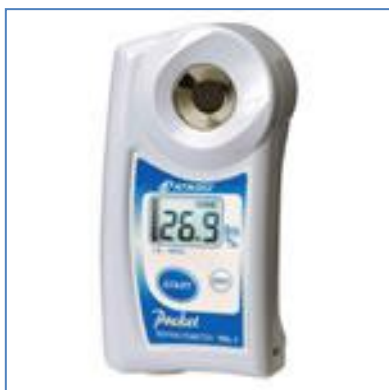
Two different models of Atago digital refractometers were used during testing. The Pal-1 was purchased for Dyess, Ellsworth and Davis-Monthan because they did not possess a digital refractometer (Figure 15). Mountain Home and Tyndall used the PR-32, which both bases already had on hand (Figure 16).

**Figure 15. Atago Pal-1 Digital Refractometer**

Both refractometers function alike and use the same calibration procedures, however; brix readings were shown by AFRL to vary between the models, therefore calibration curves not only had to be established for each brand of AFFF but also for the model of refractometer used by each base. This resulted in three different calibration curves (Appendix D). Both refractometers had a resolution of  $\pm 0.1$  brix, which translates to  $\pm 0.4\%$  foam concentration. For example, a brix reading of 0.9 could actually range anywhere from 0.85 to 0.94 with the refractometer rounding up to the nearest tenth of a brix. The resolution of the refractometer preferred by AFRL would be  $\pm 0.01$  to provide better accuracy of the foam concentration since a small change in the brix can translate to a significant difference in the true foam concentration. Very few digital refractometers have this resolution and cost approximately \$20,000, therefore, purchasing refractometers of this precision was not practical for this project. AFRL has no way to determine if discrepancies in foam concentration are from the foam proportioning system or the limited resolution of the refractometer. AFRL provided each base with a detailed set of instructions on calibration and use of the refractometer. Each base was given a class on how to use the equipment and take measurements to limit mistakes caused by different techniques. Foam concentration measurements were taken by using portions of solution drained the foam expansion and drain time testing. Refractive index readings of the test sample were converted to a percent foam concentration based on the equations calculated from the calibration curves. Each base was provided with a spreadsheet with the conversion factors already included so that the firefighters only had to enter the brix number from the refractometer to calculate foam concentration. The graphs of foam concentration measurement data for the UHP turret, UHP handline, CAF turret and CAF handline, which appear later in this section (Fig. 17 thru Fig. 20), show the foam concentrations converted from the brix readings along with the error associated with the resolution of the instrument. Dyess is represented by a diamond, Davis-Monthan by a square, Ellsworth by a triangle, Mountain Home by a circle and Tyndall by an asterisk.

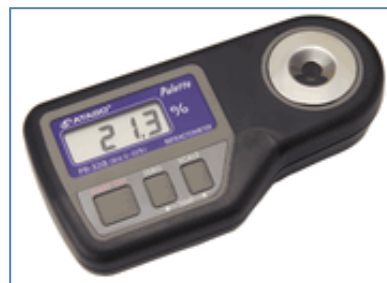
**Figure 16. Atago PR-32 Digital Refractometer**
