# **BEHAVIOR OF LIGHTWEIGHT WALL PANELS AGAINST BLAST**

ARIE BOIMEL M.Sc. Civil Engineer

TAAS -Israel Industries  
P.O.Box 1044, Ramat-Hasharon, ISRAEL

TWENTY-SIXTH DOD EXPLOSIVES SAFETY SEMINAR  
DORAL RESORT & COUNTRY CLUB, MIAMI, FLORIDA  
16 - 18 AUGUST 1994

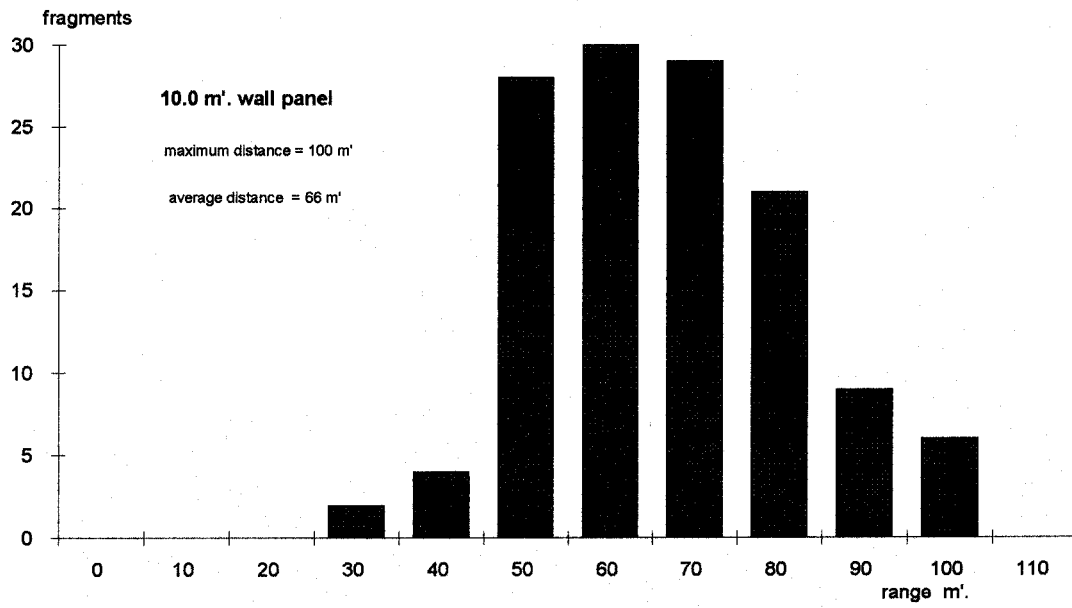
The asbestos cement sheets were fractured into hundreds of pieces ranging between 26 and 100 m' from the original place of the wall.

**Figure 2. : Asbestos-cement fragments distribution over the range**

Figure (2), shows the number of fragments per distance interval. Figure (3) shows the distribution of the fragments' size.

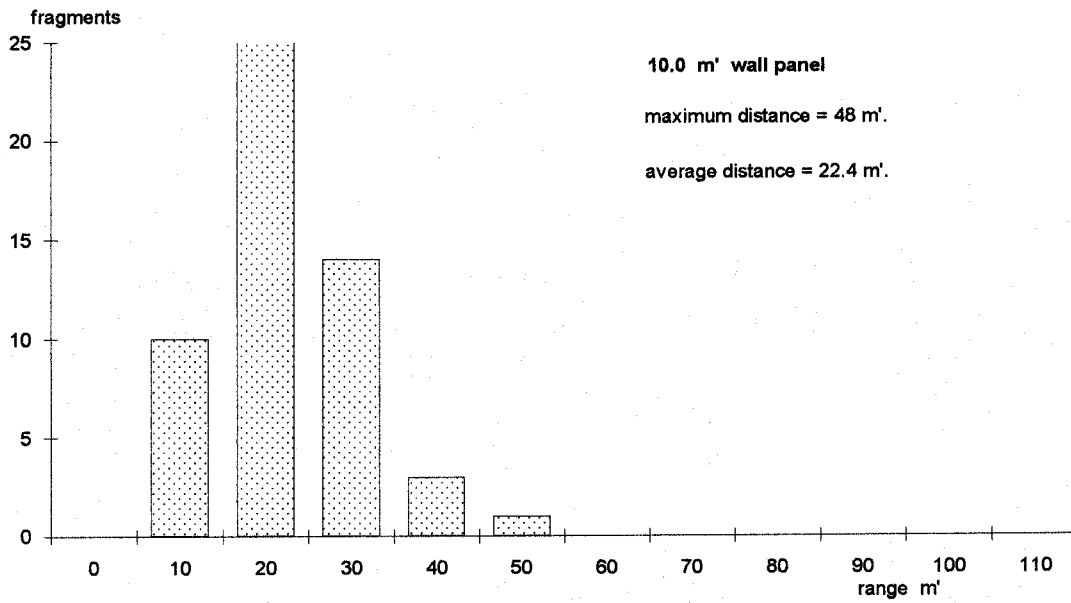
**Figure 4. : fiberglass fragments distribution over the range.**

Figures (4), (5), show the same statistic data but for the fiberglass sheets.  
It should be noted that many small fiberglass fragments were sucked backwards and were scattered between the original place of the wall, and the c.o.e.  
The furthest fiberglass piece landed 48 m' from the wall.

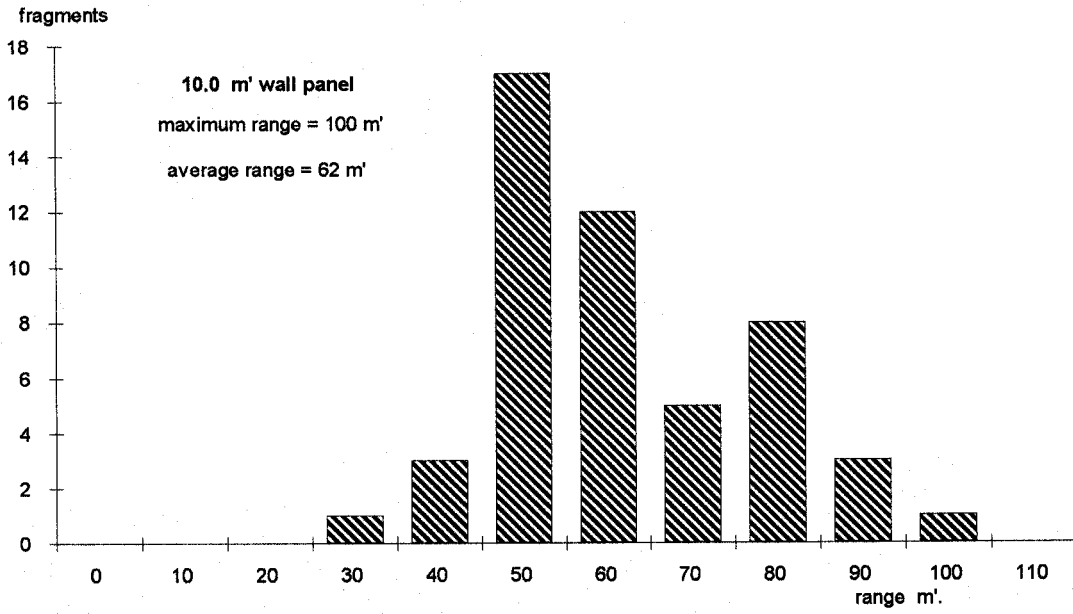
The metal sheet was shattered to 50 pieces. The big fragments were twisted and deformed in a way that it was impossible to measure their exact size, and only a rough estimation was made.

**Figure 6. : metal fragments distribution over the range.**

Fragment collection data for the metal sheet is illustrated in figures (6), (7).

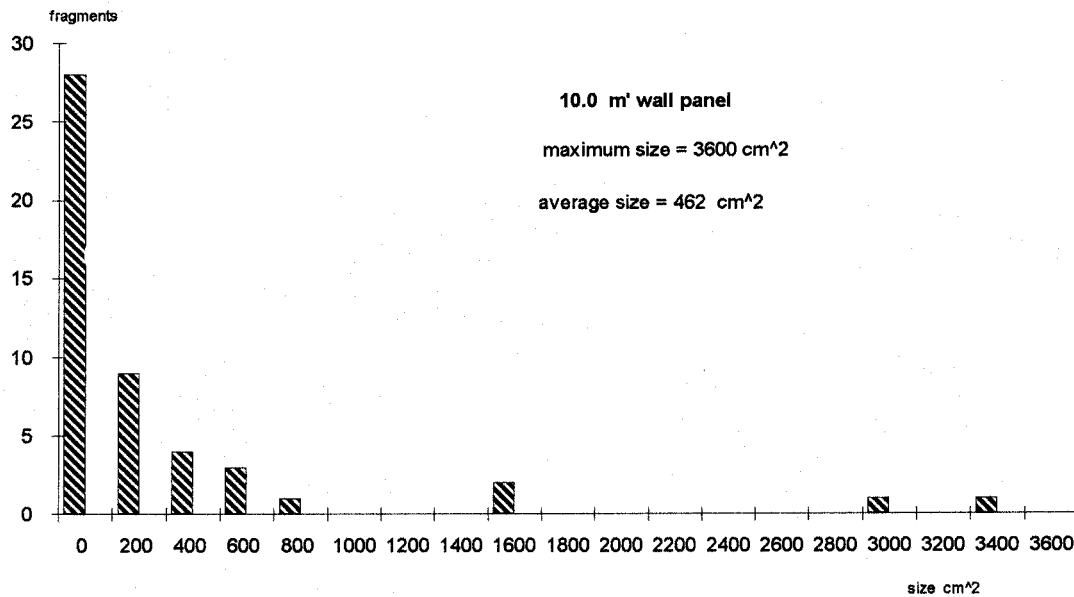
**Figure 7. : Distribution of metal fragments' size.**

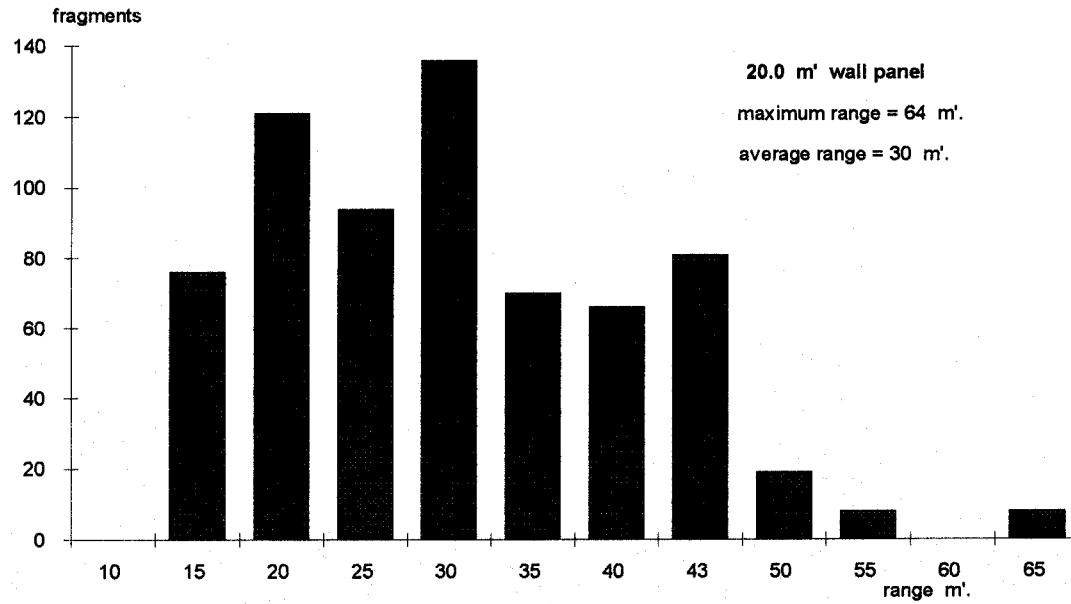
**Figure 8. : Asbestos-cement fragments distribution over the range**

The main steel construction remained in its original position , except of the middle purlin that was disconnected , and was found near the wall . The asbestos-cement sheets were fractured into hundreds of small pieces ranging between 11 and 64 m'. from the wall. Figure (8) shows the number of fragments per distance interval. Figure (9 ) shows the distribution of the fragments' size. We should note that summation of fragments' size equals the original sheets area, meaning that all the fragments were found in the collection process.

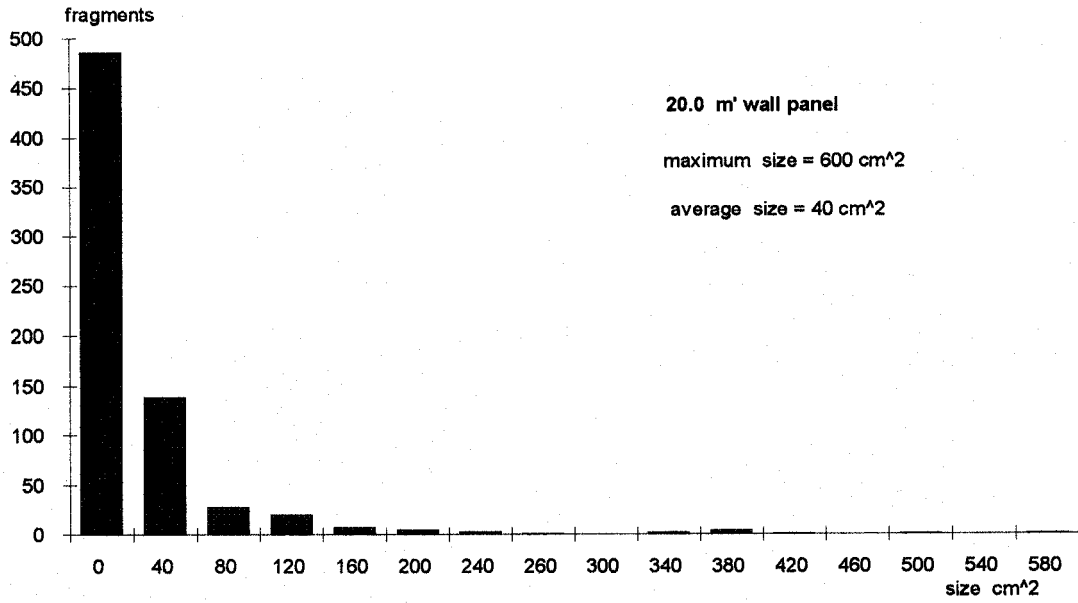
**Figure 9. : Distribution of asbestos-cement fragments' size.**

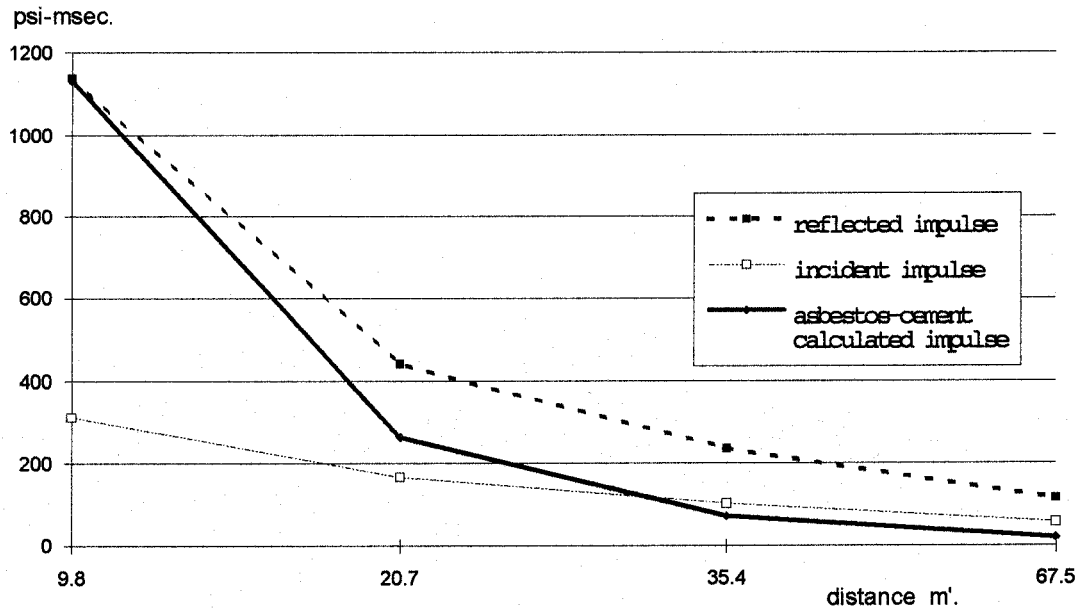
**Figure (14) : calculated impulses that propel asbestos-cement fragments to maximum distance , from different distances of the wall panels from c.o.e**

figure (14) shows us the reflected , the incident impulse , and the calculated impulses that should be taken in order to comply with the test results , all of these, versus the distance of the wall panels from c.o.e. .

The calculations we made for the asbestos-cement fragments could not be made for the other materials that were tested .The data of the fragments' weight and the impulses for the different distances involved velocities that were out of limits of the graph given in figure (2-252) of the manual (2). But, calculations we made by numeric integration of the differential equation of motion , for the fiberglass fragments , gave a very similar behavior as we see in figure (14) .

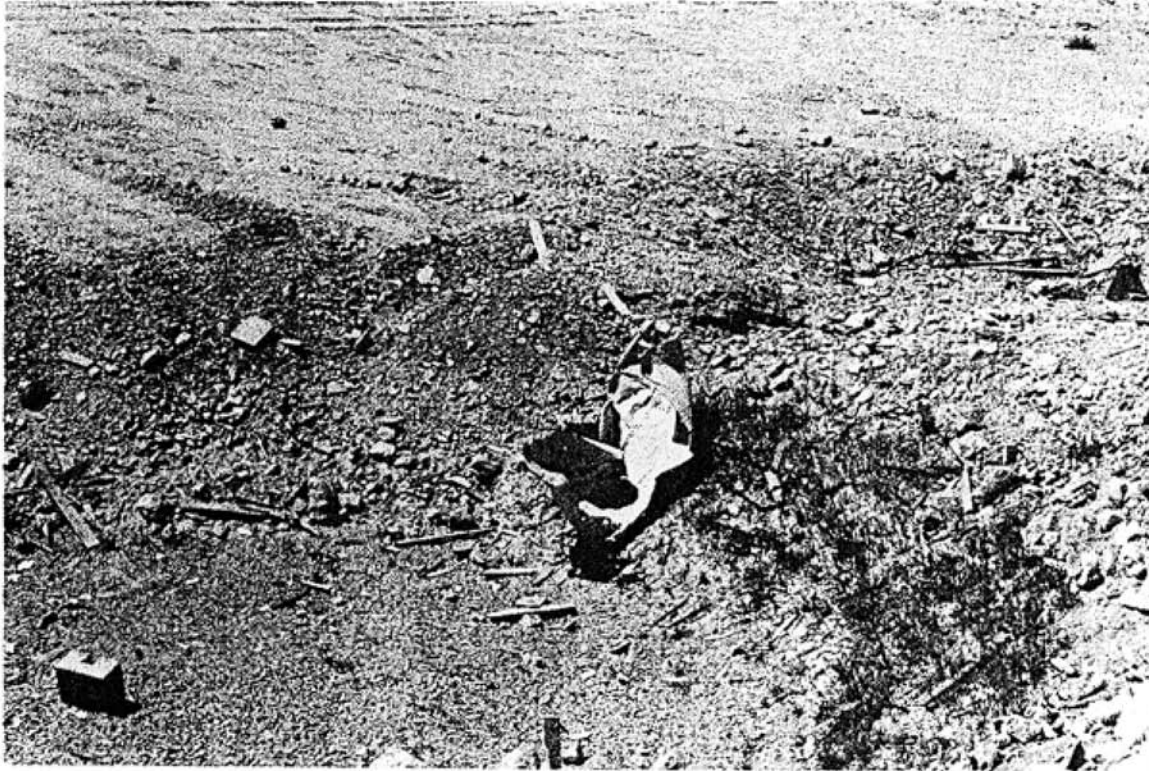
The metal sheet panel flew as one twisted piece and was found 27 m' from its original location.

**PICTURE 6.:  
METAL SHEET 27M FROM WALL PANEL, 20M FROM C.O.E.**

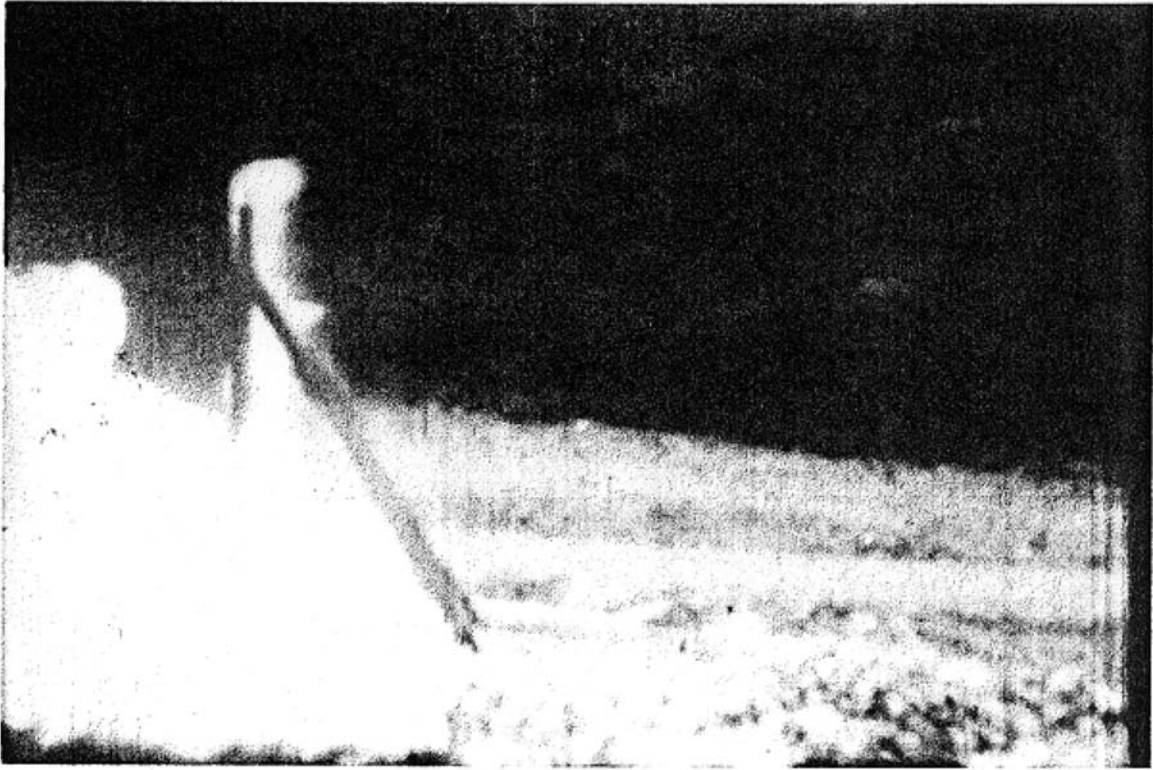
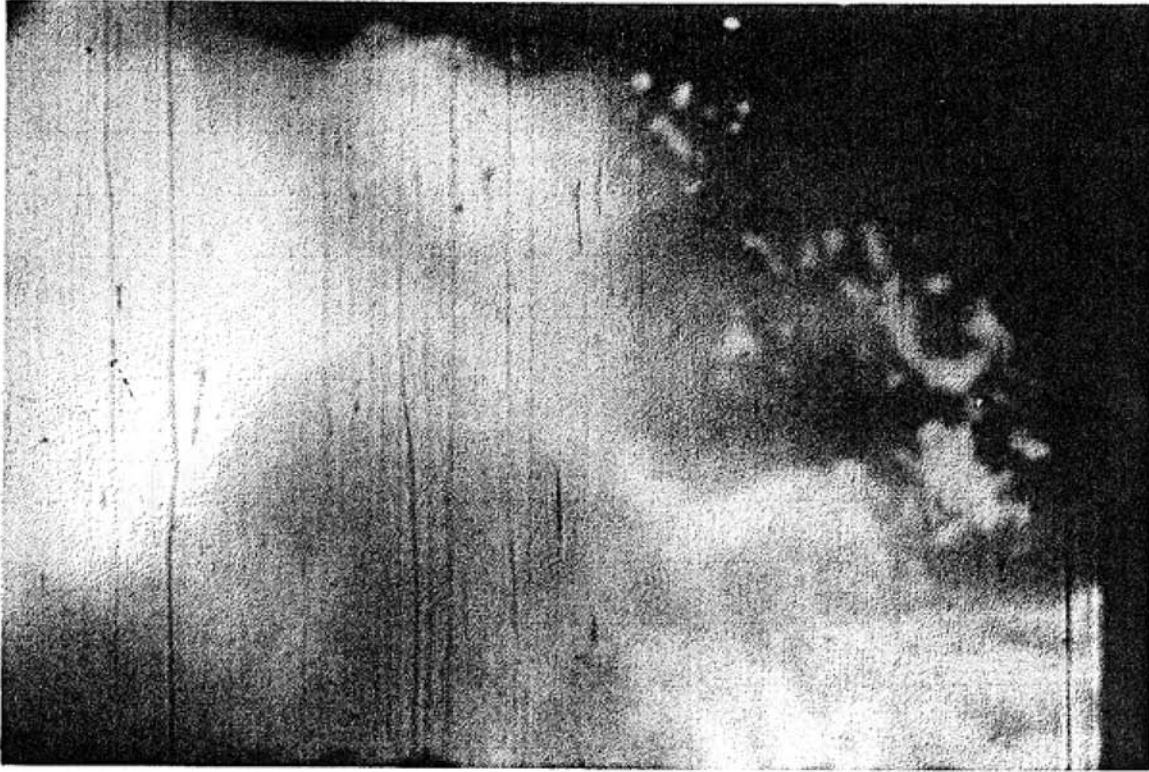
From data obtained by developing of the high speed camera's film , we could evaluate the initial velocity of the fragments to be between 50 and 140 m./sec.,with launching angle of less then 30 deg..

**PICTURE 10.: THE 20M WALL PANEL PRIOR TO THE EXPLOSION  
(HIGH SPEED CAMERA)**

**PICTURE 11.: 10 MSEC AFTER EXPLOSION (HIGH SPEED CAMERA)**

**PICTURE 12.: 30 MSEC AFTER EXPLOSION**

**PICTURE 13.: 42 MSEC AFTER THE EXPLOSION  
(HIGH SPEED CAMERA)**

**PICTURE 14.: 59 MSEC AFTER THE EXPLOSION**
