# BLADE-VORTEX INTERACTION NOISE OF AN ISOLATED FULL-SCALE XV-15 TILT-ROTOR

Army/NASA Rotorcraft Division  
NASA Ames Research Center  
Moffett Field, California 94035

Blade-vortex interaction noise of an isolated full-scale XV-15 tilt-rotor was investigated in the NASA Ames 80- by 120-Foot Wind Tunnel. The objective was to establish the baseline BVI noise signature of a full-scale tilt-rotor and to investigate several noise reduction concepts, including blade-tip subwings, reduced tip Mach number, and the addition of a fourth blade to the rotor system. At the nominal tip Mach number of 0.691, the peak BVI levels were found to occur at a tip-path-plane angle of  $4^\circ$  and at the highest advance ratio tested of 0.2. The BVI noise levels were found to be weakly dependent on  $C_T/\sigma$ . As would be expected, reducing tip Mach number, either of the baseline 3-blade rotor, or in conjunction with a 4-blade rotor, was found to be an effective way to significantly reduce noise. The addition of the tested subwings did not seem to be an effective strategy for noise reduction, and they incurred a performance penalty.

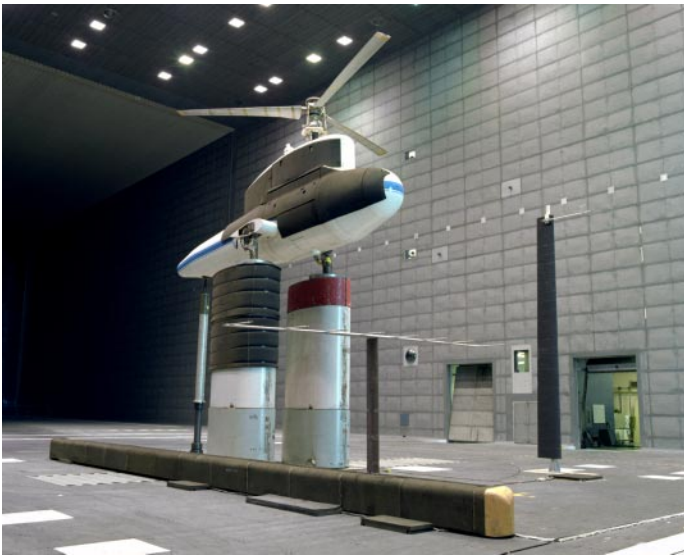
Fig 1. XV-15 right-hand rotor mounted on the RTA in the NASA Ames 80- by 120-Foot Wind Tunnel.

A full-scale, isolated, right-hand XV-15 rotor was tested in the NASA Ames 80- by 120-Foot Wind Tunnel using the Ames Rotor Test Apparatus (RTA). Figure 1 shows the RTA with the XV-15 rotor installed.

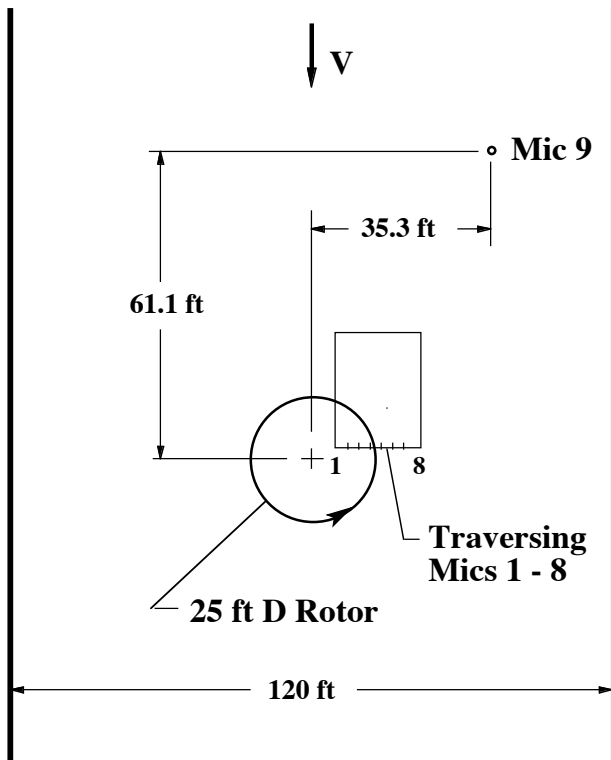
Fig 2. Microphone positions for the XV-15 test in the NASA Ames 80- by 120-Foot Wind Tunnel

For acoustic measurements, a series of microphones was placed around the model (Fig. 2). Eight microphones traversed a horizontal plane on the advancing side of the rotor 1.8 rotor radii below and 0.2 to 2.0 rotor radii upstream of the rotor hub to measure the BVI noise footprint below the advancing side of the rotor. One fixed microphone (Mic #9) was placed at a position estimated to be along the peak BVI noise radiation direction (at a rotor azimuth of  $150^\circ$  and  $20^\circ$  below the rotor plane; at a distance of 3 rotor diameters from the rotor hub). The wind tunnel test section has a sound absorbing liner which eliminates reflections down to approximately 250 Hz (absorption > 90%). In addition to the liner, sound absorbing foam was attached to portions of the model fuselage to eliminate reflections from its large surface. Additional foam treatment was added to selected points in the test section to eliminate reflection from local hard points.

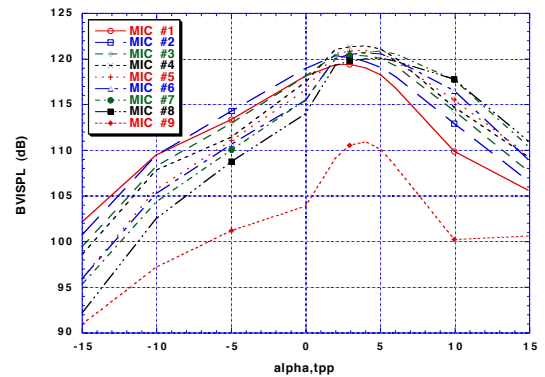
Fig 4. BVISPL as function of  $\alpha_{tpp}$  at  $\mu = 0.2$ . 3-blade rotor.  $M_{tip} = 0.691$ ,  $C_T/\sigma = 0.075$ . Traverse at  $r/R = 1.0$ .

Data for the 3-blade baseline rotor were obtained over a wide range of operating conditions up to advance ratios of 0.2, as shown in Table 1. For most operating conditions, the forward microphone and the traverse microphones showed similar trends. In the following discussion, where appropriate the forward microphone was selected as representative of all the microphones. Bandpass filtered acoustic levels for the forward microphone (Mic #9) at  $M_{tip} = 0.691$  and  $C_T/\sigma = 0.075$  are shown in Fig. 3 as function of  $\mu$  and  $\alpha_{tip}$ . No smoothing has been applied to these data and the figure exhibits some kinks due to variations in data which have been extracted from different runs throughout the test. The peak BVISPL levels occur near  $\mu = 0.2$  and  $\alpha_{tip} = 4^\circ$ . Figure 4 shows BVISPL as function of  $\alpha_{tip}$  at an advance ratio of 0.2 for all the microphones. The traverse was at one rotor radius forward of the hub. This was the location of the highest BVI levels in the majority of cases. For Microphone #9, Fig. 4 is essentially a vertical cut through Fig. 3 at  $\mu = 0.2$ . The BVI noise levels peak near  $4^\circ$ . A similar horizontal cut at a tip-path-plane angle of  $4^\circ$  shows the variation of BVISPL as function of  $\mu$  in Fig. 5. The highest BVI levels were measured at the highest tested  $\mu$  of 0.2. This figure also shows that the traverse microphone (i.e. the lateral location) where the peak BVI level was measured varies with  $\mu$ . Figure 6a shows BVISPL as function of  $C_T/\sigma$  and indicates that noise levels are quite insensitive to thrust at the highest BVI condition. However, Fig. 6b shows that at a somewhat lower BVI level, there is a relatively weak dependence on  $C_T/\sigma$ .

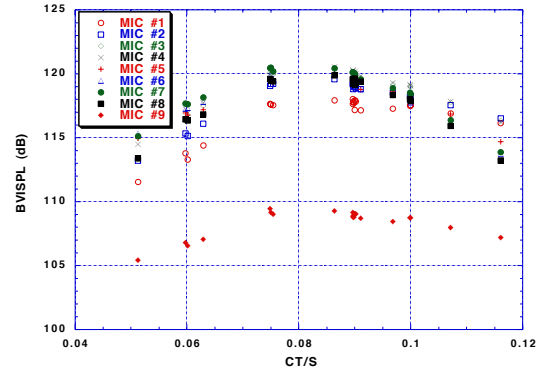
Fig 6b. BVISPL as function of  $C_T/\sigma$  at  $\mu = 0.17$  and  $\alpha_{pp} = 3^\circ$ . 3-blade rotor.  $M_{tip} = 0.691$ . Traverse at  $r/R = 1.0$ .

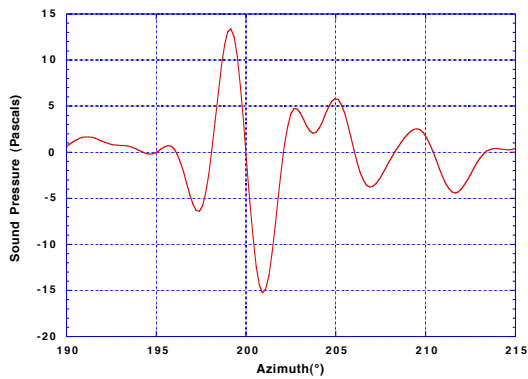
Fig 12. Filtered acoustic time history at the low BVI condition ( $M_{tip} = 0.691$ ,  $C_T/\sigma = 0.075$ ,  $\mu = 0.15$ ,  $\alpha_{pp} = -3^\circ$ ). 3-blade rotor. Mic #9. Expanded azimuth, middle pulse.

The acoustic footprint under the advancing side of the rotor is shown in Fig. 9 for the peak BVI conditions ( $\mu = 0.2$  and  $\alpha_{tip} = 4^\circ$ ). Two other acoustic footprints at a moderate BVI condition and a low BVI condition are included in Figs 10 and 11. Note that the peak BVI region moves forward as  $\mu$  decreases and inward as the rotor tip-path-plane rotates down. Figure 12 is the bandpass filtered time history at the low BVI condition. Note the lower amplitude, as well as the change in the pulse shape compared to Fig. 8(b).

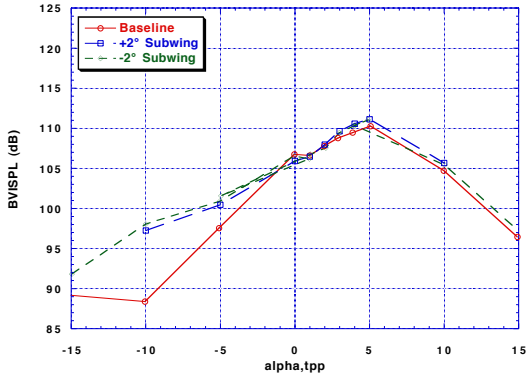
Fig 15. Comparison of two subwings with baseline rotor.  $M_{tip} = 0.691$ ,  $C_T/\sigma = 0.09$ ,  $\mu = 0.17$ . Mic #9.

Figure 15 is a comparison of BVI noise levels of the two subwings with the baseline rotor measured at the forward microphone (Mic #9) at fixed  $C_T/\sigma$ ,  $M_{tip}$ , and  $\mu$  over a range of  $\alpha_{tip}$ . Figures 16 – 18 are the acoustic footprints at the same operating conditions near the peak BVI condition,  $\alpha_{tip} = 3^\circ$ . The effect of the addition of both sets of subwings was to increase, rather than decrease, the noise.

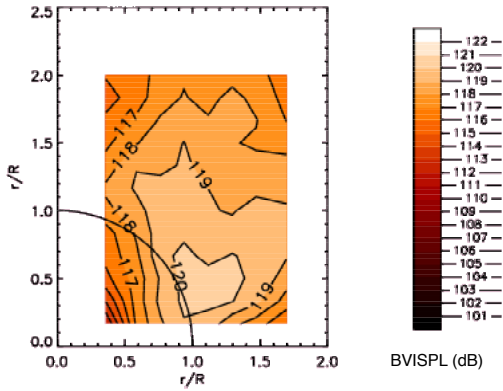
Fig 16. Acoustic footprint of baseline rotor.  $M_{tip} = 0.691$ ,  $C_T/\sigma = 0.09$  (thrust = 5500 lbs),  $\mu = 0.17$ ,  $\alpha_{pp} = 3^\circ$ .

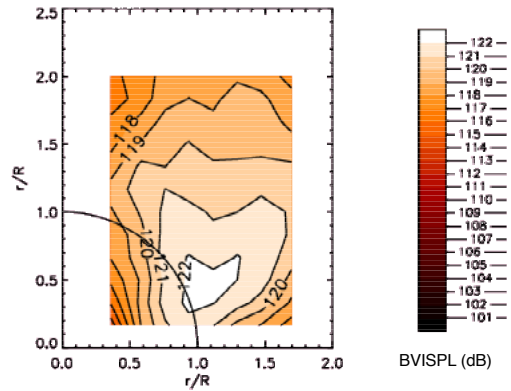
Fig 18. Acoustic footprint of rotor with -2° subwings.  $M_{tip} = 0.691$ ,  $C_T/\sigma = 0.09$ ,  $\mu = 0.17$ ,  $\alpha_{pp} = 3^\circ$ .

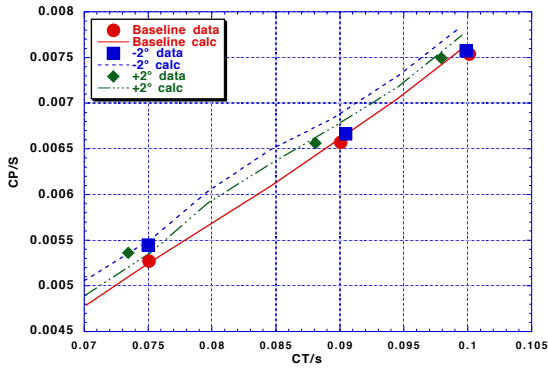
Fig 19. Effect of subwings on rotor performance.  $M_{tip} = 0.691$ ,  $\mu = 0.17$ ,  $\alpha_{pp} = -10^\circ$ .

The influence of the subwings on rotor performance was also examined, including comparison with CAMRAD II calculations. Figure 19 shows measured and calculated power for the XV-15 rotor with and without subwings, as a function of thrust,  $\mu = 0.17$ ,  $M_{tip} = 0.691$ , and  $\alpha_{tip} = -10^\circ$  (nose down). The measured performance data show a general increase of power required with the subwings installed. There is some effect of subwing angle in the data. The rectangular subwing at  $-2^\circ$  gives the smallest increase in power compared to the baseline; the rectangular subwing at  $+2^\circ$  produces the largest power increase.

In the calculated performance, the profile and induced power are both increased by the subwing. The propulsive force is reduced with the subwing, and hence the parasite power is reduced. The profile and parasite power changes are about the same magnitude (hence cancel in the change of total power), and about one-third the induced power change. The calculated net

power increase is smallest for the  $+2^\circ$  subwing and largest for the  $-2^\circ$  subwing. The induced power increase produced by the  $+2^\circ$  subwing is  $\Delta C_p/\sigma = .00019$ , that for the  $-2^\circ$  subwing  $\Delta C_p/\sigma = .00026$ . This larger value of induced power is caused by more extensive negative loading at the blade tip for the  $-2^\circ$  subwing, compared to the  $+2^\circ$  subwing. While the calculated influence of subwing angle is not very great for power, it is more noticeable for the blade loading and wake geometry.

Overall, the correlation between measured and calculated power is good. For the  $-2^\circ$  subwing, the measurements and calculation exhibit different trends compared to the other subwing. Work underway on correlation with the baseline XV-15 results may improve the calculated influence of thrust, but probably will not change the calculated influence of the subwing. Little influence has been found of rolled up vortex core size on the calculated performance, with or without the subwing. There might be some influence of blade elasticity for the XV-15. Aerodynamic model deficiencies relevant to these results are calculation of loading on low aspect ratio subwings, and the lack of a representation of merging of the primary and subwing vortices.

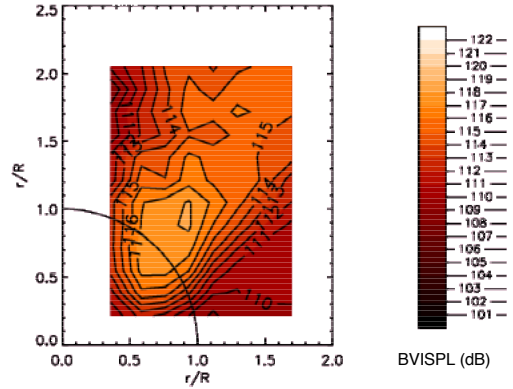
Fig 21. Acoustic footprint of 4-blade rotor.  $M_{tip} = 0.691$ , thrust = 5500 lbs, speed = 77 knots,  $\alpha_{pp} = 3^\circ$ .

Figure 20 is a comparison of the BVI noise, at the forward microphone, of the 3 - and 4 - blade rotors, operated at the same thrust and speed, at both the same and lower  $M_{tip}$ . Figures 21 and 22 are the respective acoustic footprints of the 4 - blade rotor at  $\alpha_{tip} = 3^\circ$ . The corresponding 3-blade data at  $M_{tip} = 0.691$  is shown in Fig. 16. It is clear that noise reductions of as much as 10 dB are possible, but only in conjunction with lower RPM operation.

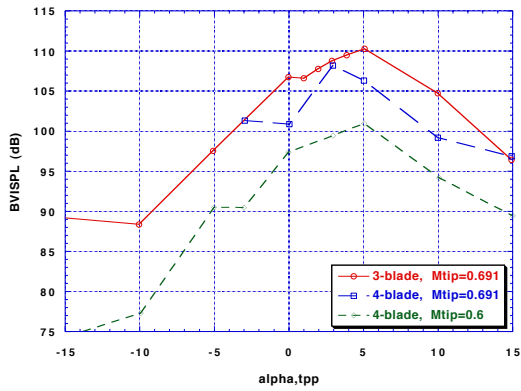
Fig 20. Comparison of 4-blade rotor with 3-blade rotor at fixed thrust = 5500 lbs and speed = 77 knots. Mic #9.

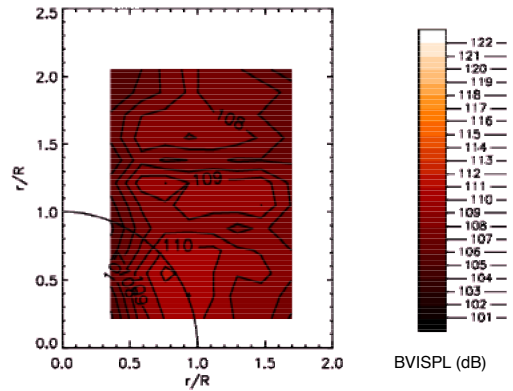
Fig 22. Acoustic footprint of 4-blade rotor.  $M_{tip} = 0.6$ , thrust = 5500 lbs, speed = 77 knots,  $\alpha_{pp} = 3^\circ$ .
