Scaled Debris Throw of Third Generation Norwegian/US Aircraft Shelters

Patricia M. Bowles
Kirk A. Marchand
John W. Strybos

1. REPORT DATE AUG 1990	2. REPORT TYPE	3. DATES COVERED 00-00-1990 to 00-00-1990			
4. TITLE AND SUBTITLE Scaled Debris Throw Tests of Norwegian/US Aircraft Shelters		5a. CONTRACT NUMBER			
		5b. GRANT NUMBER			
		5c. PROGRAM ELEMENT NUMBER

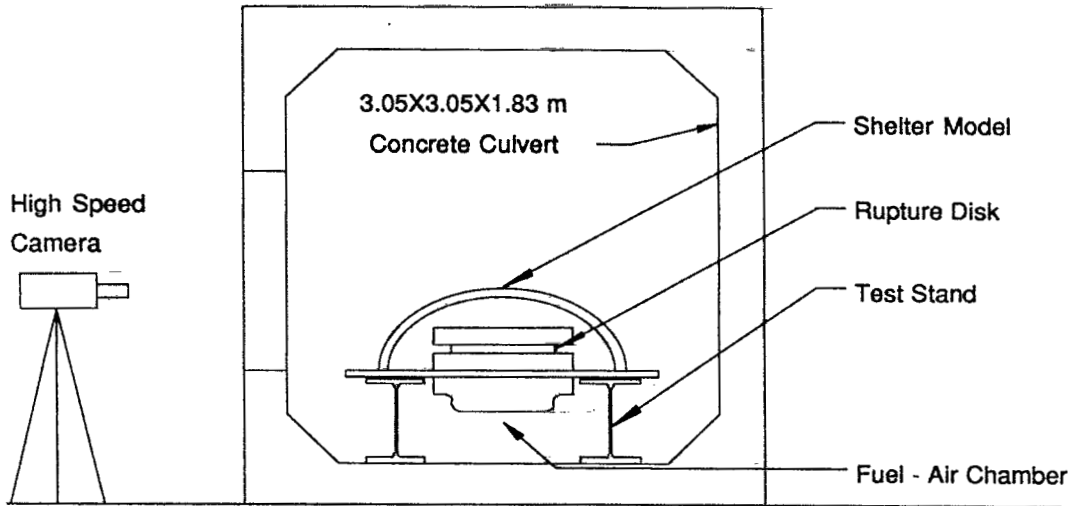
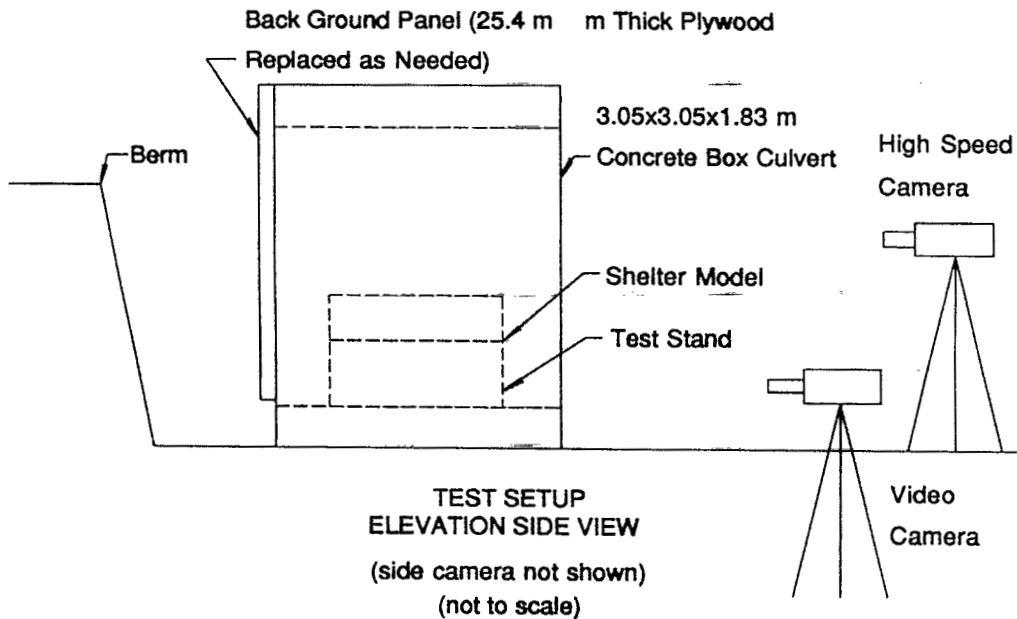
Figure 1. Test Setup

The test setup is shown in Figure 1. The test stand was used to support the shelter model and contained a chamber for the fuel/air mixture. The front of the test stand consisted of a rigid steel panel which formed the "rear wall" of each shelter tested. The vent panel of each shelter faced the rear end of the test stand. The test stand and shelter were placed inside a 3.0 meter tall by 3.0 meter wide by 1.8 meter deep reinforced concrete box culvert. Viewing ports were cut into the side and roof of the culvert for cameras and lights. Background panels, fabricated from 25 mm thick plywood, were painted and attached to the culvert. The background panels were painted blue with a 150 mm by 150 mm white grid pattern. The grid pattern was used for the data analysis. Two high speed cameras and a videotape camera were used to record each test. One high speed camera was focused on the side of the model and the other camera and the video camera were focused on the front of the test frame. The high speed cameras operated at between 1000 to 3000 frames per second depending on the available light conditions for the test. The high speed films were analyzed to determine the velocity and the trajectory of the debris. Blast gages were mounted in the test stand to record the blast pressure/impulse. Still camera coverage was used to provide before and after documentary pictures.

TEST SETUP
FRONT ELEVATION
(not to scale)

TEST SETUP
ELEVATION SIDE VIEW
(side camera not shown)
(not to scale)

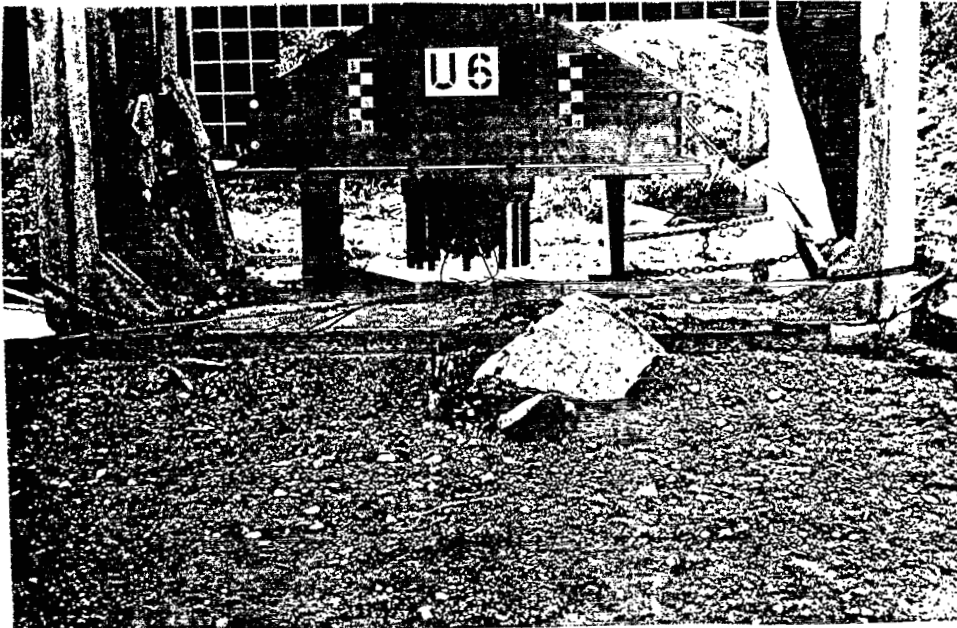
Figure 2. Results of Test 6 Using 0.27 Kg Charge

The third generation Norwegian/US shelter breakup pattern was identical to the DISTANT RUNNER shelter and falls into the category of two major debris segments. This is true for both 0.27 Kg and 0.82 Kg charge weights. Before and after pictures of Test 6, a 0.27 Kg charge in a third generation Norwegian/US shelter model, demonstrate this type of breakup in Figure 2. The FRG shelters behaved somewhat differently than the third generation Norwegian/US and

Test Setup

Resultant Debris
