# **NAVAL POSTGRADUATE SCHOOL**

## **THESIS**

**CONSOLIDATION OF SURFACE COATINGS BY  
FRICTION STIR TECHNIQUES**

September 2010

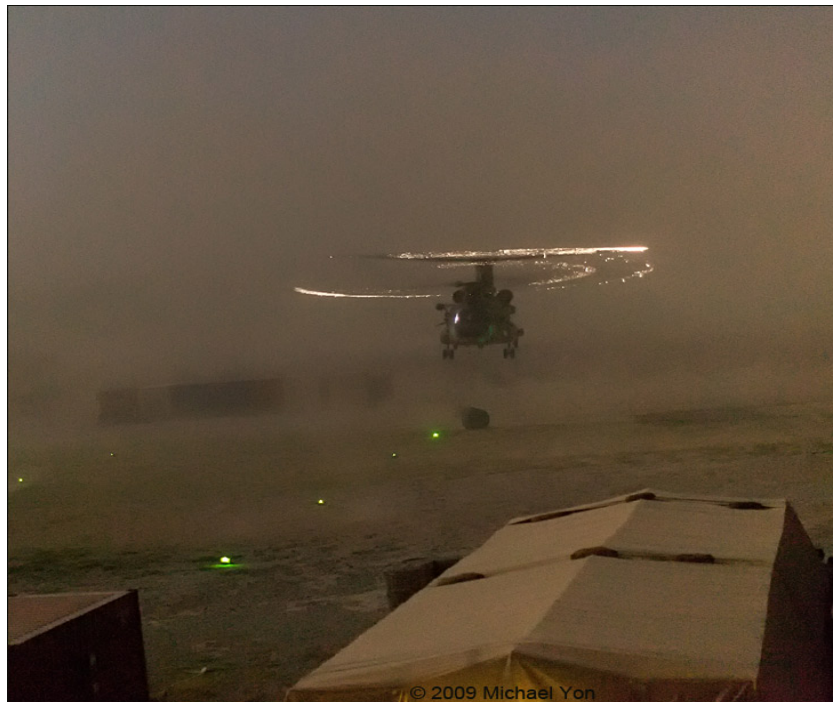
Figure 5. Arcing of helicopter blade leading edges in contact with debris in the air, in this case, sand. From [14].

Figures 5 and 6 show helicopters conducting operations in the harsh environment of the Middle East. As the helicopter blades encounter airborne sand, several incendiary particles are seen. These fragments are believed to be the protective coating, applied to the leading edges of the blades, being removed by the collision with the sand. This phenomenon has not only been observed during takeoff and landing, but also at higher altitudes, especially during sandstorms. In addition to the damage caused to the leading edges of the blades, this effect can be especially dangerous during night-time operations, as the incendiary halo can be visible for miles.

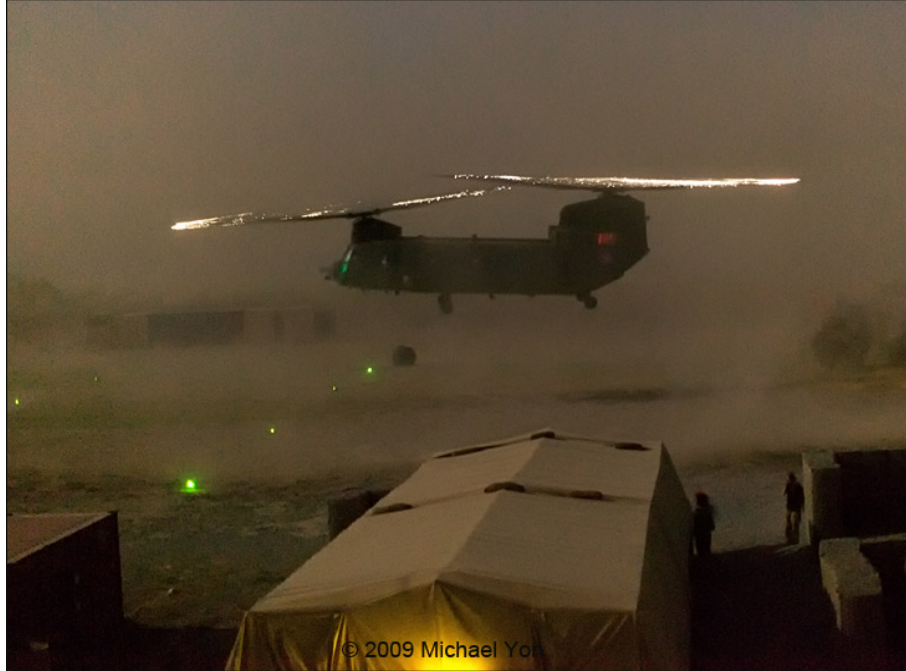
Figure 6. Arcing of helicopter leading edges erodes protective metal layer leaving the blades vulnerable to excessive pitting and further erosion. From [14].

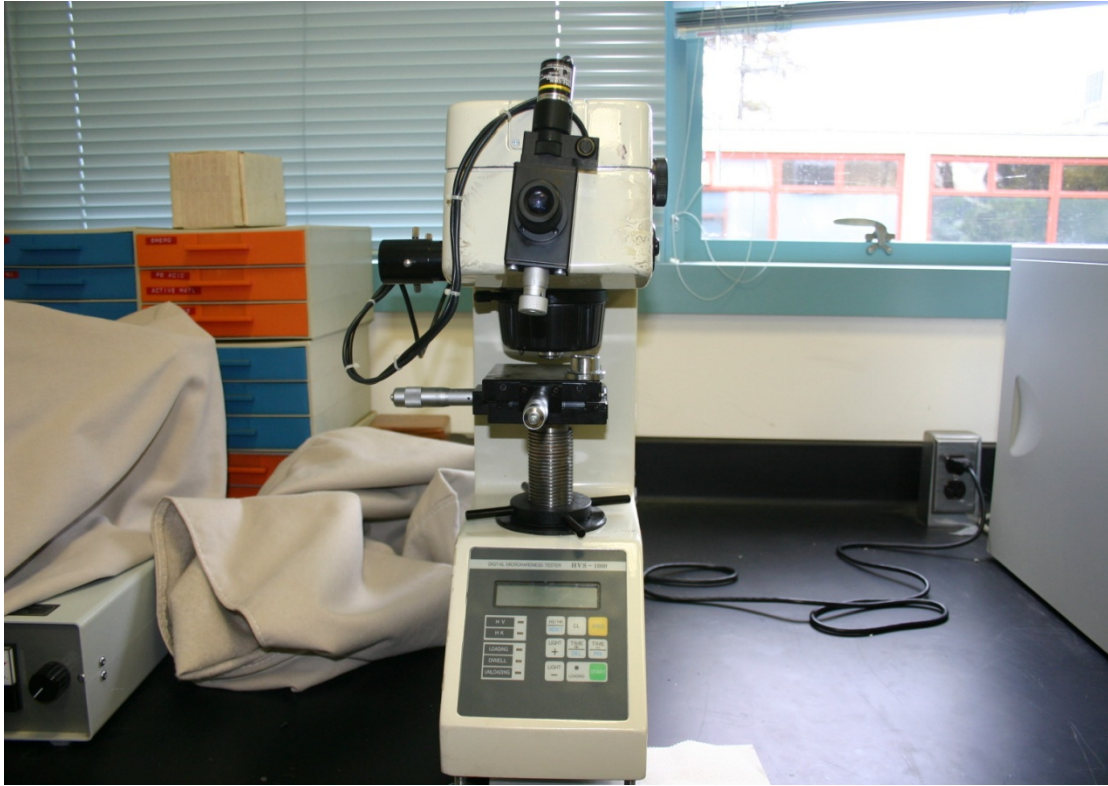
Figure 14. Harness testing machine.

Hardness measurements were conducted using a Digital Micro-hardness Tester model HVS-1000. The machine allows for various methods of obtaining hardness data; for this experiment, the Vickers hardness scale was utilized. The methodology involved applying a square based-pyramid diamond micro-indenter to the surface of the sample. The applied force was .96 newtons, and the force was held for a dwell time of ten seconds. After removal of the indenter, the diagonals of the diamond shape indentation are measured via the attached microscope and measuring device, while onboard electronics calculated the hardness value, which was displayed on the machine.

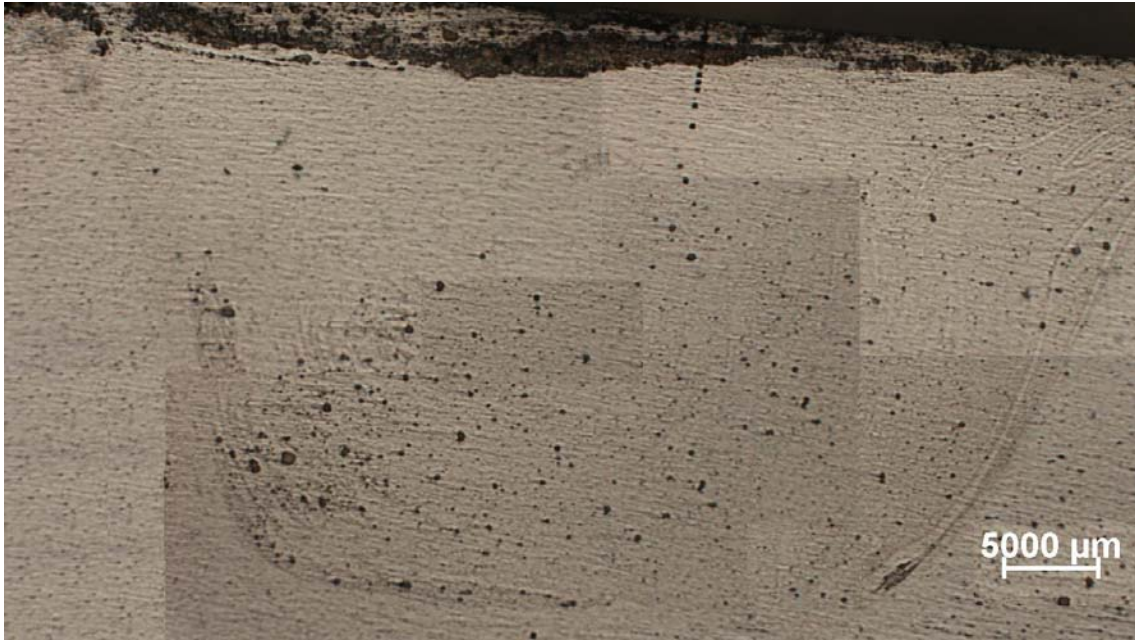
Figure 19. FSP stir zone A, single pass, pinned tool sample.

The figures below show a low magnification montage of the stir zone A, a single pass pinned tool sample, as well as stir zone B, the multi-pass pinned tool sample. The stir is evident by the apparent shape and change in grain structure.

Figures 19-22 show a refinement of the microstructure in the stir zone as a result of the FSP. The average grain size has been reduced, and the coating has been partially consolidated, but not in a particularly useful way. Run D yielded similar results, but too much downward force was applied during the FSP, and the end result was the removal of the Titanium coating. Runs C and E were done with a pinless tool, so no obvious stir zone was found.
