## **Field Testing and Load Rating of a Short-Span Thermoplastic Bridge System, Bridge T-8519**

Brett Commander and Henry Diaz-Alvarez

November 2010

Final report

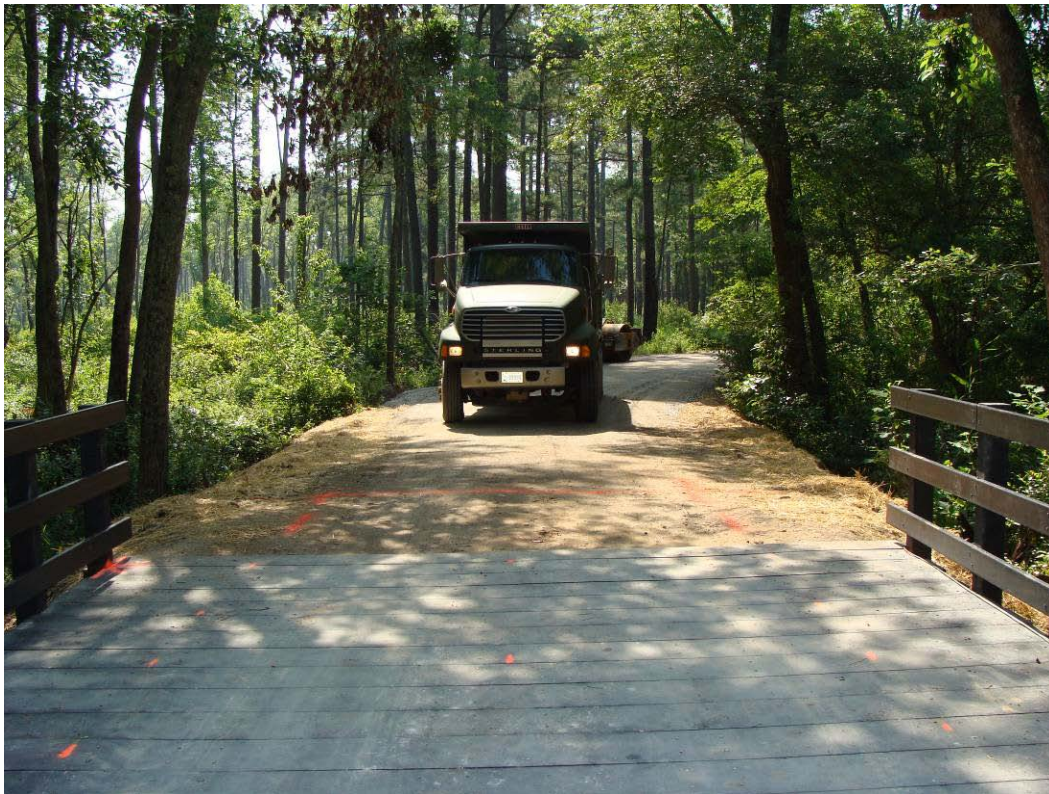
Figure 9. Dump truck approaching bridge during initial test.
