**BASRAH INTERNATIONAL AIRPORT –  
AIR SIDE POWER SUPPLY TO  
NAVAIDS AND VISAIDS  
BASRAH, IRAQ**

**PROJECT NUMBER SIGIR-PA-06-050**

**JUNE 30, 2006**

### **Basrah International Airport – Air Side Power Supply to NAVAIDS and VISAIDS, Basrah, Iraq**

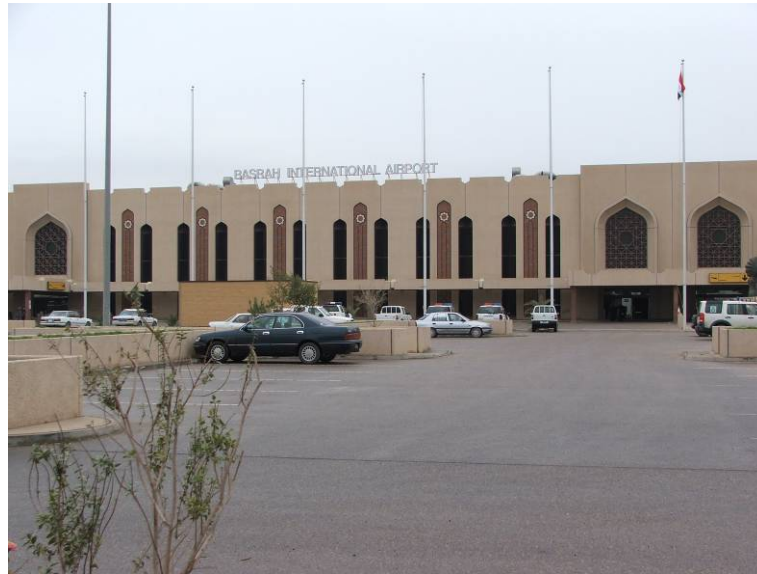
The BIA was an existing airport located outside of the city of Basrah in southern Iraq. Site Photo 1 shows the exterior of the terminal building at BIA. The airport is one of three major airports in Iraq. The airport electrical distribution systems were not operational because the systems were not properly maintained throughout the previous regime, and the electrical systems were damaged, looted, and cannibalized.

**Site Photo 1: Exterior view of the terminal building**

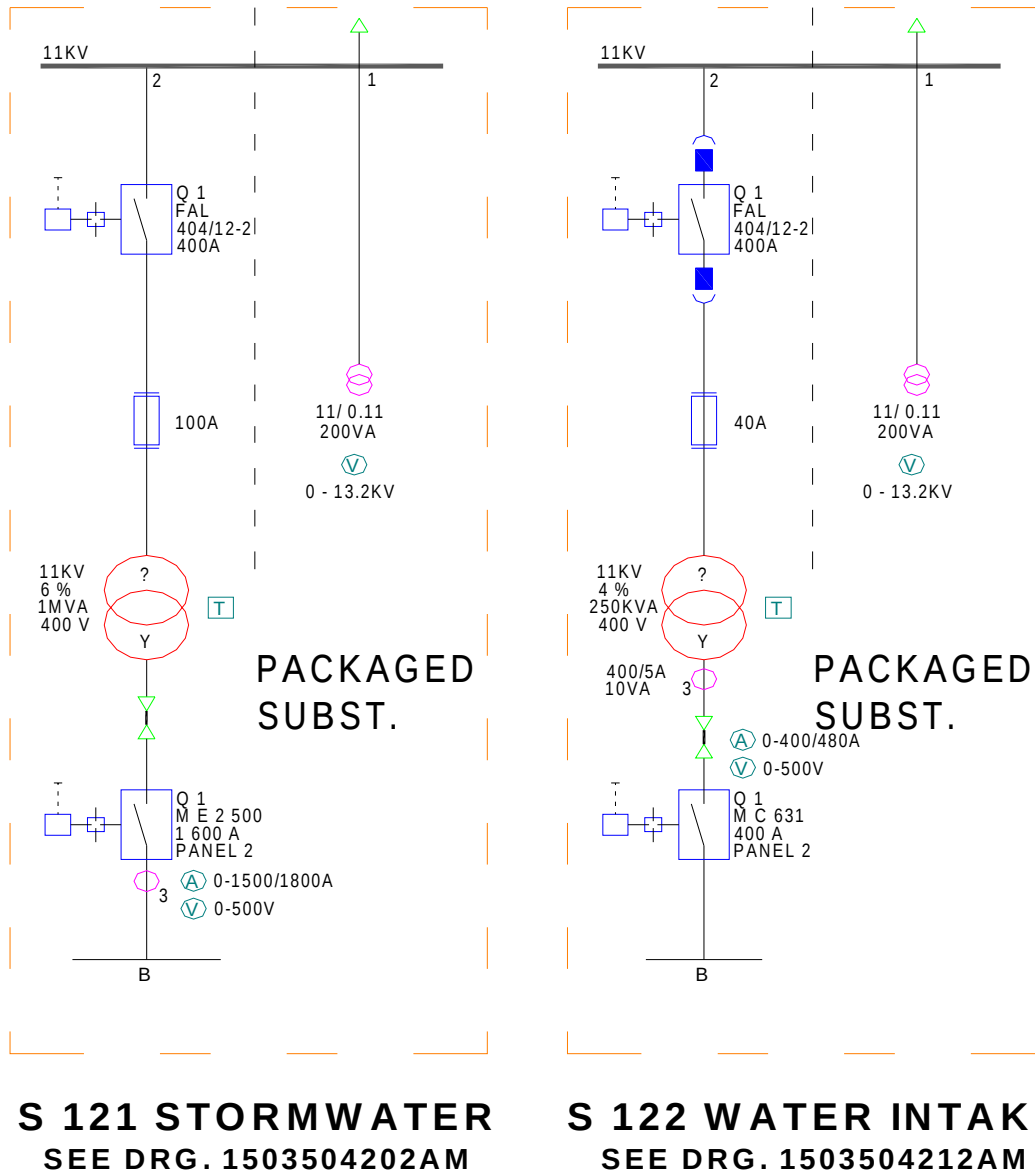
The electrical schematic diagram included the complete BIA MV system with the three MV rings and individual substations. Specific details for the quantity and type of components were included within the schematic. Figure 2 shows an example of a portion of the schematic, which included electrical system details for two of the substations.

**Figure 2: Excerpt from PDR schematic showing details of the electrical distribution system at the Basrah International Airport**

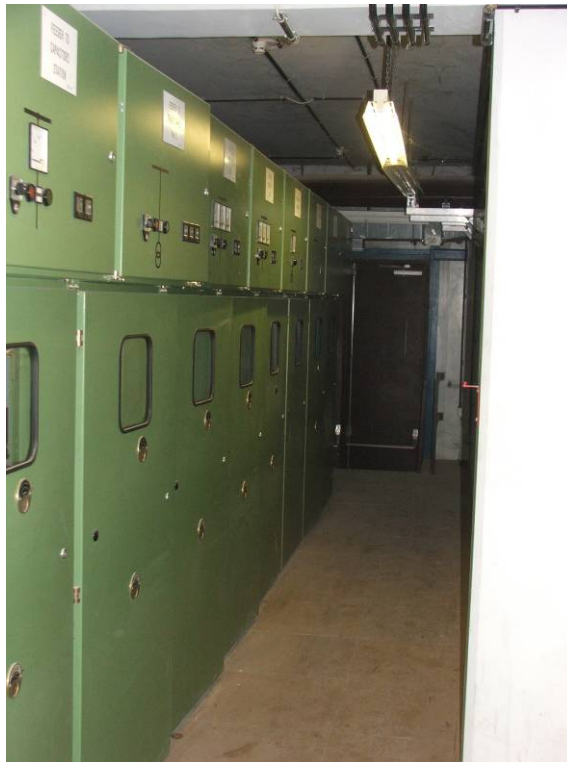
The main plant facility is located across a large parking area from the BIA passenger terminal. The plant facility houses the airport chillers and boilers, as well as the 33 kV to 11 kV switchgears and transformers. The main plant building appeared to be in good condition, and the 33 kV to 11 kV switchgear and transformers were in-place. The 33 kV switchgear and transformers were designed to feed the three MV distribution rings to supply power to the secondary transformers for ultimate usage. At the time of the assessment, the 33 kV switchgear and transformer appeared to be complete with no obvious missing components. The final PDR ROM recommended repair, maintenance, and upgrade of the systems. Site Photo 2 shows the external cabinets of the 33 kV to 11 kV switchgears.

**Site Photo 2: Exterior view of 33 kV to 11 kV switchgear cabinets**

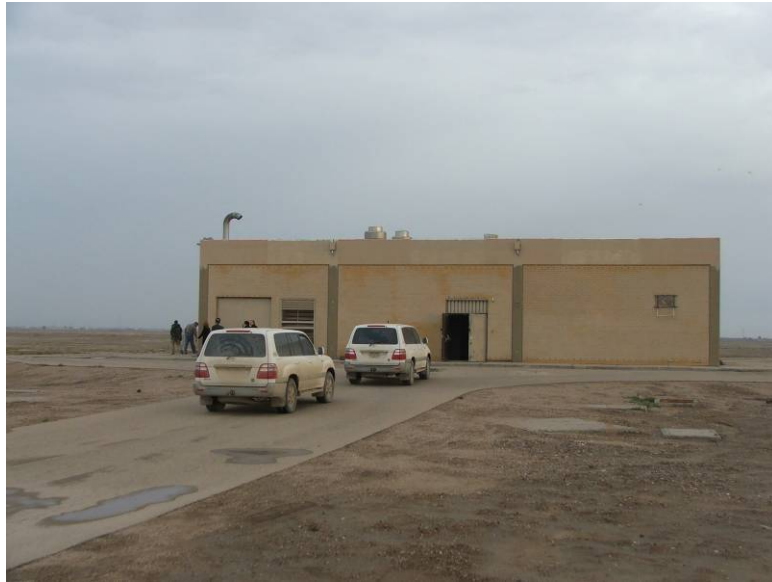
At the time of the assessment, the building appeared to be in good condition, although the electrical equipment appeared to be incomplete and was not operational. The recessed runway lighting receptacles were in-place, although the lights themselves were missing. The interim PDR recommended replacement of all equipment at S-330 and completing minor repairs to the existing building. The recommendations of the PDR were consistent with the observations during the site assessment visit.

**Site Photo 3: Exterior view of S-330 substation**

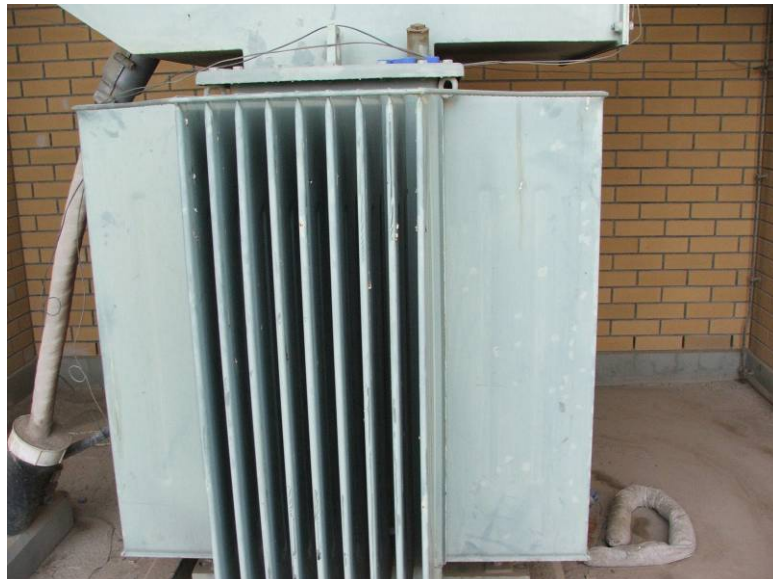
**Site Photo 4: Transformer located at S-330**

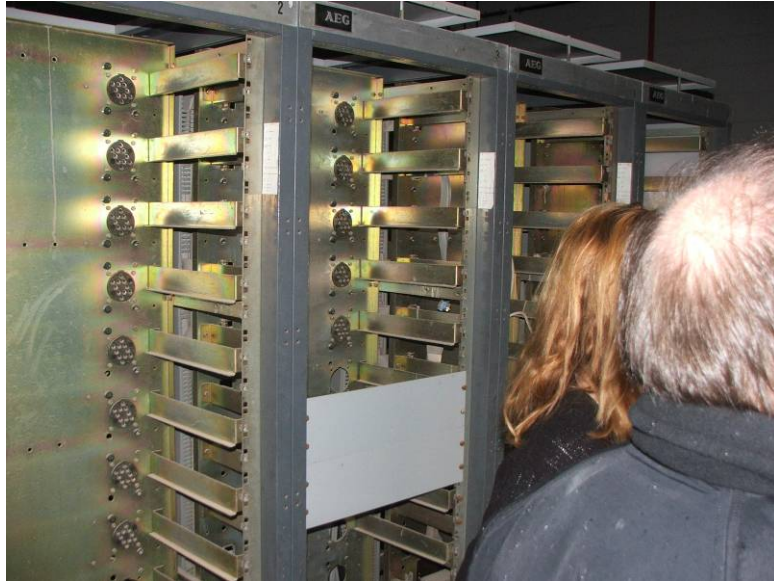
**Site Photo 5: Missing electronic equipment at S-330**

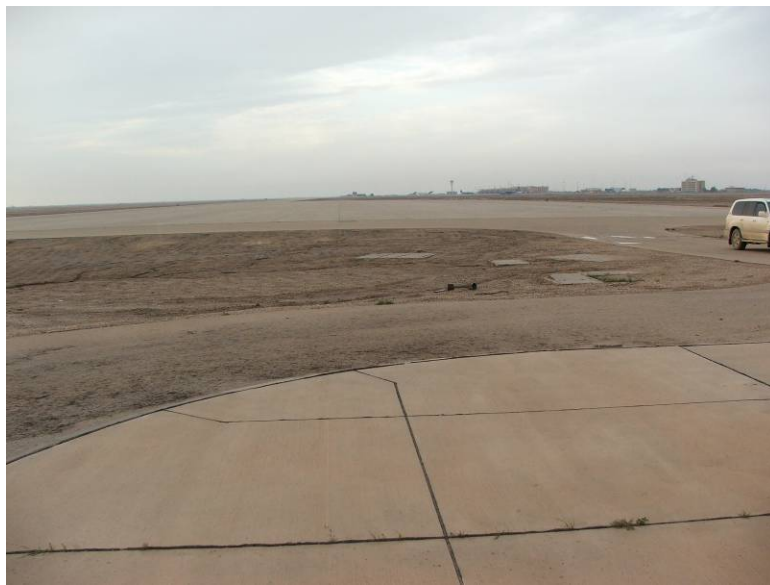
**Site Photo 6: Runway system at Basrah International Airport**

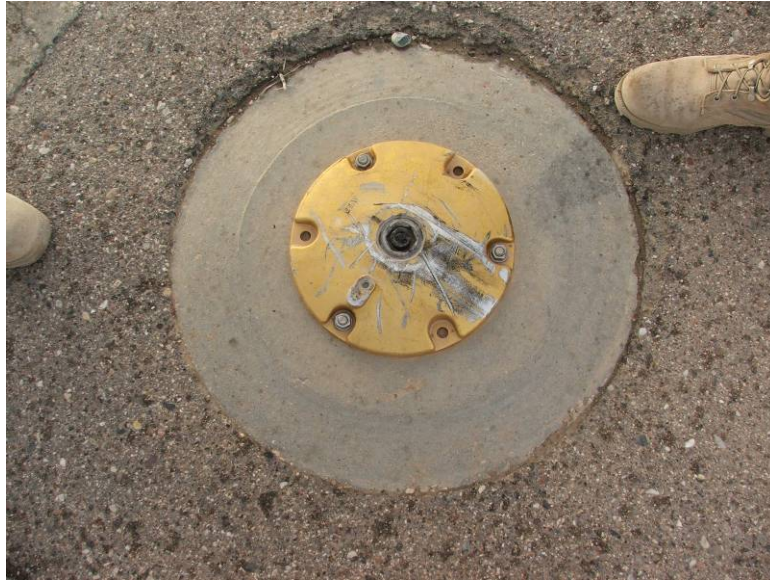
**Site Photo 7: Runway light (VISAID)**
