CRITICAL CARE UNIT  
IBN AL BITAR HOSPITAL  
BAGHDAD, IRAQ

**SIGIR-PA-06-066**  
**SEPTEMBER 12, 2006**

SUBJECT: Report on Project Assessment of the Critical Care Unit at the Ibn Al Hospital,  
Baghdad Iraq (Report Number SIGIR-PA-06-066)

## Critical Care Unit, Ibn Al Bitar Hospital Baghdad, Iraq

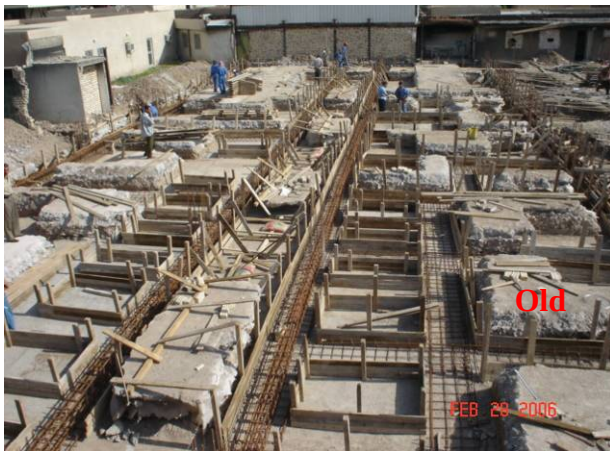
**Site Photo 2 - Wall footings and tie beams under construction (Photo provided by USACE)**

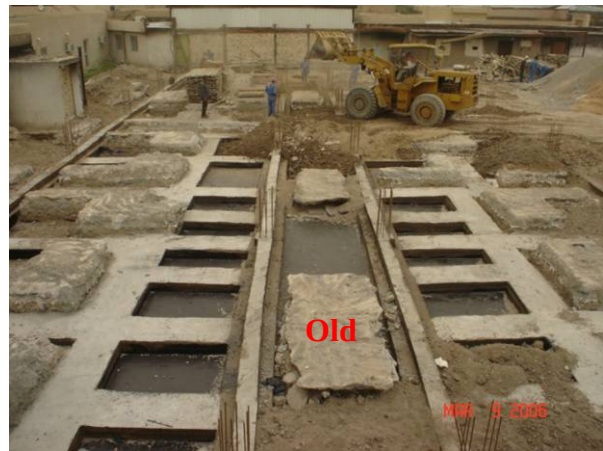
The CCU building structural design required a reinforced concrete frame supported by a foundation consisting of isolated pad footers, wall footings, and interconnecting tie-beams. Prior to placement of the footers, the concrete foundation from the previous building needed removal. The contractor removed the existing foundation as the new foundation was constructed. Site Photo 2 shows some of the remaining foundation as well as the form work and reinforcing steel placement for the new tie beams and wall footings. Site Photo 3 shows the completed foundation including tie-beams and wall footings, and some of the previous concrete foundation remaining. According to the DRE, the contractor subsequently removed all of the concrete comprising the previous foundation. Based on our review of the Government Quality Assurance (QA) reports, the construction of the foundation occurred without any known deficiencies.

**Site Photo 3 - Completed wall footings and tie-beams (Photo provided by USACE)**

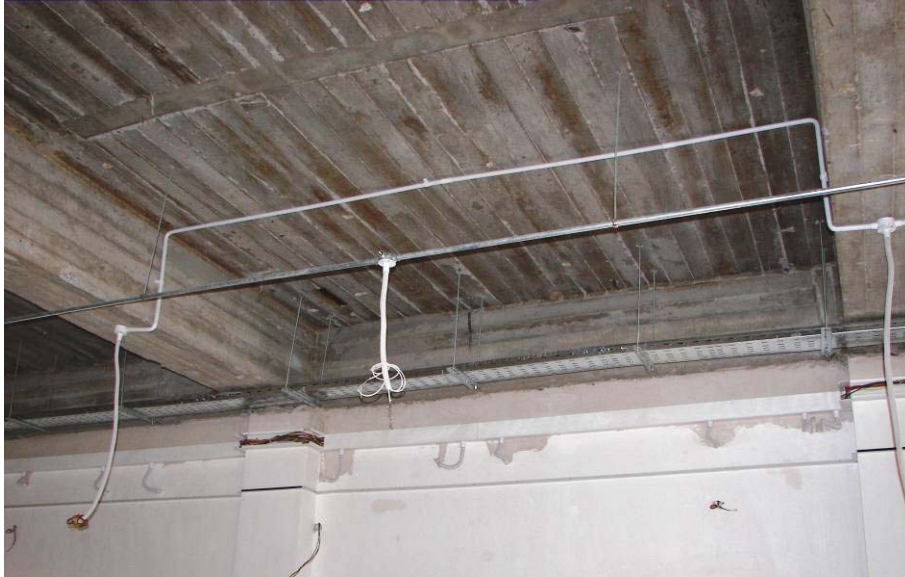
At the time of the site visit, the suspended ceiling had not been completely installed so the assessment team could see the upper portions of the ground floor columns and beams. We did not observe any noticeable defects with the concrete workmanship such as honeycombing, segregation, or exposed reinforcing steel. Site Photo 4 shows some of the structural concrete work at the CCU.

**Site Photo 4. Structural concrete supporting the first floor**

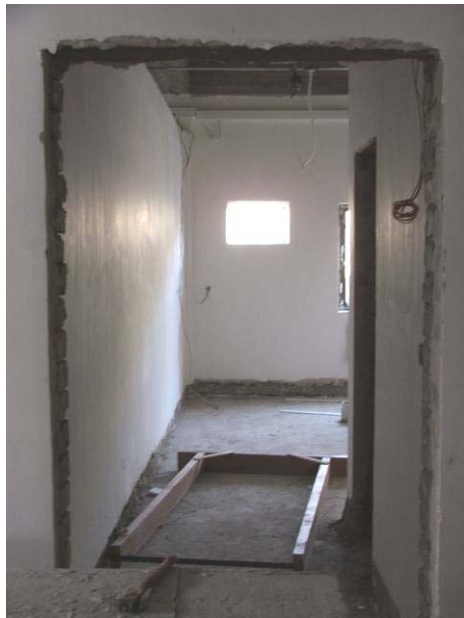
All observed work in the patient rooms and doctors' room and their adjoining bathrooms appeared to meet the standards of the design. We did not find any noticeable defects associated with the quality of workmanship.

**Site Photo 7. Patient room looking from entrance**

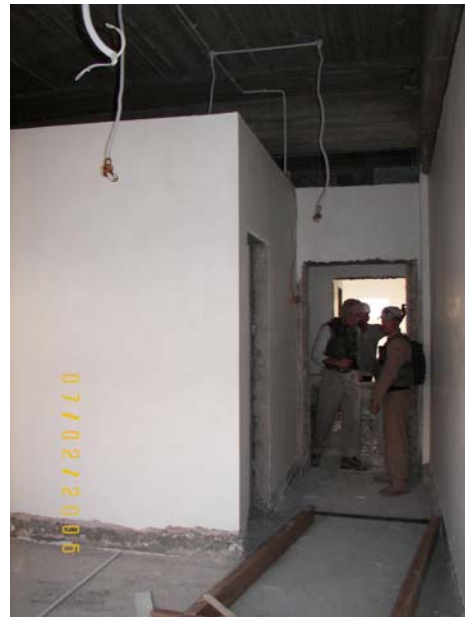
**Site Photo 8. Patient room looking towards entrance**

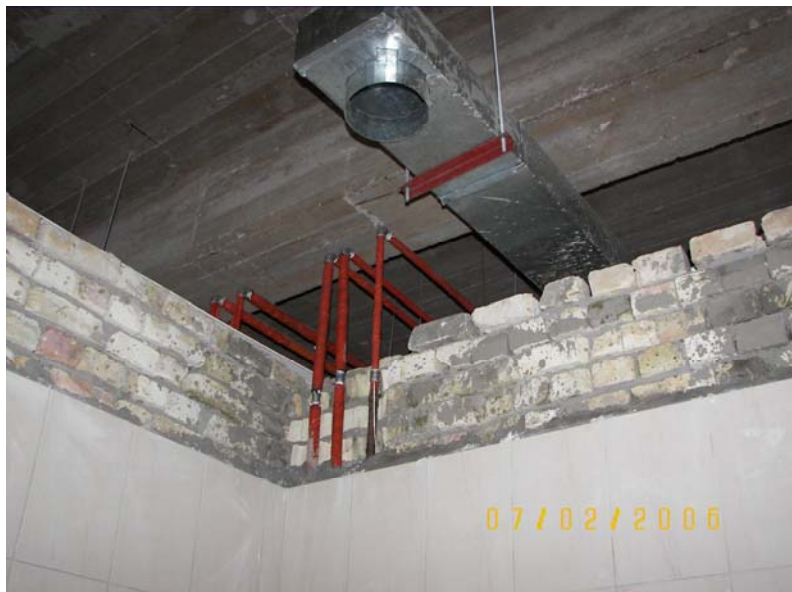
At the time of the assessment, the patient room walls had been plastered and painted. The contractor had also completed the installation of ceramic tile on the bathroom walls. The flooring and ceilings were not yet installed in any of the patient rooms including the bathrooms. Window frames were in place, but the glass was not yet installed. The frame for the window HVAC unit was in place, but the unit was not yet installed. The contractor was in the process of installing door frames. The contractor also began to rough-in plumbing for the toilets, wash basins, and showers. Site Photos 7 and 8 show the ongoing construction in one of the patient rooms. Site Photo 9 shows the above ceiling water lines and exhaust system ductwork for one of the bathrooms.

**Site Photo 9. Water lines and exhaust system ductwork above one of the patient bathrooms**

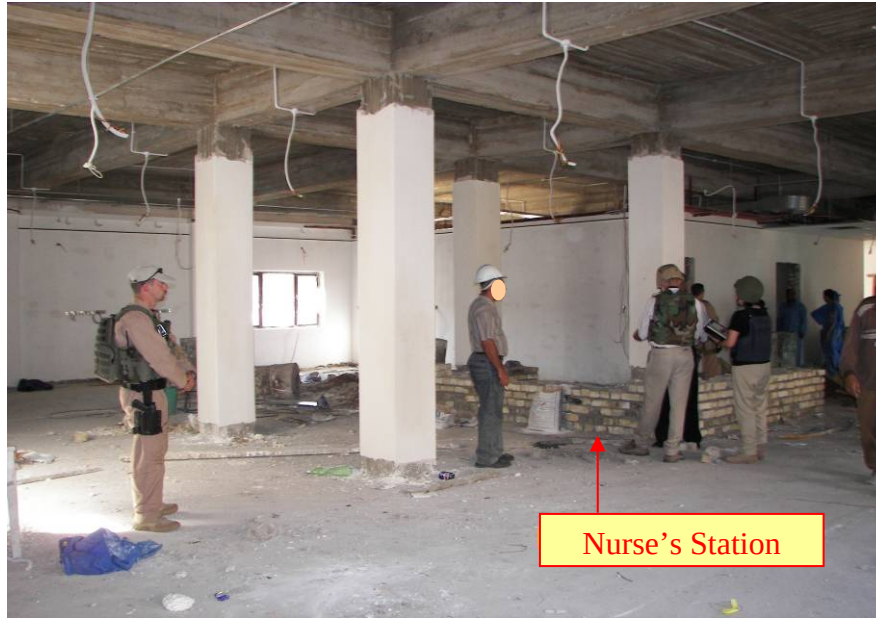
At the time of our assessment, the contractor had completed plastering and painting the exterior walls. Aluminum window frames were installed. Electrical conduits were in place, and the contractor was in the process of pulling wire to recessed boxes for outlets and switches. Site Photo 10 shows part of the open ward observed during the site visit.

**Site Photo 10. Ward area under construction.**

In addition to the building components, the contractor was also constructing a brick reception table base (Site Photo 10) for the nurse's station in the open ward area. The BOQ required a ceramic tile finish for the table.

Based on our observations, the work to date in the ward area appeared to meet the standards of the design.

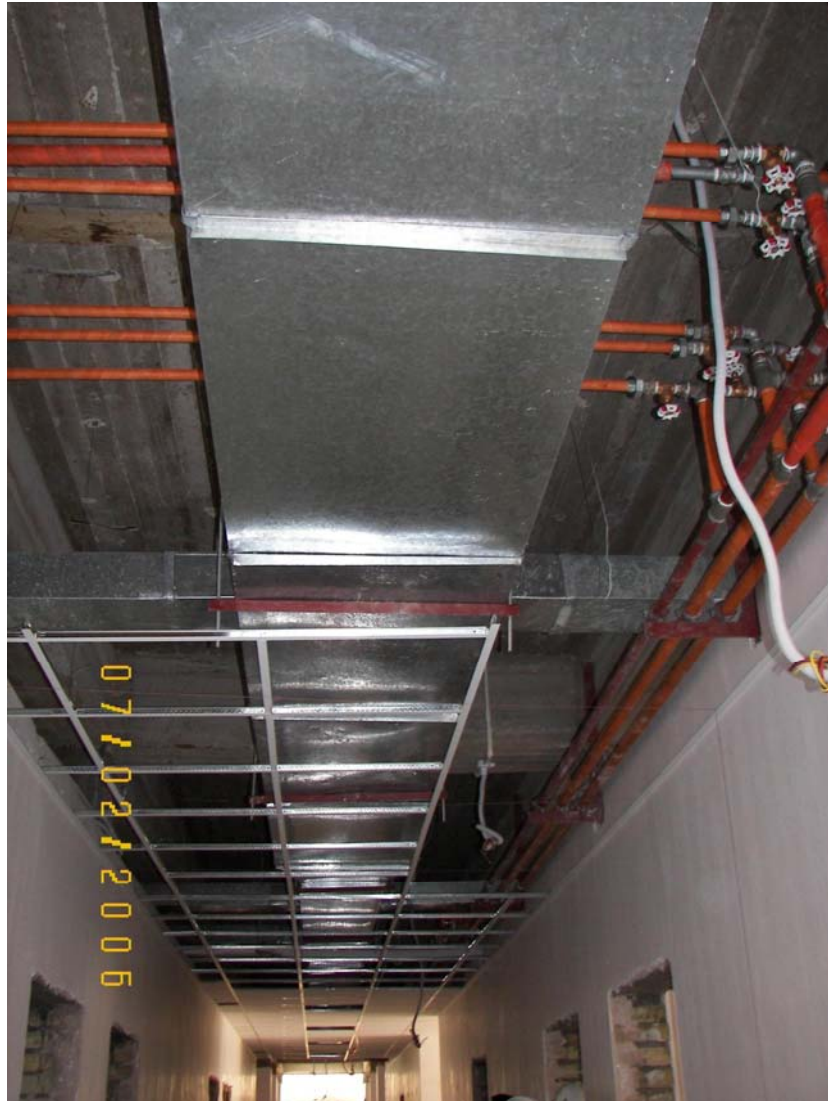
The CCU contained a central corridor (21.6 m in length) providing access to the patient rooms and the ward area. The corridor also provided an access way for the utilities (water, exhaust, and electric), located above the suspended ceiling. Site Photo 11 shows the water lines, the exhaust system ductwork, and the electrical drops installed by the contractor, as well as part of the suspended ceiling grid. The water supply system consists of three lines of various diameters [15 – 50 millimeters (mm)] of schedule 40 galvanized steel pipes for cold water, hot water, and re-circulated hot water. No noticeable defects were found with the installation of these utilities and the quality of workmanship appeared adequate.

**Site Photo 11. Utility installation above corridor suspended ceiling.**

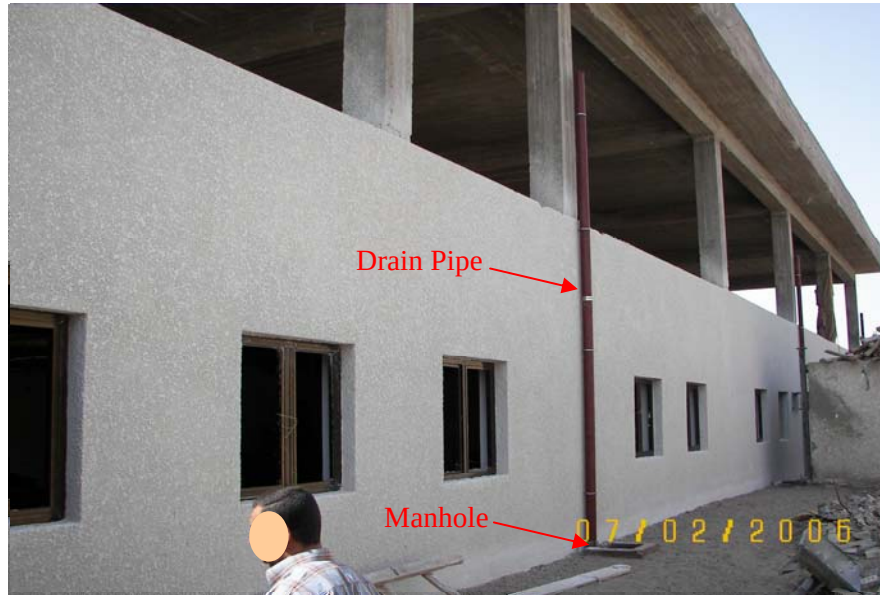
The BOQ listed a requirement for 80 linear meters of 100 mm (diameter) cast iron downspouts. The architectural drawings show the location of the seven roof drains along the column lines for the building. During the exterior inspection, we observed the cast iron downspouts in the locations noted on the design along the column line. We also noted the downspouts drained directly into the manholes, as shown in Site Photo 13, although the design drawings did not provide details showing the downspouts or connections into manholes.

**Site Photo 13. CCU exterior with downspout feeding into sewer manhole.**

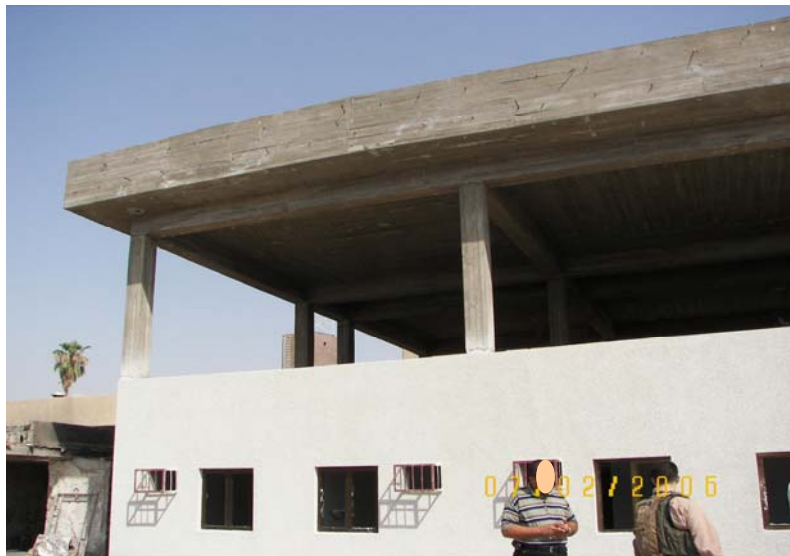
The assessment team planned to inspect the first floor and roof. However, because of recent activity in this area of Baghdad, security concerns prevented the team from going up to the first floor and to the roof. From the ground, we did walk around the building and looked at the exterior columns and beams of the first floor and roof parapet. We did not observe any noticeable defects associated with the concrete workmanship. Site Photo 14 shows the first floor and roof structural concrete work.

**Site Photo 14. First floor columns and beams supporting roof**
